# Inspection Photos

Operator: Caerus Piceance LLC- #10456

Location Name: Couey-67S92W /5SESW

Inspection Document #: 702800134

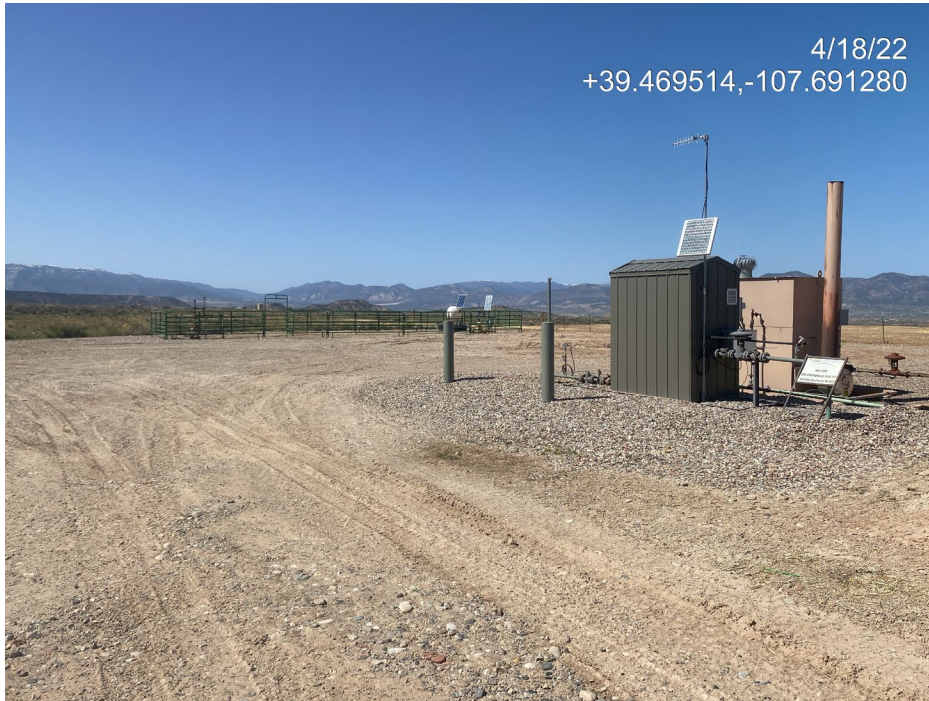
**Photo 1.** Photo taken from the Location entrance facing northwest shows an overview of the Location.

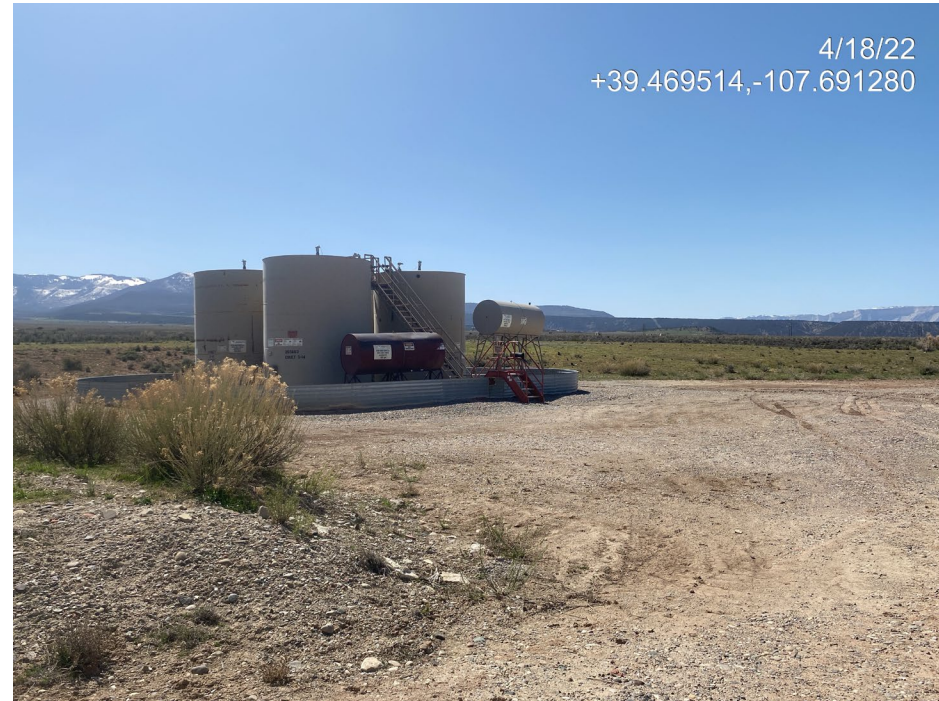
**Photo 2.** Photo taken from the Location entrance facing southwest shows an overview of the Location.

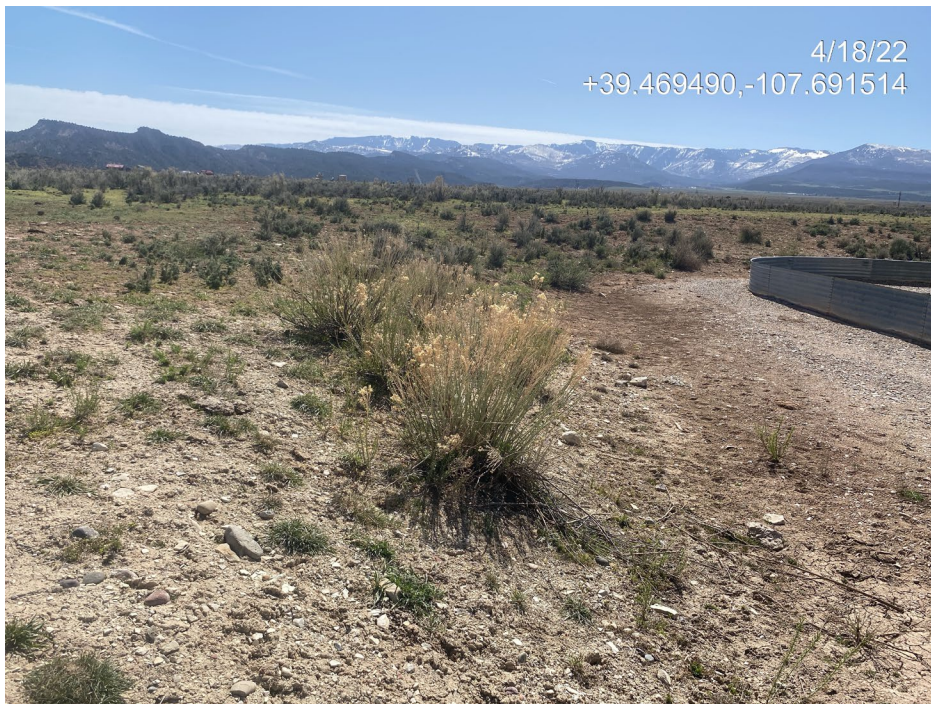
**Photo 3.** Photo taken from the southeast of the Location facing south shows interim areas colonized by sparse perennial grasses, curlycup gumweed, rubber rabbitbrush and sagebrush.

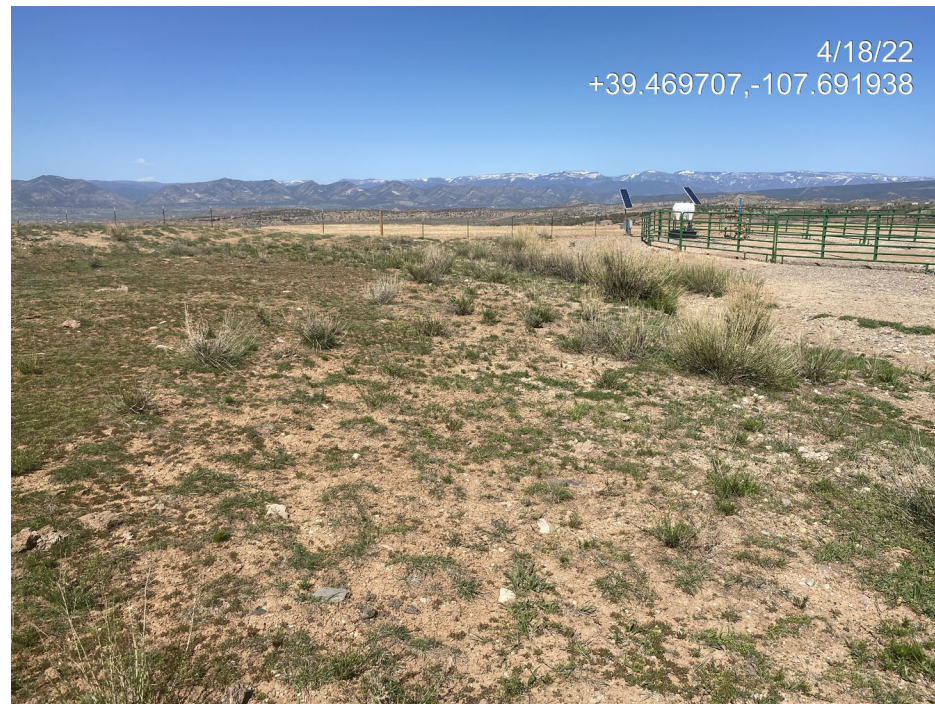
**Photo 4.** Photo taken from the west of the Location facing north shows interim areas colonized by sparse perennial grasses, rubber rabbitbrush and annual invasive weeds/undesirable plant species.

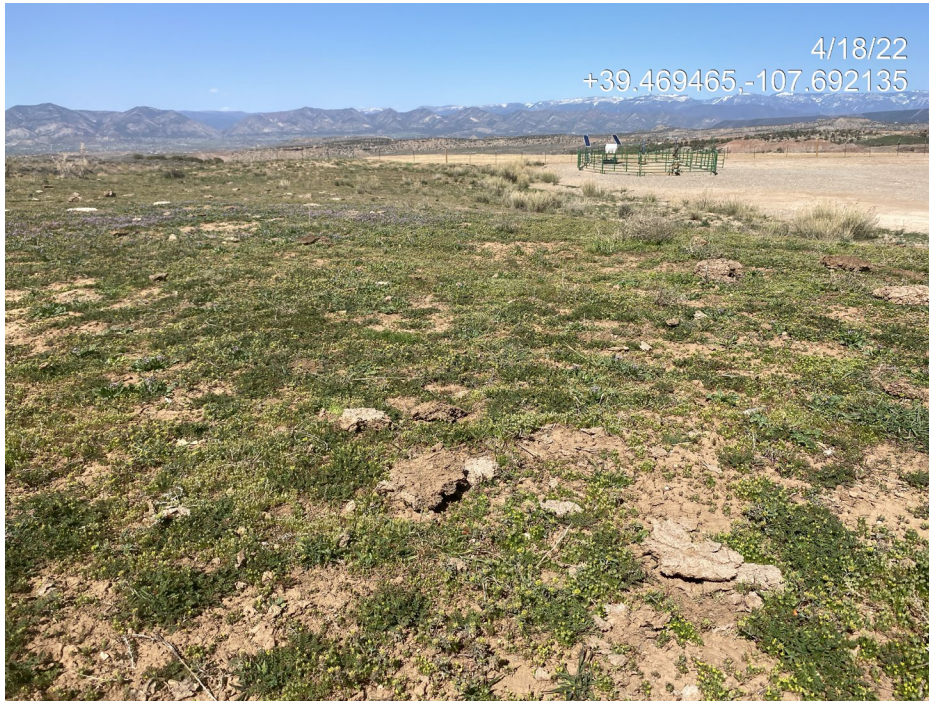
**Photo 5.** Photo taken from the west of the Location facing north shows the western interim area dominated by annual invasive weeds/undesirable plant species including pale madwort, cheatgrass, bur buttercup and Russian thistle, with minimal perennial grasses.

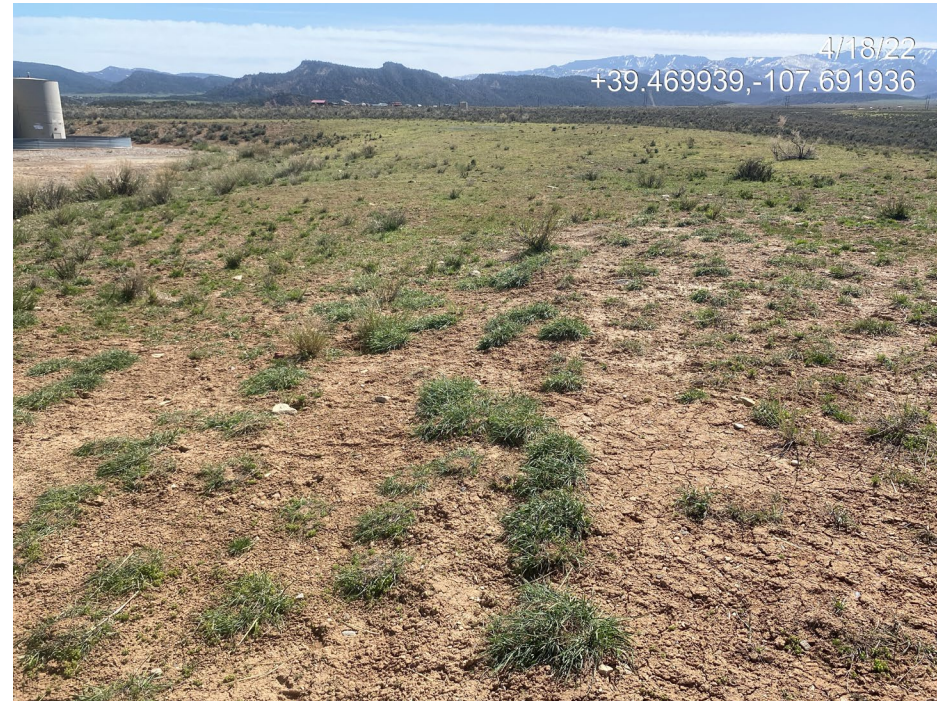
**Photo 6.** Photo taken from the west of the Location facing south shows contrasting perennial establishment, with perennial grasses established in the foreground and a lack of establishment in the middleground.
