Inspection Photos

Operator: Caerus Piceance LLC- #10456

Location Name: Brynildson-66S92W /29NENW

Inspection Document #: 702800141

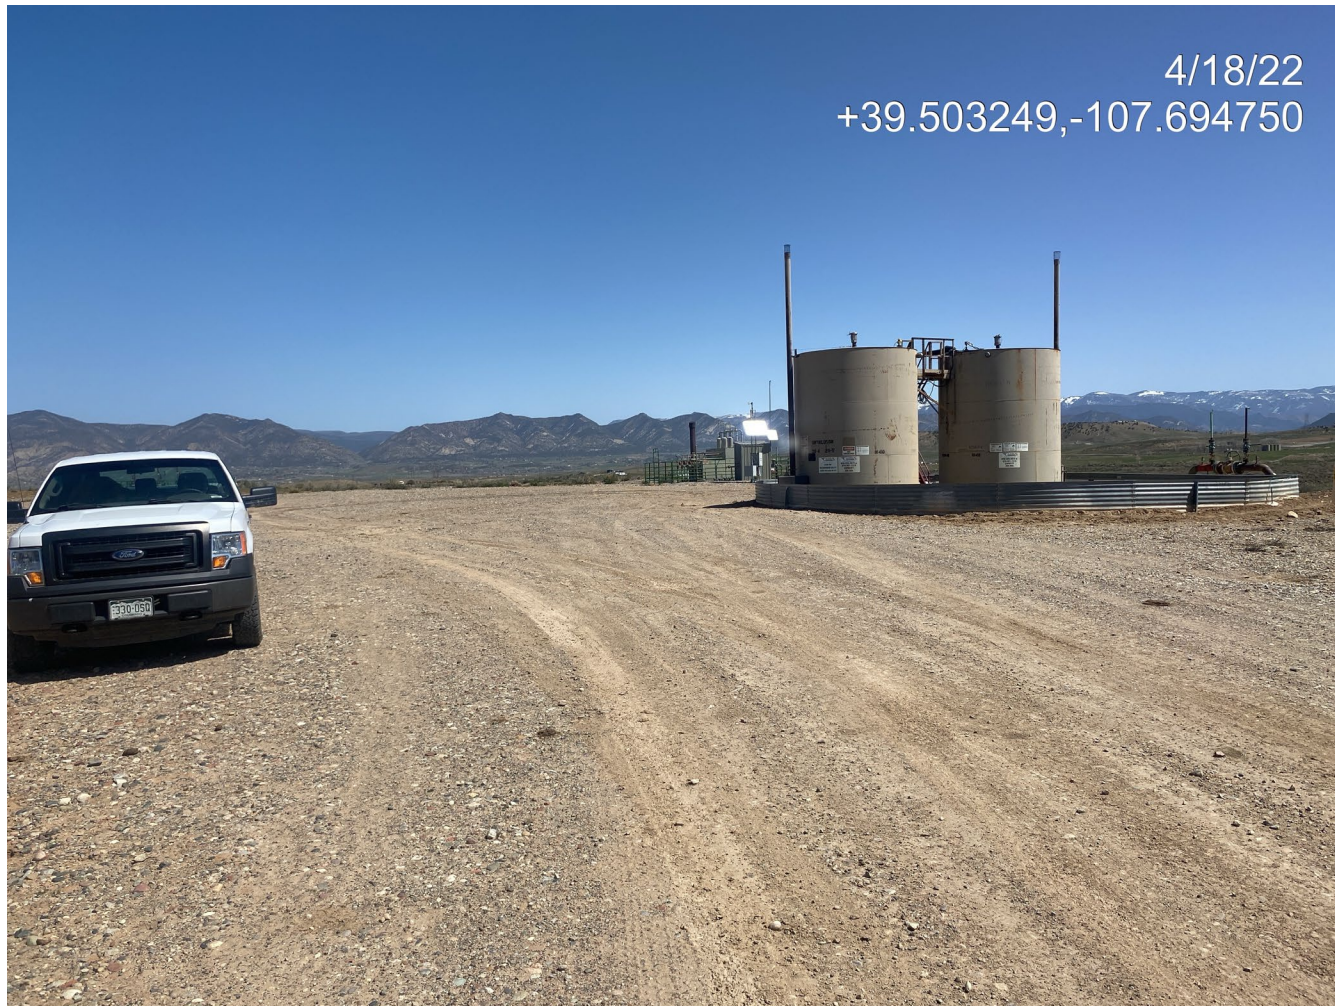
Photo 1. Photo taken from the Location entrance facing north shows an overview of the Location.

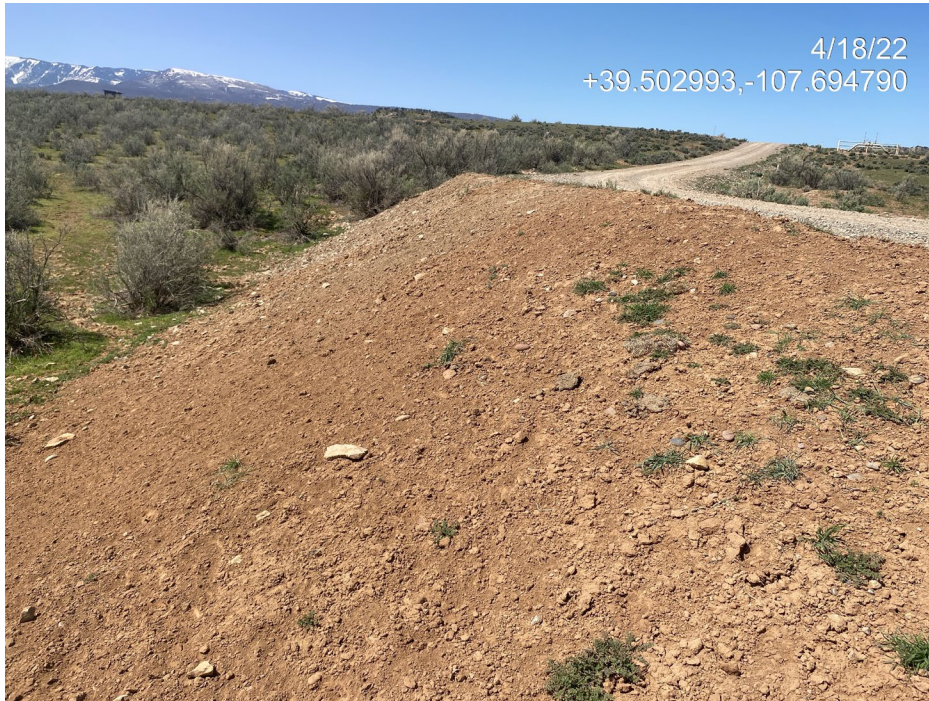
Photo 2. Photo taken from the south of the Location facing west shows the slopes of the access road appear stable, but are largely unvegetated.

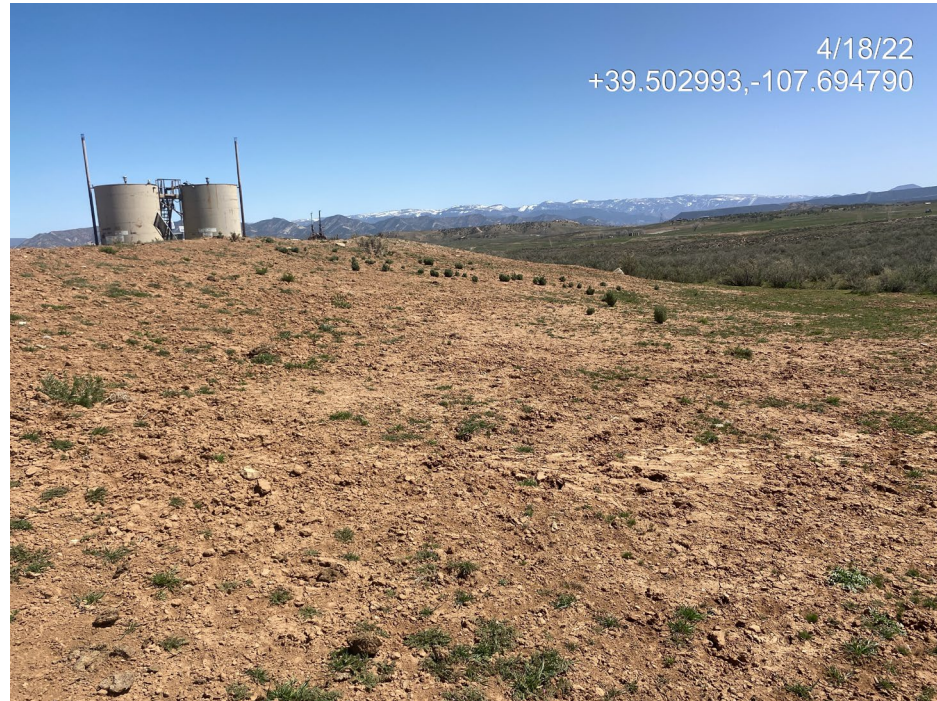
Photo 3. Photo taken from the south of the Location facing north shows interim areas colonized by sparse perennial grasses, forbs and shrubs and annual invasive/undesirable plant species/weeds.

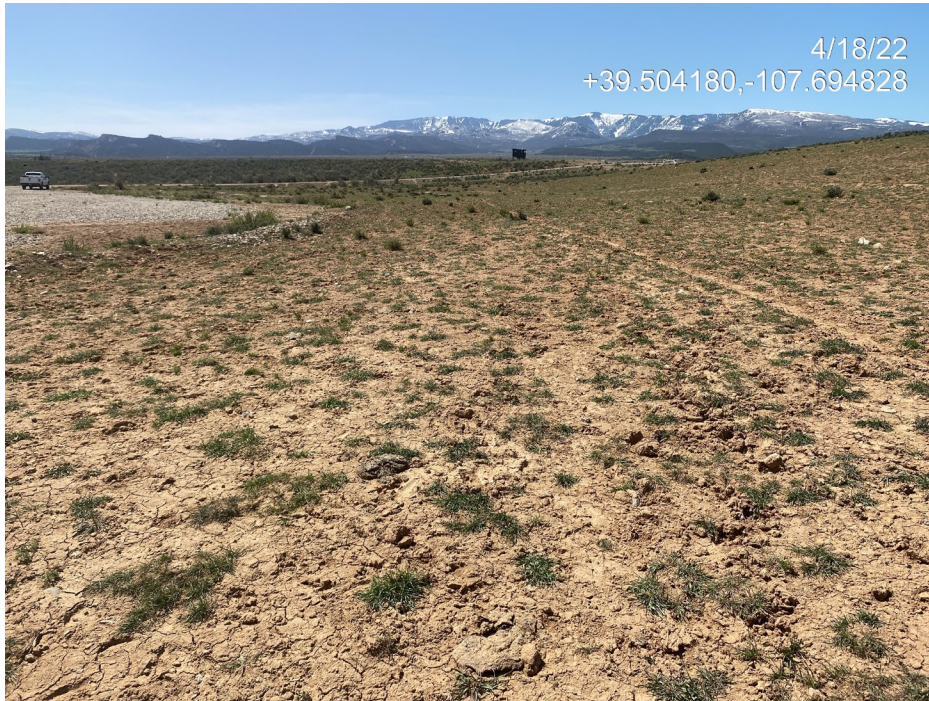
Photo 4. Photo taken from the northwest of the Location facing south shows the western interim area is dominated by perennial grasses, with annual invasive/undesirable plant species/weeds also present.

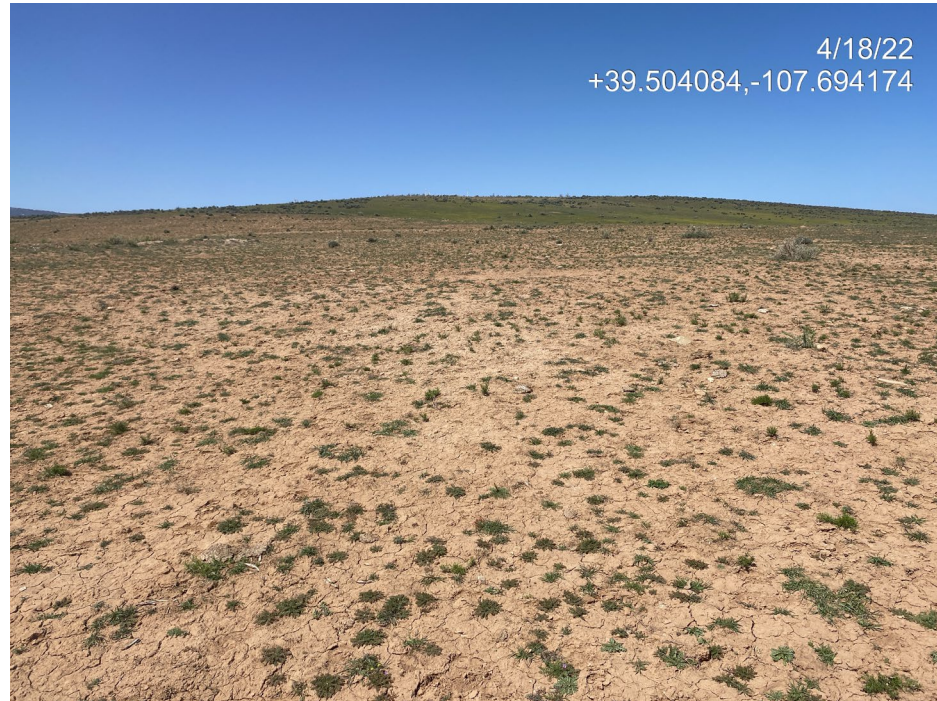
Photo 5. Photo taken from the north of the Location facing west shows the northern interim area is colonized by perennial grasses, with a high amount of annual invasive/undesirable plant species/weeds also present.
