Attachment B

WELLHEAD ABANDONMENT FORM

SITE NAME: Kerbs 1-20 Wellhead							DATE: 5/13/2021	REM. PROJECT #:	WEATHER: 40s Sunny
SITE DIRECTIONS: 0.2 miles E of county rds 44 & 60, S into							CLIENT: PDC - Erin Crawford		
LEGALS AND LAT/LONG: 40.301565, -104.805232							TASMAN PERSONNEL: Kevin Fletcher		
SOIL TYPES: Clayey Sand - SC							SURFACE GRADIENT: East		
SOIL SAMPLING							FACILITY INFRASTRUCTURE		
Date/Time	Soil Sample ID	PID (ppm)	Visual	Olfactory	Photo?	Grab or Lab Sample?	EQUIPMENT		Quantity
							Above Ground Storage Tank (AST)		
5/13/2021 16:54	SS01@4'	580.3	HC Staining	HC Odor	Yes	Lab	Buried or Partially Buried Vessel		
5/13/2021 16:55	GS01@3'	24.2	No Staining	HC Odor	Yes	Grab	Separator		
5/13/2021 16:56	GS02@3'	580.1	HC Staining	HC Odor	Yes	Grab	Emission Control Device (ECD)		
5/13/2021 16:57	GS03@3'	483.2	HC Staining	HC Odor	Yes	Grab	Dump Line		
5/13/2021 16:58	GS04@3'	335.7	HC Staining	HC Odor	Yes	Grab	Wellhead		1
							Flowline

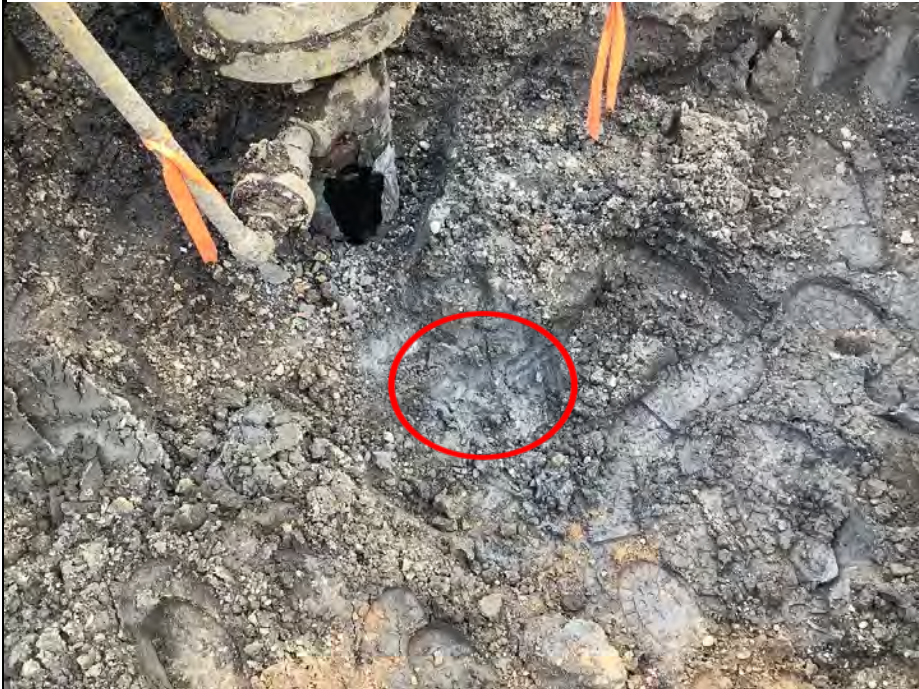
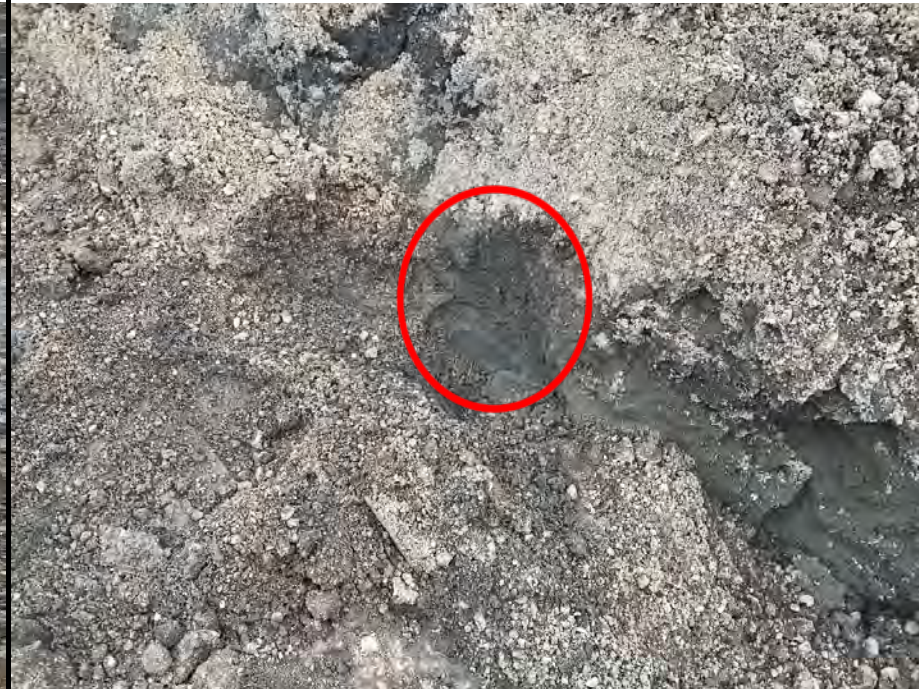
Material:	Volume:	Contents:	Material:	Volume:	Contents:
Notes/Conditions:SS01@4'			Notes/Conditions:GS01@3'

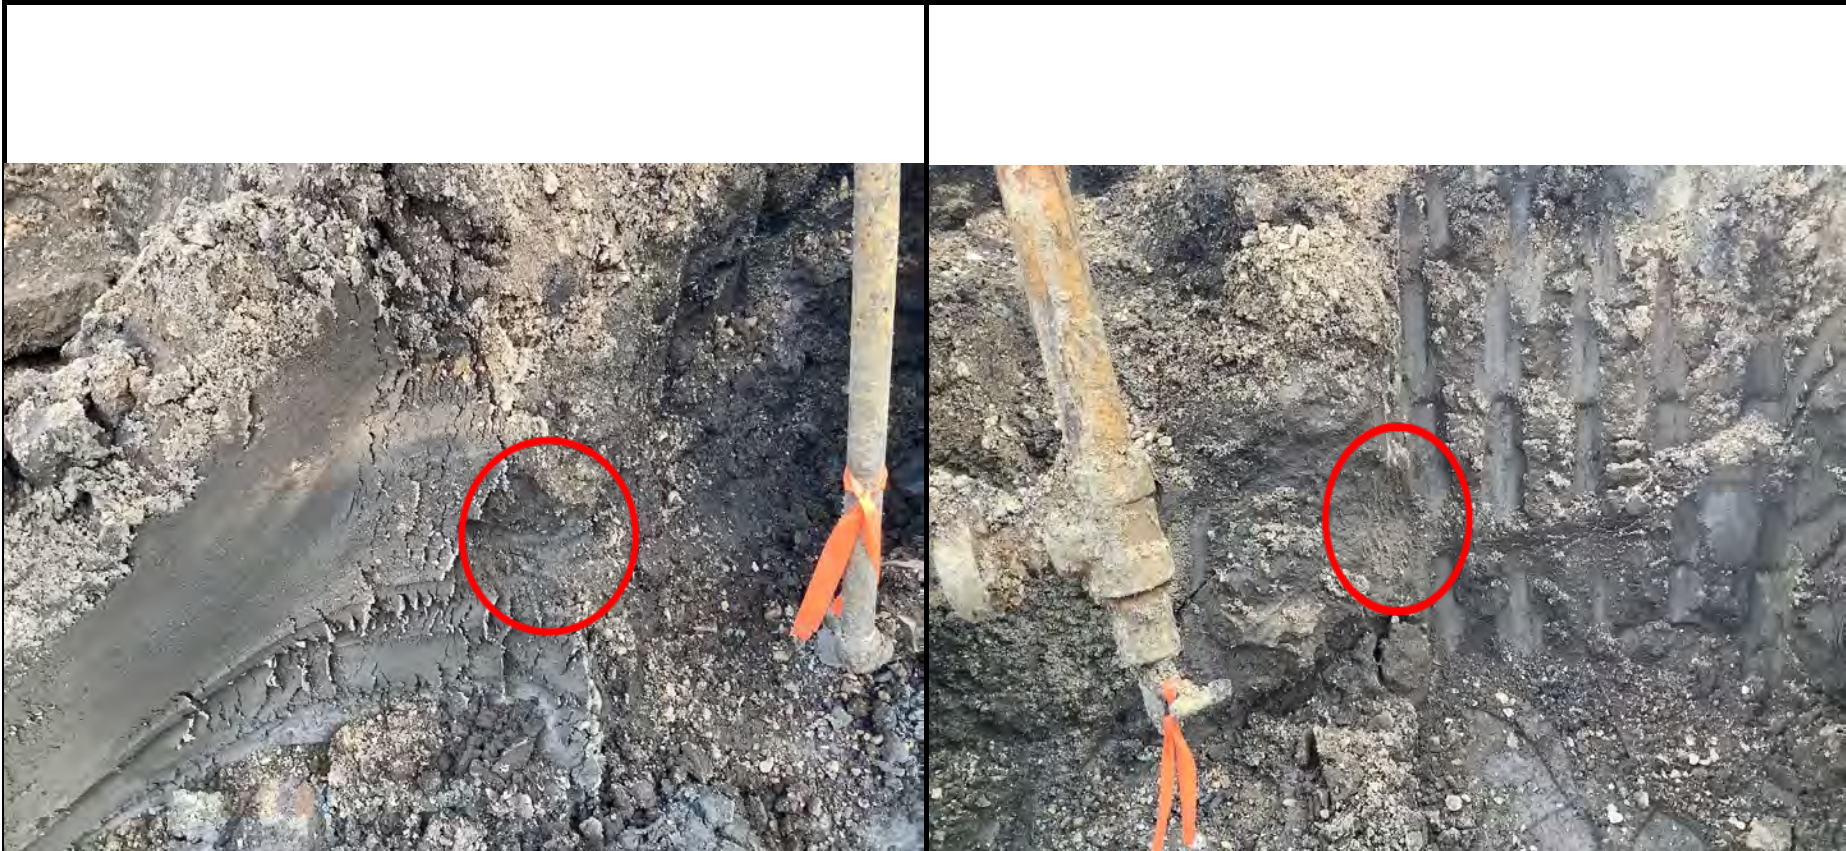
Equipment ID: GS02		Equipment Type:		Equipment ID: GS03		Equipment Type:	
Material:	Volume:	Contents:		Material:	Volume:	Contents:	
Notes/Conditions: GS02 @ 3'				Notes/Conditions: GS03 @ 3'

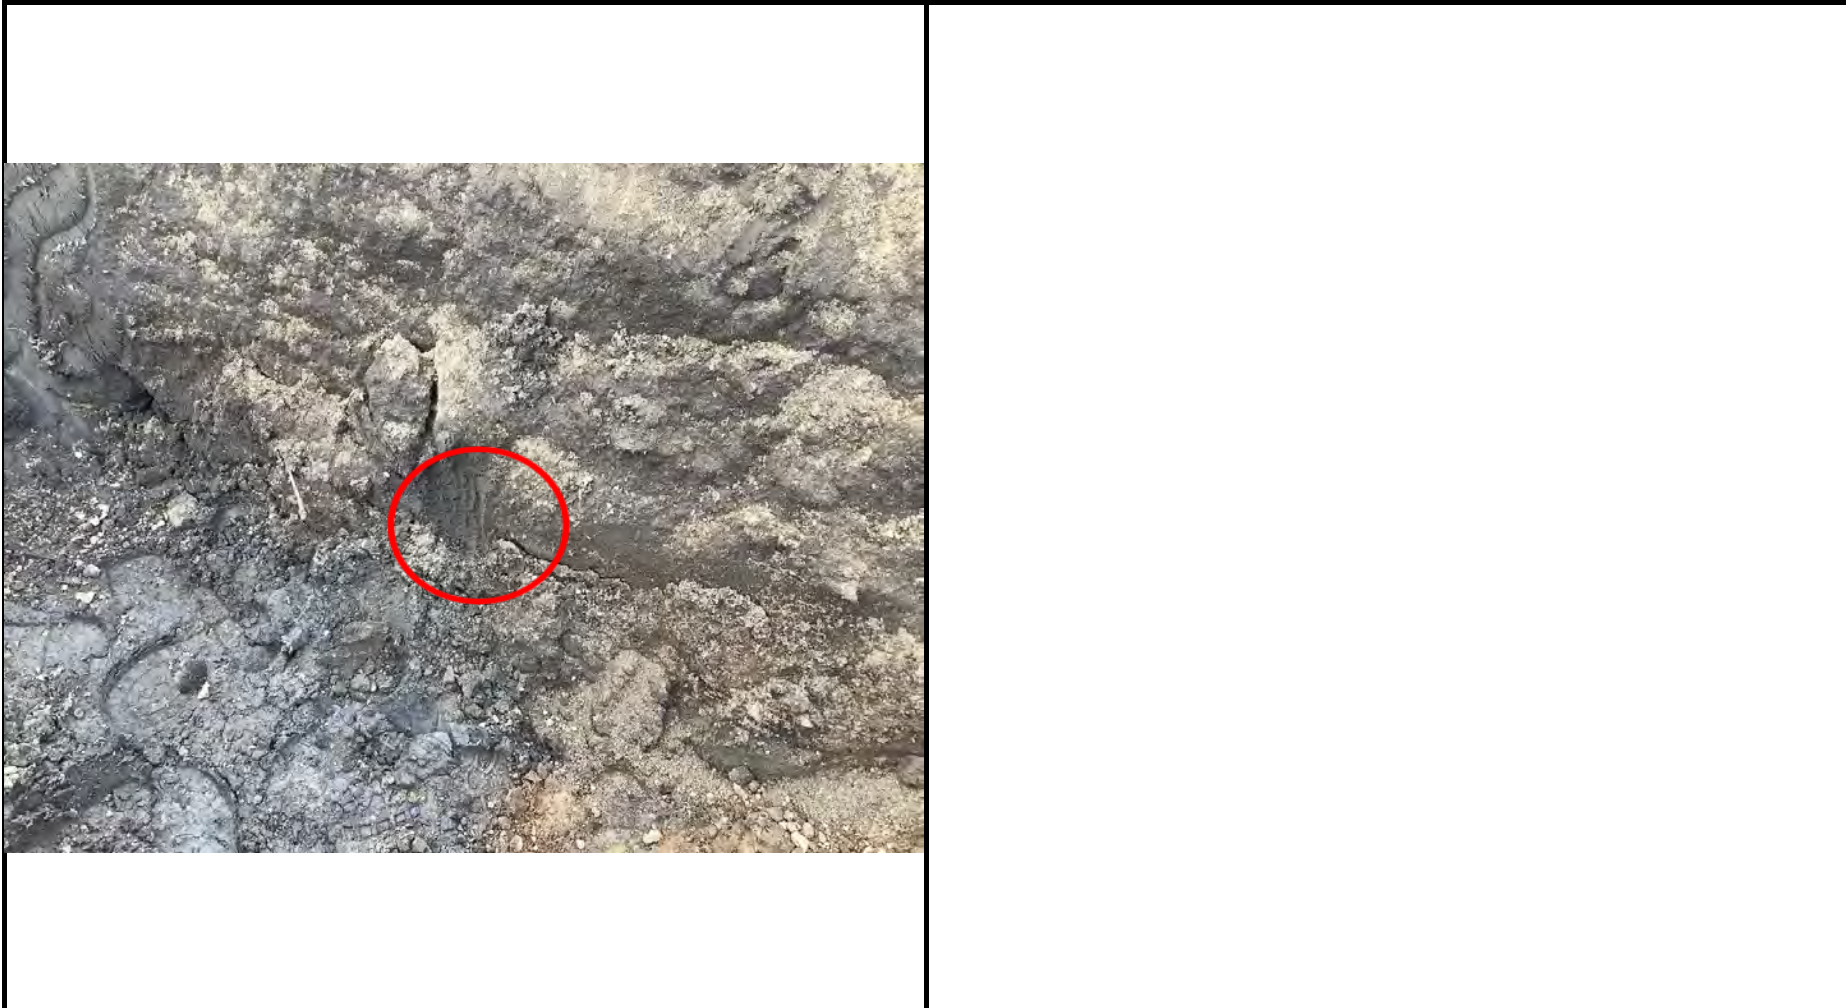
Equipment ID: GS04		Equipment Type:		Equipment ID:		Equipment Type:	
Material:	Volume:	Contents:		Material:	Volume:	Contents:	
Notes/Conditions: GS04 @ 3'				Notes/Conditions:
