Inspection Photos

Operator: Caerus Piceance LLC- #10456

Location ID: 334853

Location Name: Shideler-66S92W /32SWNE

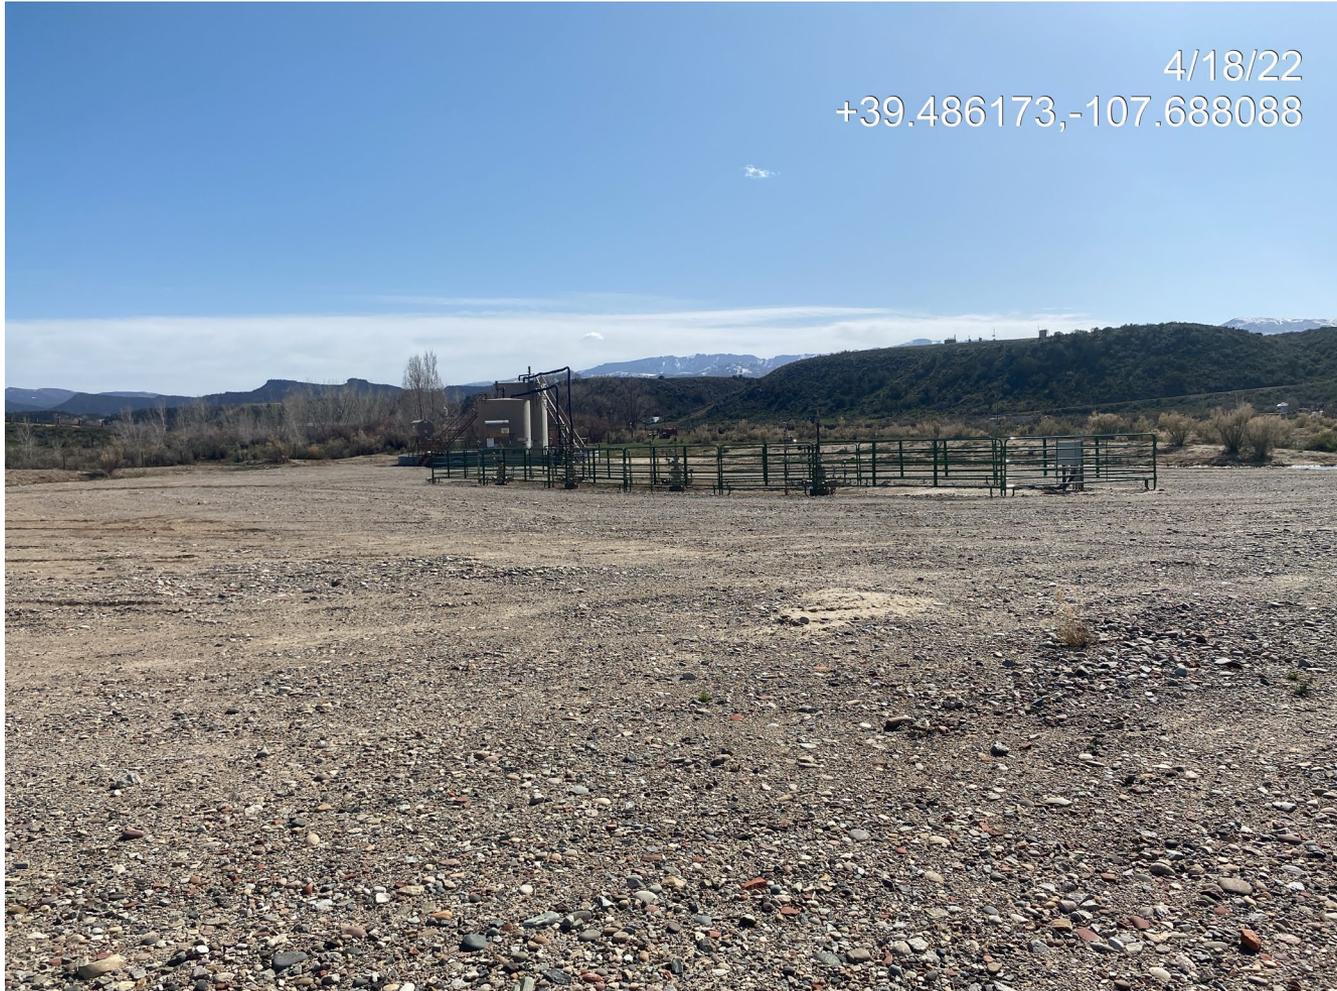
Photo 1. Photo taken from the southwest of the Location facing northeast shows an overview of the Location.

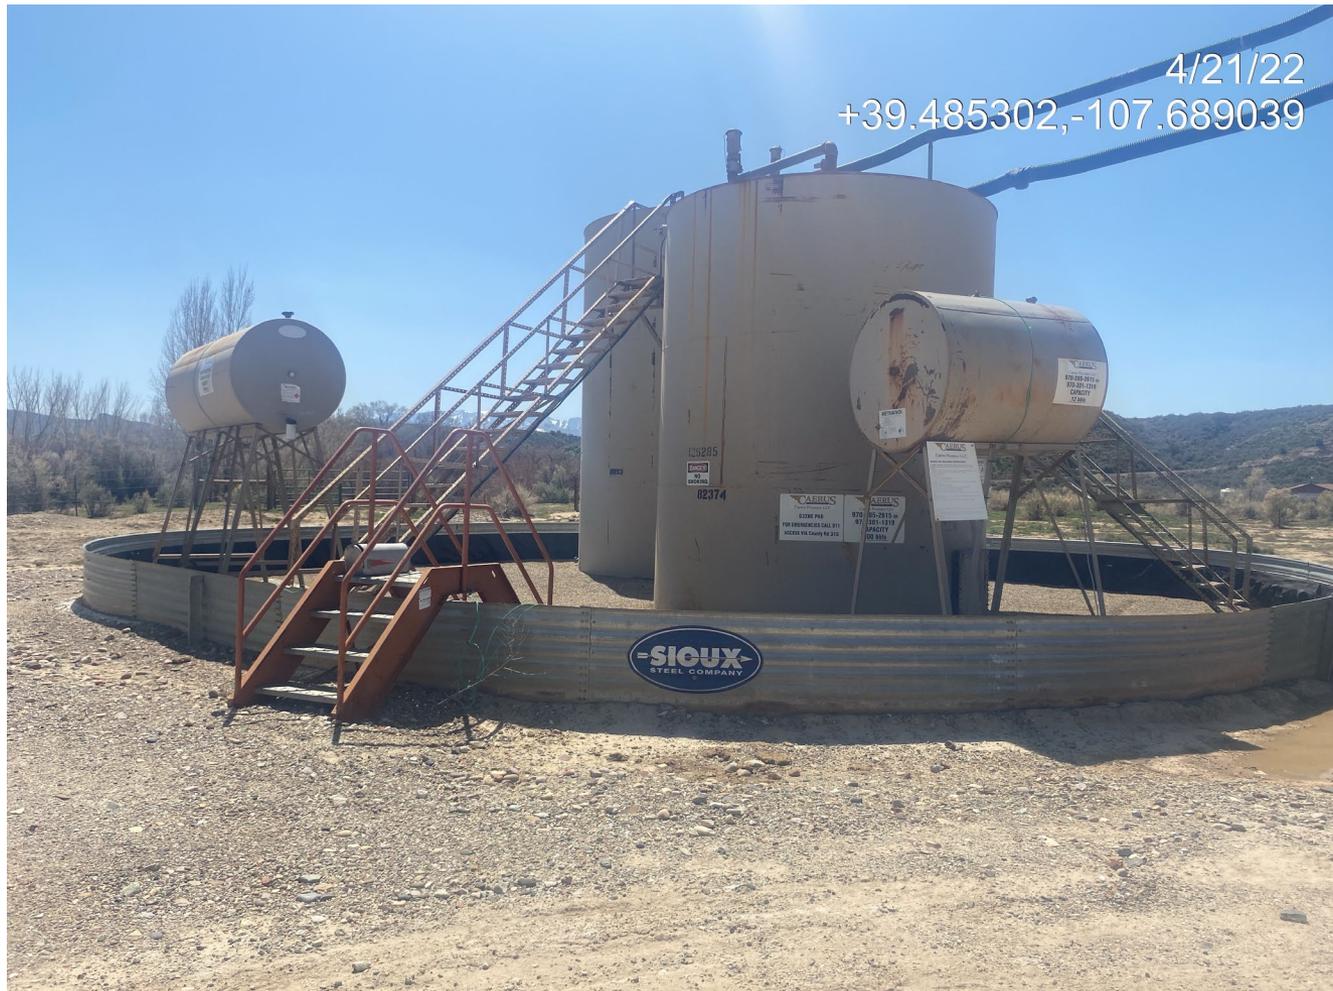
Photo 2. Photo taken from the tank battery shows a lack of required signage.

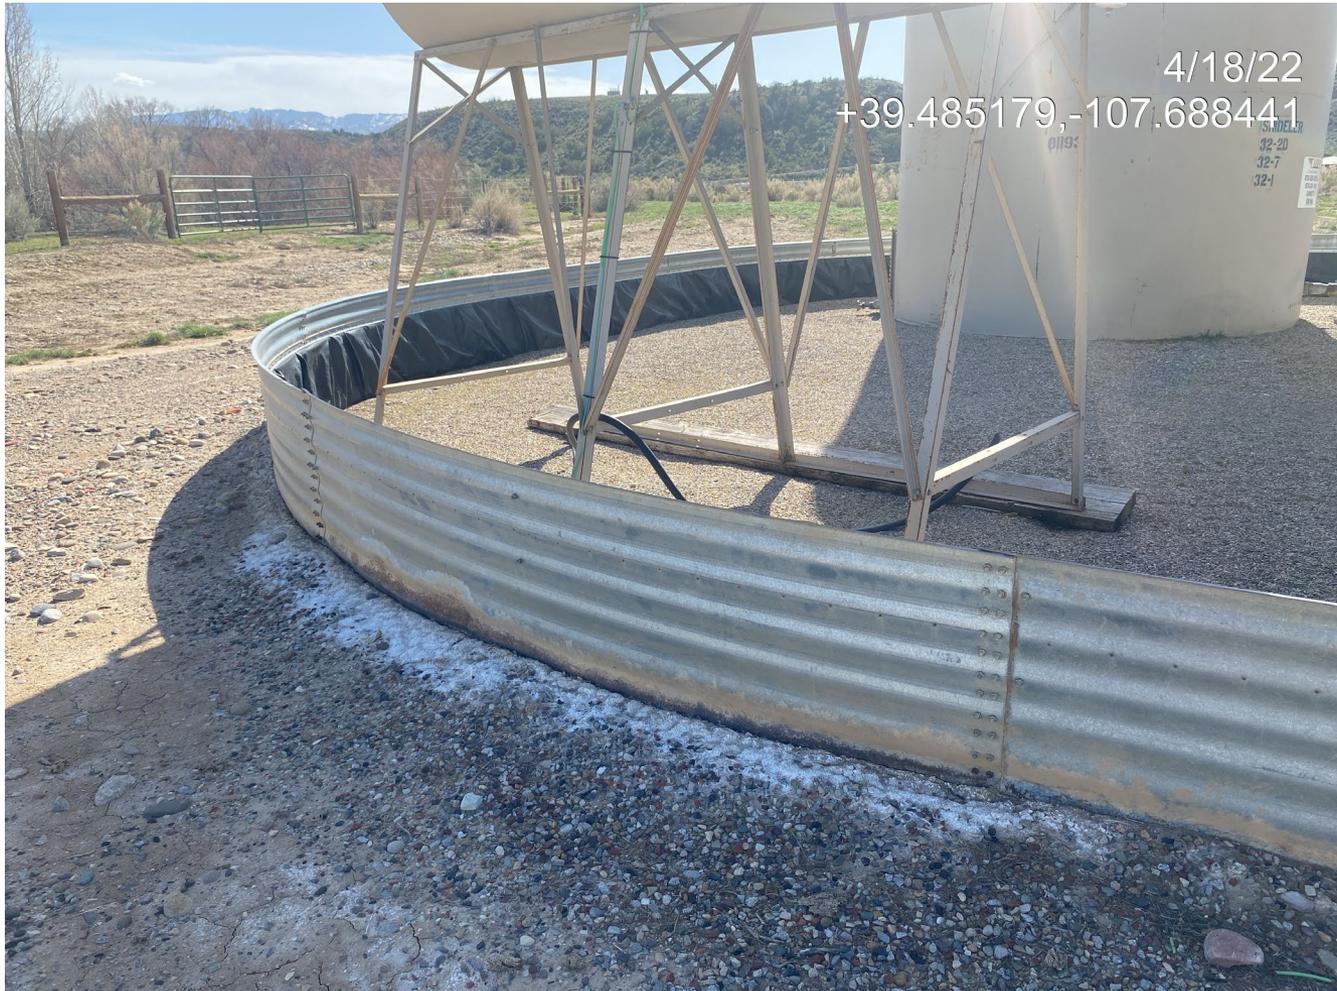
Photo 3. Photo taken from the tank battery shows salt staining outside of secondary containment along the northeast side of the tank battery. Corrosion is apparent at the base of the metal containment

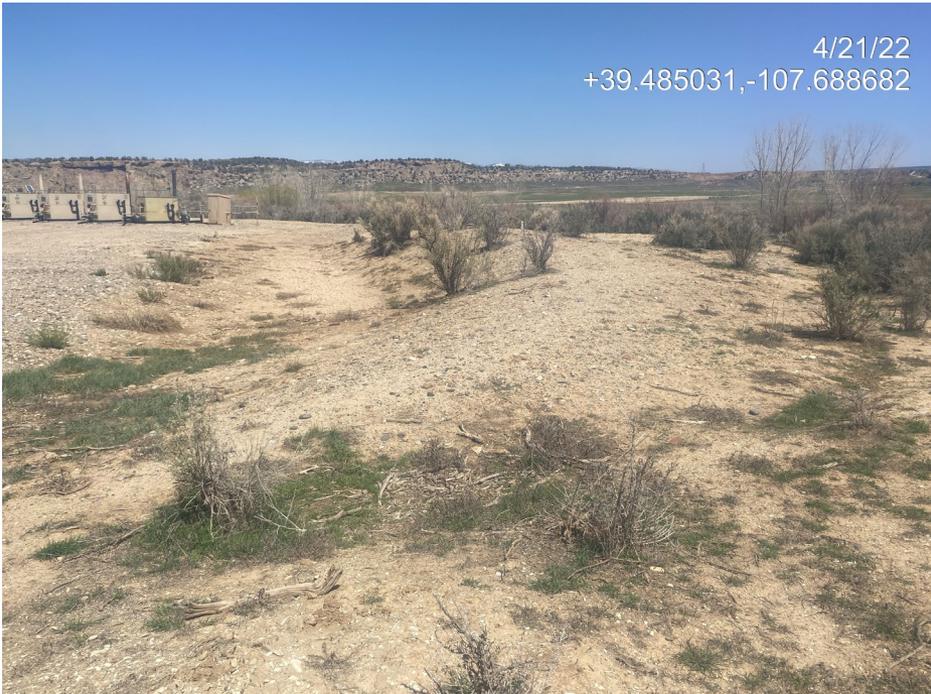
Photo 4. Photo taken from the interim areas to the south of the Location facing north shows a lack of uniform, native, perennial plant establishment.

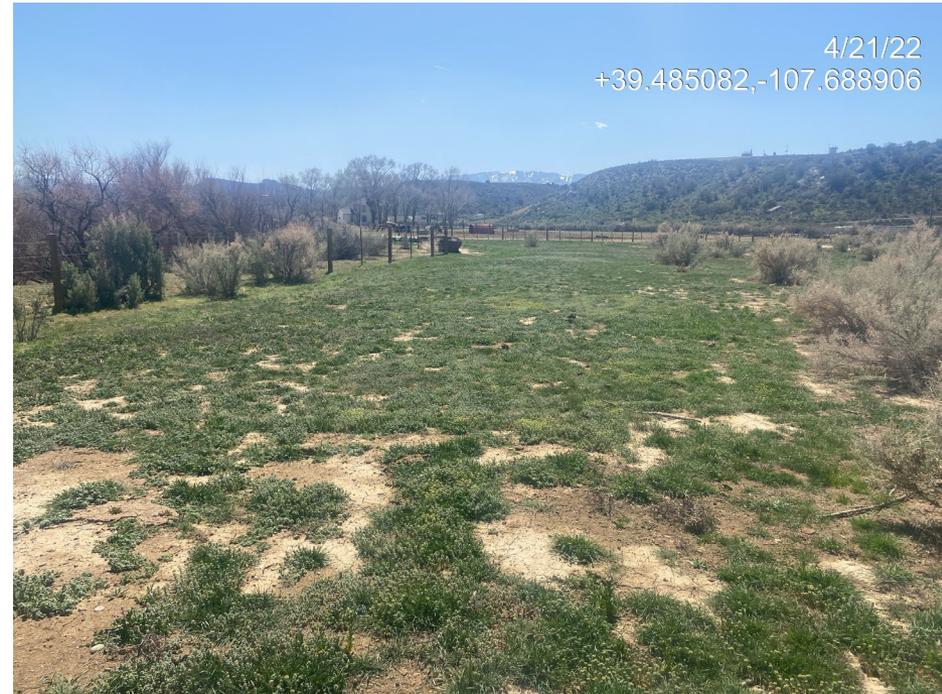
Photo 5. Photo taken from the interim areas to the southwest of the Location facing south shows the interim area dominated by undesirable plant species/weeds.

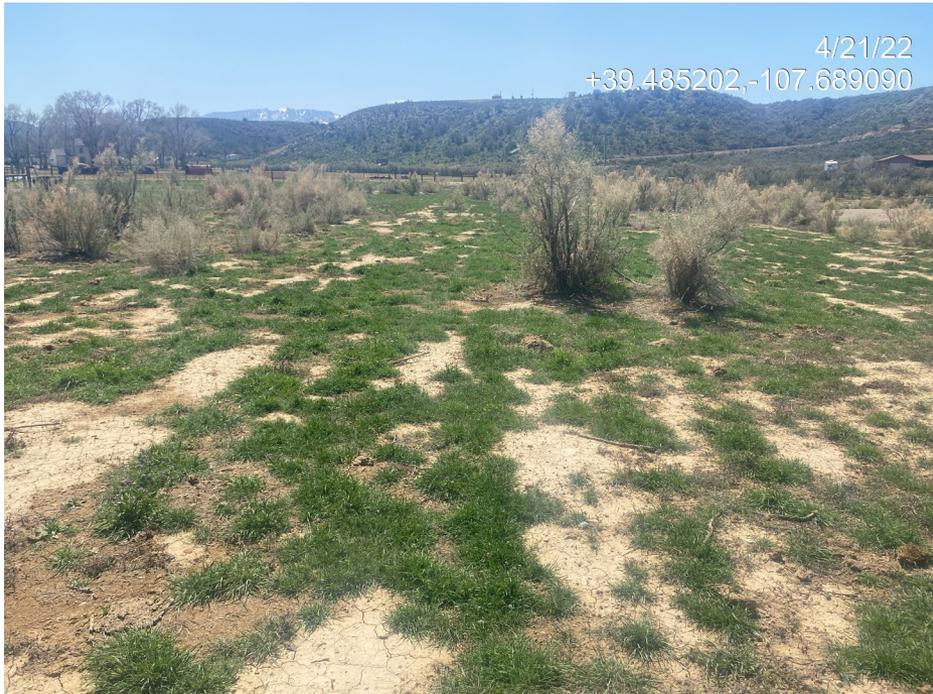
Photo 6. Photo taken from the interim areas to the southwest of the Location facing south shows the interim area dominated by annual wheatgrass, an introduced weed.

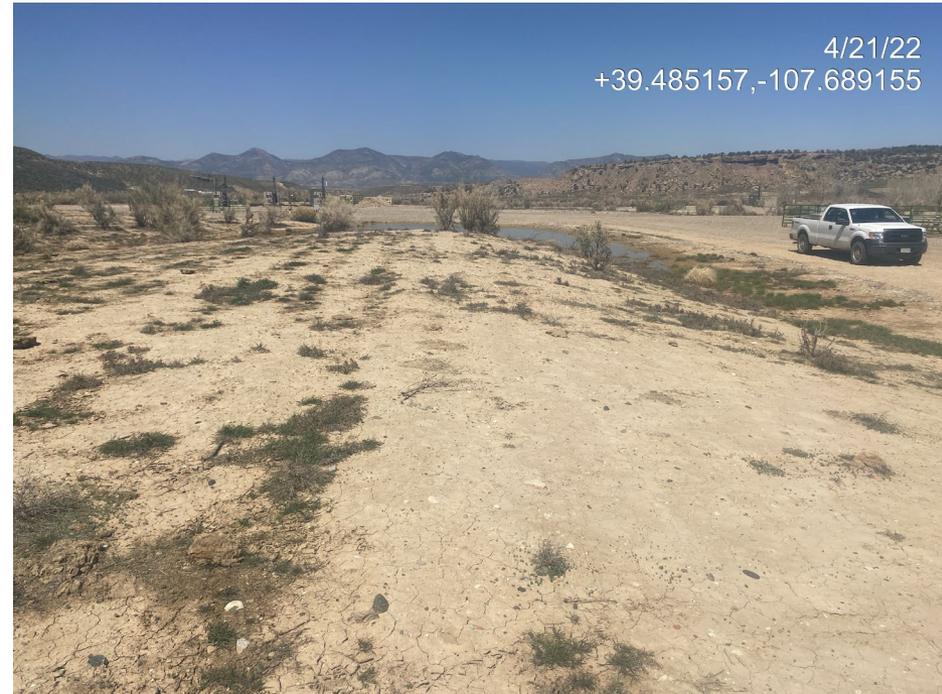
Photo 7. Photo taken from the interim areas to the southwest of the Location facing north shows the interim area dominated by bare ground and undesirable plant species/weeds.
