**Inspection Photos**  
**Operator: Kinder Morgan**  
**API: 083-06577**  
**Date: 4/21/2022**

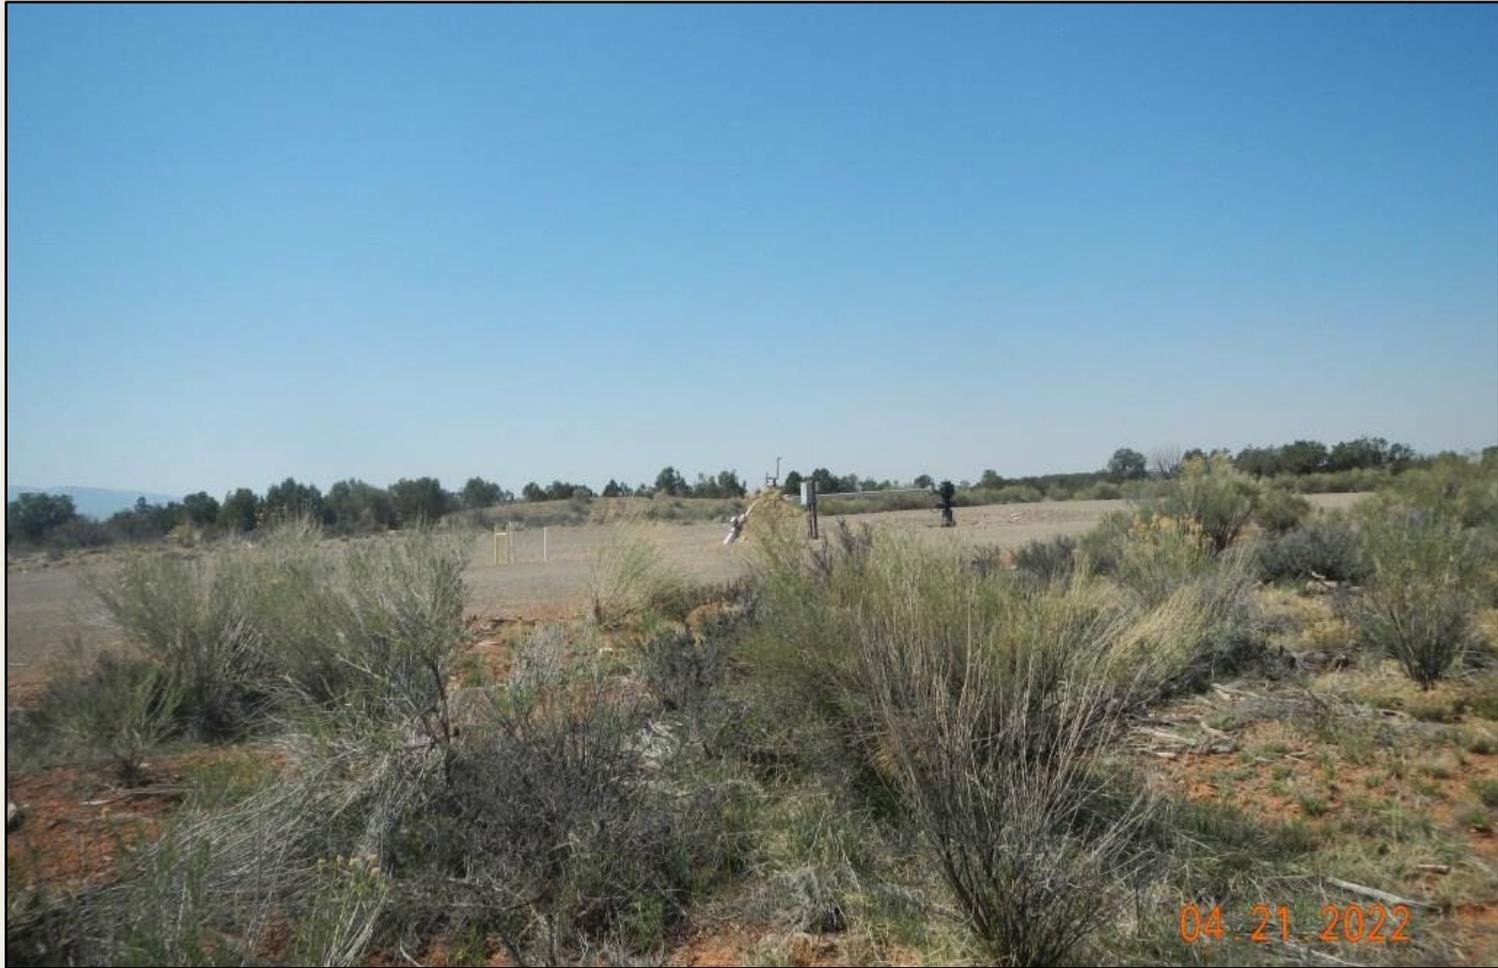
Photo 1. View of the project area from the northeastern corner facing center.

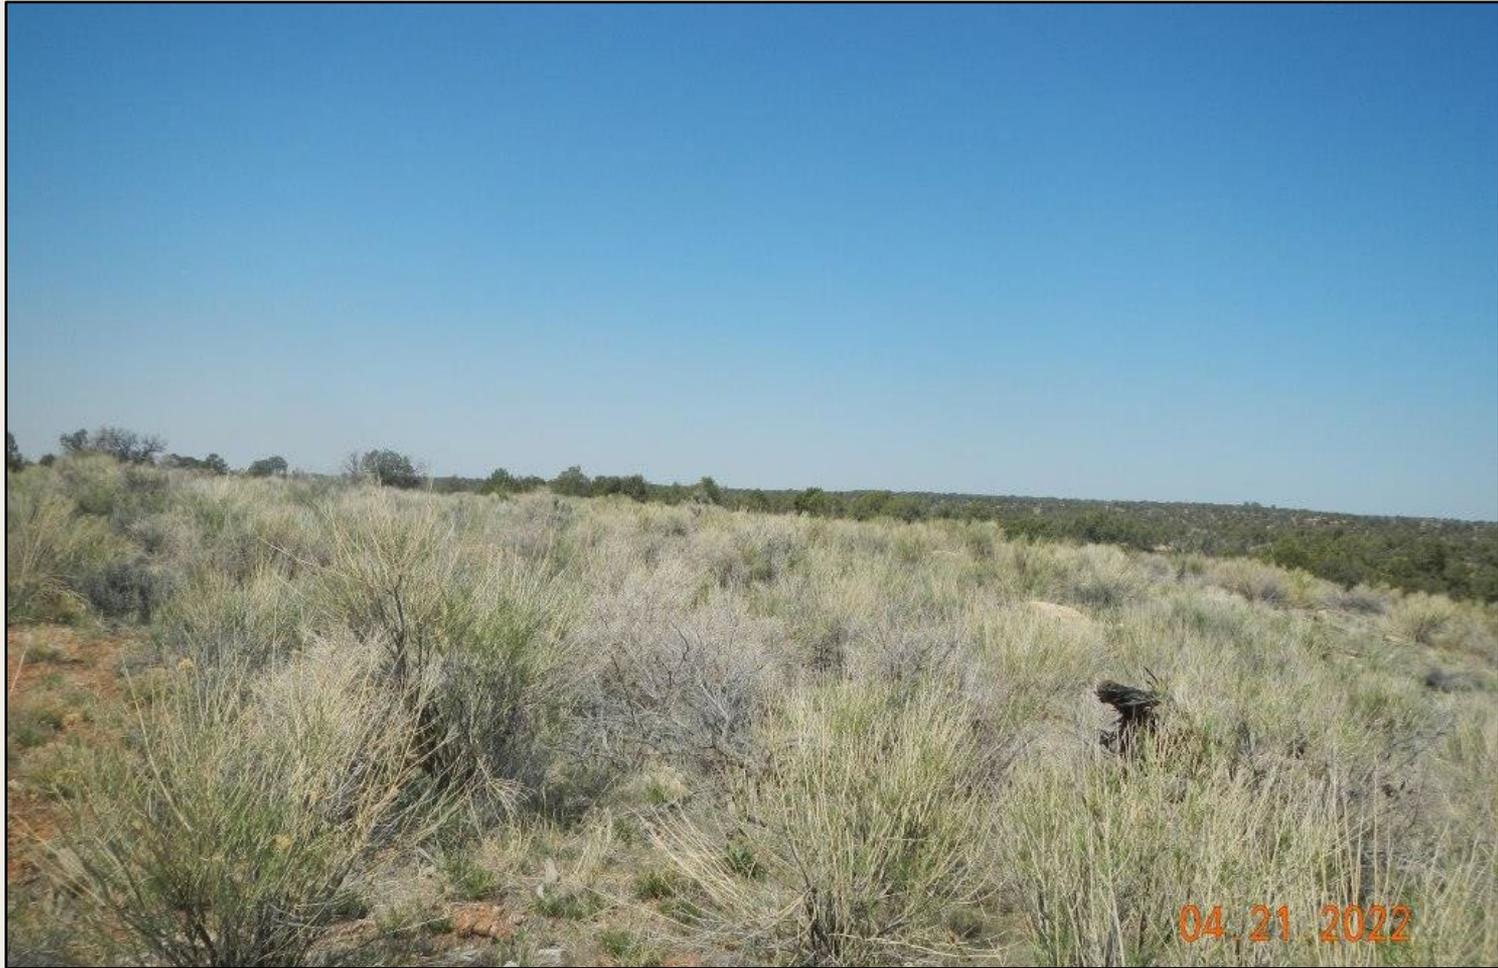
Photo 2. View of the northern project area from the northeastern corner facing westward. Revegetation is progressing with western wheatgrass, sand dropseed, snakeweed, and rubber rabbitbrush.

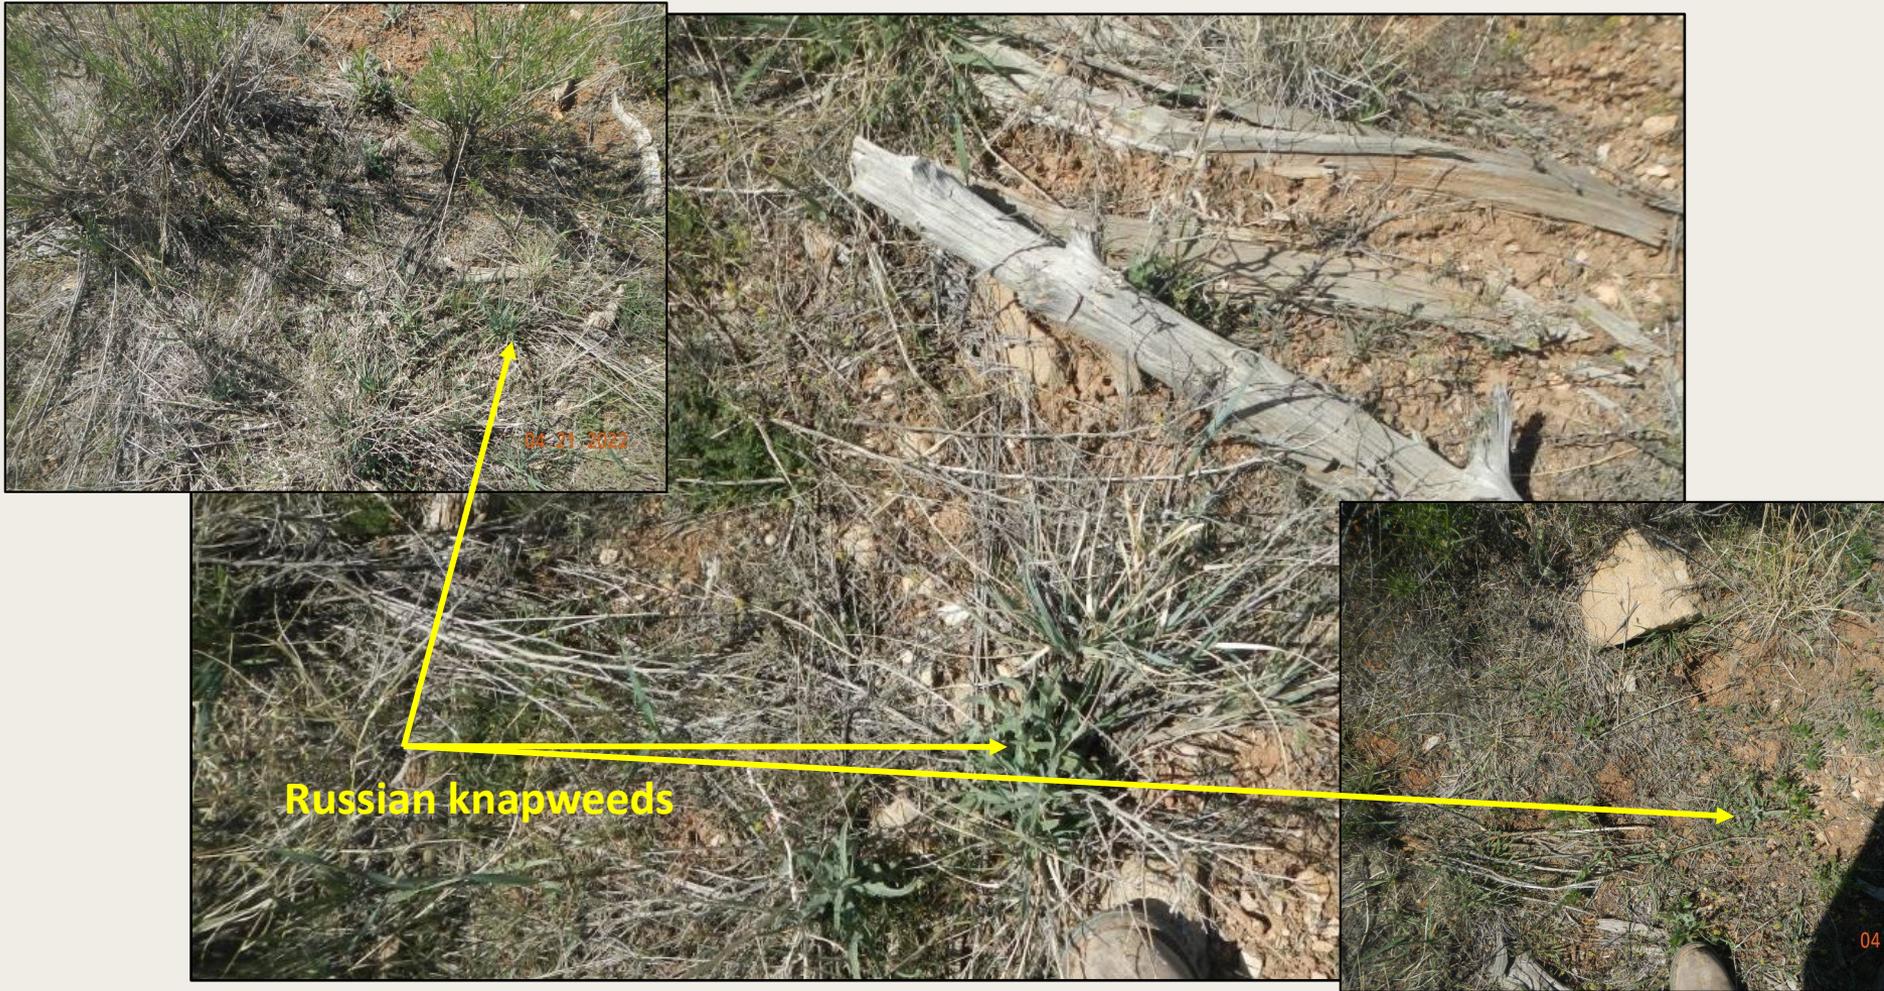
Photo 3. View of Russian knapweeds largely concentrated within the northern and western project area. Approx. 150 individuals observed.

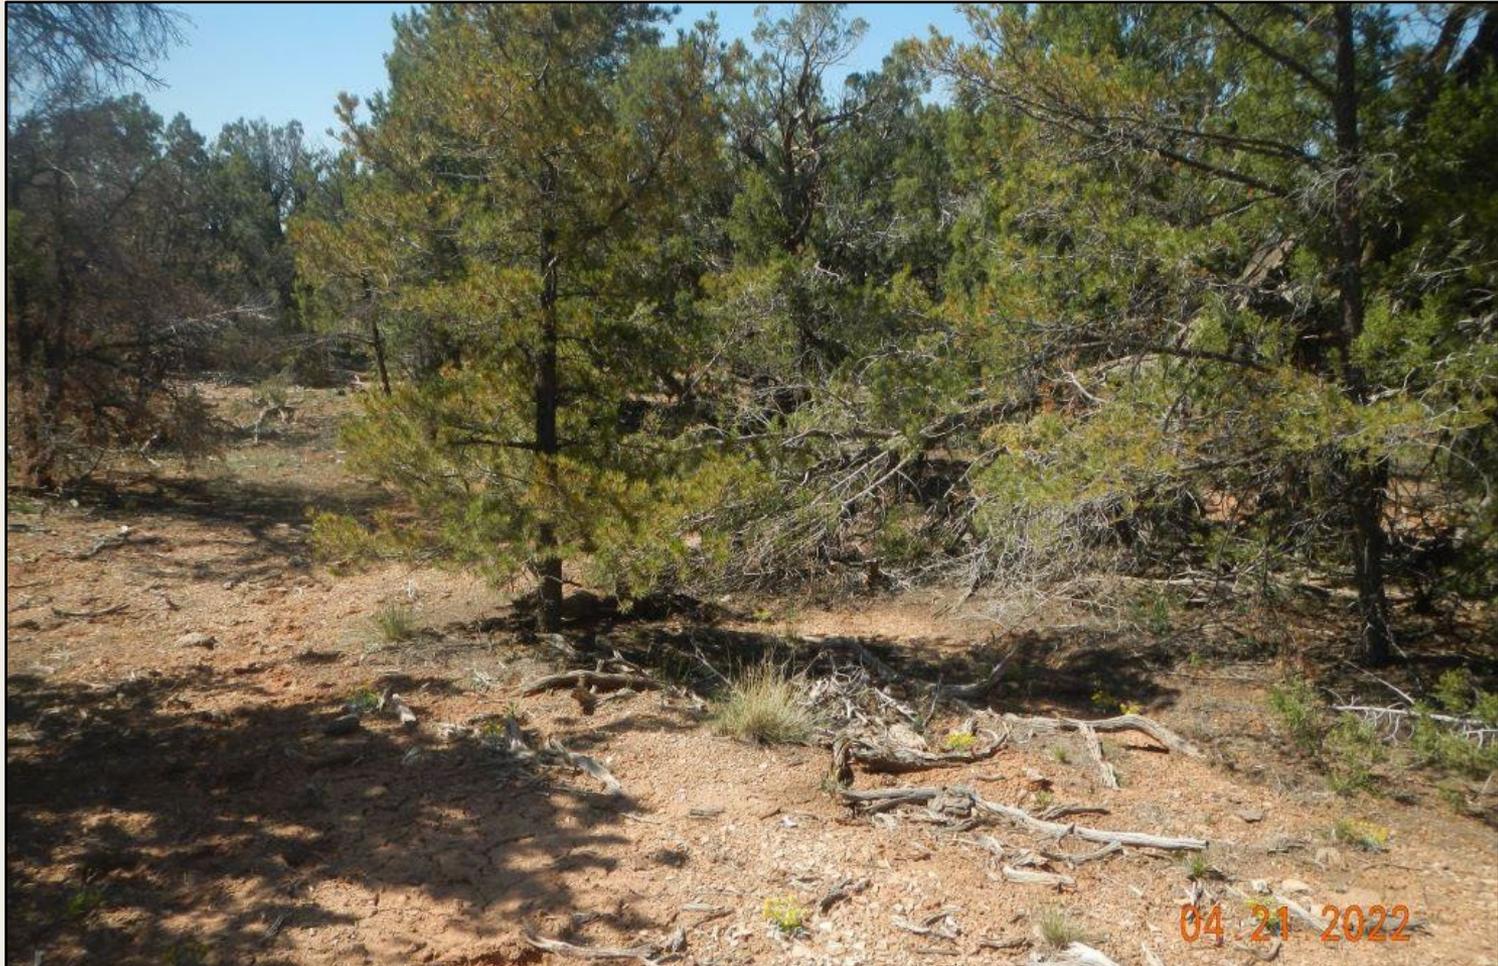
Photo 4. View of reference area comprised of pinyon and juniper woodland with understory of Indian ricegrass (*Achnatherum hymenioides*), sagebrush (*Artemisia tridentata*), muttongrass (*Poa fendleriana*), and bladderpod (*Physaria acutifolia*).
