Inspection Photos
Operator: Kinder Morgan
API: 083-06339
Date: 4/21/2022

Photo 1. View of the project area from the northwestern corner facing center.

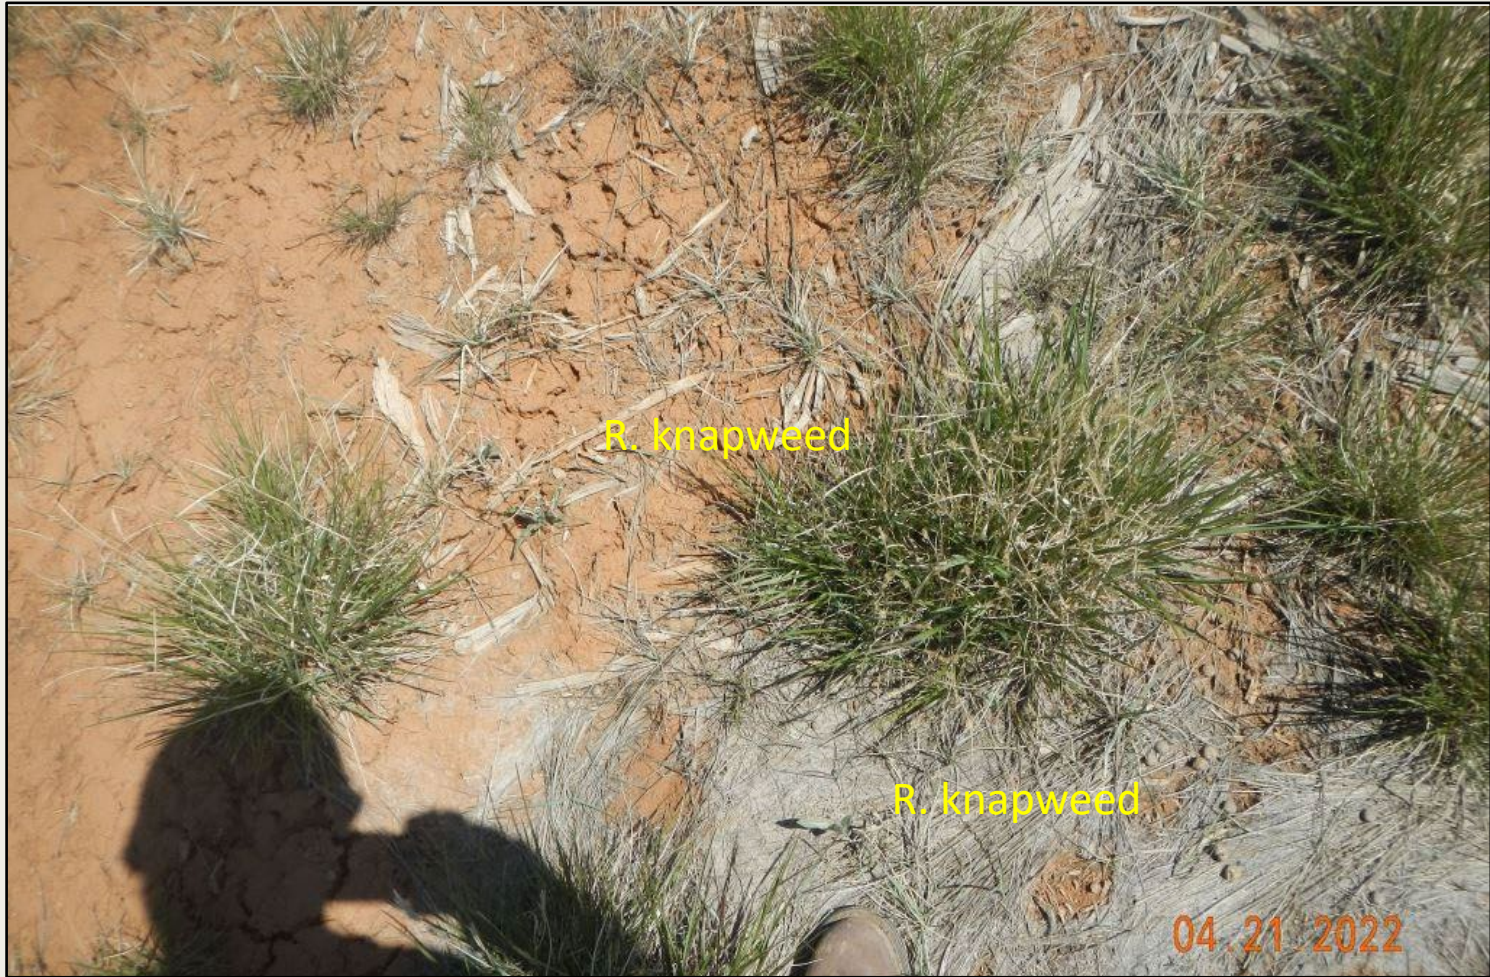
Photo 3. View of young Russian knapweeds observed within the northern project area.

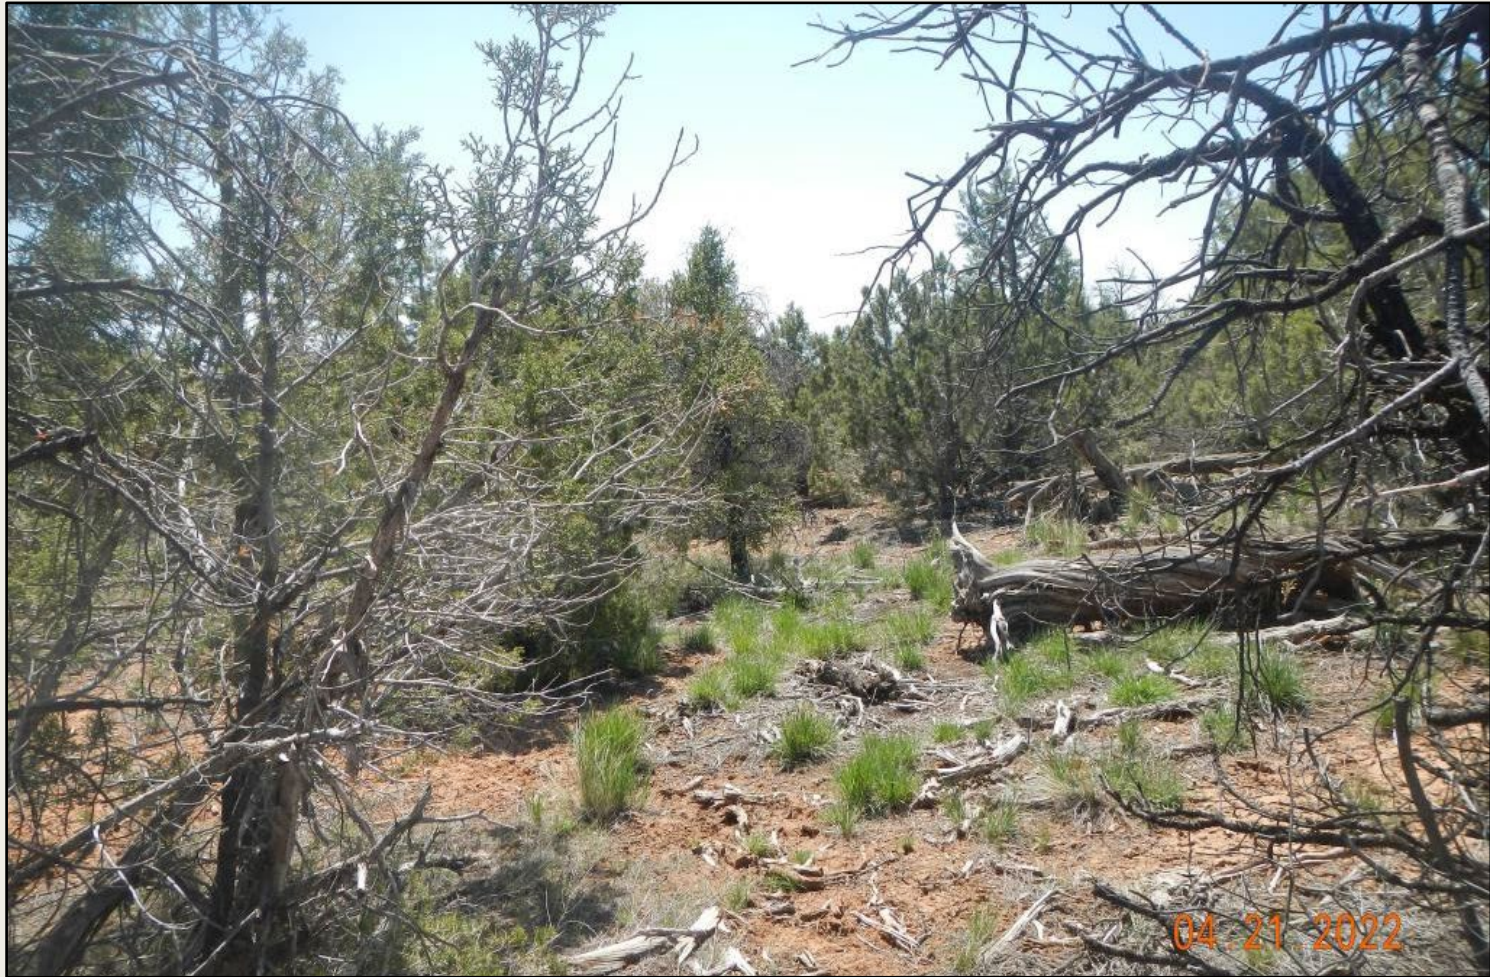
Photo 4. View of reference area comprised of pinyon and juniper woodland with sagebrush (*Artemisia tridentata*), snakeweed (*Gutierrezia sarothrae*), Indian ricegrass (*Achnatherum hymenioides*), and muttongrass (*Poa fendleriana*).
