Inspection Photos

ID: 150131

Operator: STRACHAN EXPLORATION INC

Inspection Date: 4/25/2022

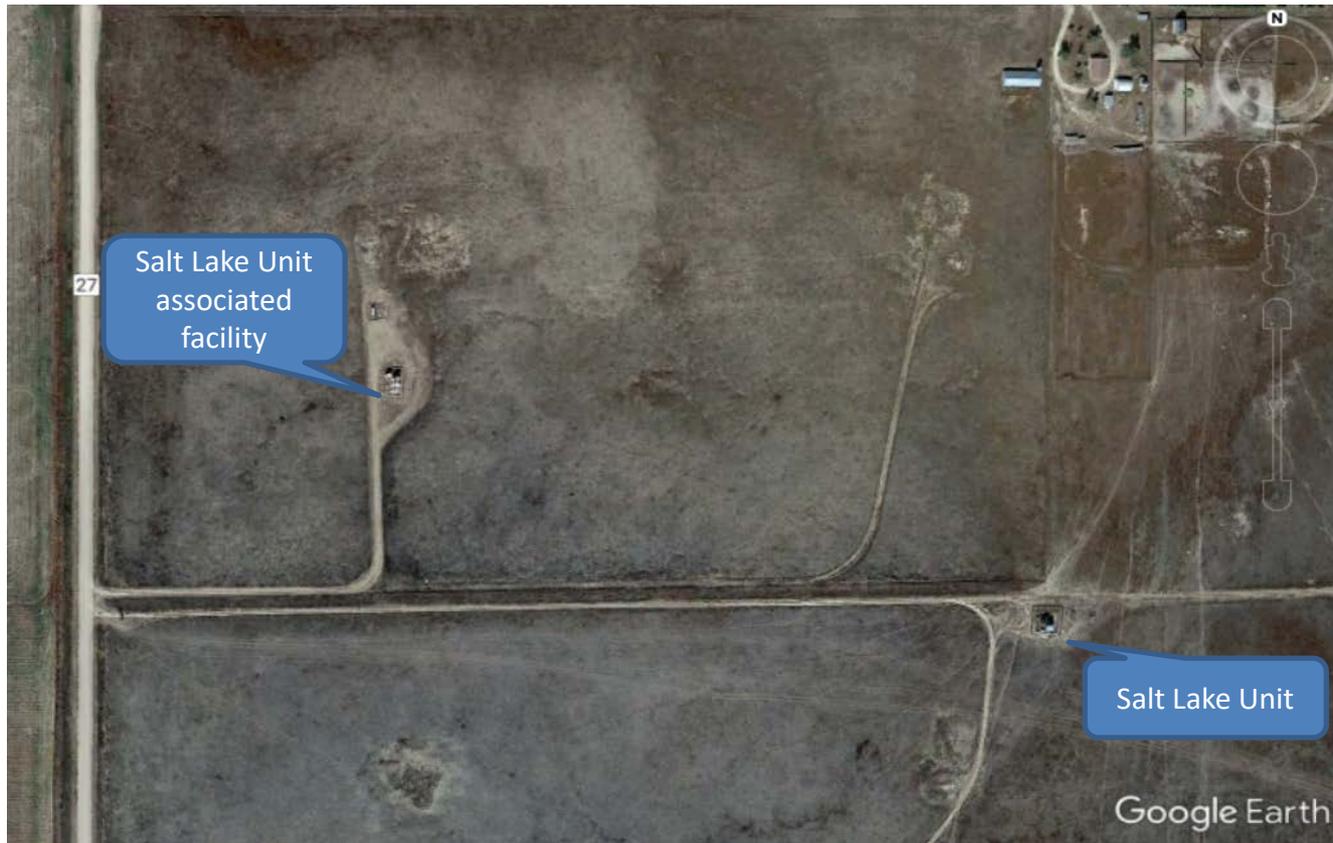
Photo 1. 2015 Aerial image showing the SALT LAKE UNIT abandoned location and associated facility.

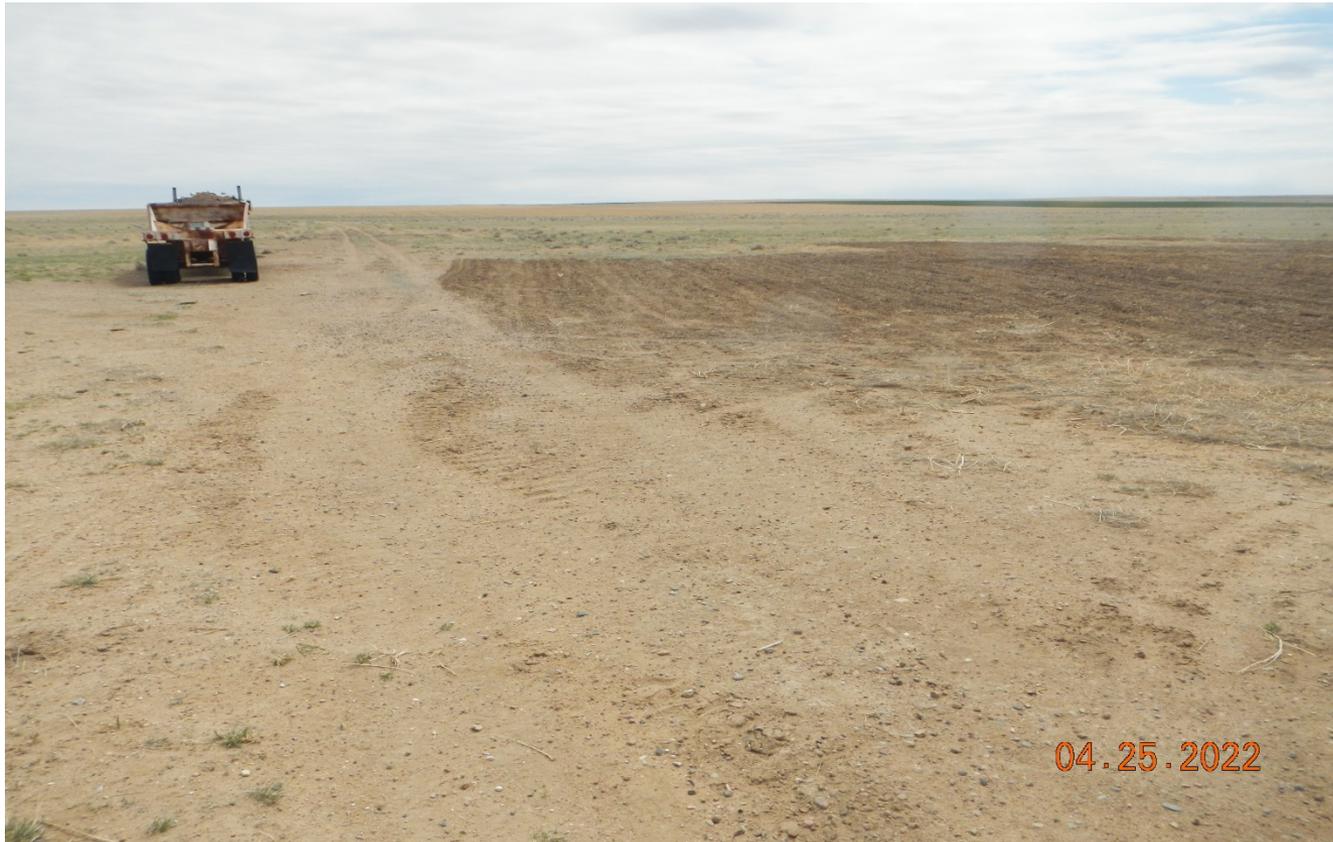
Photo 2. Facing east toward the SALT LAKE UNIT abandoned location. The electric utility line has been removed.

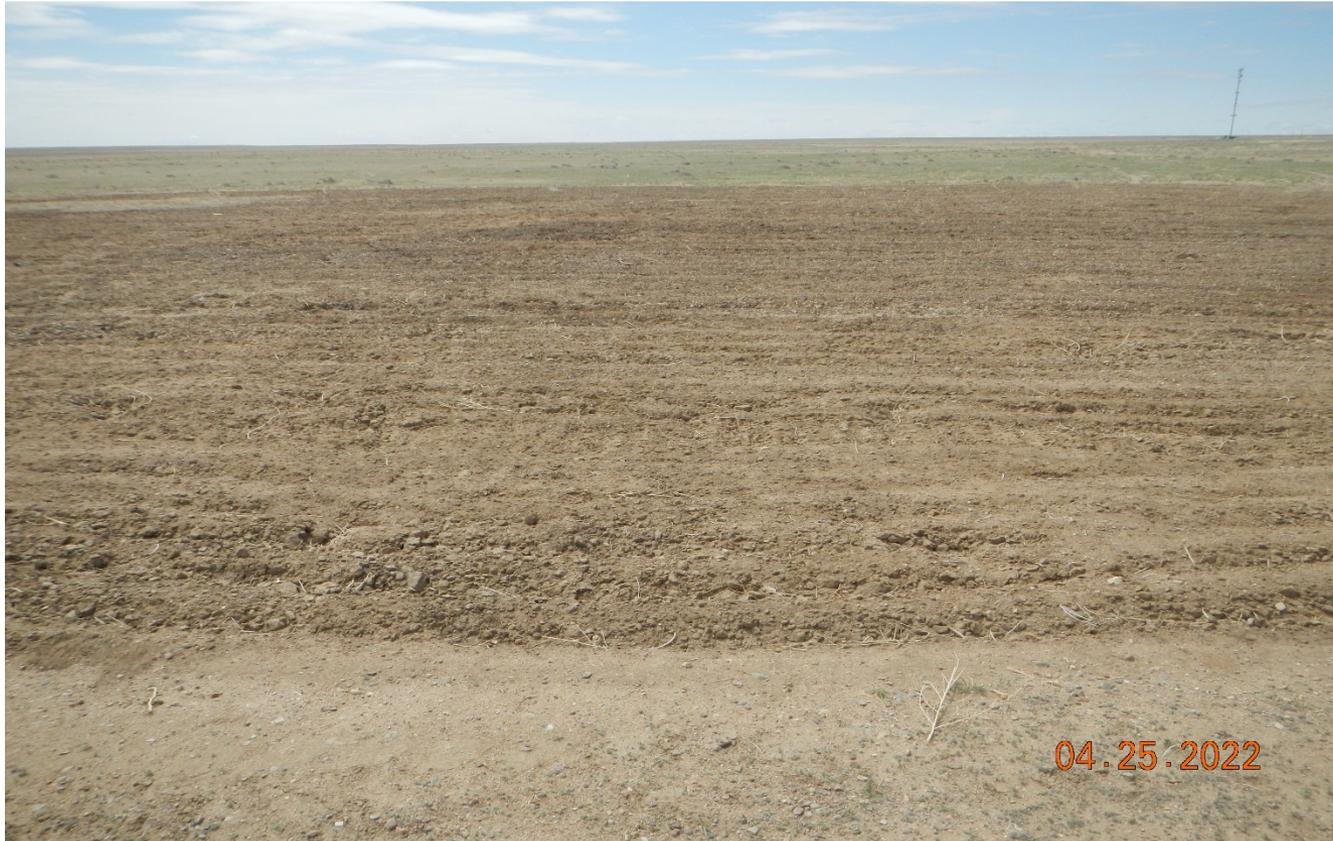
Photo 3. Facing south at the location. Soils have been ripped one direction.

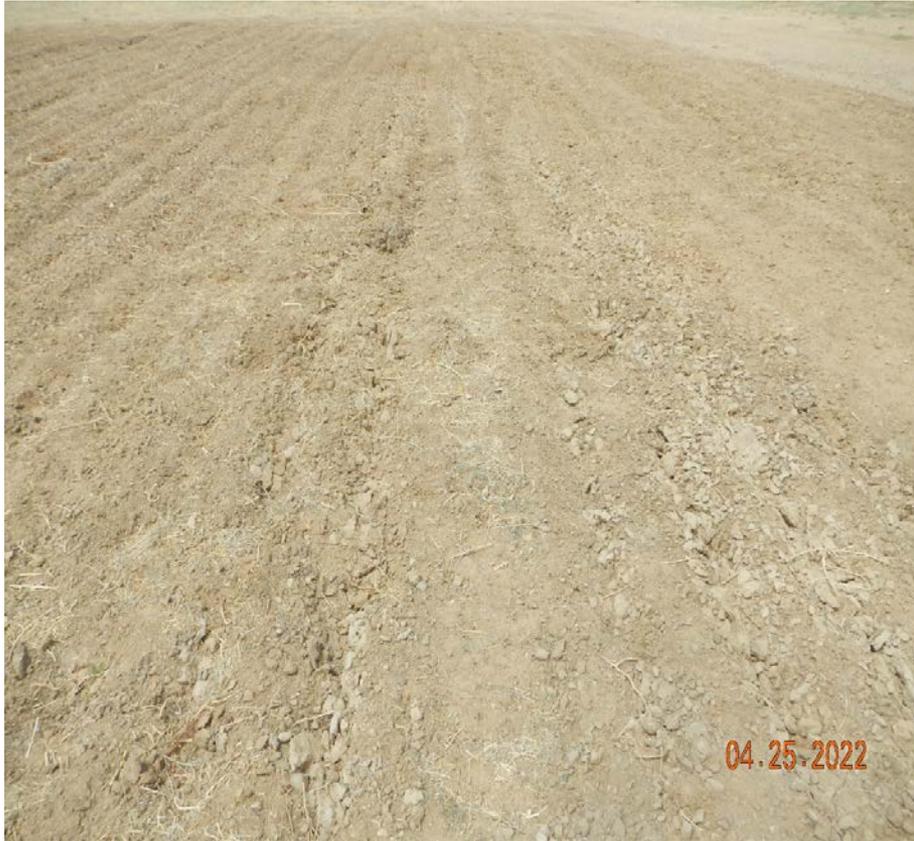
Photo 4. Soils have been ripped one direction. 1003.c. requires decompaction by cross ripping.

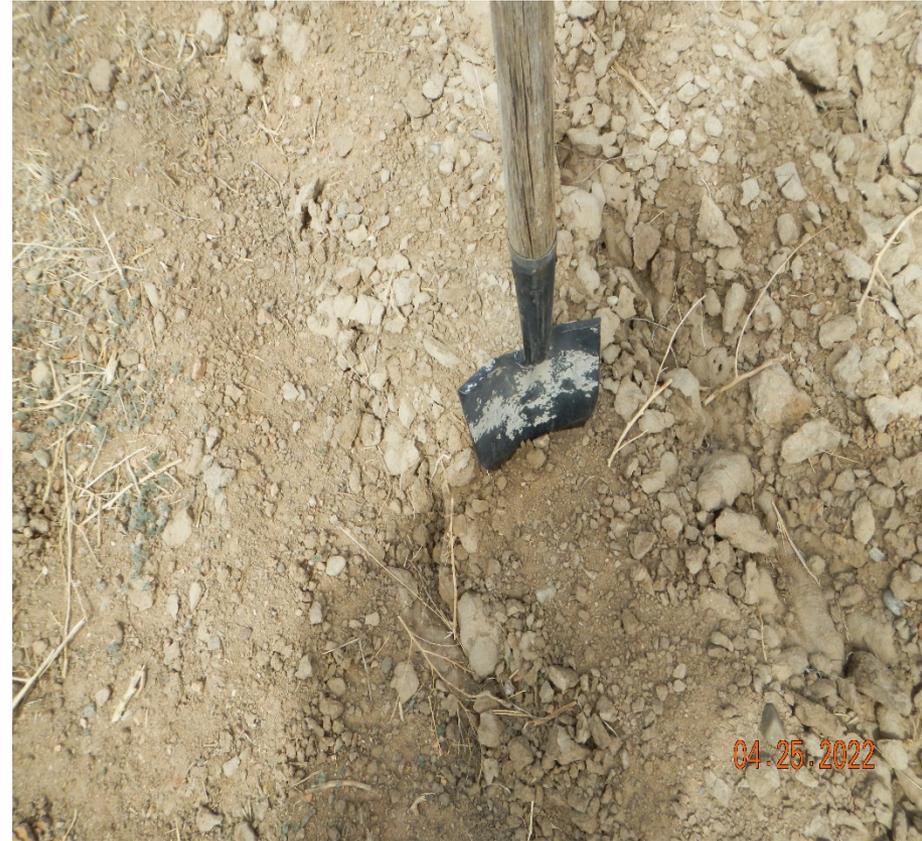
Photo 5. The soils are still compacted between the area ripping occurred. This is why cross ripping must be performed along with tilling to establish a proper seedbed.

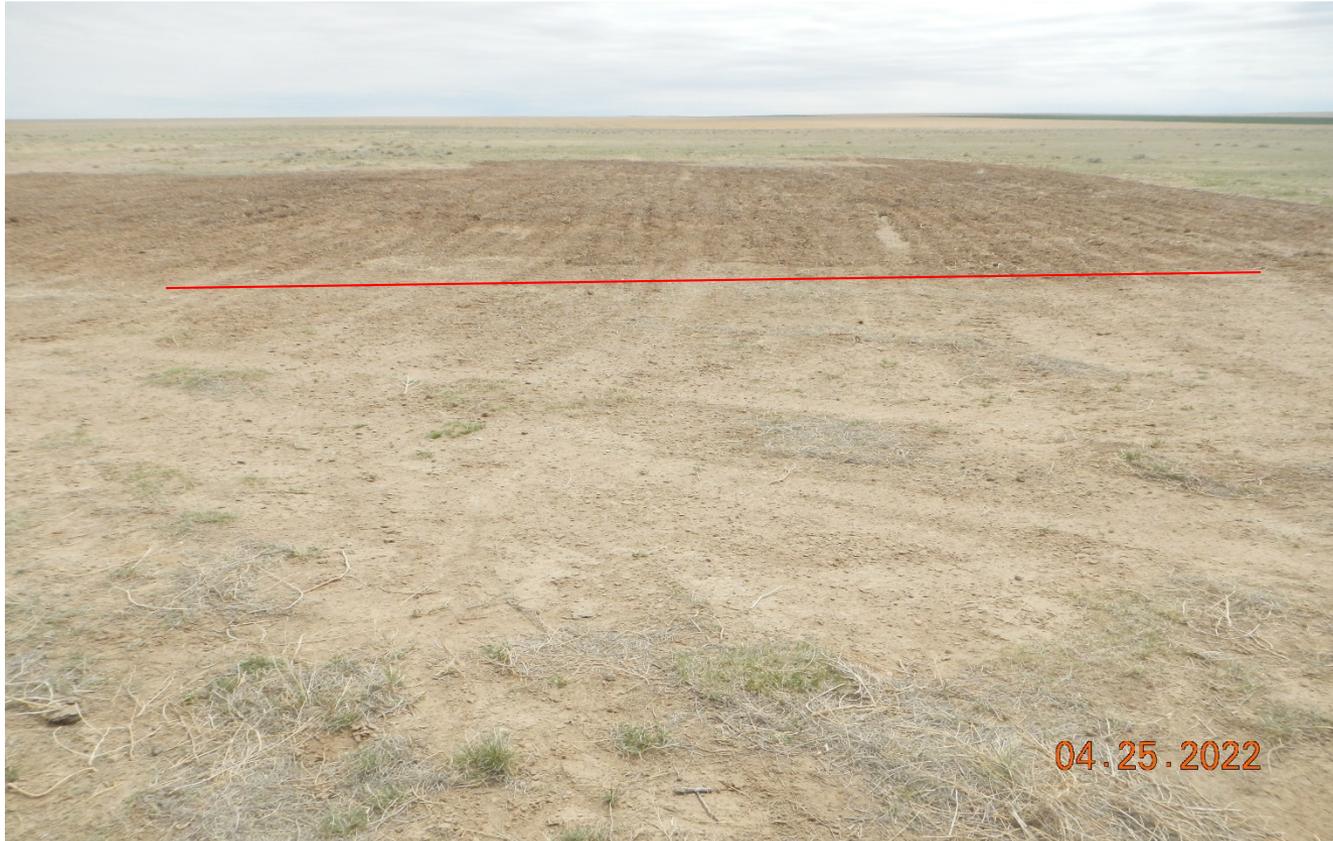
Photo 6. Facing east toward the location. The entire disturbed location was not properly decompacted. Soils were ripped above red line but not below.

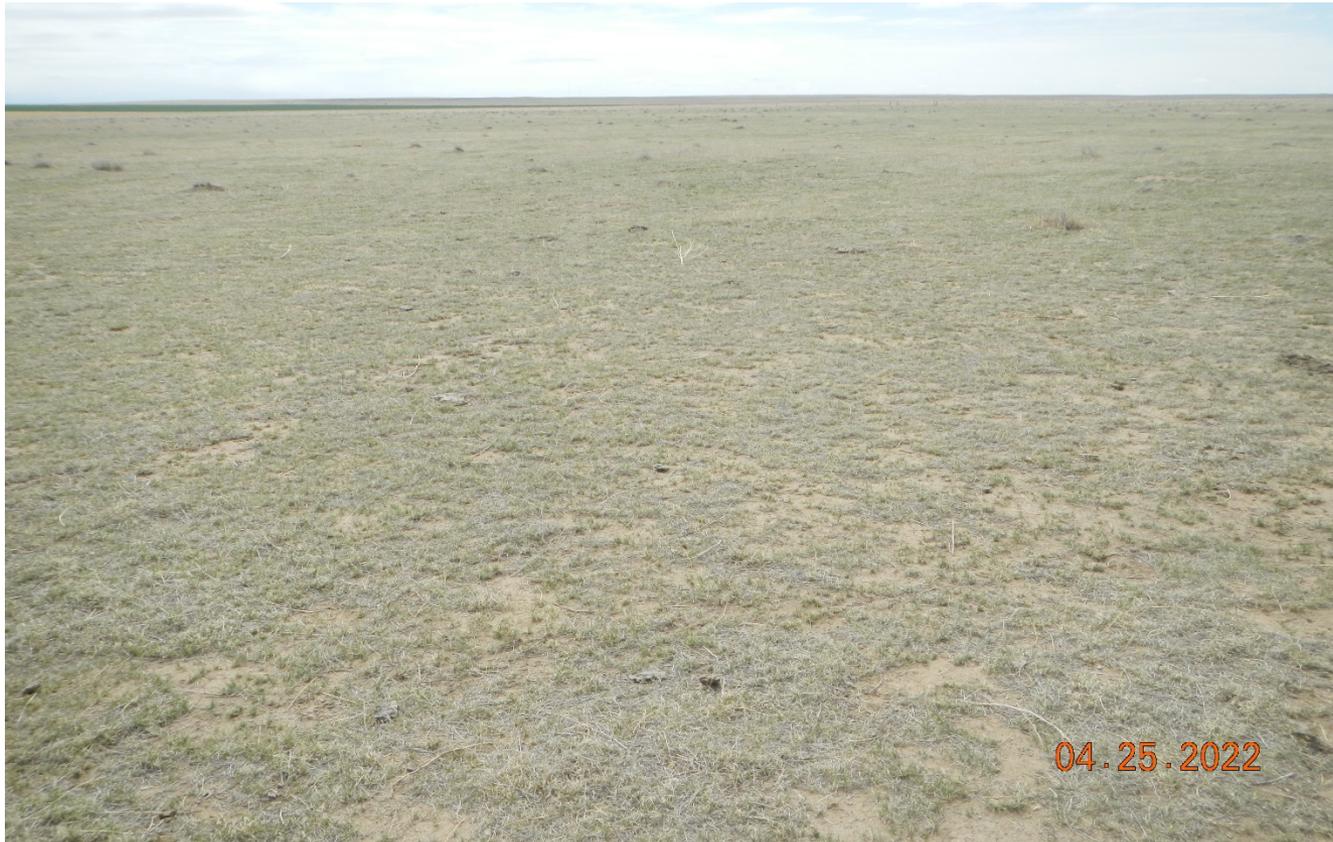
Photo 7. Facing south toward the surrounding undisturbed pasture which consists of native Blue grama grassland.

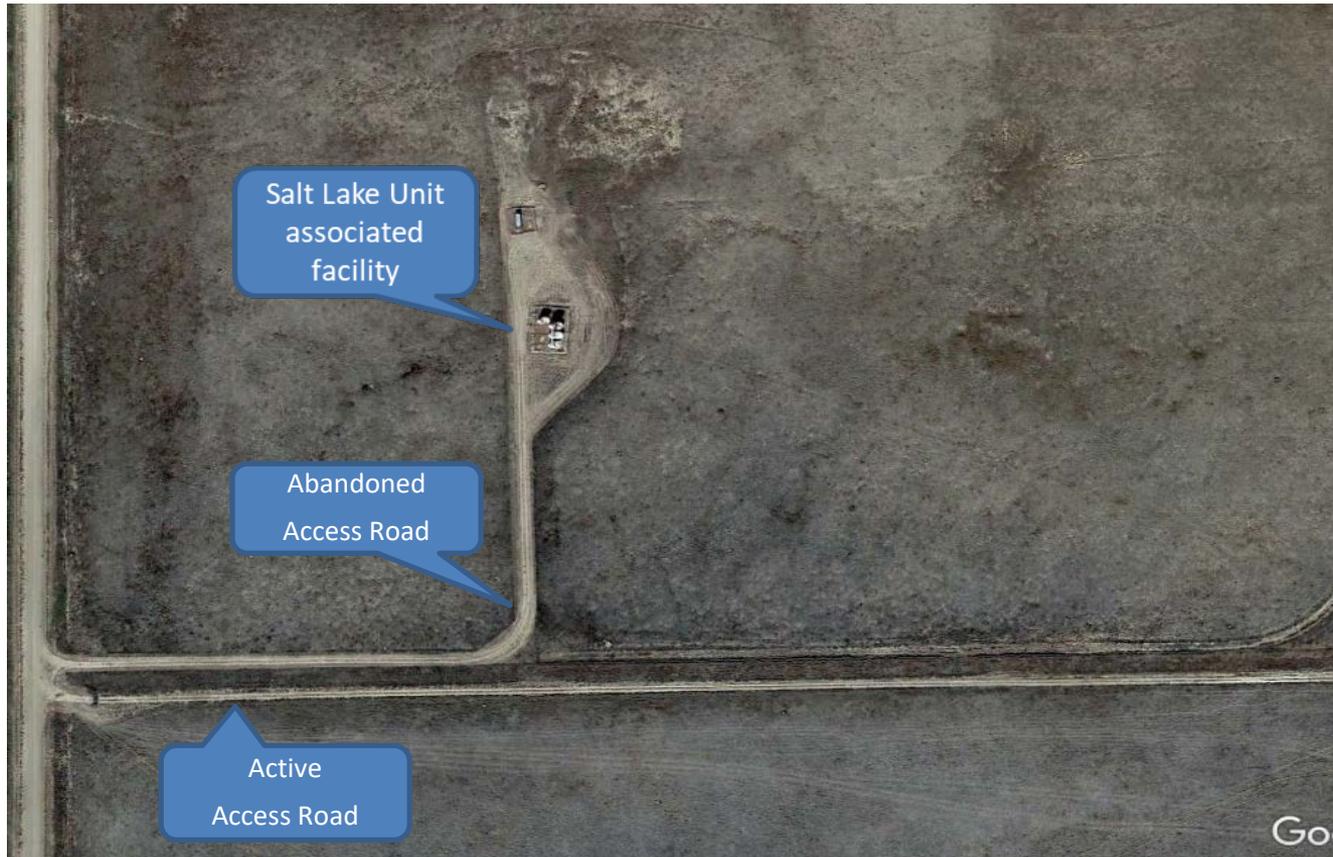
Photo 8. 2015 Aerial image showing the SALT LAKE UNIT associated battery facility. The abandoned access road that goes to the abandoned location needs to be reclaimed. The active road which travels east is in use for the FRAZEE #B-14-2 PR well site.

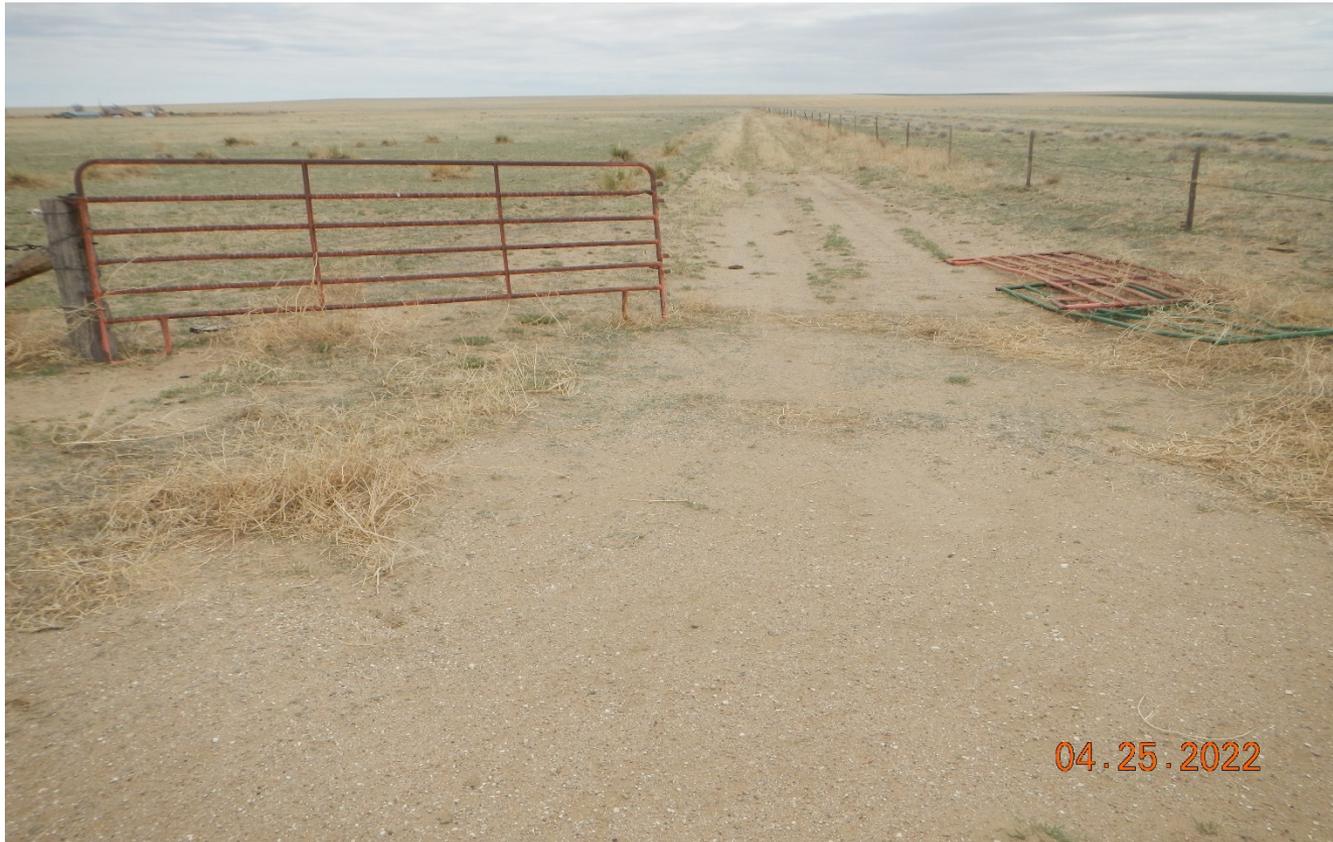
Photo 9. Facing east at the beginning of the access road from CR 27 to the Salt Lake Unit associated battery facility. The gates have fallen over and the access road was not reclaimed.

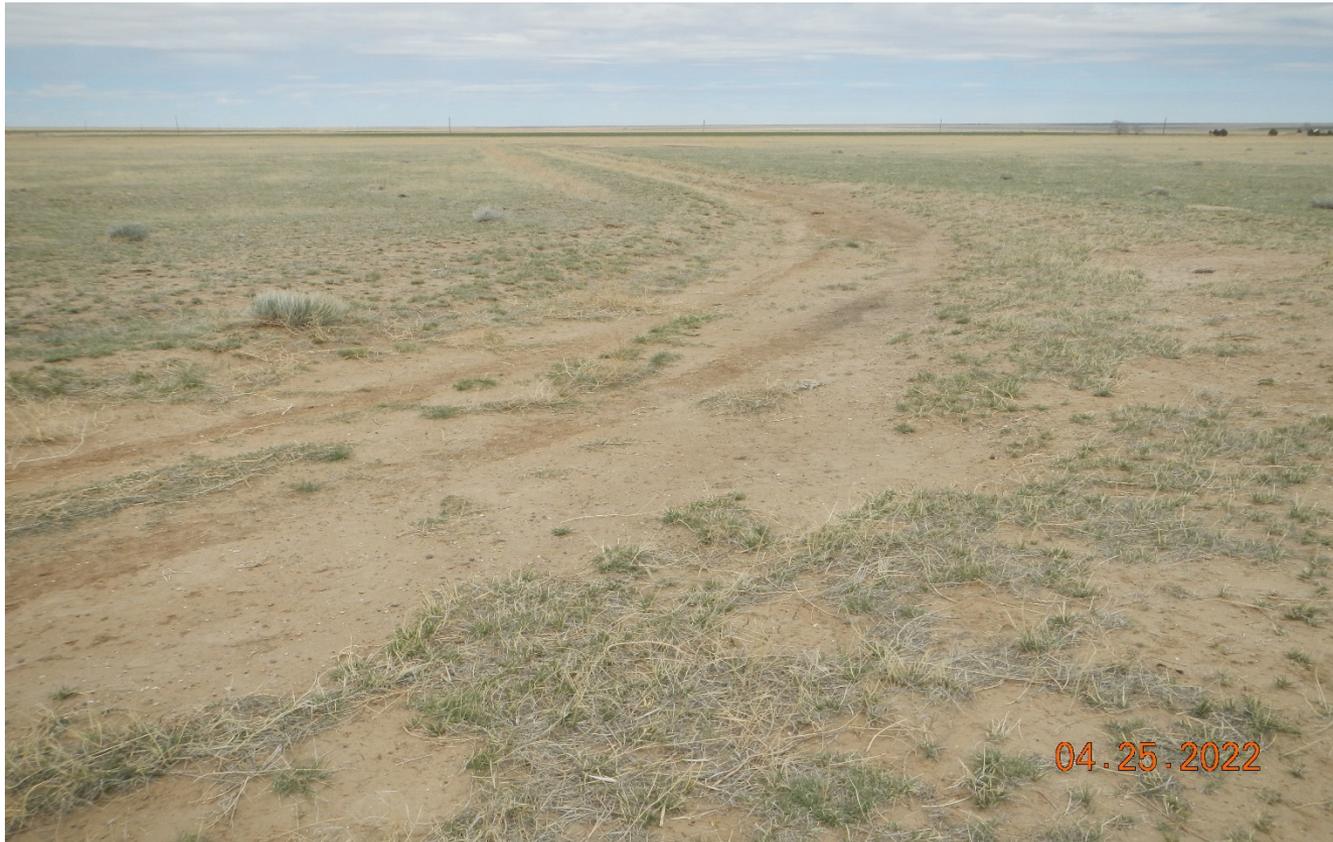
Photo 10. The access road turns north toward the location and dead ends. The soils are compacted and the road has not been reclaimed.

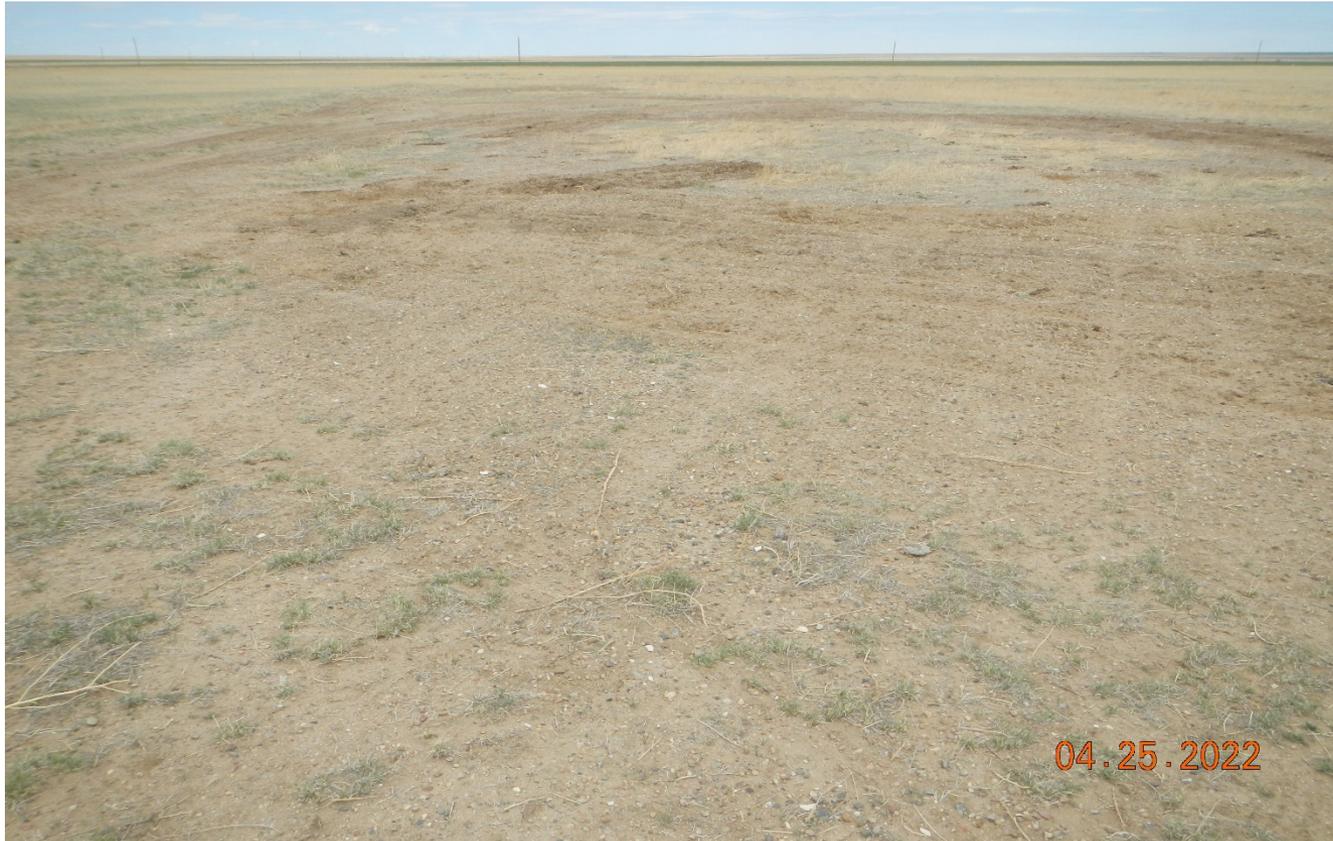
Photo 11. Facing north at the location. Soils were ripped in one direction at some areas however other areas remain compacted.

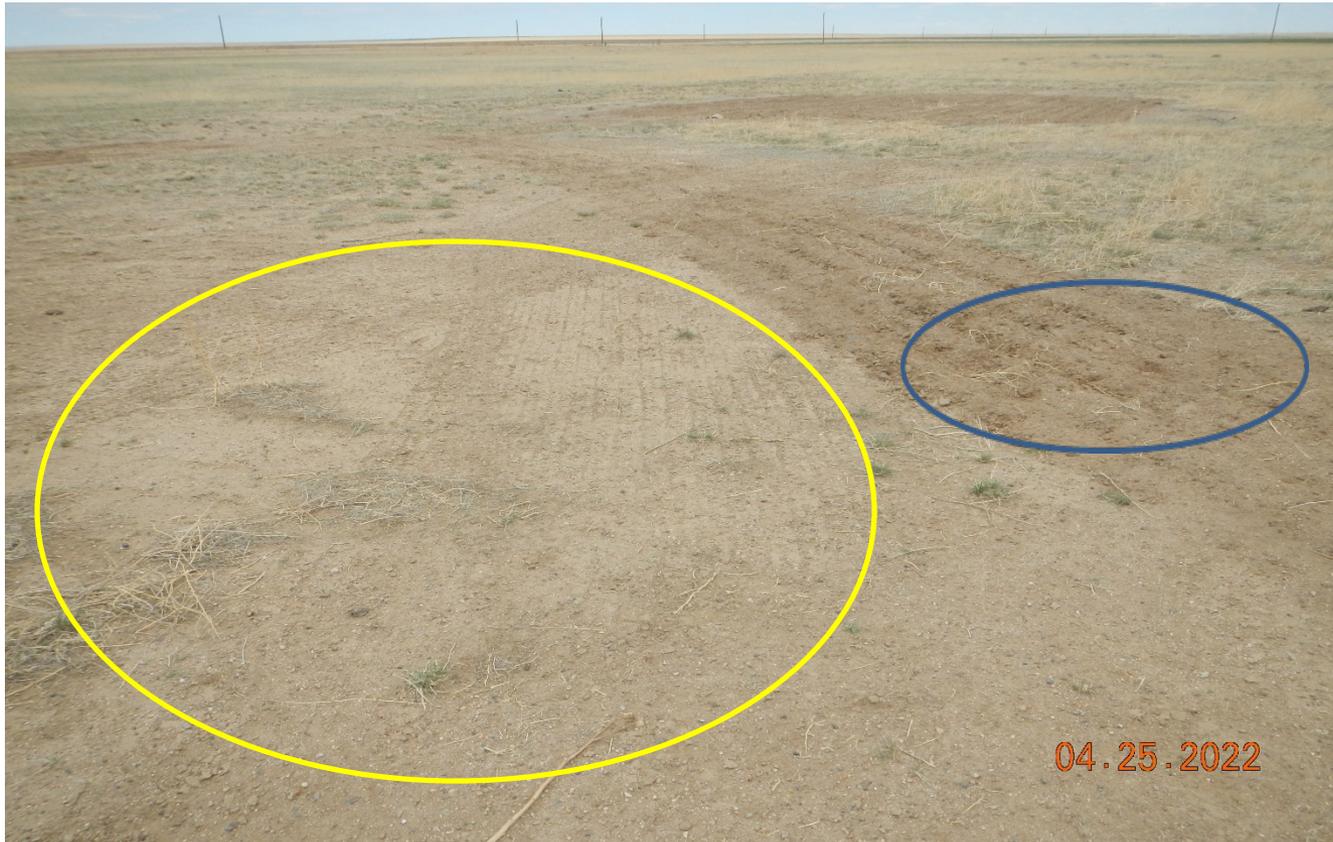
Photo 12. Facing northwest at the location. Soils were ripped in one direction at some areas (blue circle) however, other areas remain compacted (yellow circle). Unable to determine if seeding was performed (No seed observed on the soil surface).

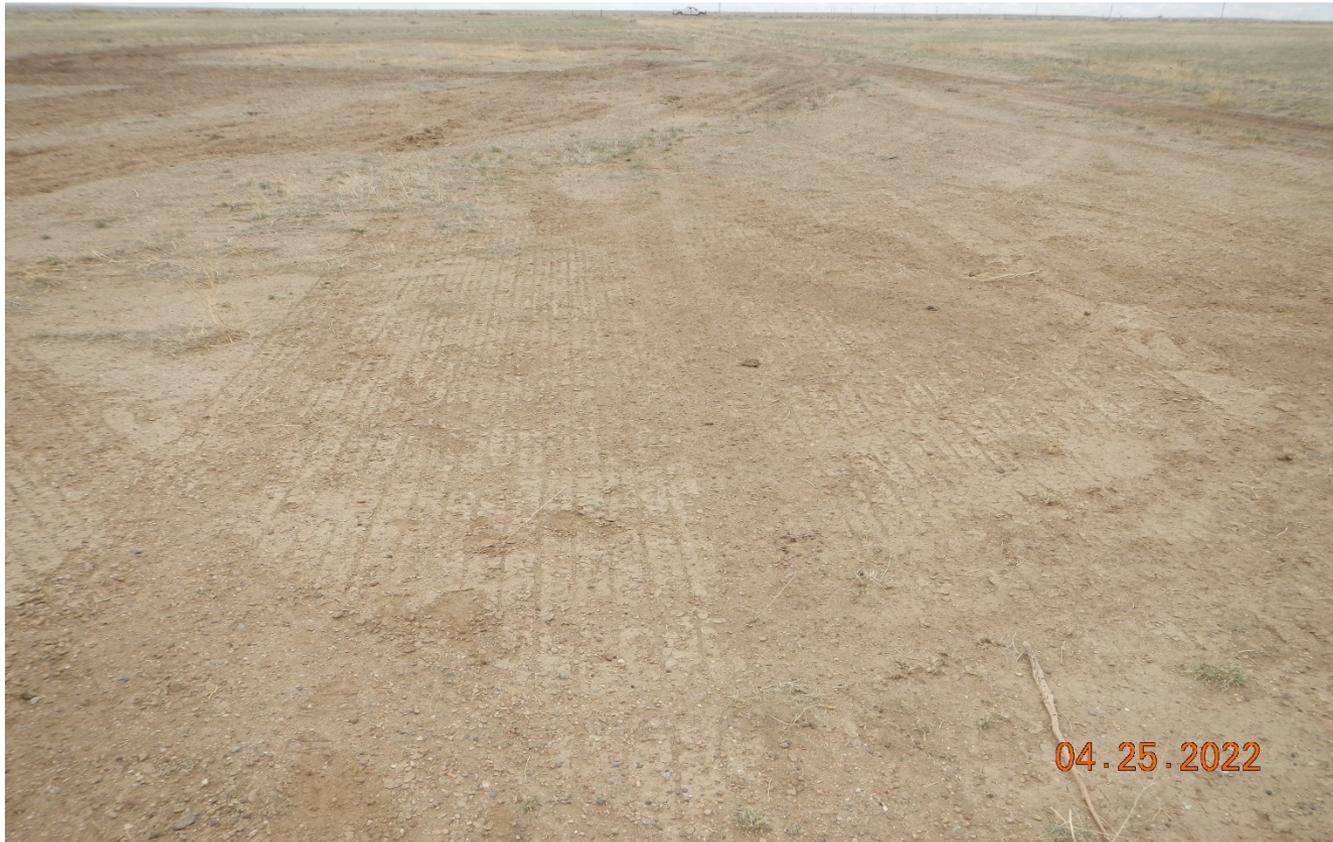
Photo 13. Soils remain compacted in areas of the location. Cross ripping of soils must be performed to at least 18 inches along with tilling to establish a proper seedbed.

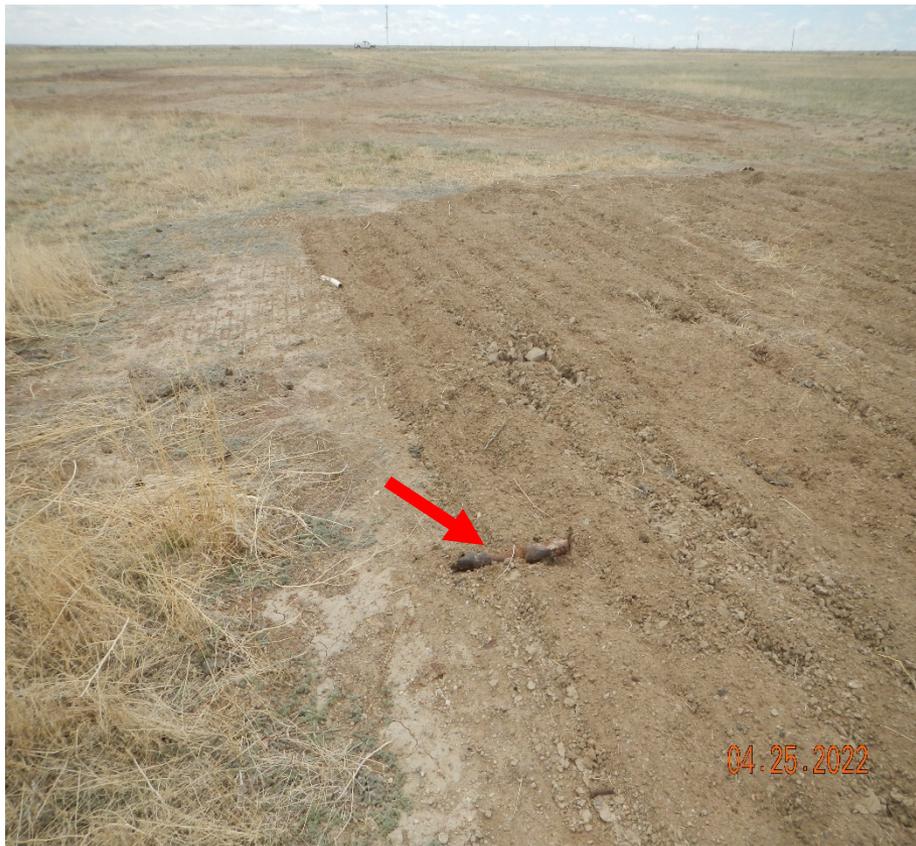
Photo 15. There is metal debris found at north side of the location.

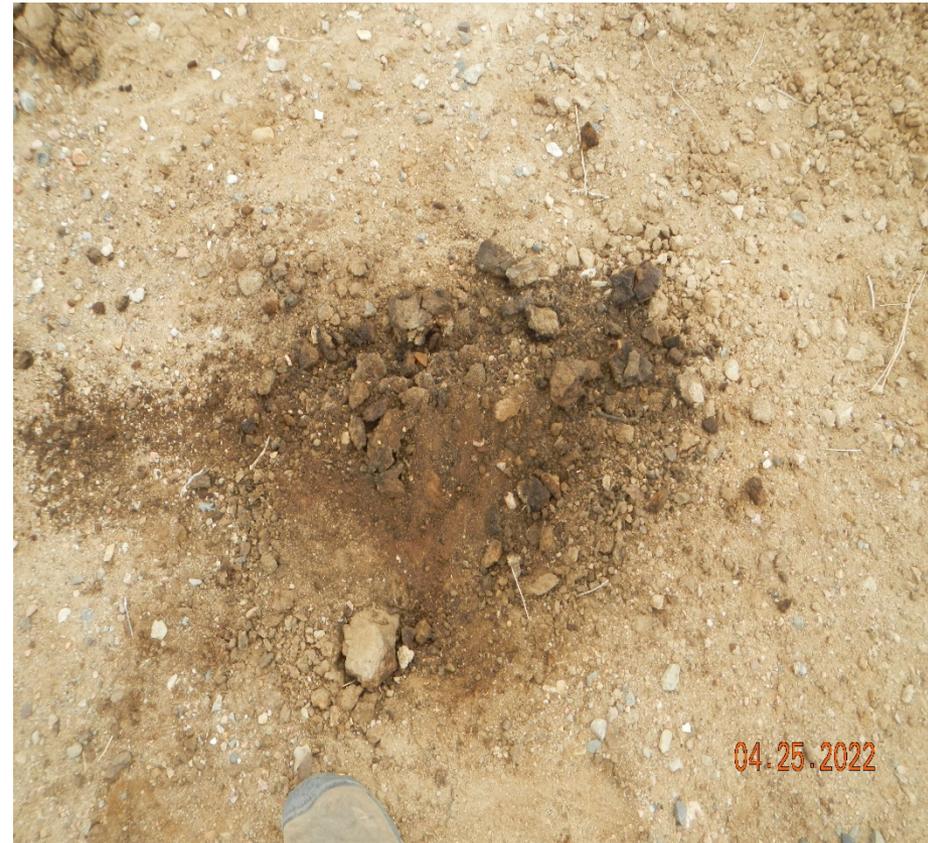
Photo 16. There was oily soils found at center of the location which needs to be cleaned up.
