Inspection Photos

4/22/2022

Operator: CAERUS PICEANCE LLC # 10456

Location ID: 335594

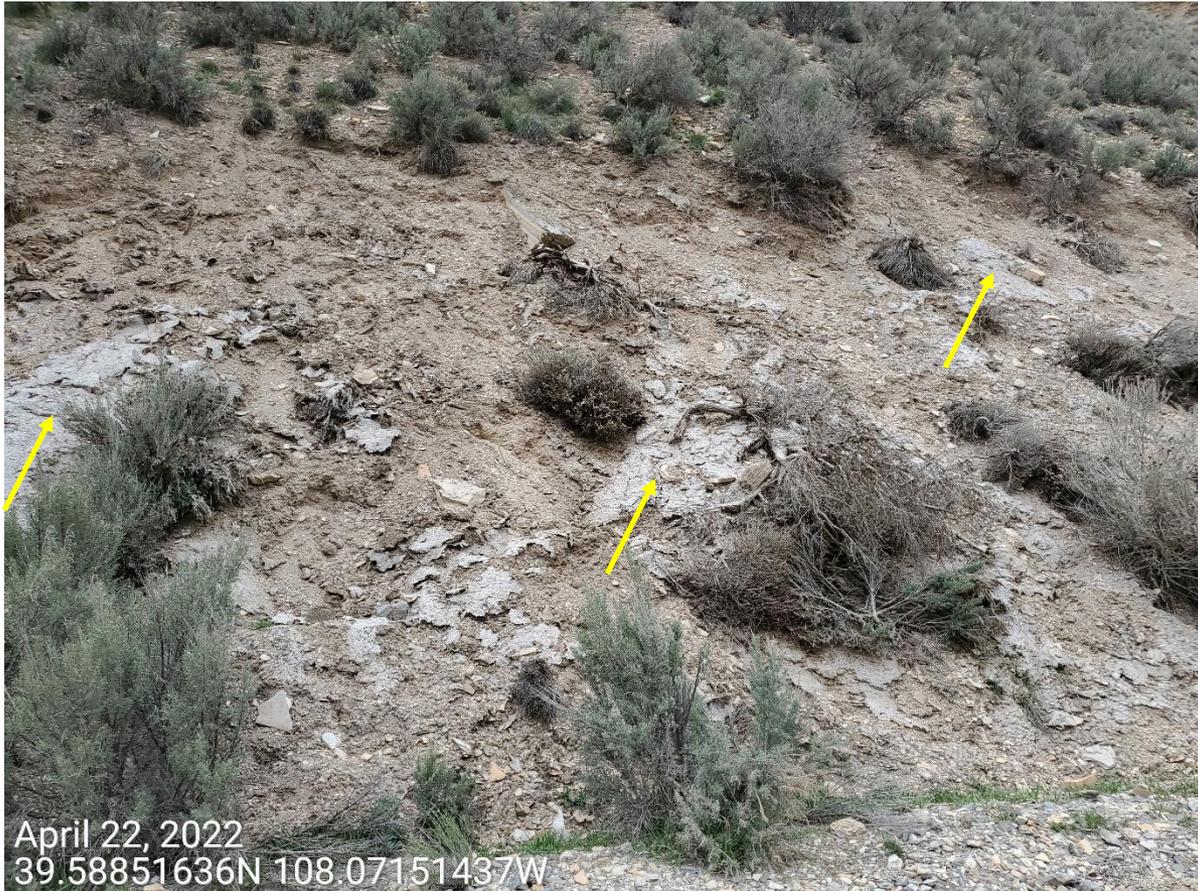
Photo 1: Photo taken from the disturbed slopes on the north end of the Location. Photo example showing hydromulch (yellow arrow) implemented by Operator has not been maintained in a proper functioning condition to minimize erosion, degradation, and to stabilize the slopes; erosion and degradation to the slopes have persisted.

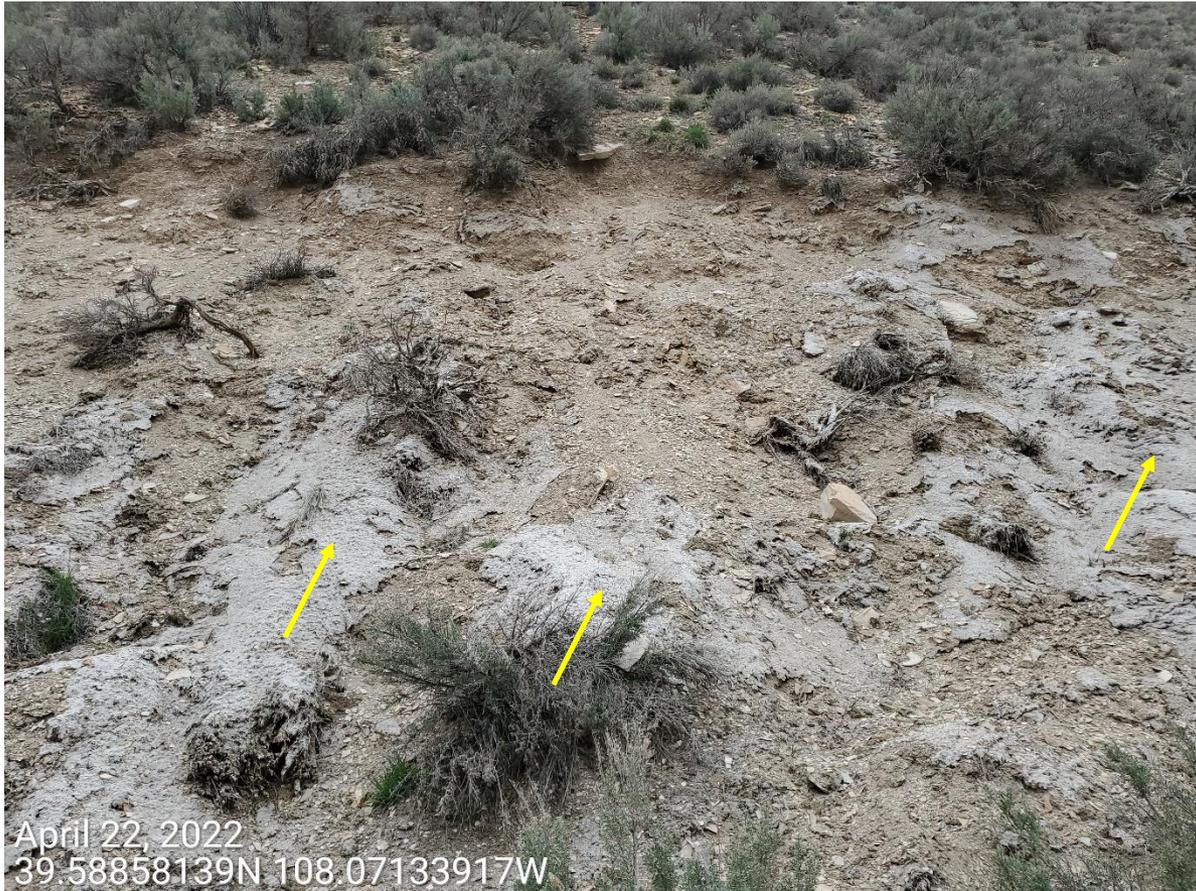
Photo 2: Photo taken from the disturbed slopes on the north end of the Location. Photo example showing hydromulch (yellow arrow) implemented by Operator has not been maintained in a proper functioning condition to minimize erosion, degradation, and to stabilize the slopes; erosion and degradation to the slopes have persisted.

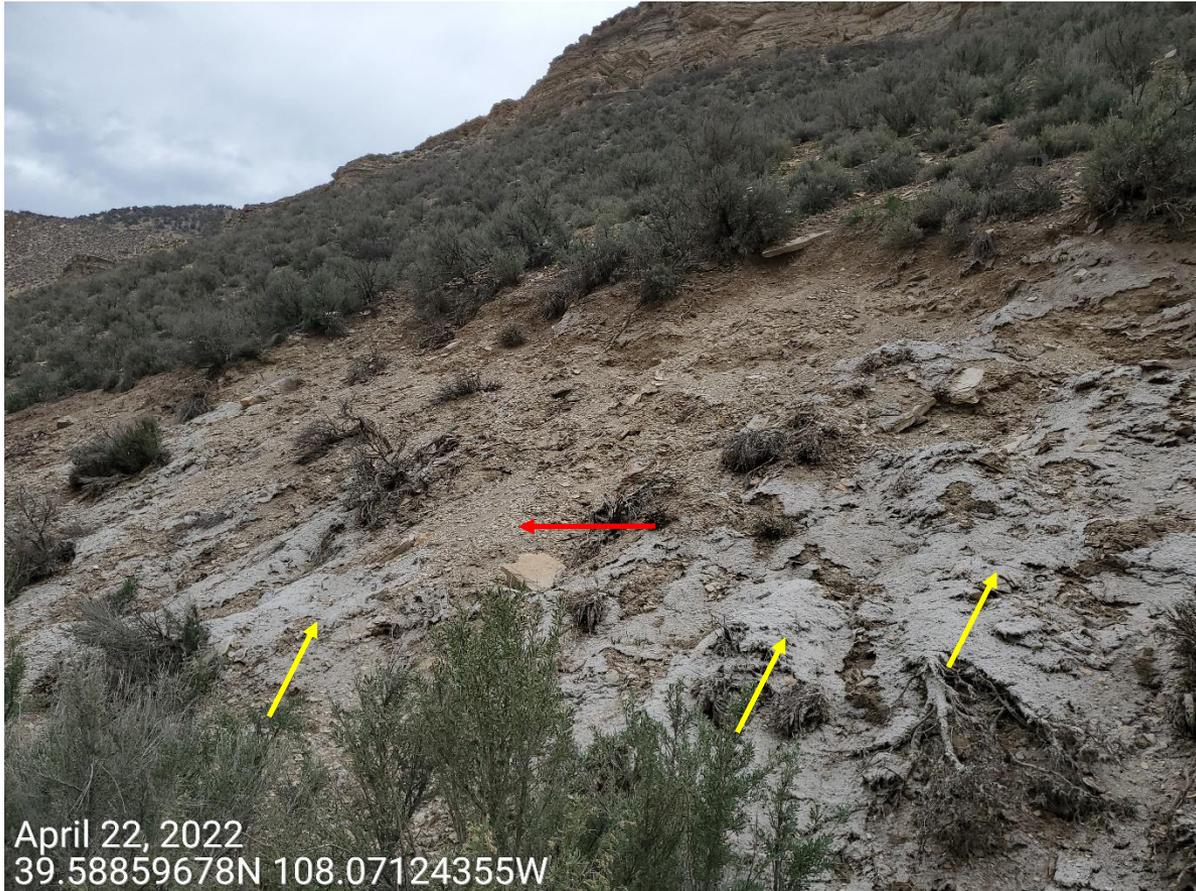
Photo 3: Photo taken from the disturbed slopes on the north end of the Location. Photo example showing hydromulch (yellow arrow) implemented by Operator has not been maintained in a proper functioning condition to minimize erosion, degradation, and to stabilize the slopes; erosion and degradation to the slopes have persisted. Red arrow shows areas where soils have eroded and covered sections of the hydromulch

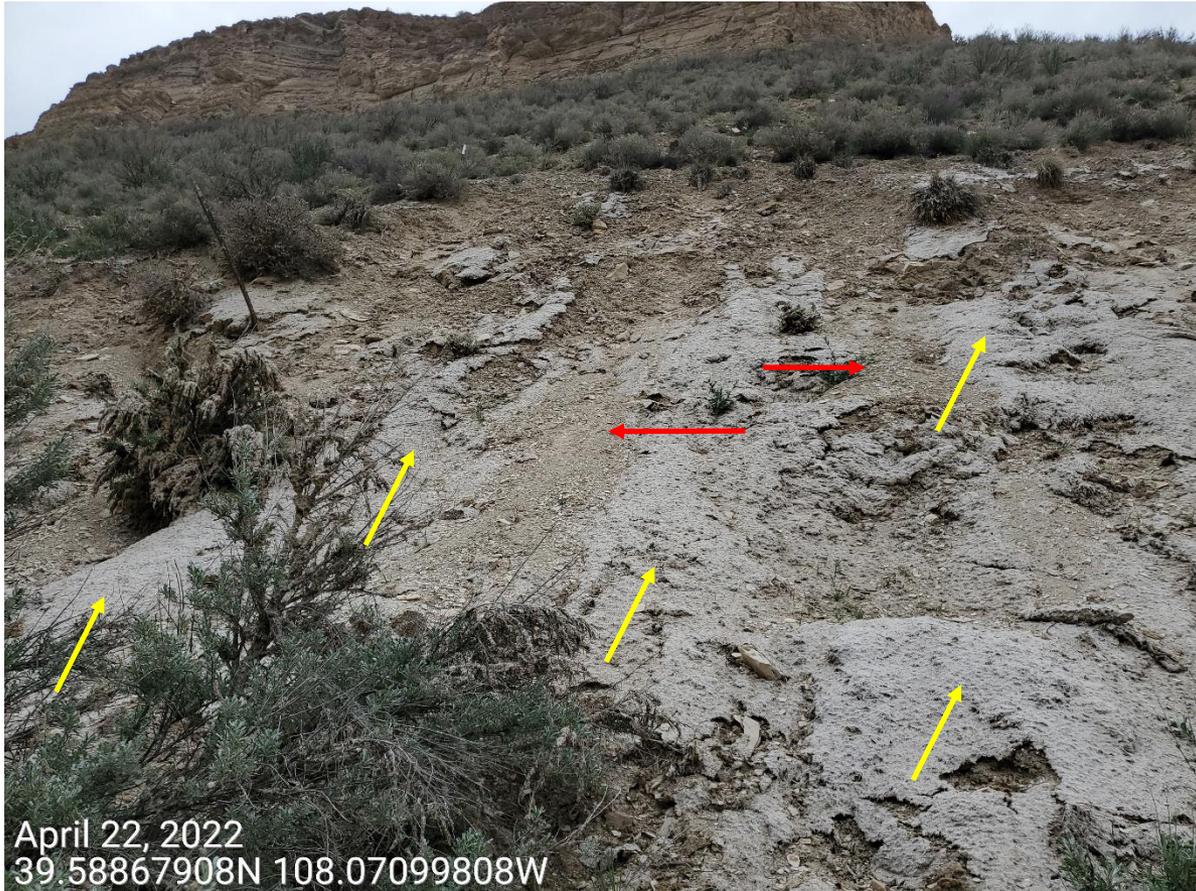
Photo 4: Photo taken from the disturbed slopes on the north end of the Location. Photo example showing hydromulch (yellow arrow) implemented by Operator has not been maintained in a proper functioning condition to minimize erosion, degradation, and to stabilize the slopes; erosion and degradation to the slopes have persisted. Red arrow shows areas where soils have eroded and covered sections of the hydromulch
