Inspection Photos

ID: 150396

Operator: CHEMCO INC

Inspection Date: 4/25/2022

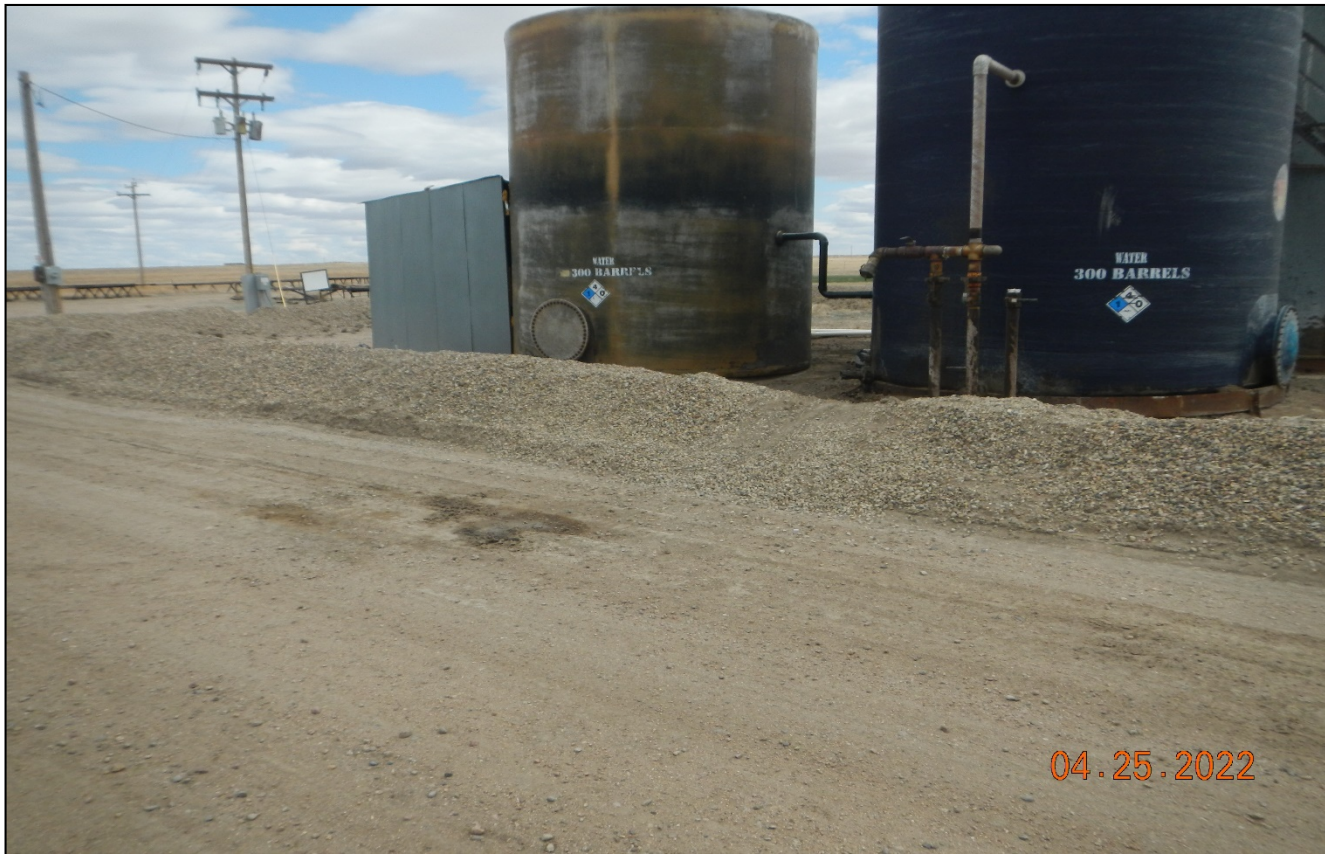
Photo 1. Facing southeast toward the tank battery. Berms have rebuilt around the tank battery.

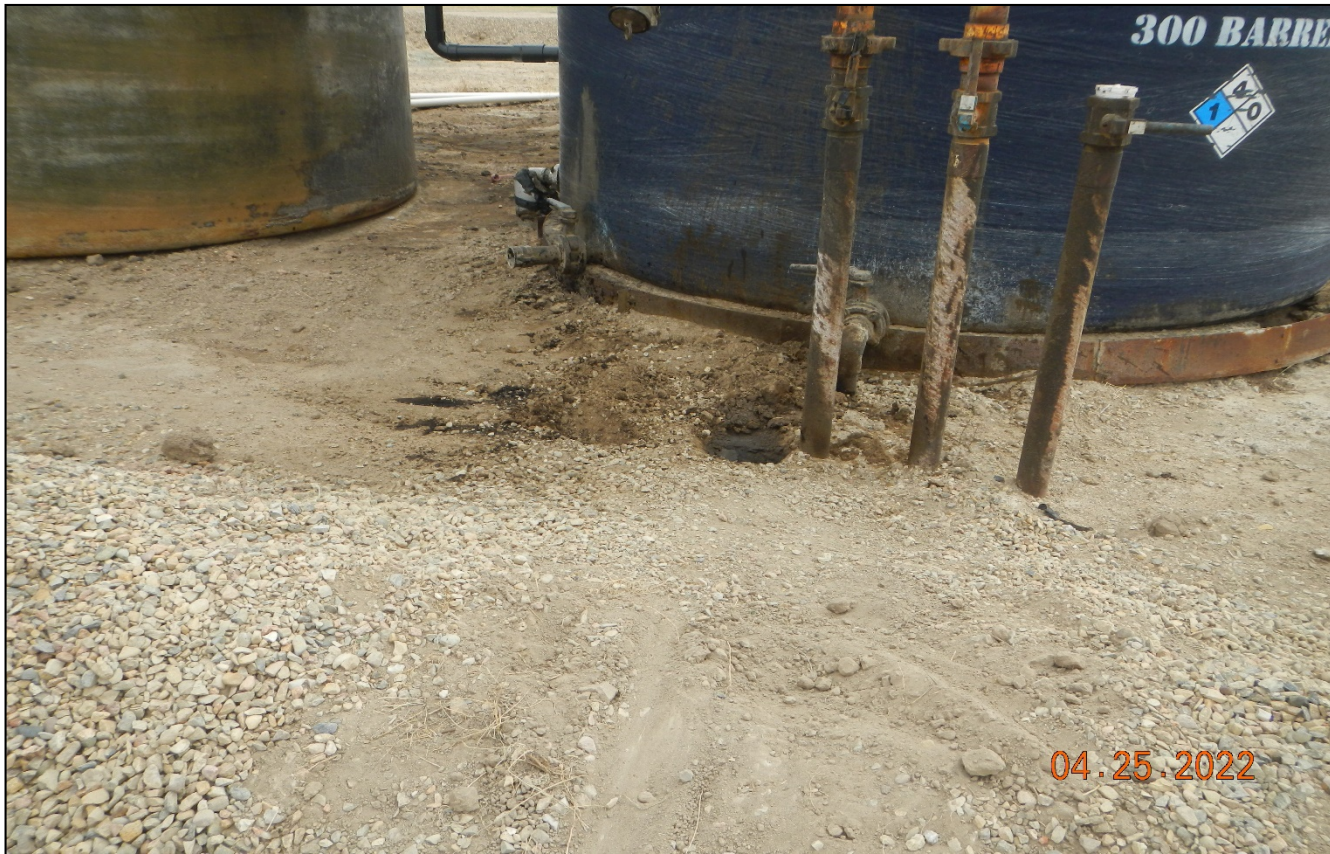
Photo 2. There is still oil stained soils that need to be cleaned up.

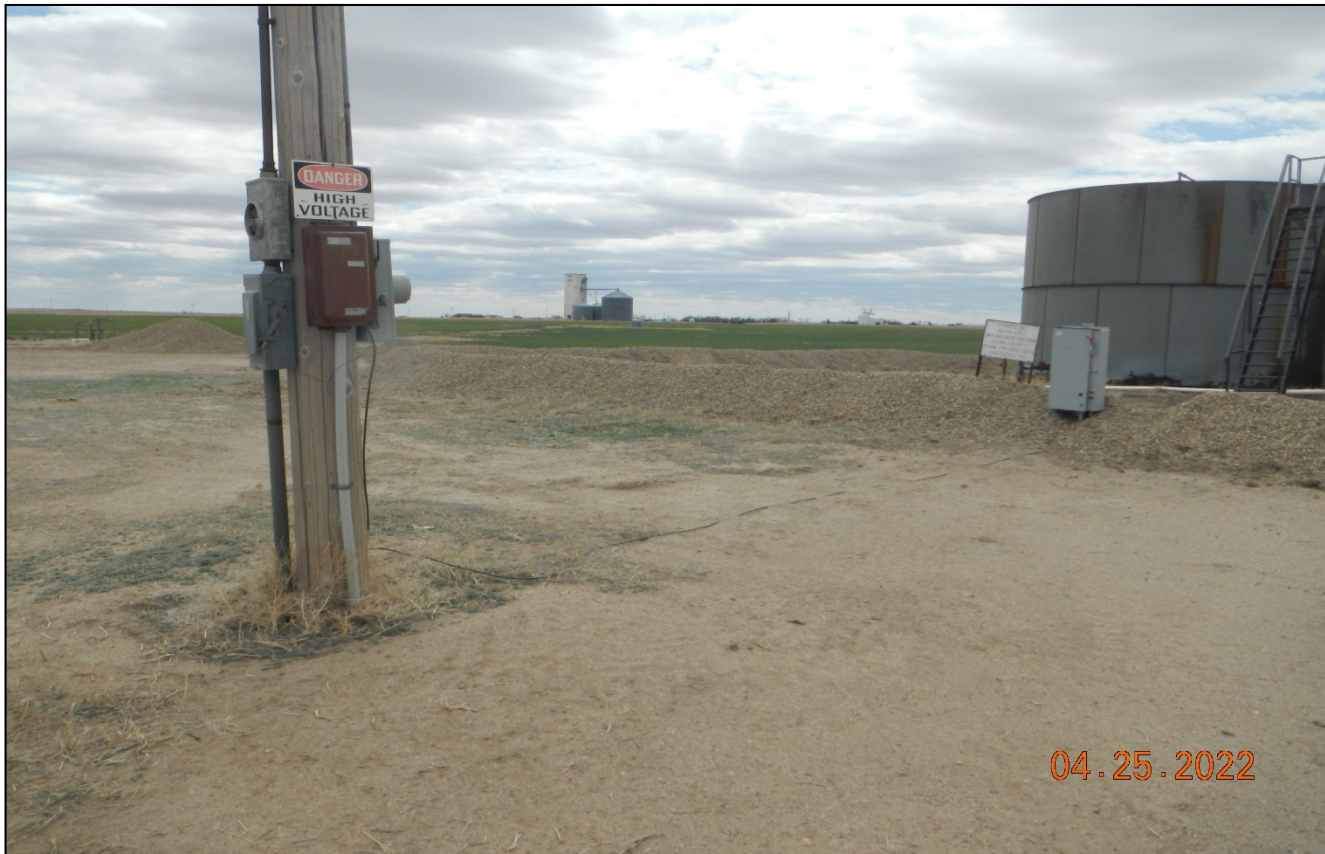
Photo 3. The electric box lid has been closed and wired. The electric cable on the ground is still a safety concern and needs to be covered and protected.

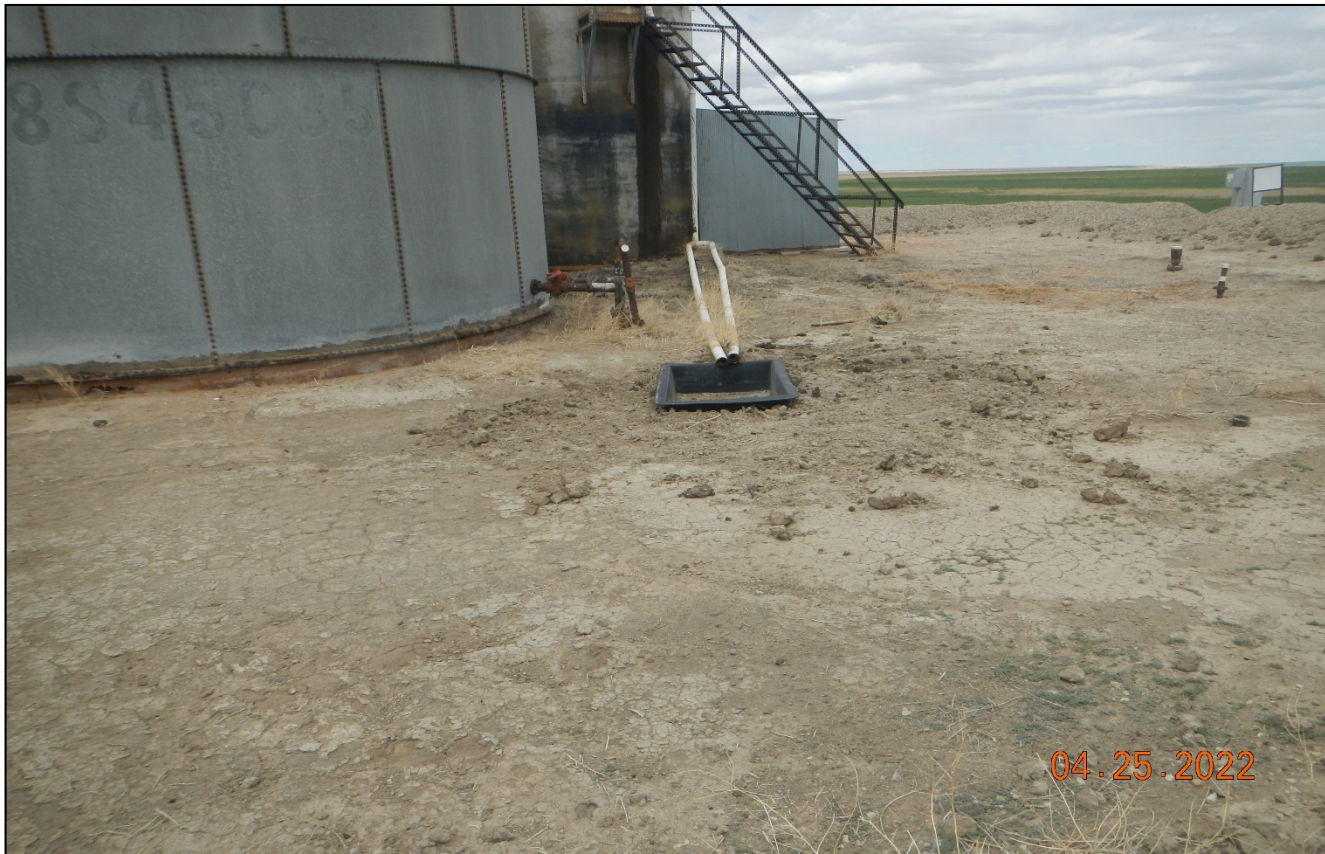
Photo 4. Oil waste has been cleaned out at the pipe outlet and a plastic tub was added to control spill. The tub will need to be monitored and cleaned out if it fills with oily waste.

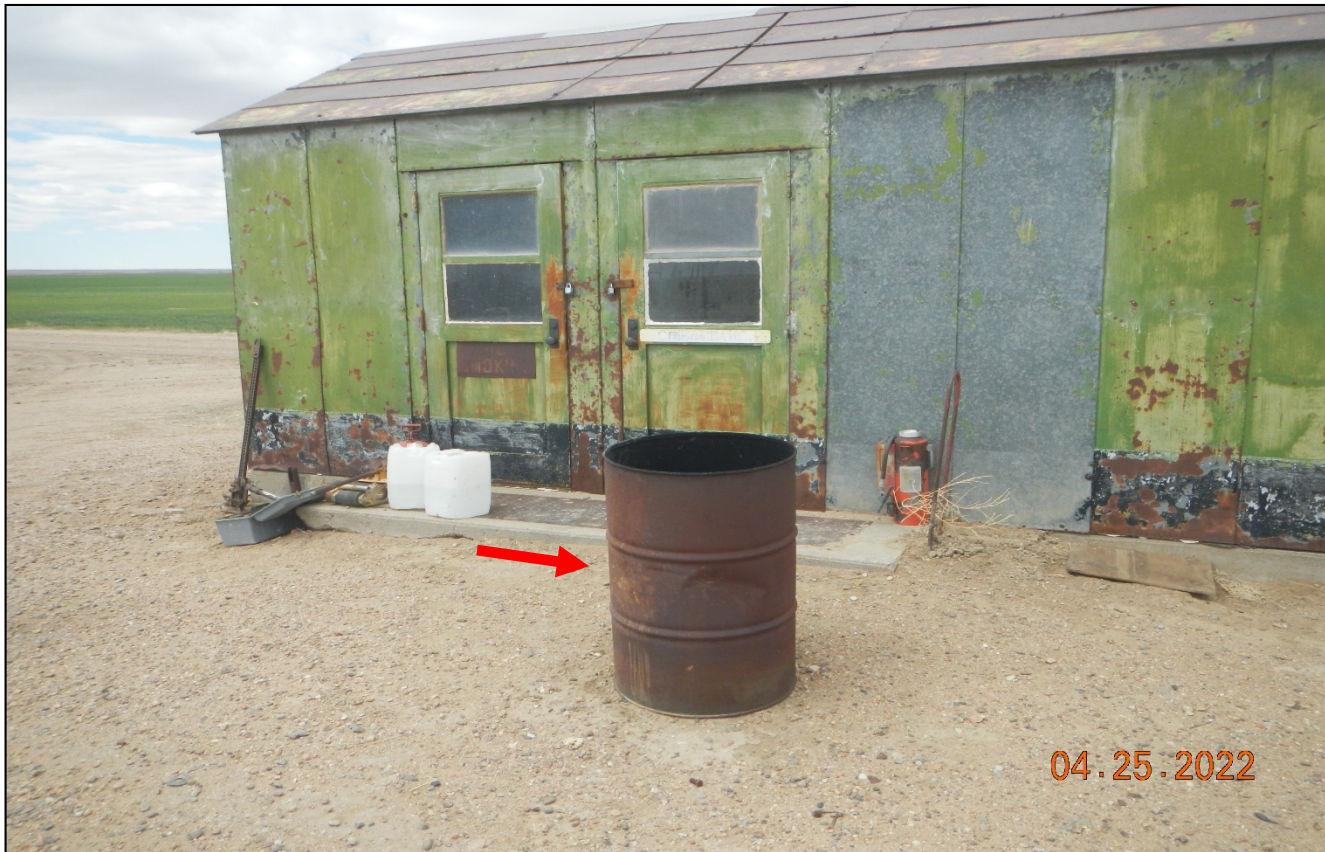
Photo 5. There is various unused unnecessary equipment/supplies being stored at the location. The barrel shown at red arrow contains burnt ashes. Burning is prohibited on the location.

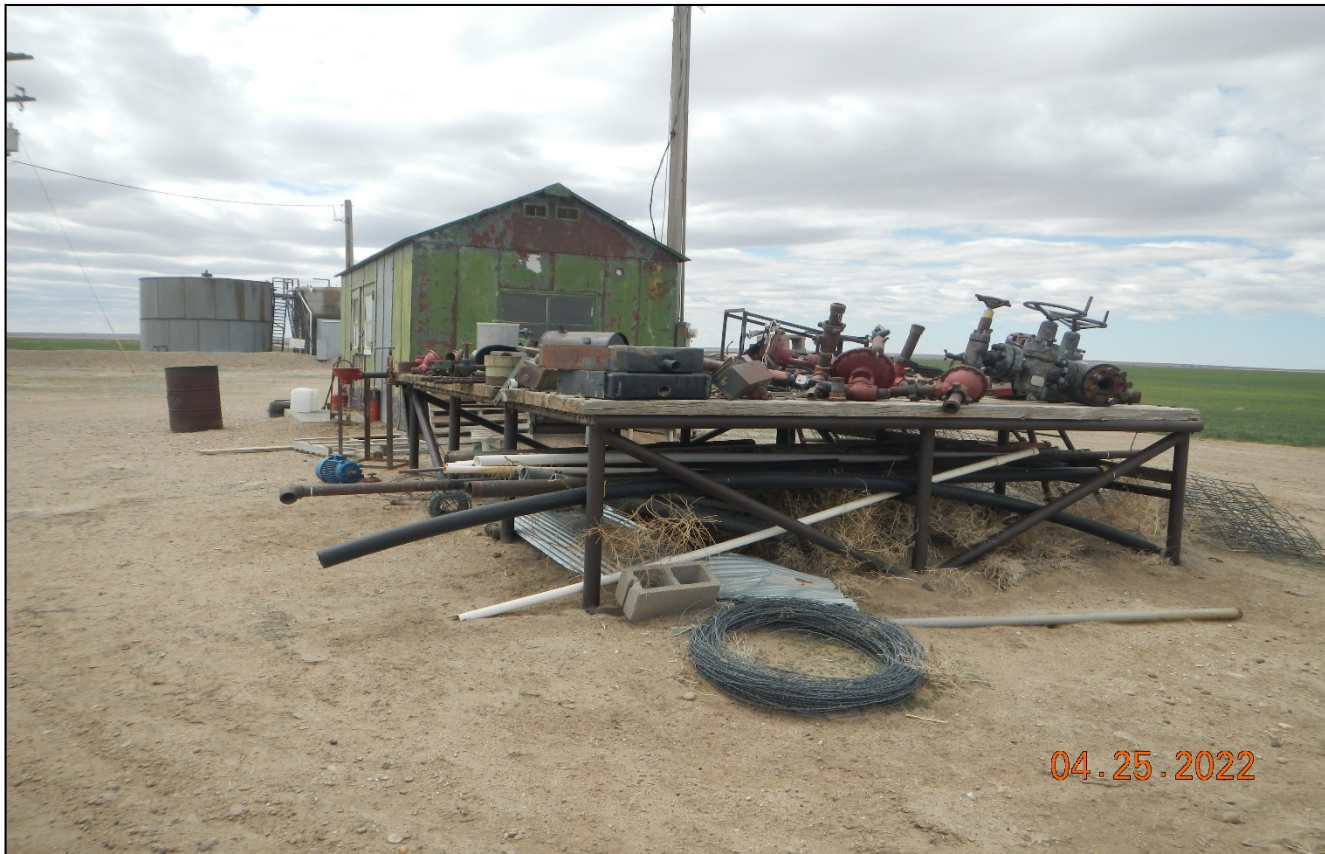
Photo 6. Facing east at the location. There is various unused unnecessary equipment/supplies being stored at the location. All supplies not necessary for use on the location is prohibited.
