Inspection Photos

5/2/2022

Operator: CAERUS PICEANCE LLC # 10456

Location ID: 334752

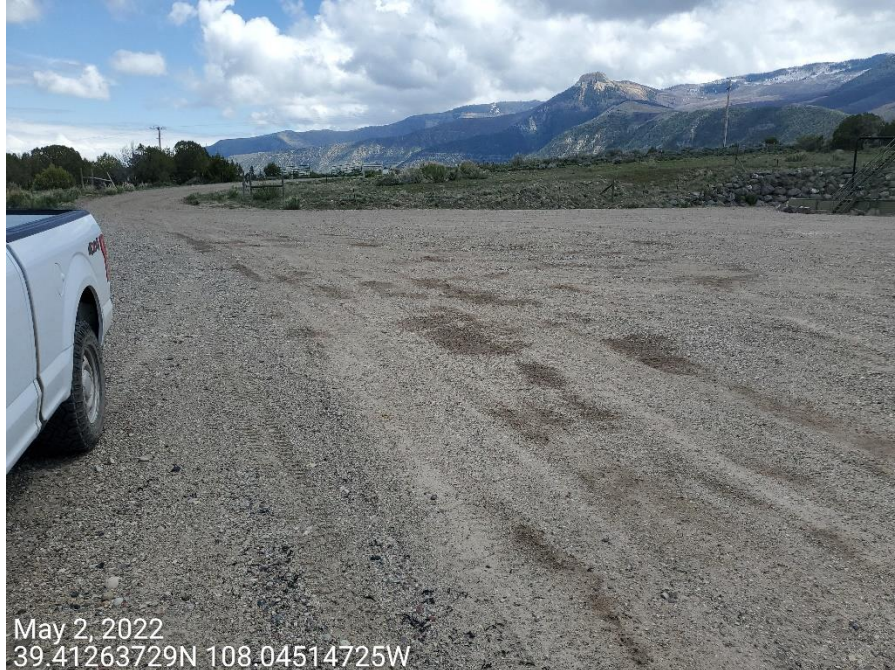
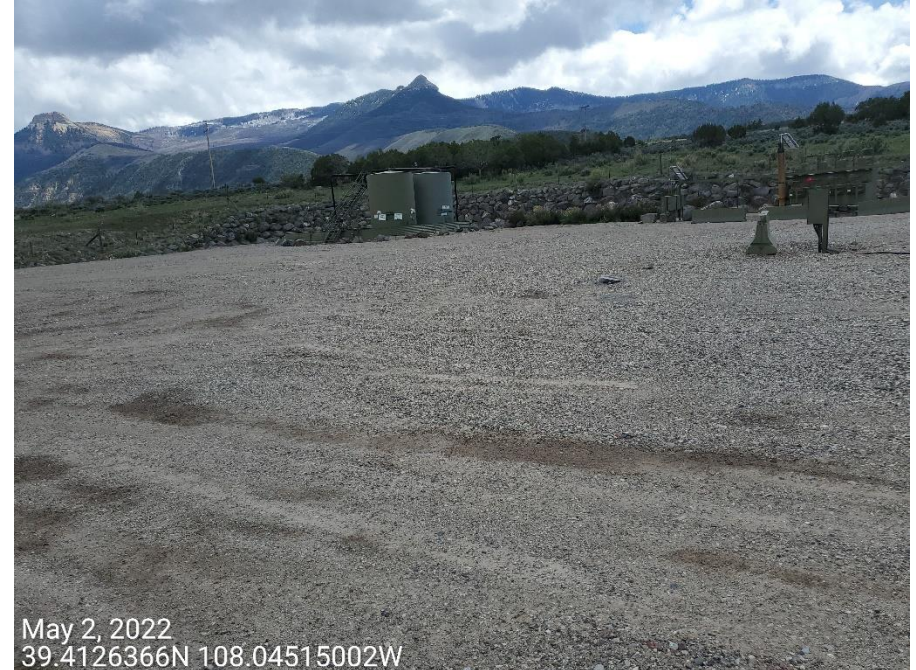
Photo 1: Photos taken from the north end of the Location. Photos 1-2 provide an overview of the Location from east, southeast, southwest to west.

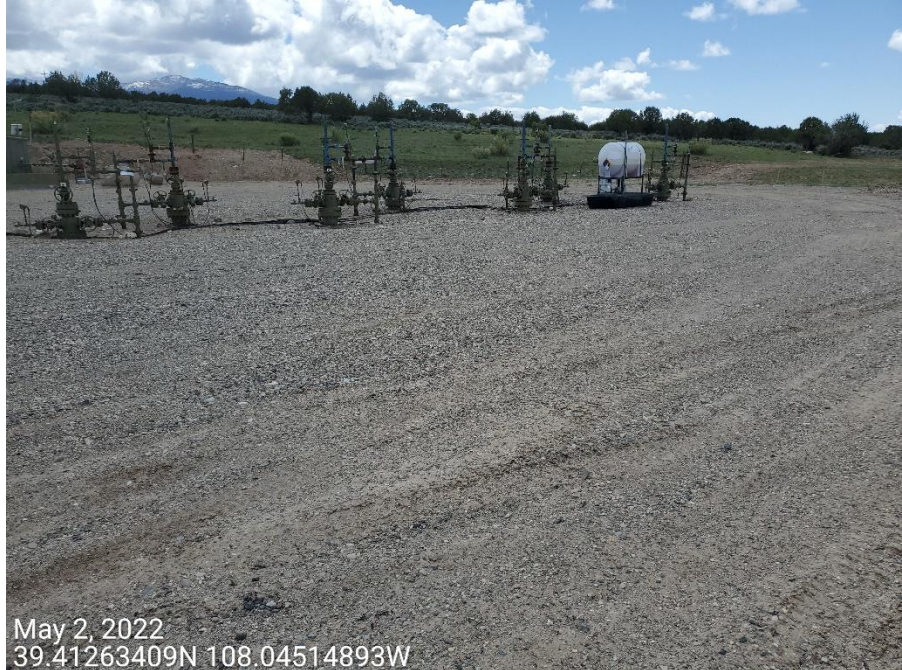
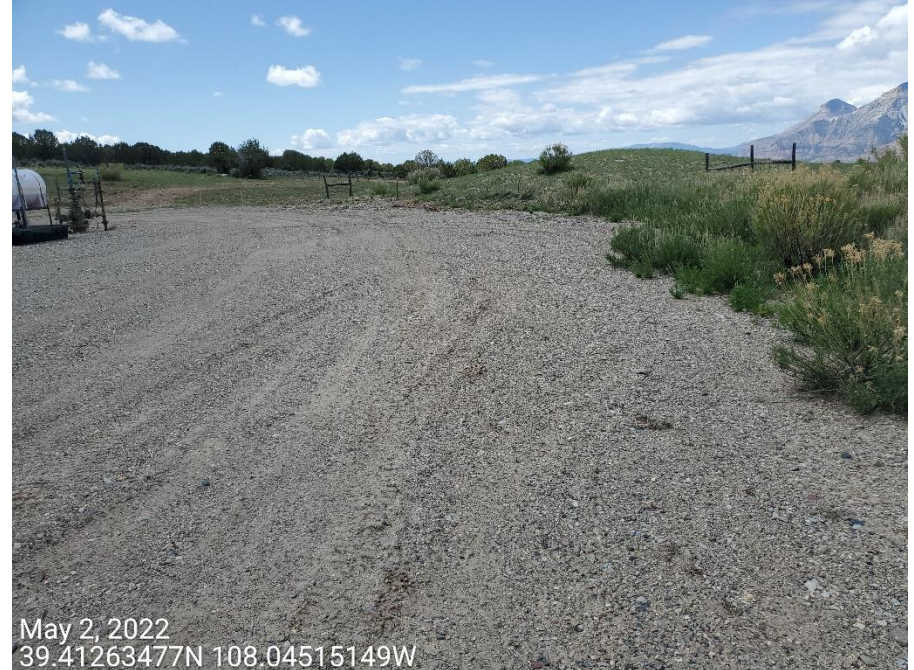
Photo 2: See comments under photo 1.

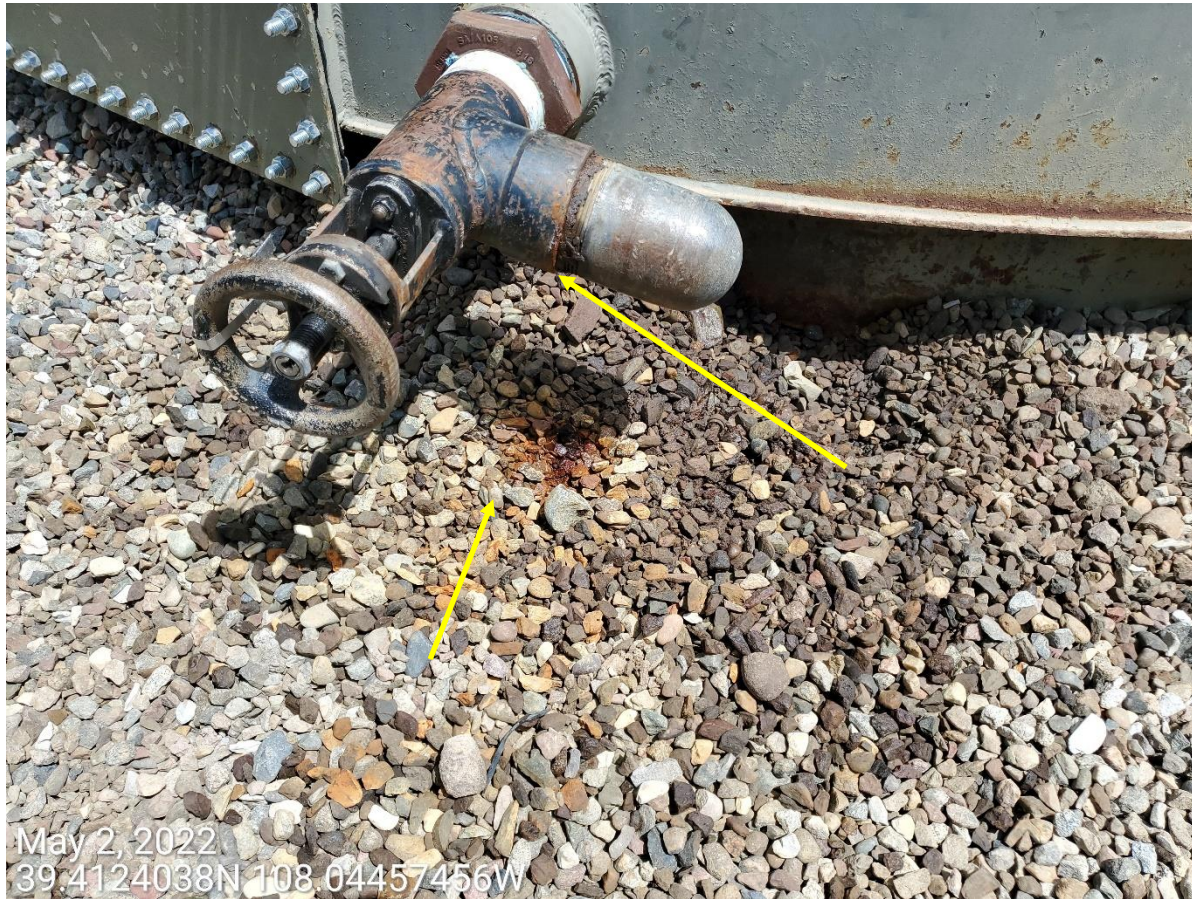
Photo 3: Photo taken from the west side, of the southwestern produced water tank; leak observed at the bull plug. Photo also shows stained soils observed within the tank battery.

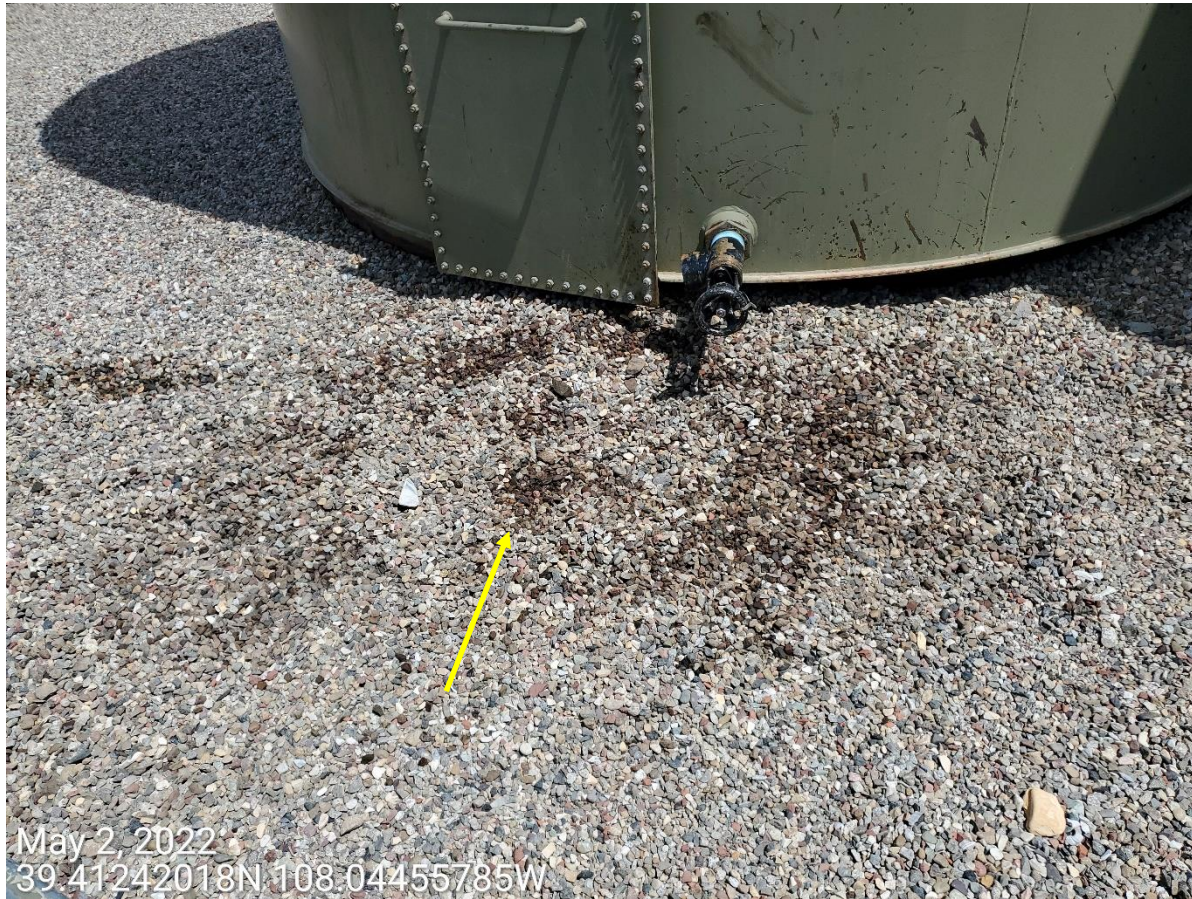
Photo 4: Photo example showing additional stained soils observed at the tank battery.

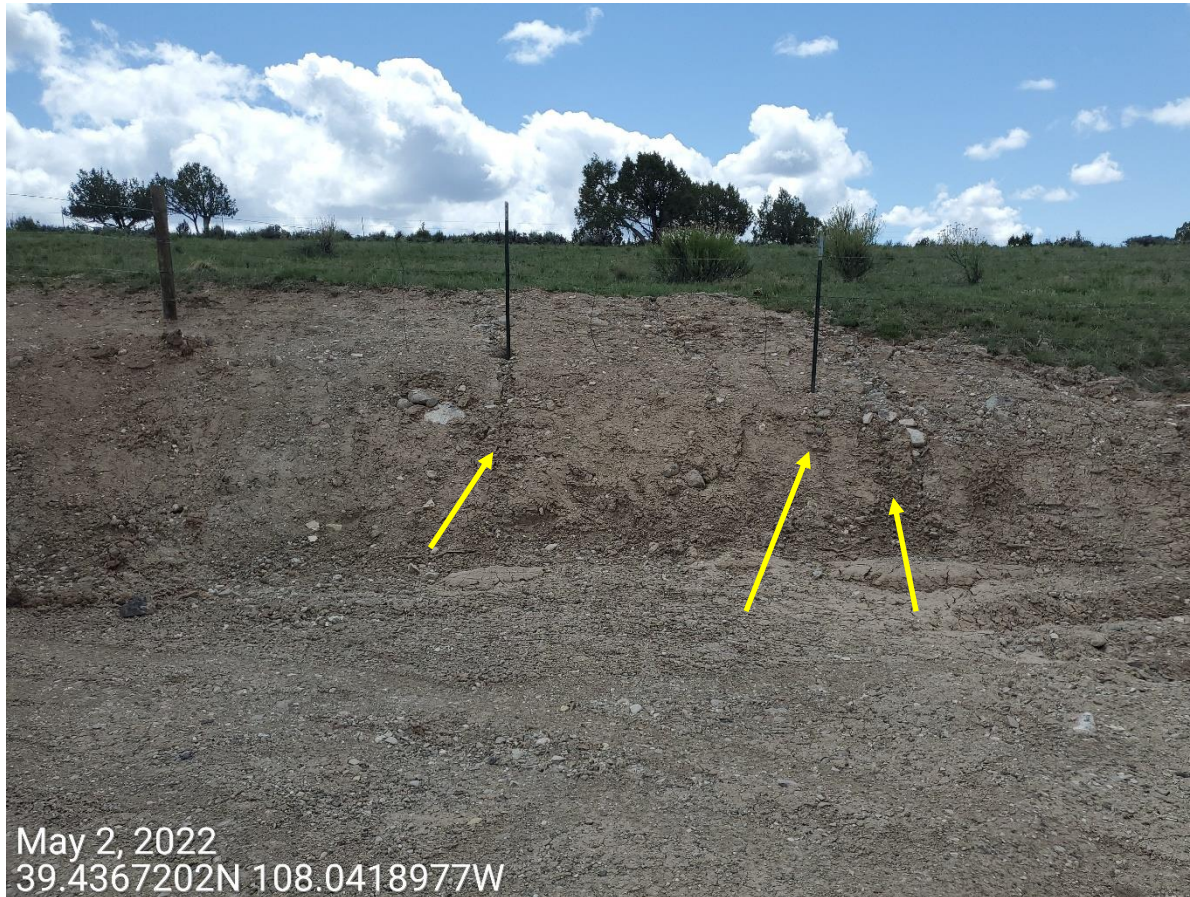
Photo 5: Photo taken from the cut slopes on the north end of the Location. Control measures to minimize erosion missing or insufficient at the cut slopes; erosion degradation observed.

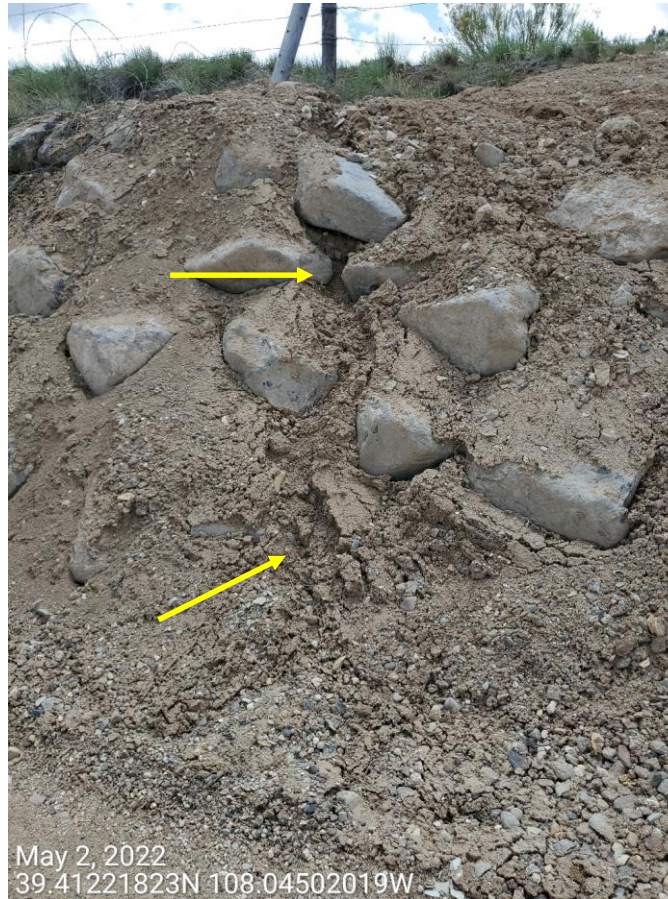
Photo 6: Photo taken from the cut slopes on the north end of the Location. Control measures to minimize erosion missing or insufficient at the cut slopes; erosion degradation observed.

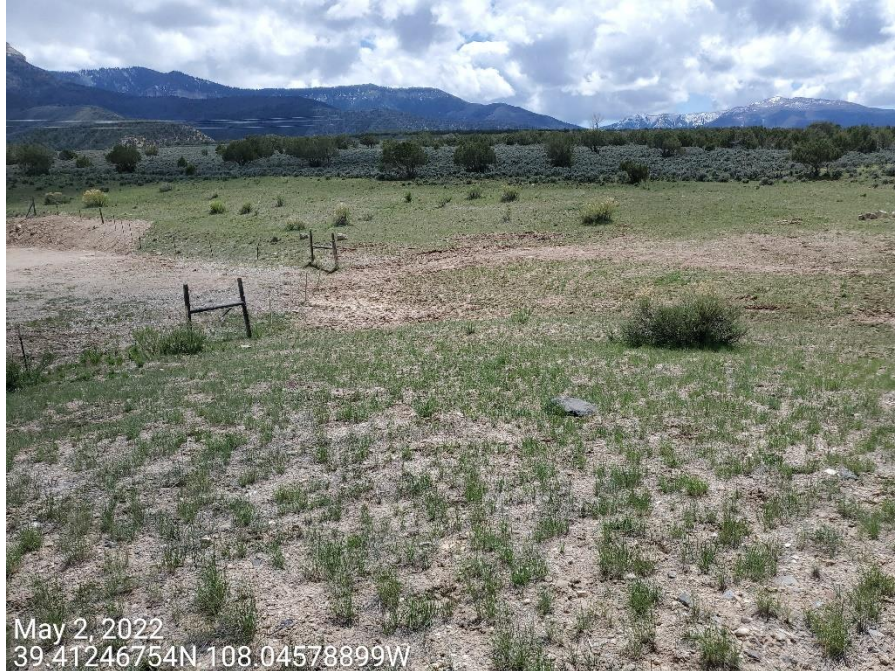
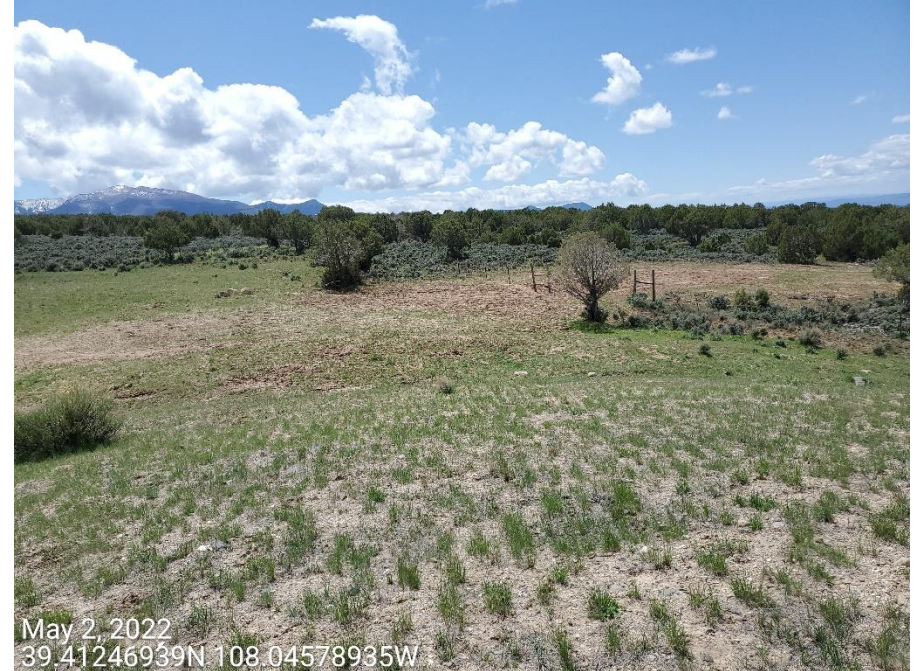
Photo 7: Photos taken from the western interim areas of the Location, facing north. Photos show interim areas that appear to have been recently disturbed.

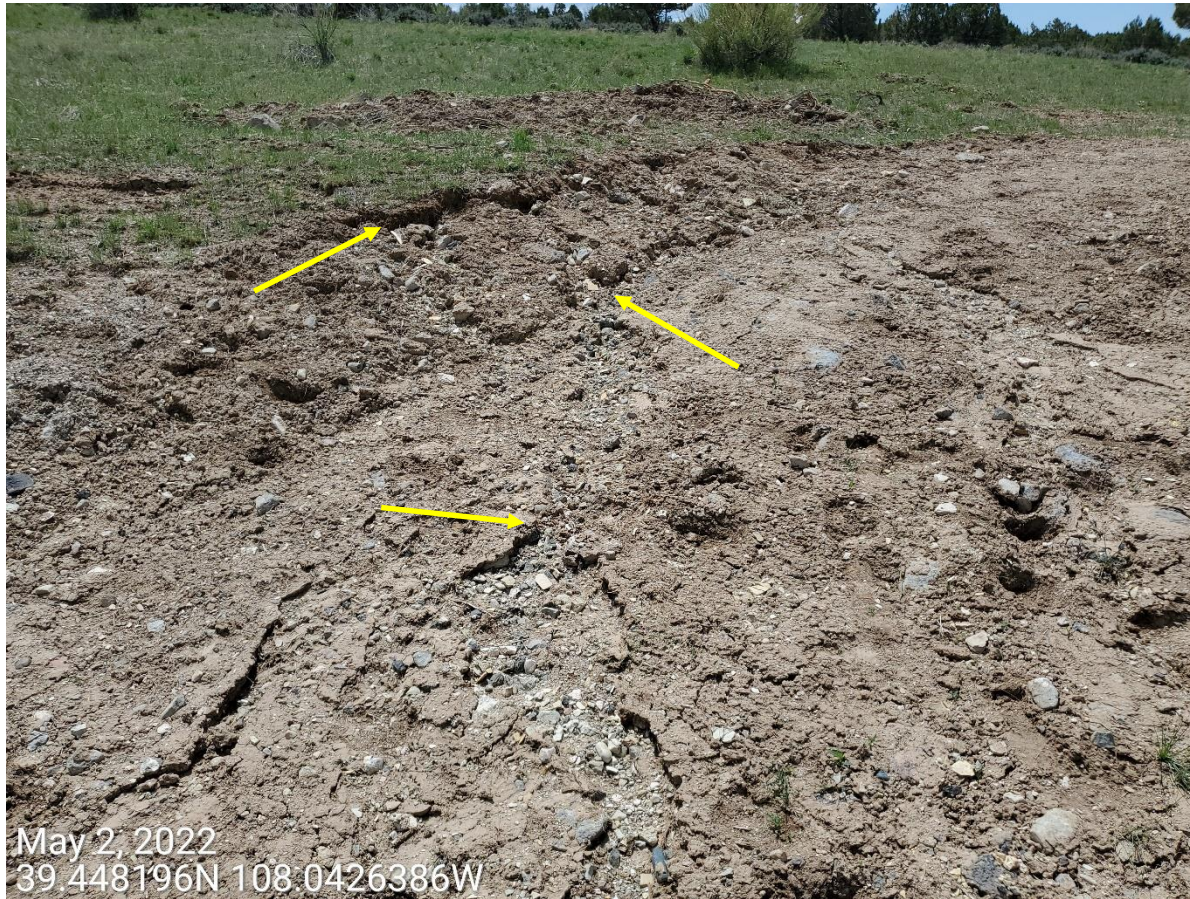
Photo 8: Photo taken from the interim areas on the west end of the Location. Photo shows control measures to minimize erosion are missing or insufficient; erosion degradation observed.

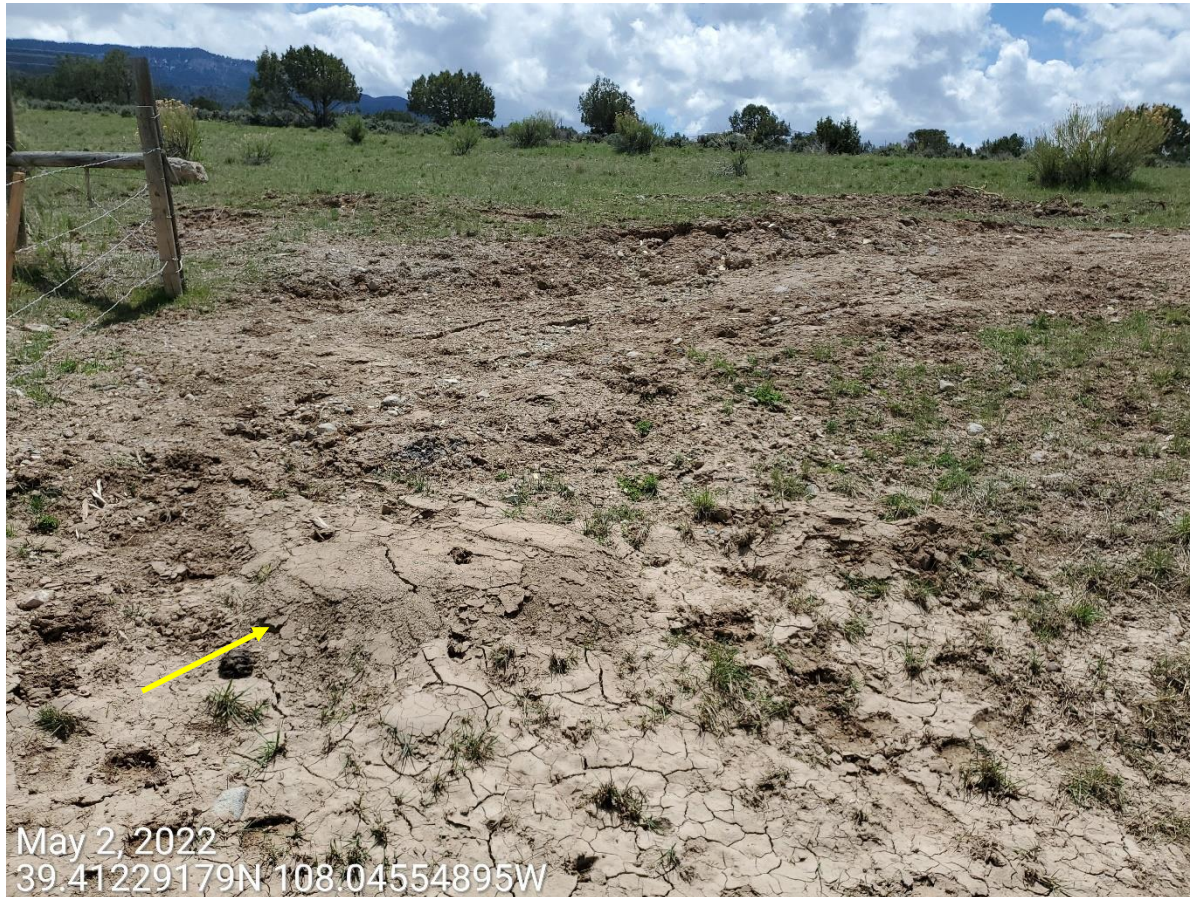
Photo 9: Photo taken from the interim areas on the west end of the Location. Photo shows control measures to minimize erosion are missing or insufficient; erosion degradation observed. Arrow showing sediment deposition due to erosion degradation on the interim areas.
