Final Reclamation Inspection

Operator: CRESTONE PEAK RESOURCES OPERATING LLC - 10633

Location ID: 333129

Inspection Photos
Location Name: SELTZER #24-34
Location ID: 333129

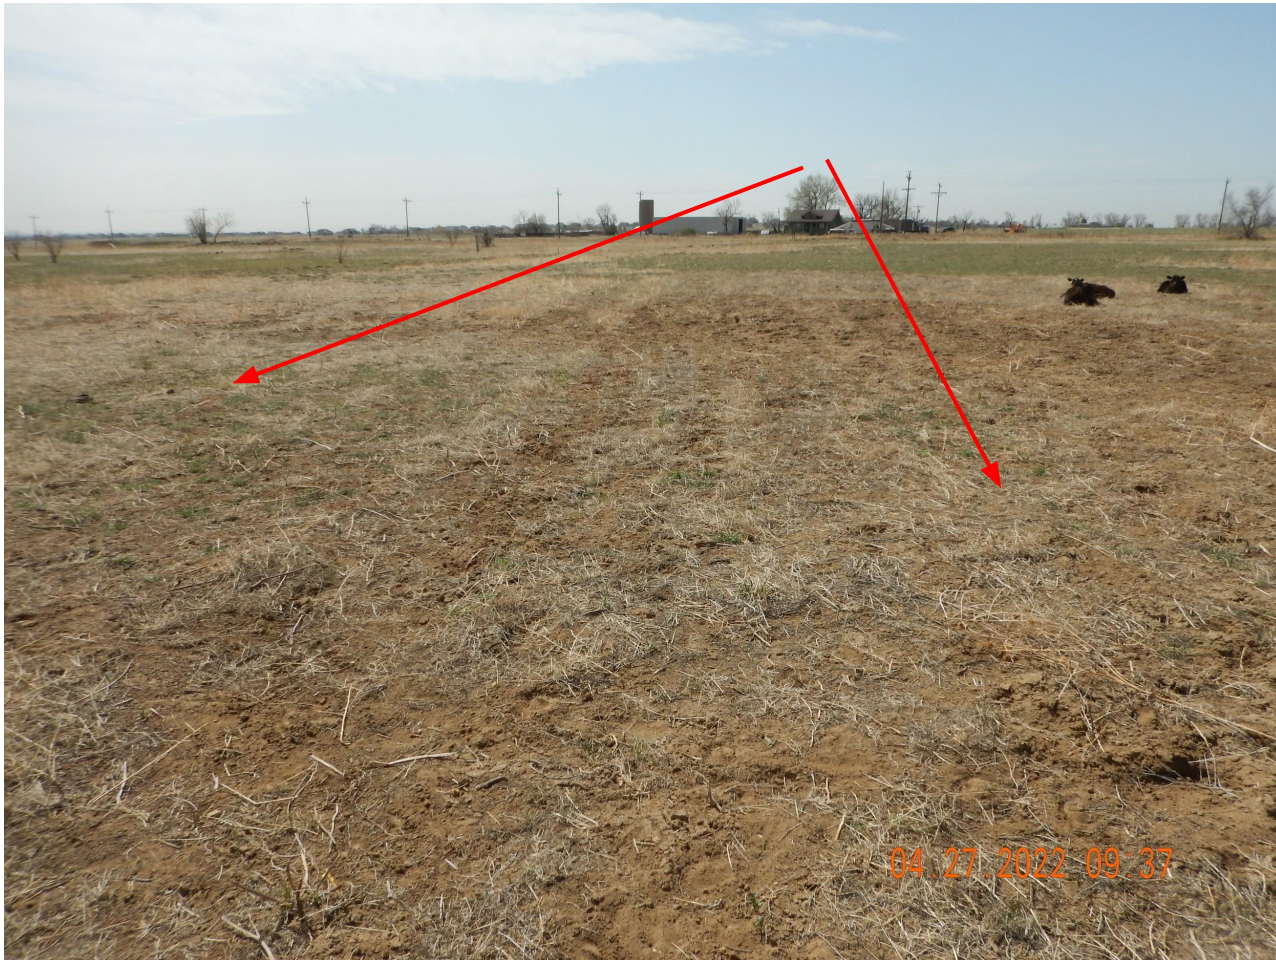
Photo 1. Photo taken from the well location, facing South. Photo illustrates the well location has little to no establishment of desirable plant species. Establishment appears to be limited to the central location (note arrows are pointing to the green vegetation). The northern and southern well location lack establishment.

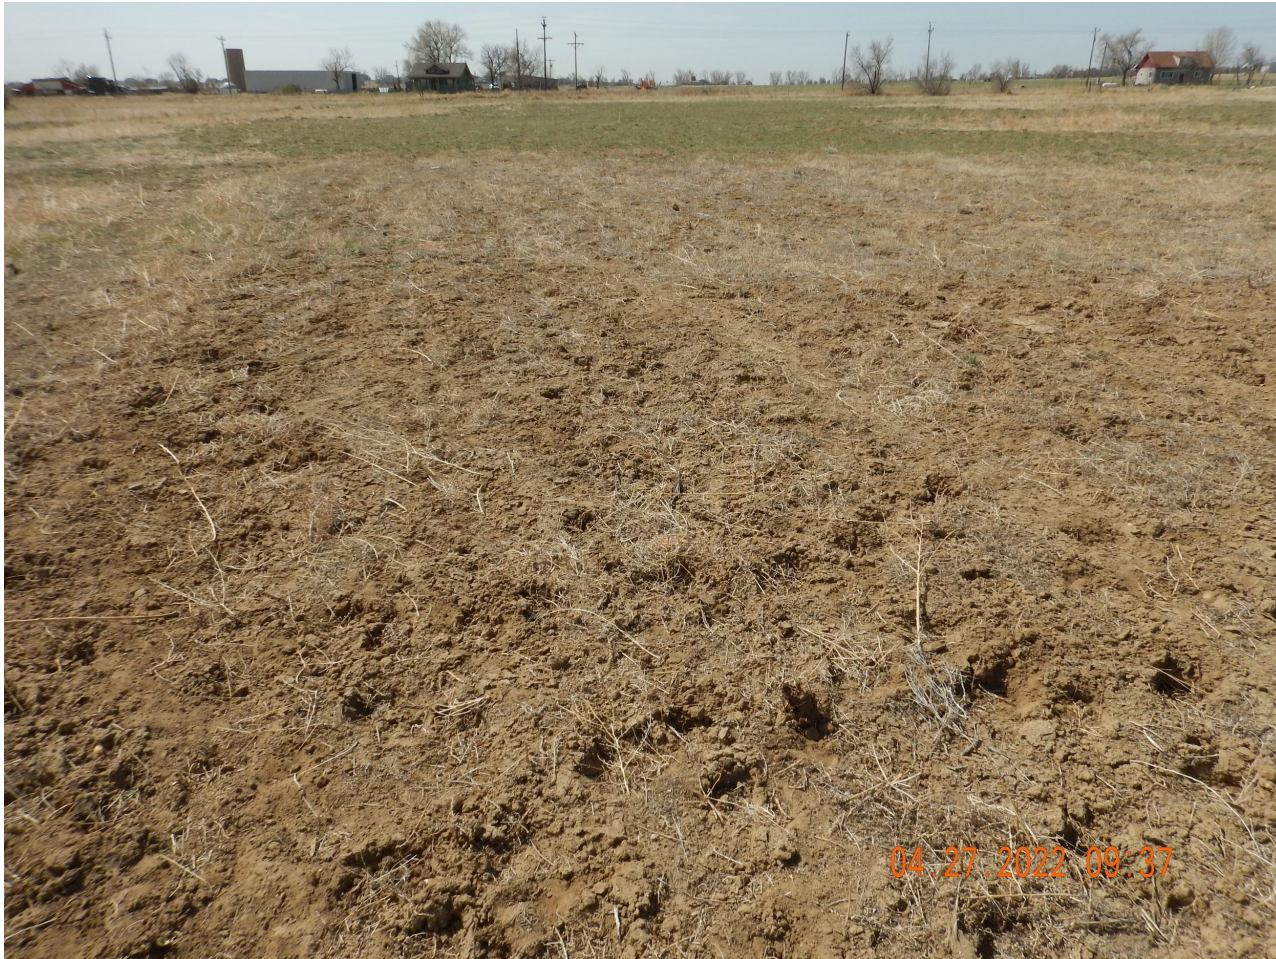
Photo 2. Photo taken from the southern the well location, facing South. See comments under Photo 1.

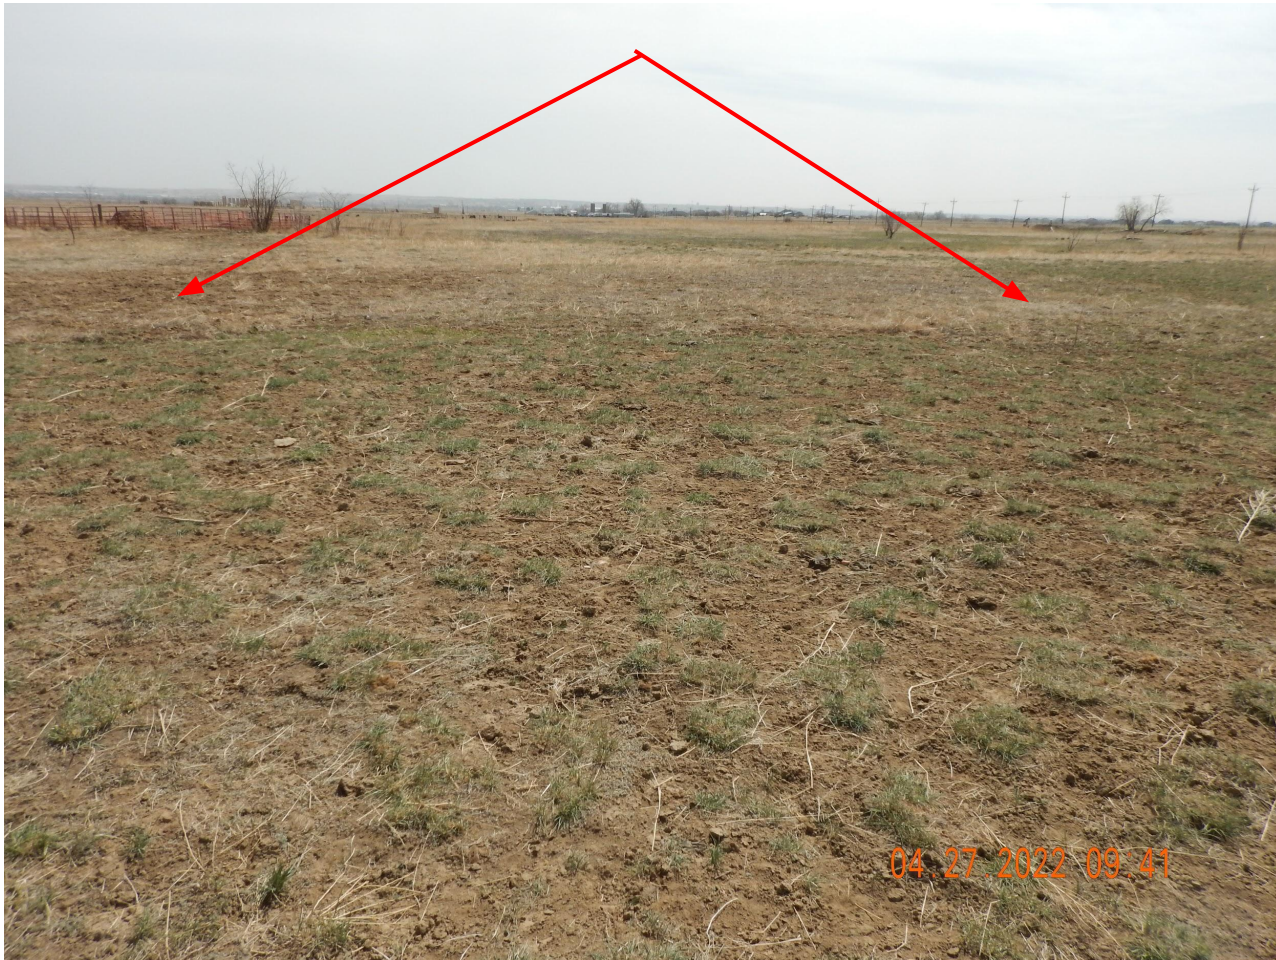
Photo 3. Photo taken west of the well location, facing East. Photo illustrates the well location (red arrows) in the background and the reference area vegetation in the foreground demonstrating the lack of establishment.

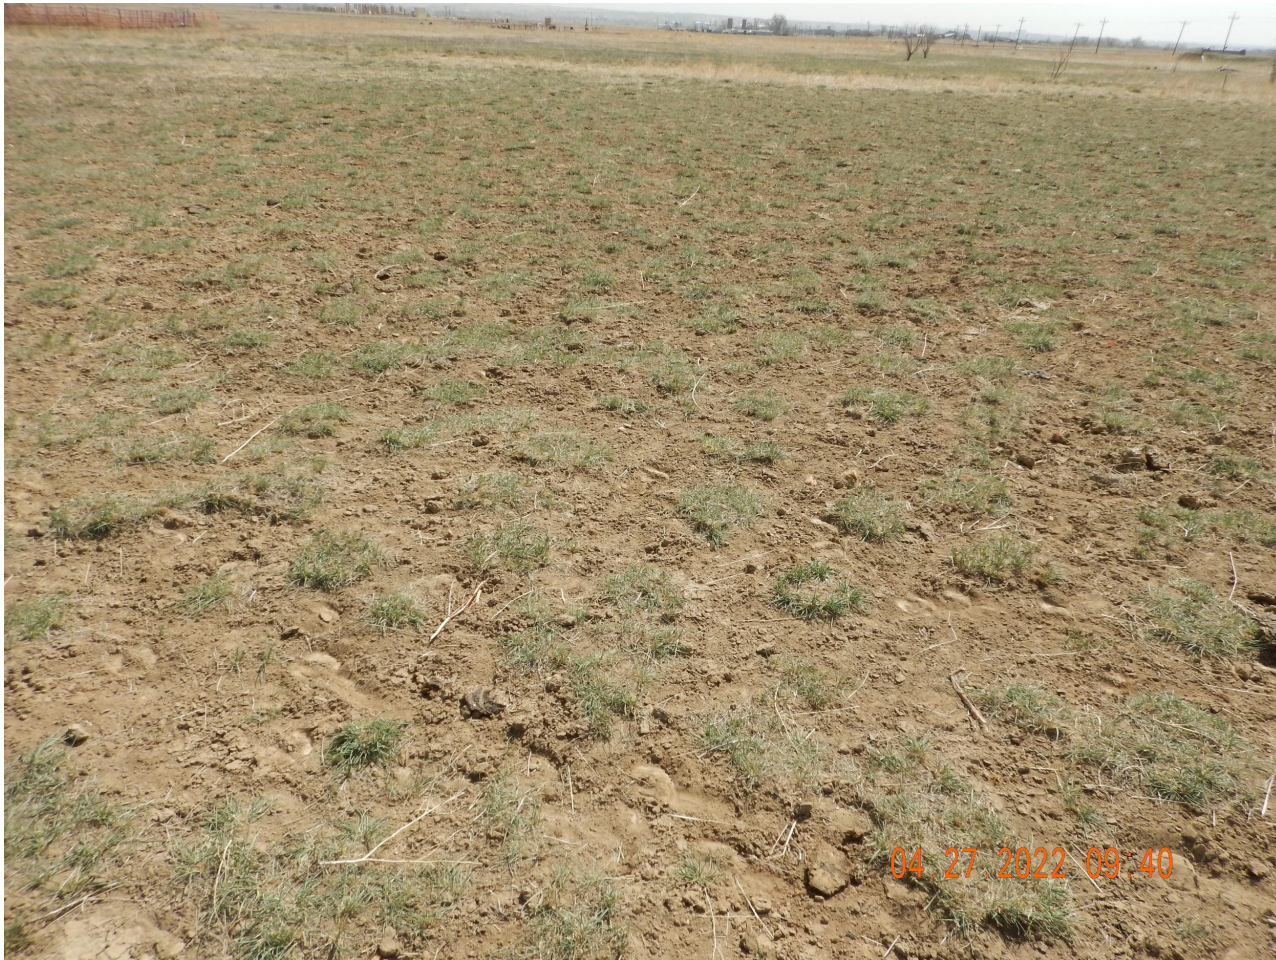
Photo 4. Reference photo taken west of the well location, facing East.
