Inspection Photos

Operator: CAERUS PICEANCE LLC # 10456

Location ID: 334089

Aaron Trujillo
NW Reclamation Specialist
COGCC

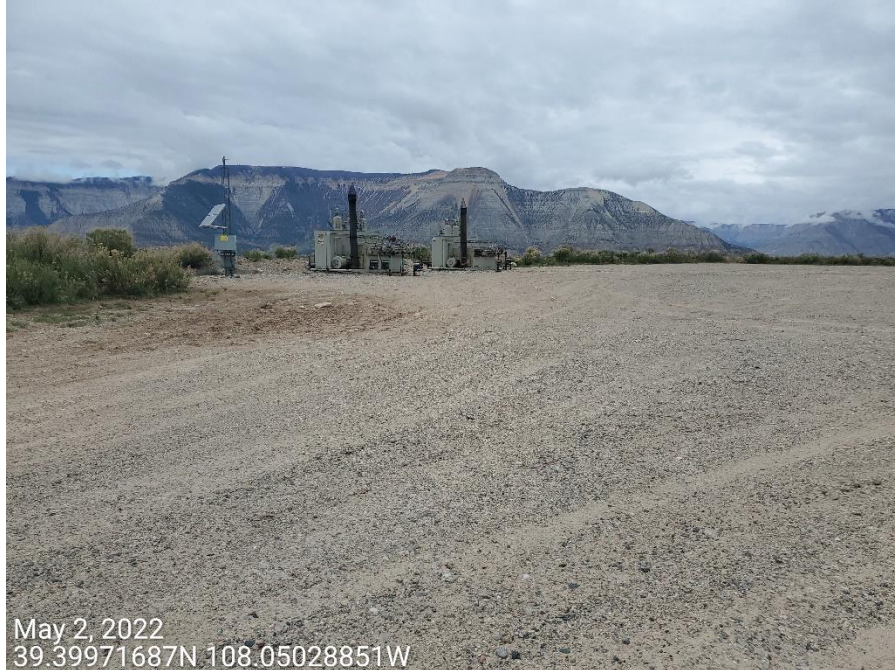
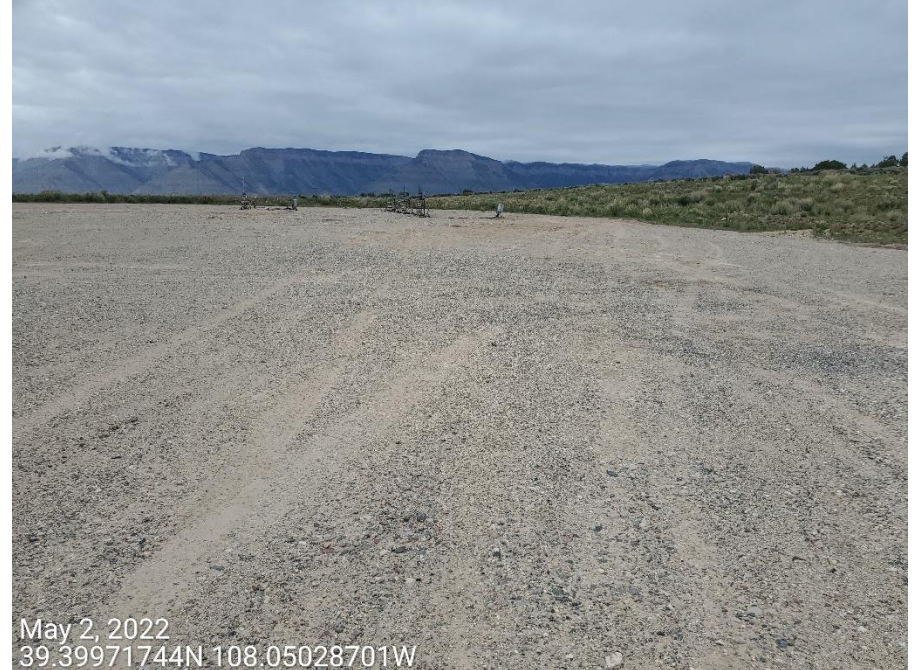
Photo 1: Photos taken from the south end of the Location. Photos 1-2 provide an overview of the Location from northwest, north to northeast.

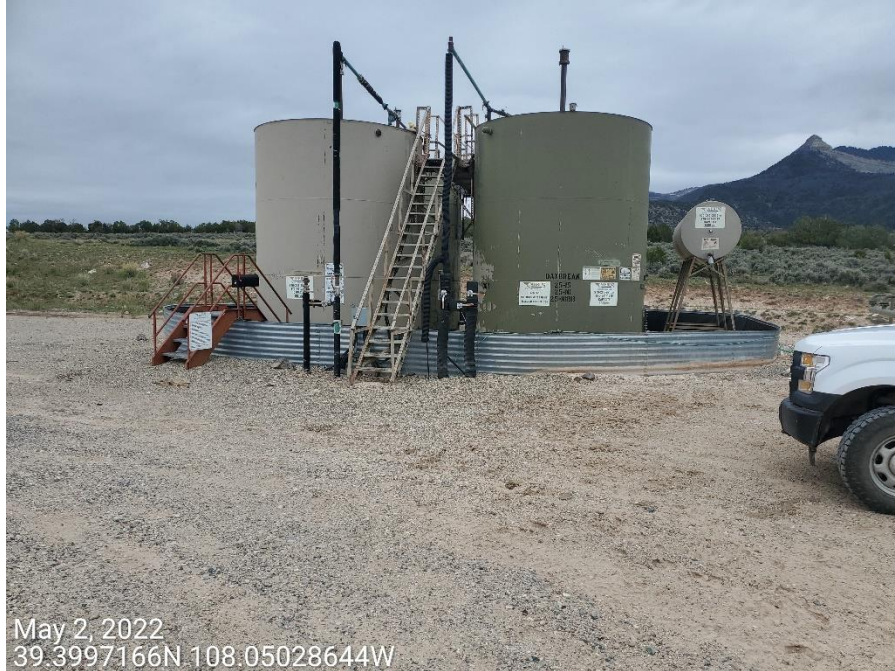
Photo 2: See comments under photo 1.

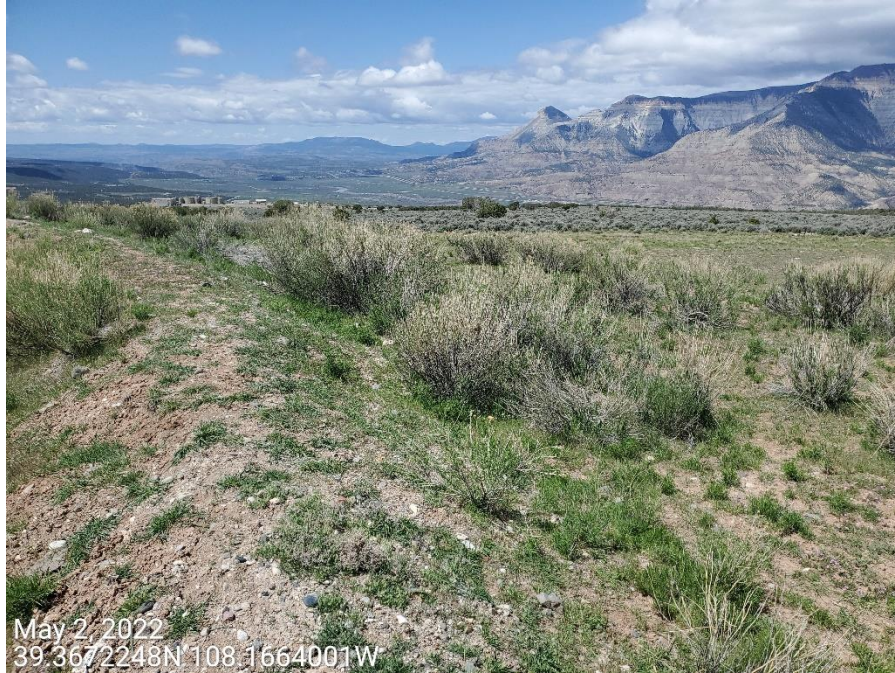
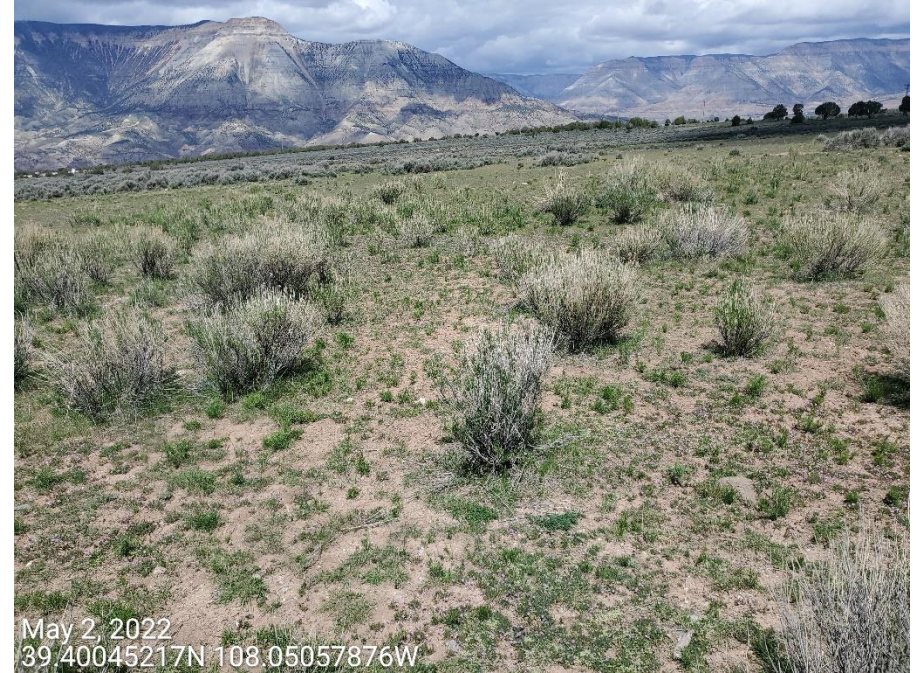
Photo 3: Photos provide example of the interim areas; interim areas of the Location meet COGCC 1003 reclamation standards. Vegetation observed is predominantly desirable, perennial plant species with a uniform establishment. Continue to monitor and maintain interim areas until site receives a passing final inspection.

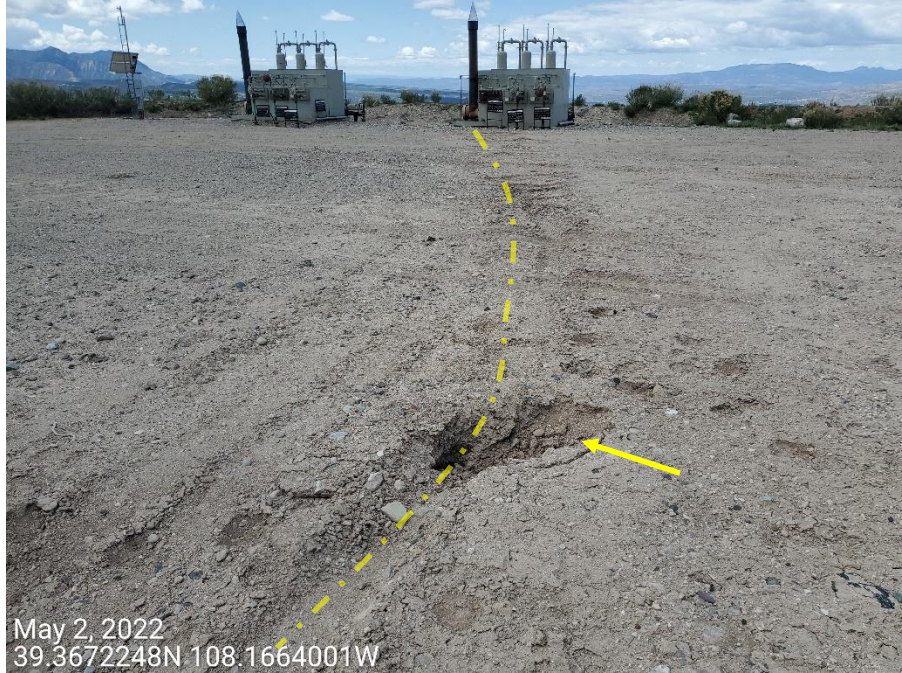
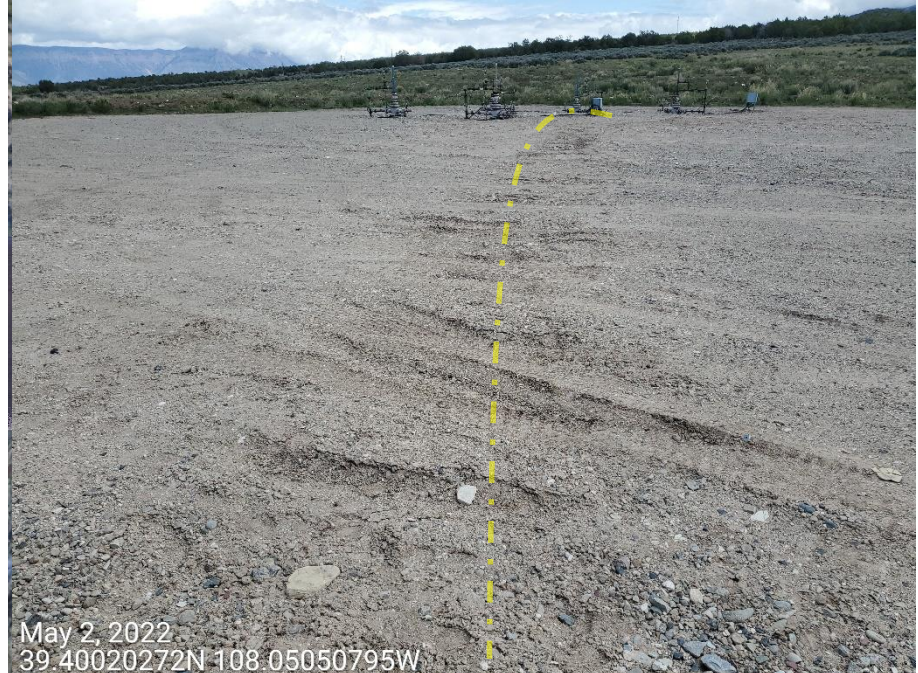
Photo 4: Photos show subsidence issues are becoming evident along the flowline path between the former Day Break 36-2BB (PA 36) well and the separator. Advise maintenance to ensure pad remains stabilized.

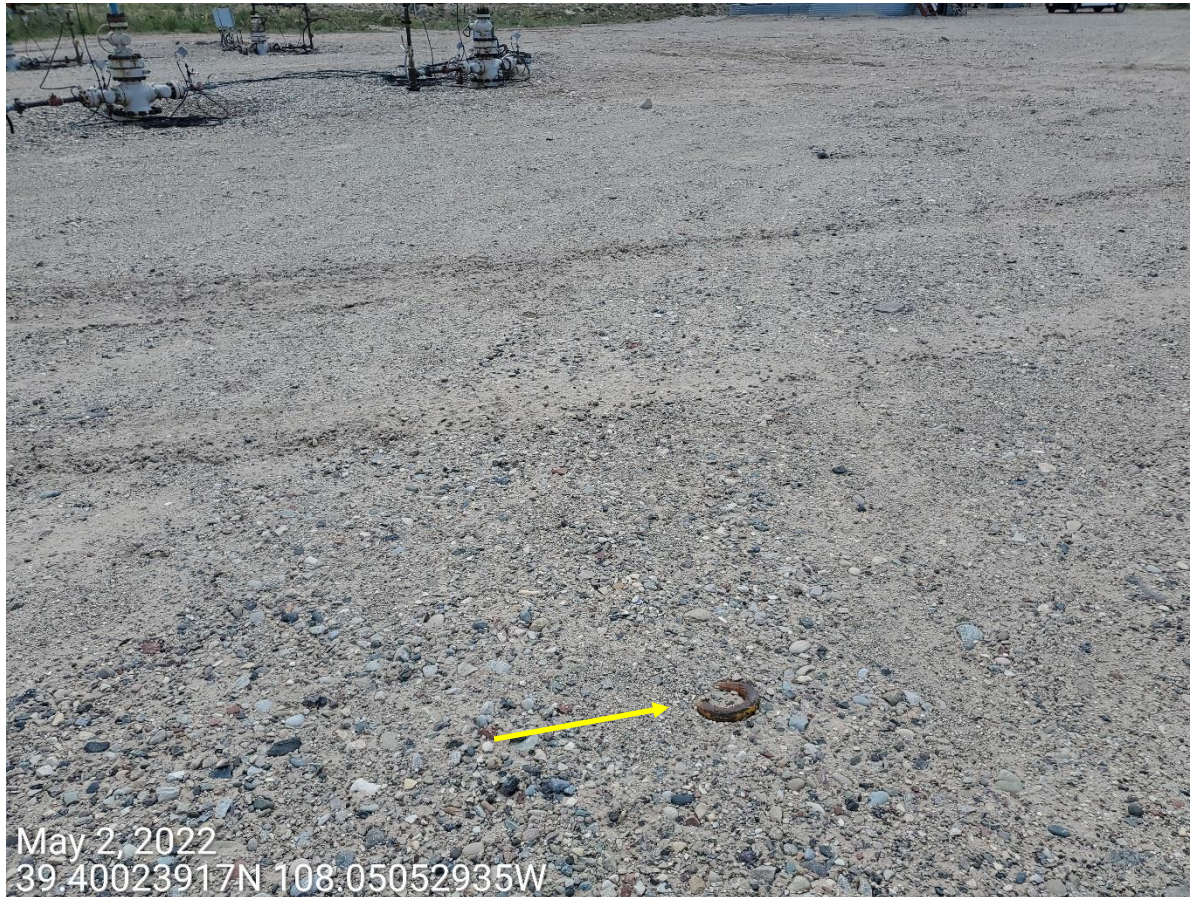
Photo 5: Photo taken from the northeast end of the Location. Photo shows unmarked anchor on Location.
