Inspection Photos

5/2/2022

Operator: CAERUS PICEANCE LLC # 10456

Location ID: 334682

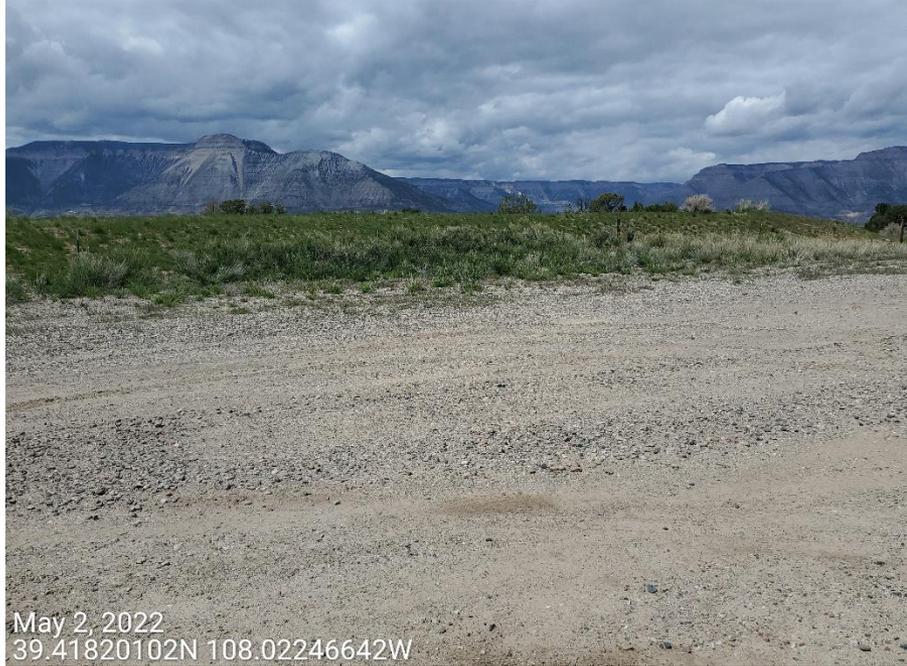
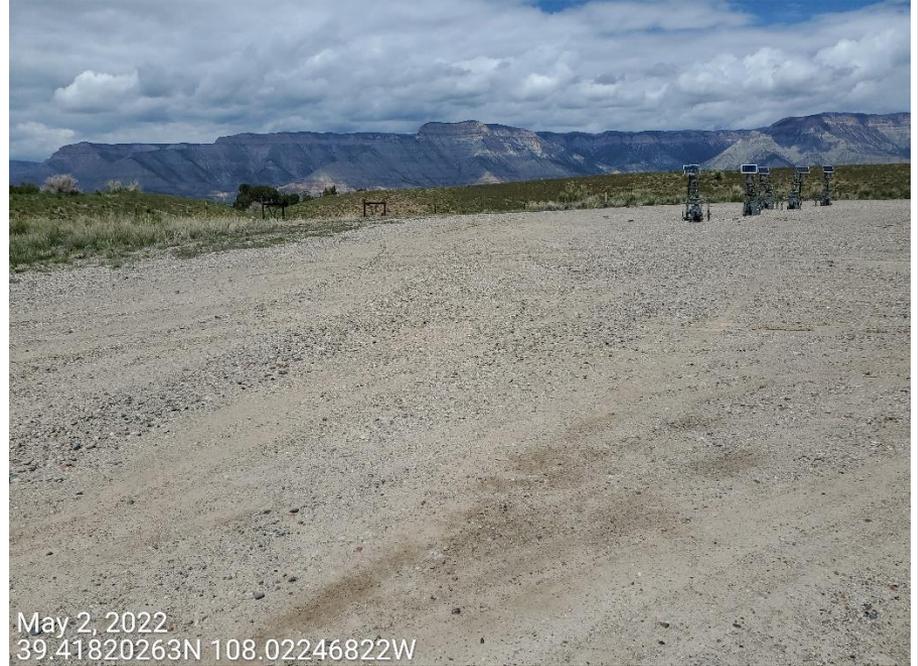
Photo 1: Photos taken from the south end of the Location. Photos 1-2 provide an overview of the Location from northwest, north, northeast to east.

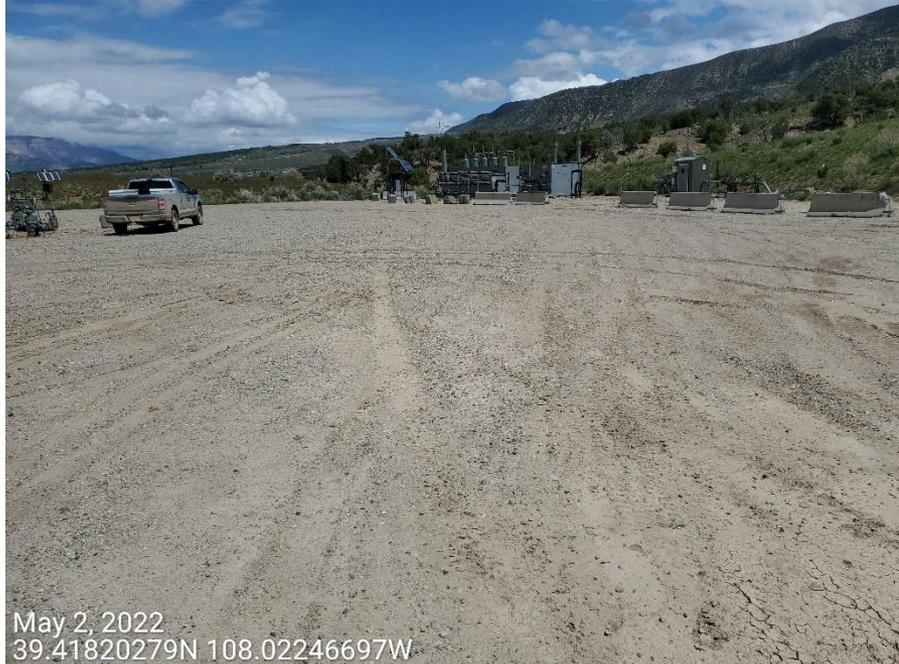
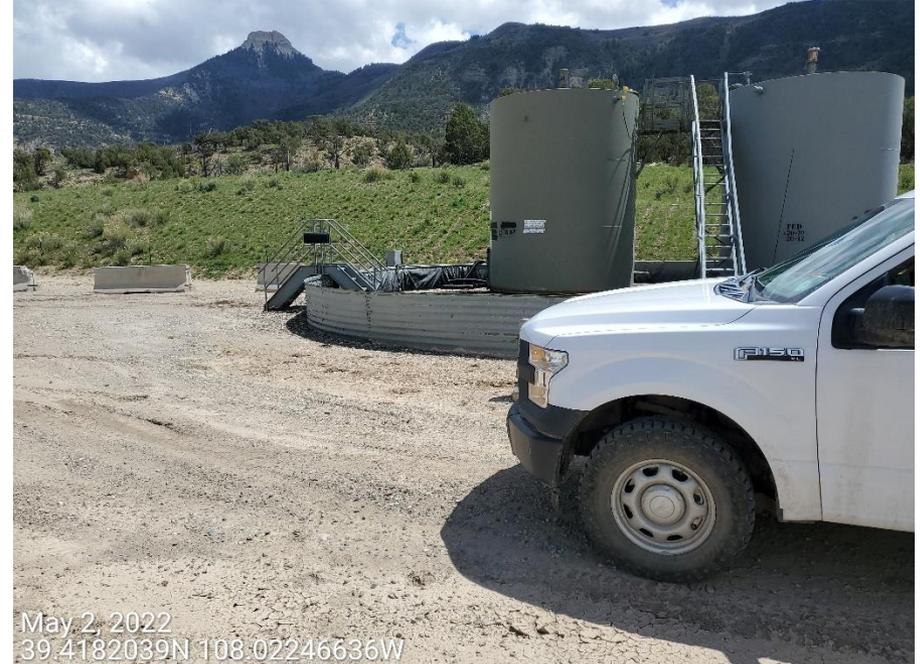
Photo 2: See comments under photo 1.

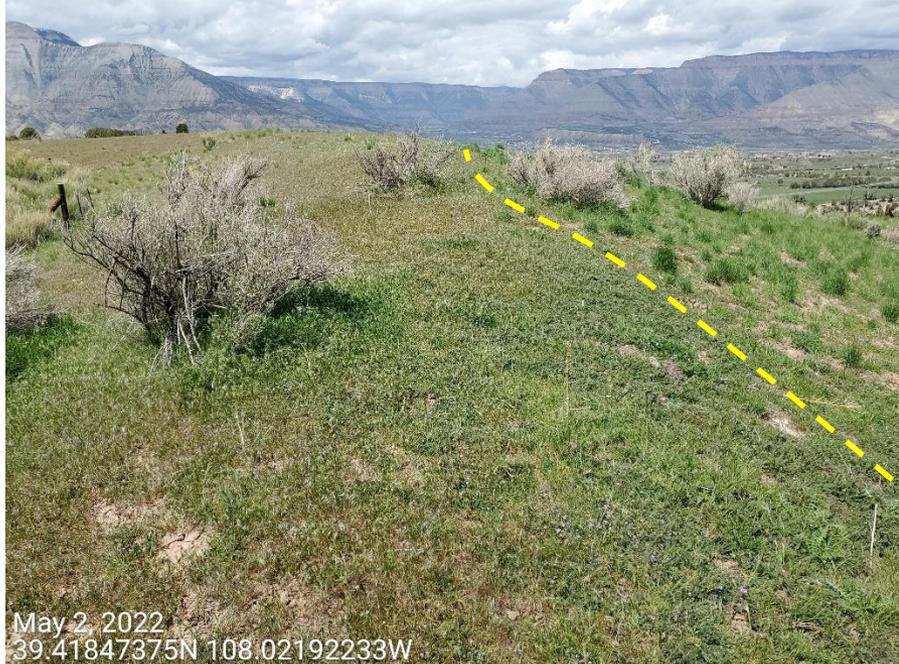
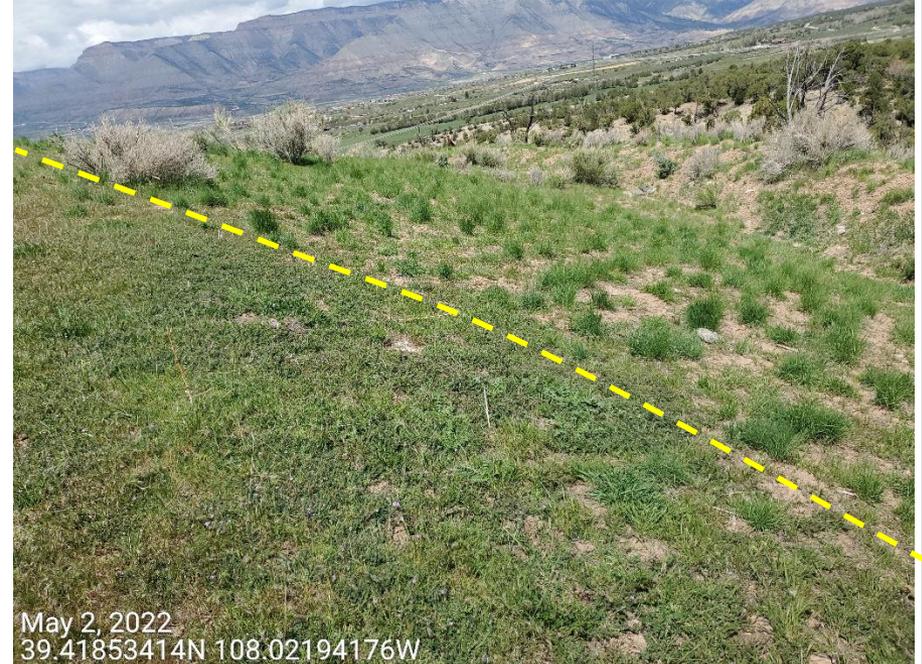
Photo 3: Photos taken from the soil stockpile on the north end of the Location, facing northwest, north. Photo left shows areas of the berm where vegetation is predominantly a cheatgrass monoculture (left of yellow line). Photo right shows areas on the north and east facing slopes of the berm where desirable perennial vegetative establishment is evident and uniform.

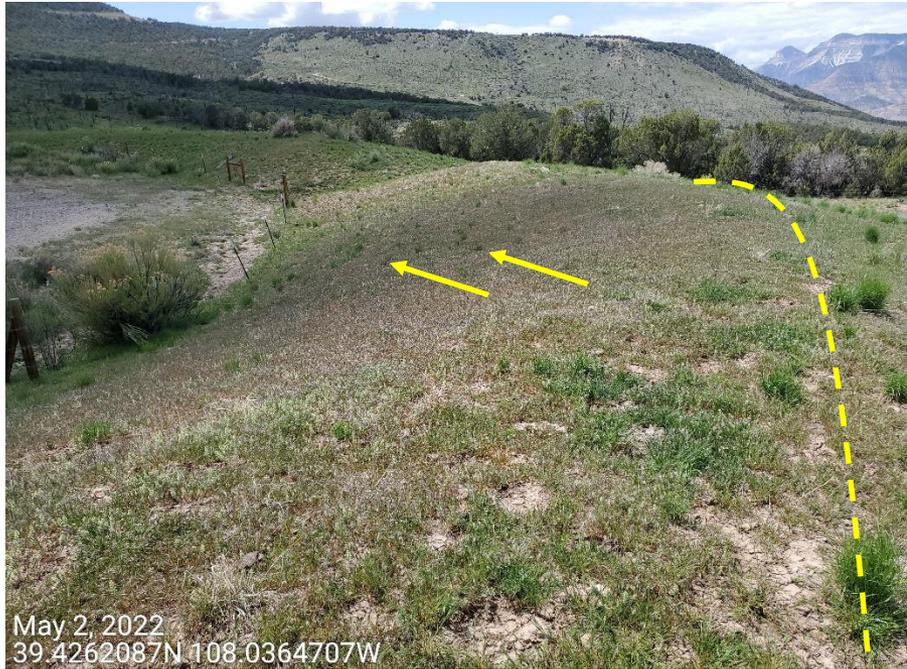
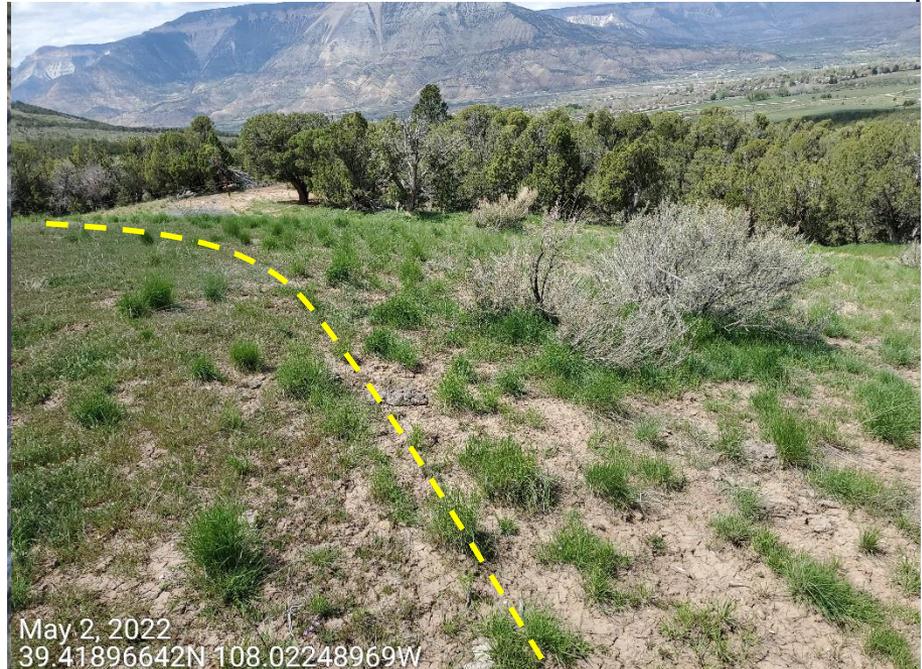
Photo 4: Photos taken from the soil stockpile on the north end of the Location, facing west, northwest. Photo left shows areas of the berm where vegetation is predominantly a cheatgrass monoculture (left of yellow line). Yellow arrow shows clumps of desirable plants within areas of cheatgrass. Photo right shows areas on the north and west facing slopes of the berm where desirable perennial vegetative establishment is evident and uniform.

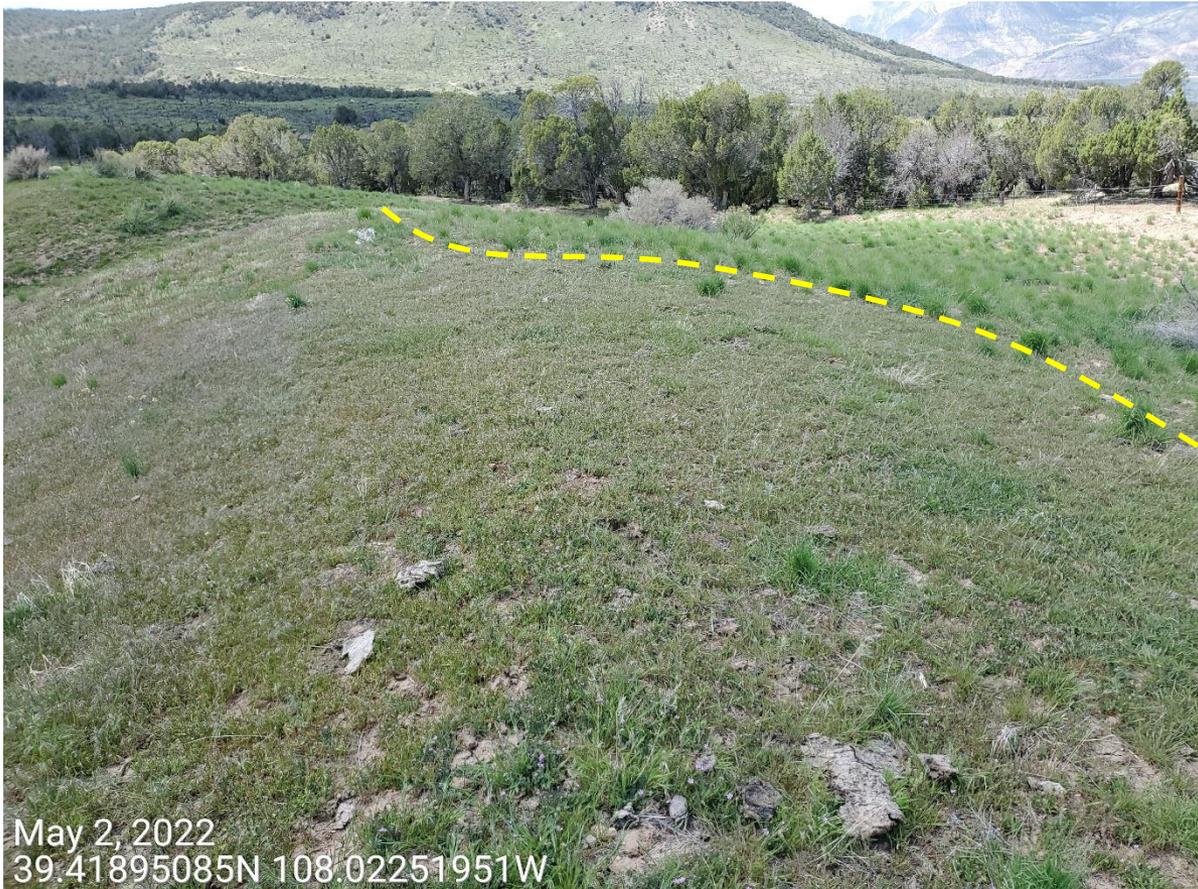
Photo 5: See comments under photo 4.

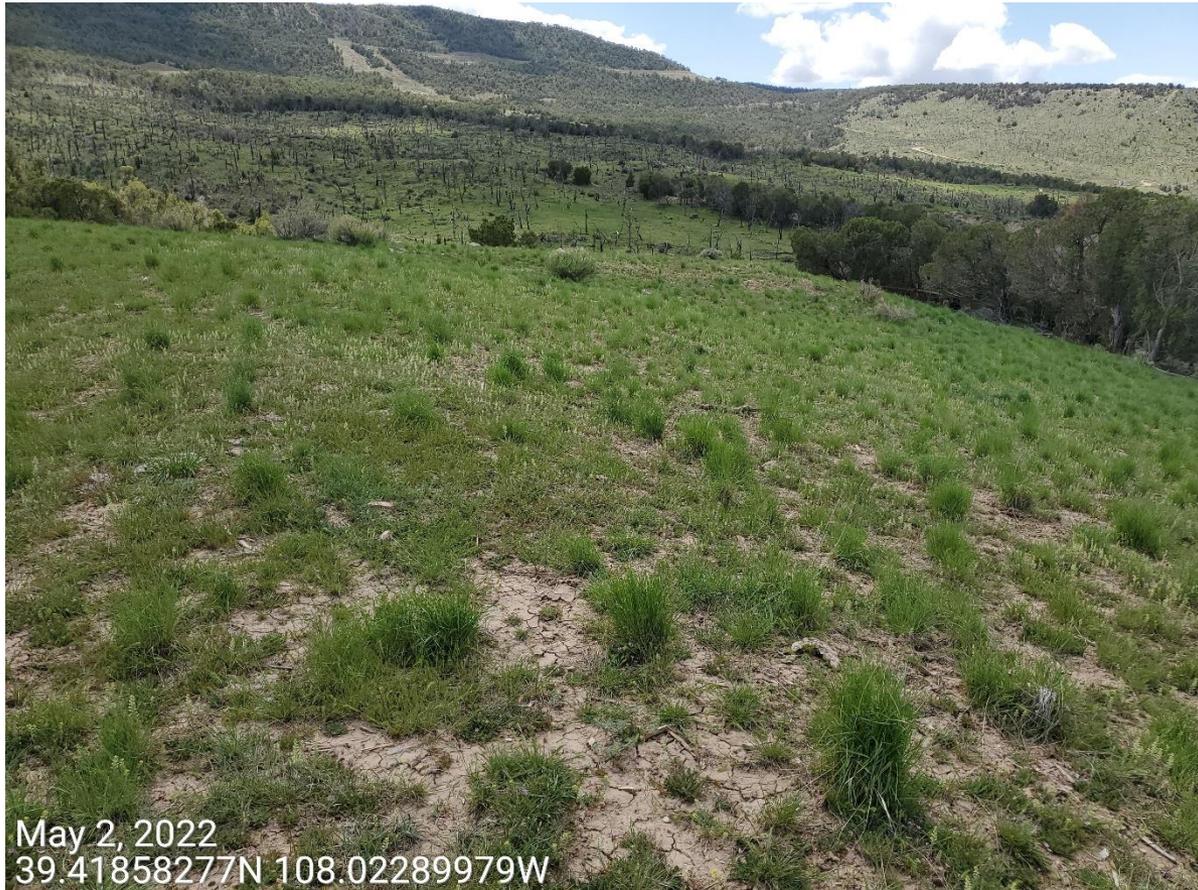
Photo 6: Photo taken from the western interim areas of the Location. Photo shows example of areas beyond the berms that have achieved uniform, desirable perennial vegetative establishment. Though cheatgrass is evident within these areas, it is not the dominant species.
