Inspection Photos

Operator: CAERUS PICEANCE LLC # 10456

Location ID: 334983

Garfield County, CO

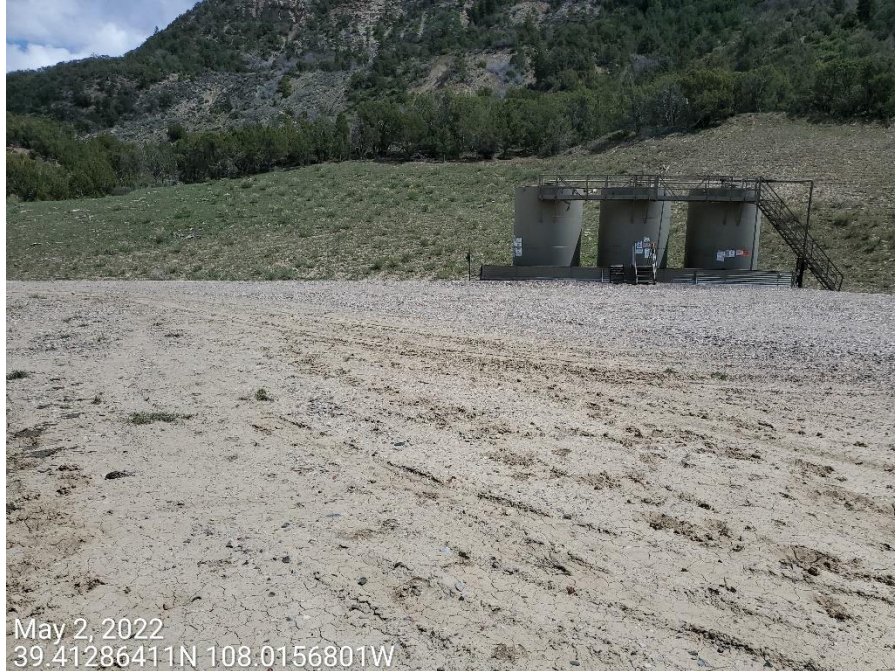
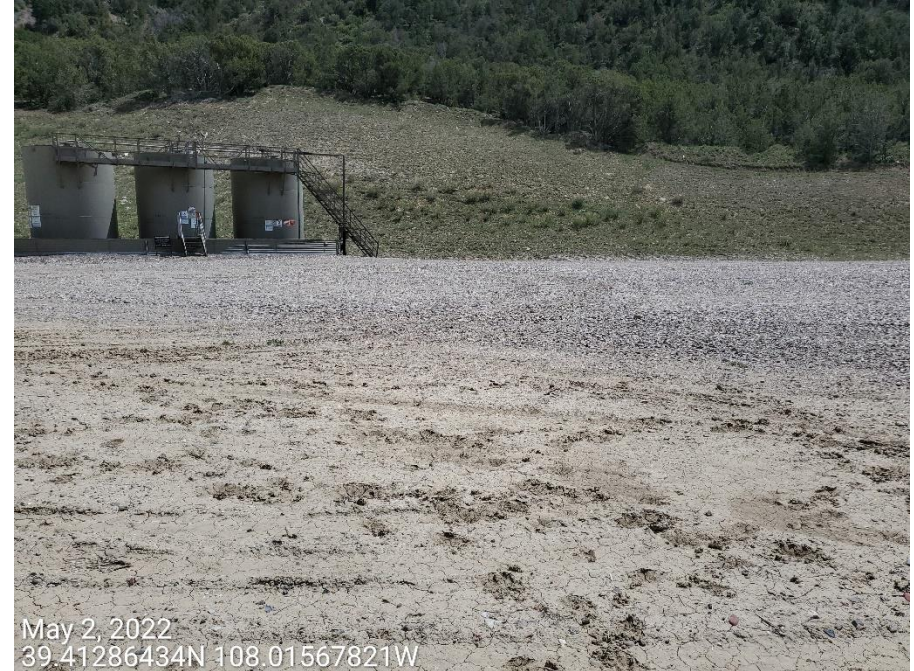
Photo 1: Photos taken from the north end of the Location. Photos 1-2 provide an overview of the Location from east, southeast, southwest to west.

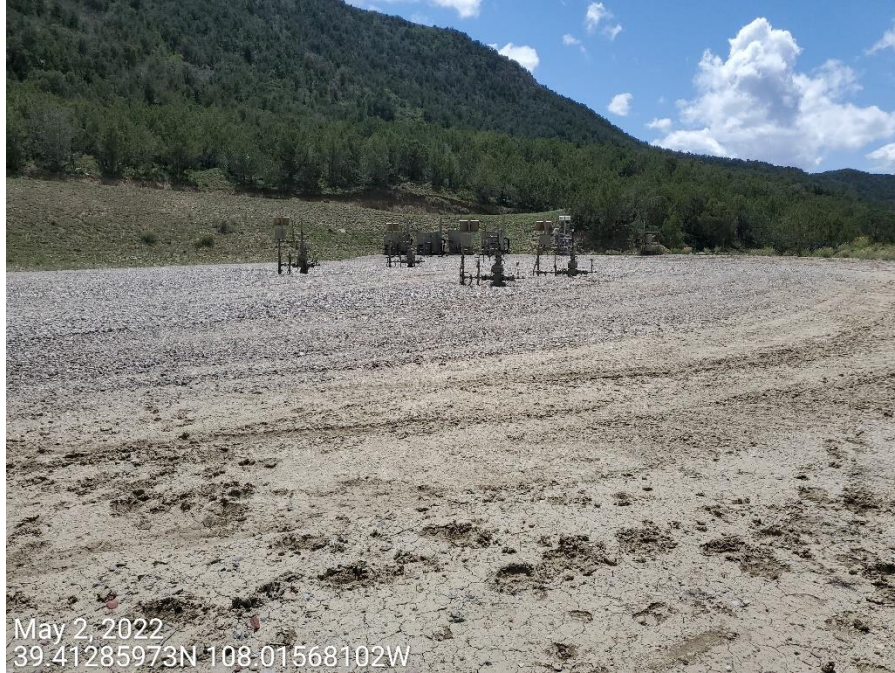
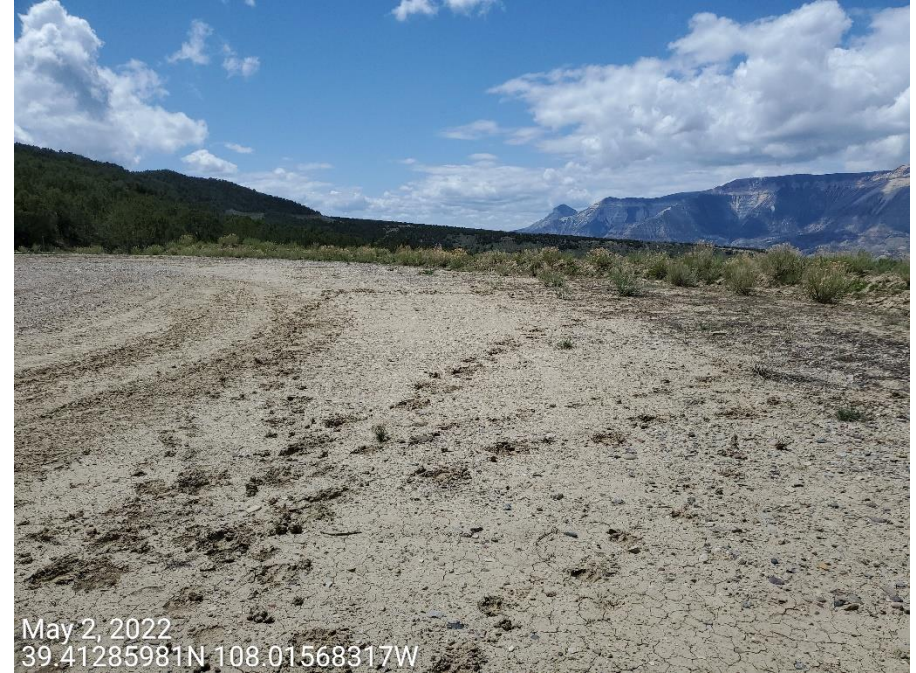
Photo 2: See comments under photo 1.

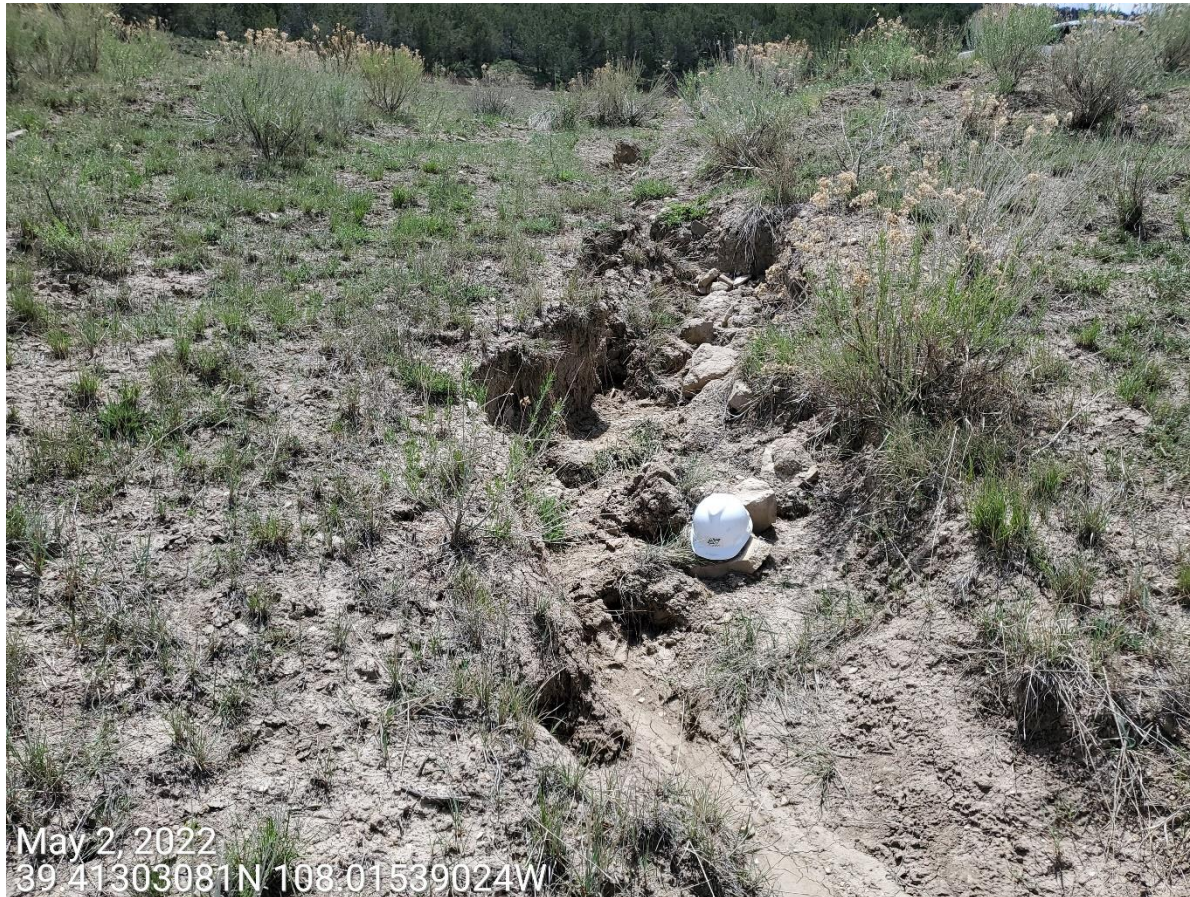
Photo 4: Photo taken from the north end of the Location. Photo shows erosion degradation at the sediment trap control measure. Hard hat used for reference.

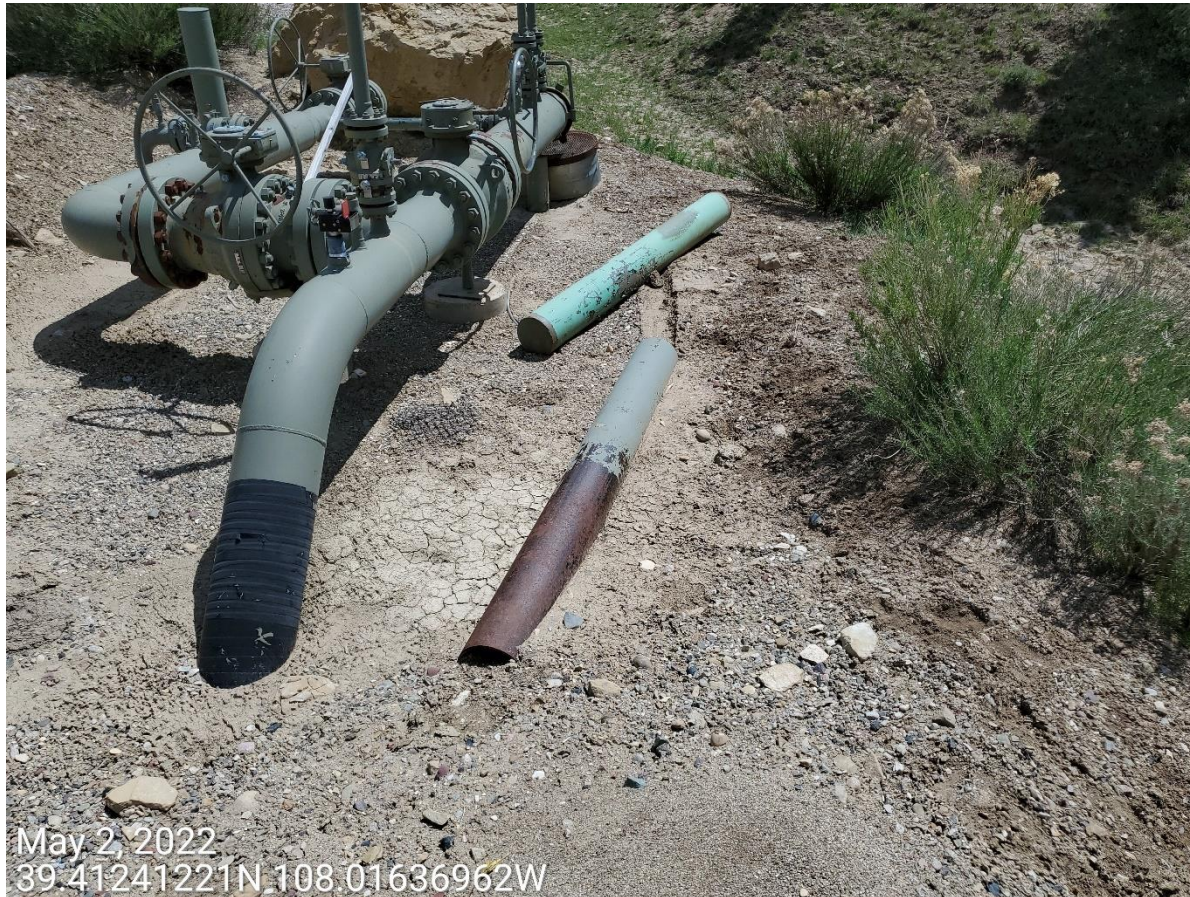
Photo 5: Photo shows unused pipe stored next to pipeline.

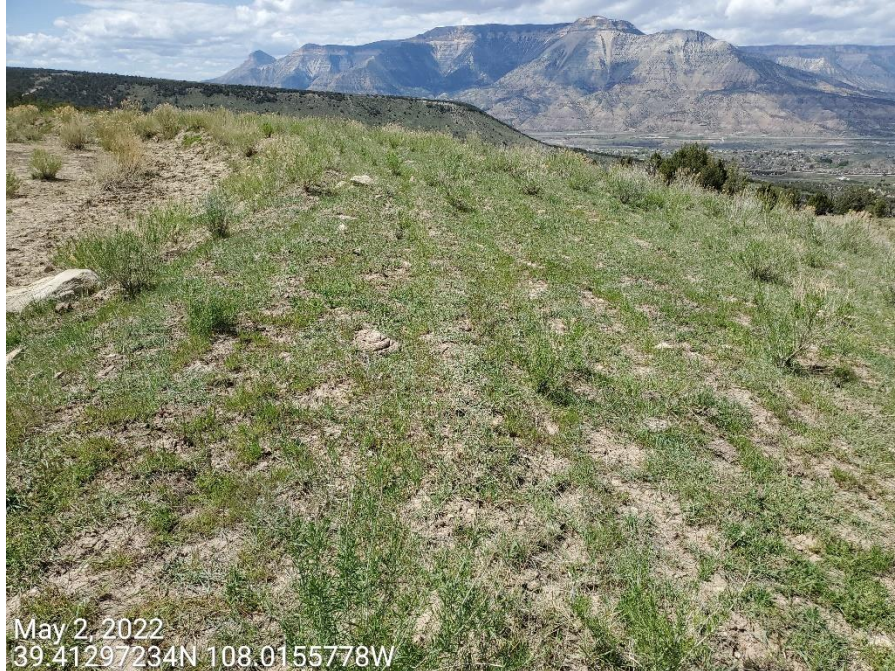
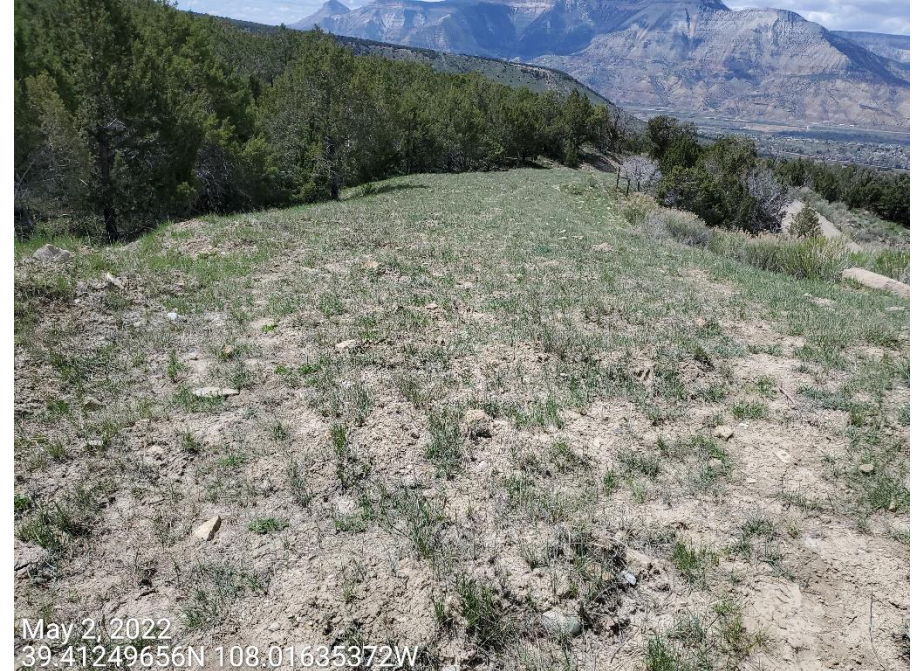
Photo 6: Photos taken from the interim areas of the Location. Photos examples showing interim areas have met 1003 standards.
