Inspection Photos

Operator: CAERUS PICEANCE LLC # 10456

Location ID: 311692

Garfield County, CO

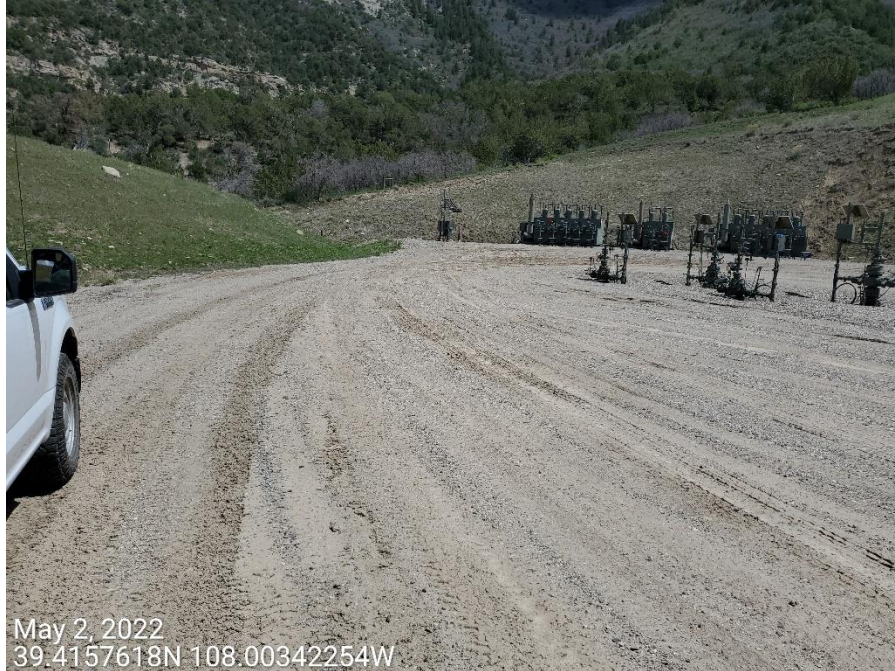
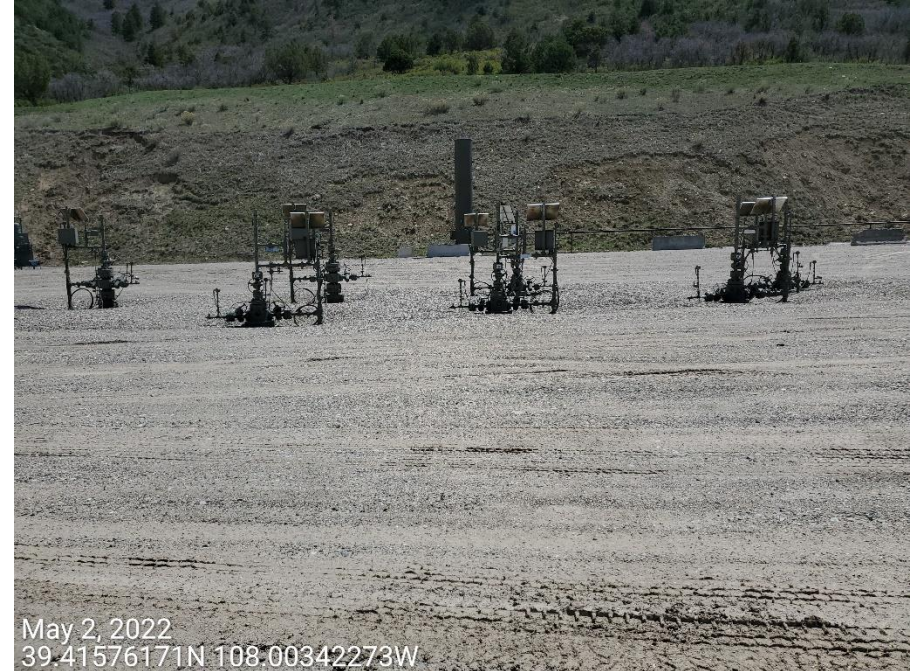
Photo 1: Photos taken from the north end of the Location. Photos 1-2 provide an overview of the Location from east, southeast, southwest to west.

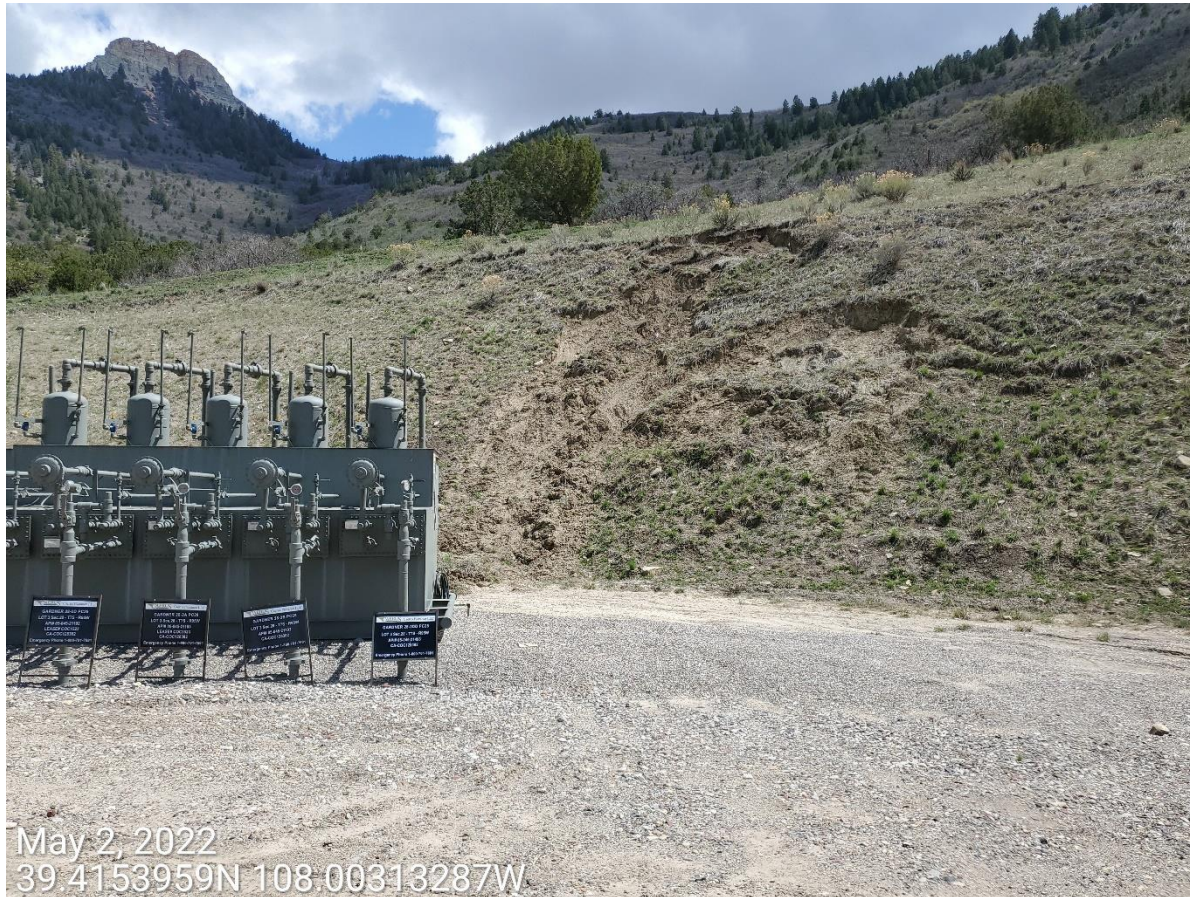
Photo 3: Photo taken from the southeast end of the Location, facing west. Photos 3-8 show areas along the slopes on the south end of the Location, where erosion degradation resulting in mass soil migration from the slopes is evident. Areas require additional reclamation and stabilization.

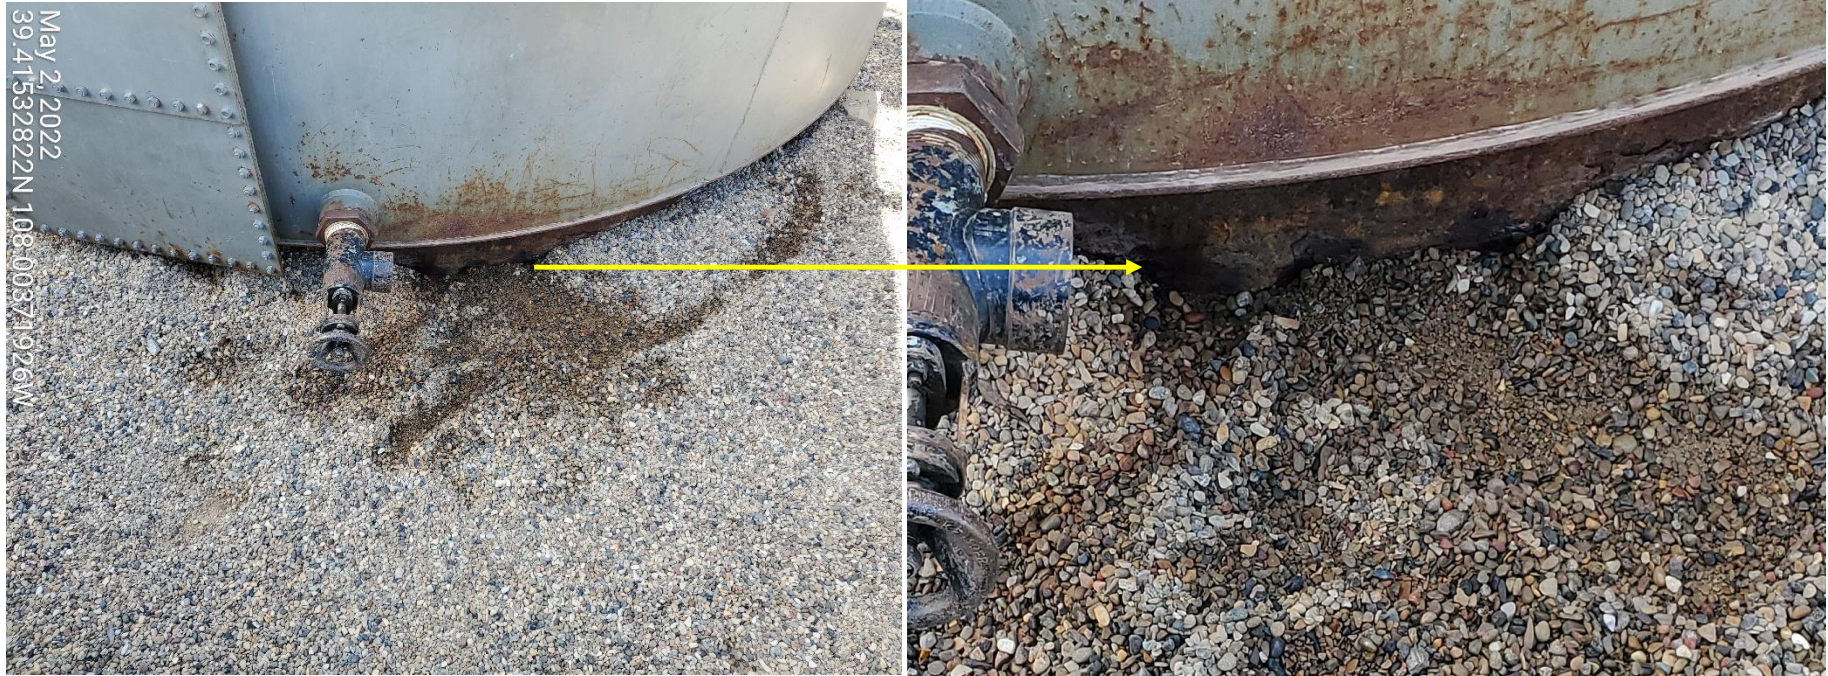
Photo 9: Photos taken from the northeastern-most condensate tank on the Location. Photo shows rusting and possible integrity issues at the base of the tank, as well as stained soils within the same area.
