Final Reclamation Inspection

Operator: PETROSHARE CORPORATION - 10454

Location ID: 320465

Inspection Photos
Location Name: GUTHRIE #22-2
Location ID: 320465

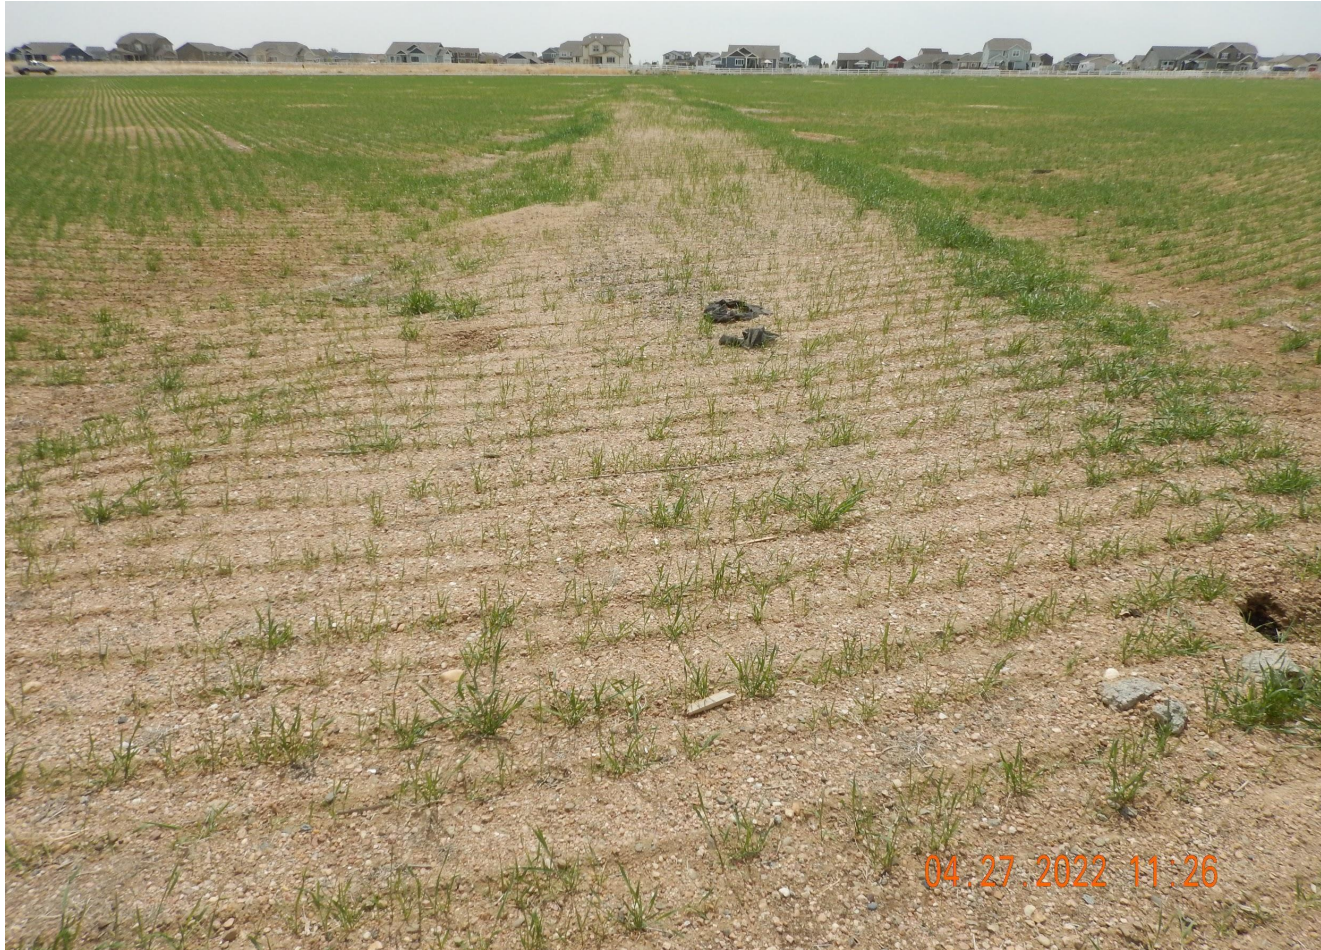
Photo 1. Photo taken from the northern well location access road, facing South. Photo illustrates Operator has failed to comply with Rule 1004 standards and has not removed gravel, recontour and perform subsequent final reclamation (i.e., compaction alleviation, etc..).

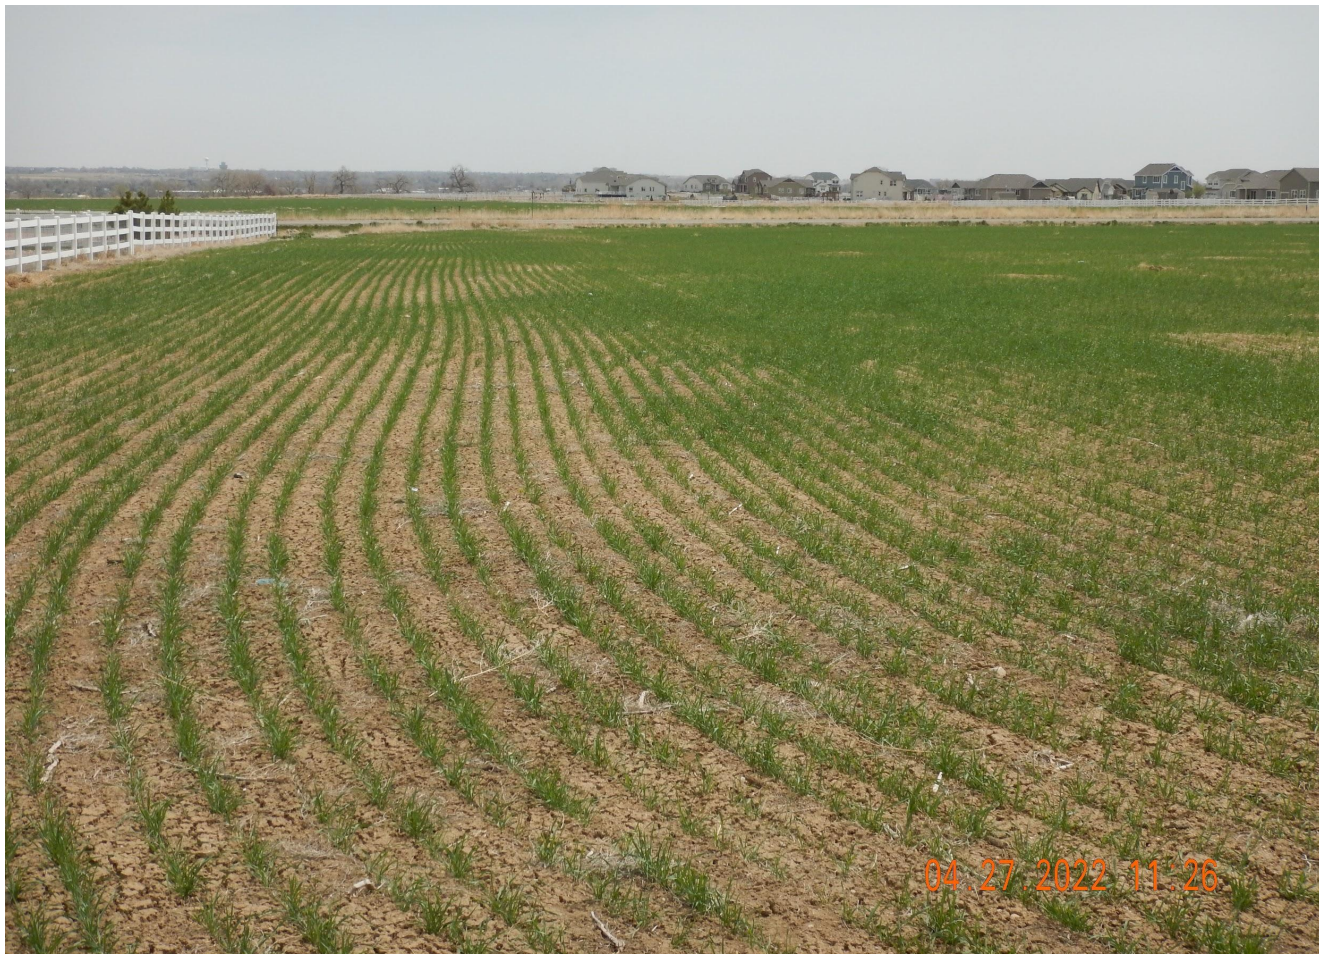
Photo 2. Reference photo taken from the northern well location access road, facing East.
