Inspection Photos

ID# 441082

Operator: DOVER ATWOOD CORPORATION

Inspection Date: 5/6/2022

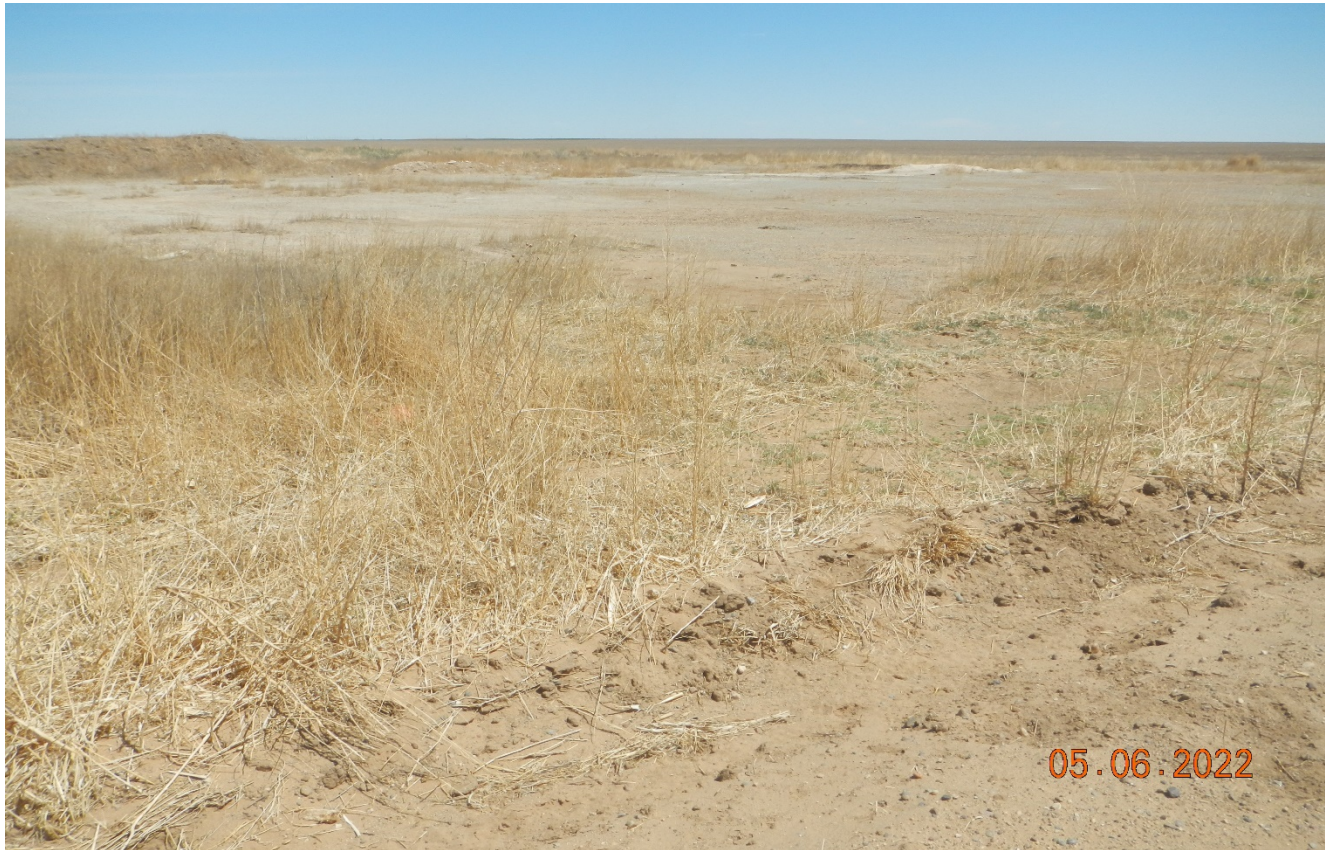
Photo 1. Facing northeast toward the location. The disturbed location has not been reclaimed. Previous corrective actions were not performed.

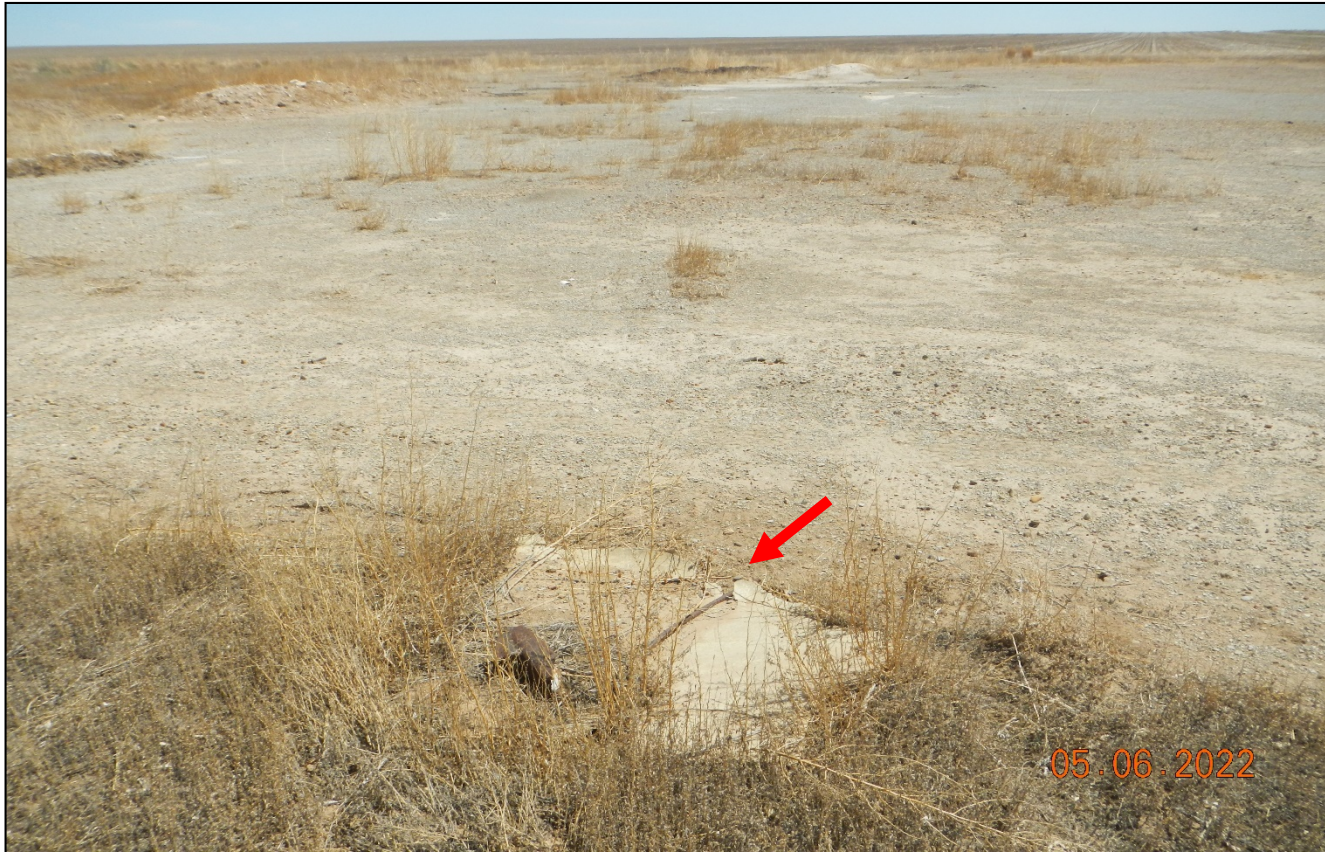
Photo 2. Facing northeast at the location. Soils are compacted and the location has not been reclaimed. Previous corrective actions were not performed. Soils must be decompacted by cross ripping to a depth of 18 inches. There is various debris that remains around the location.

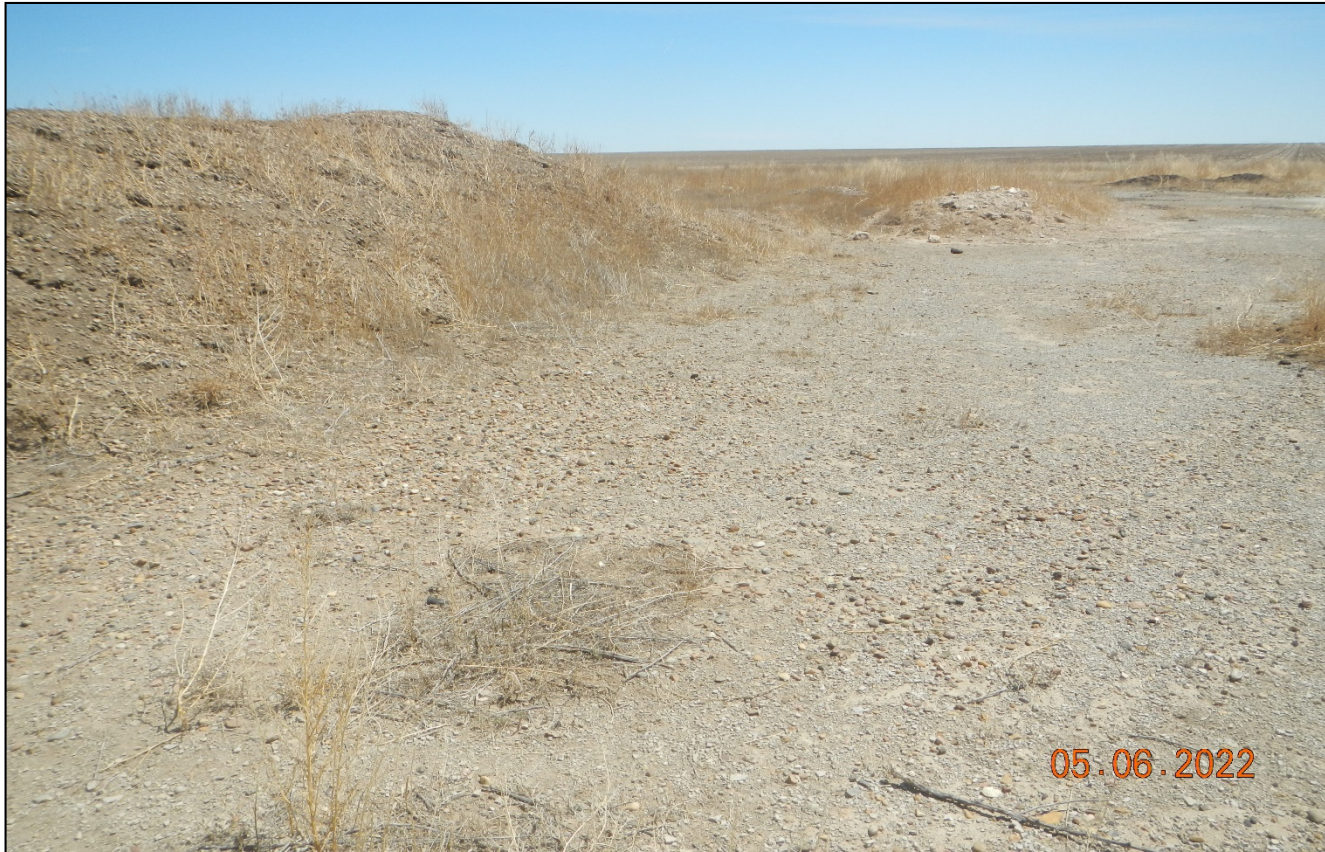
Photo 3. There are gravel and soil piles that remain at the north side of the location. The piles need to be removed. There are undesirable weeds on the piles.

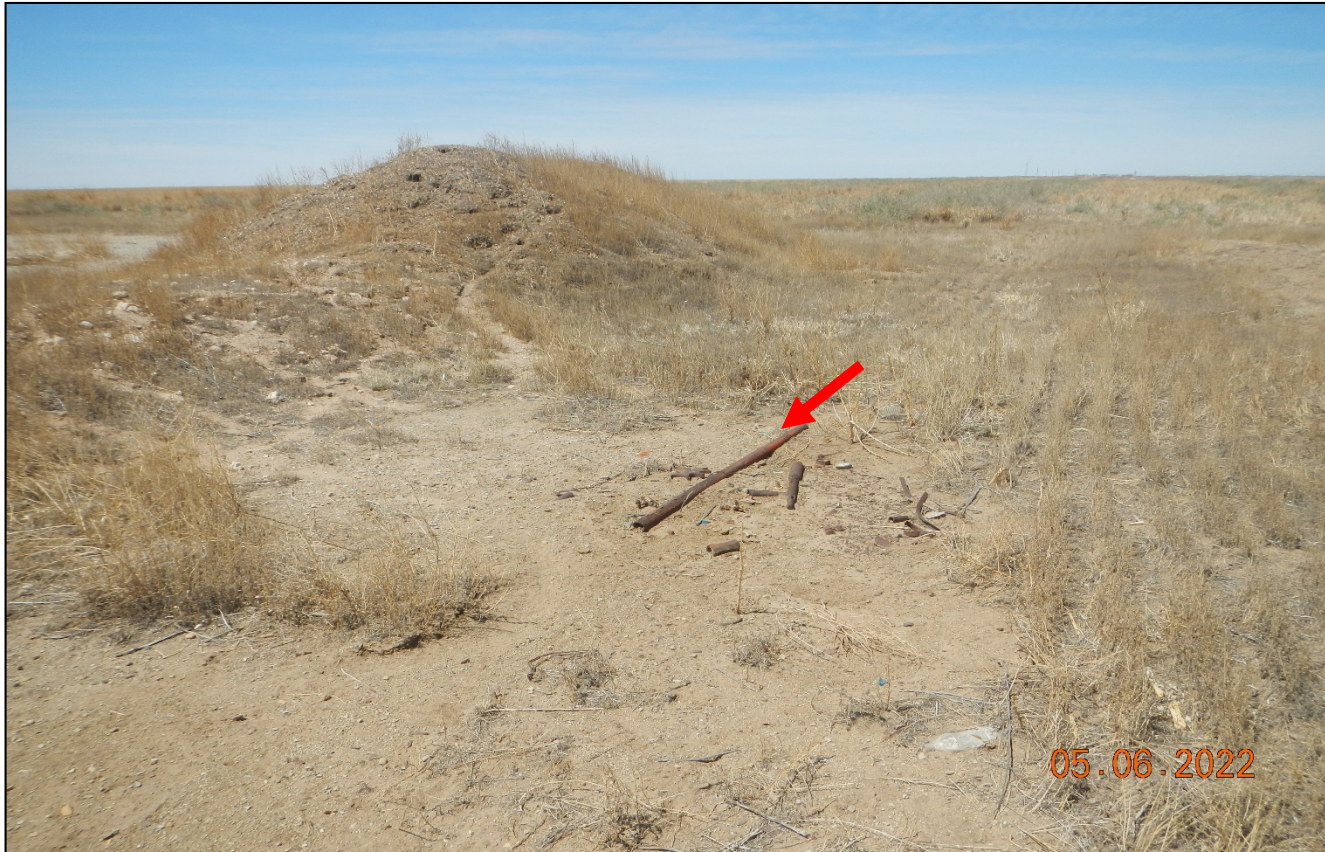
Photo 4. Facing east at the north side of the location. There is undesirable throughout the location which must be controlled. There is metal debris shown at red arrow.

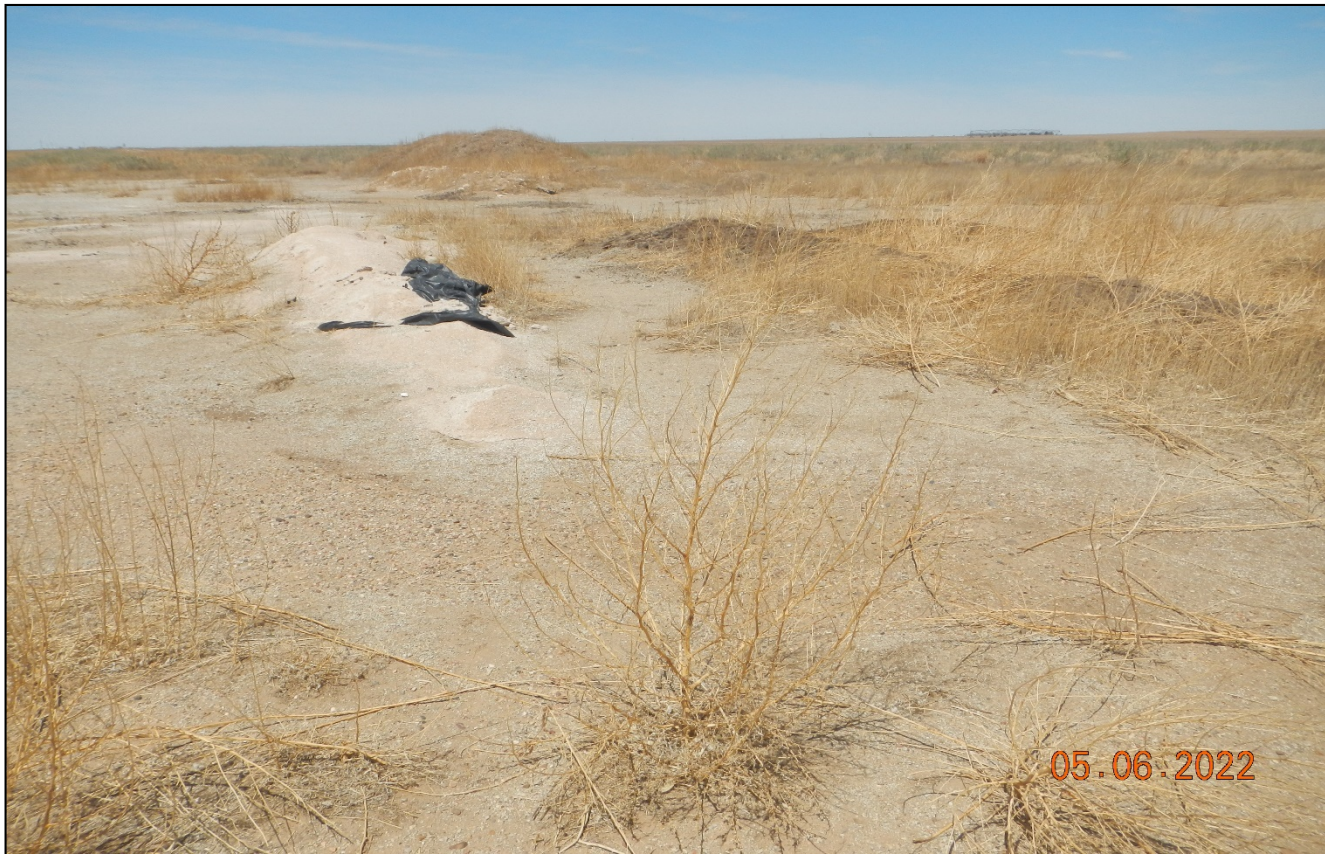
Photo 5. There is piles of manure and material left on the location.

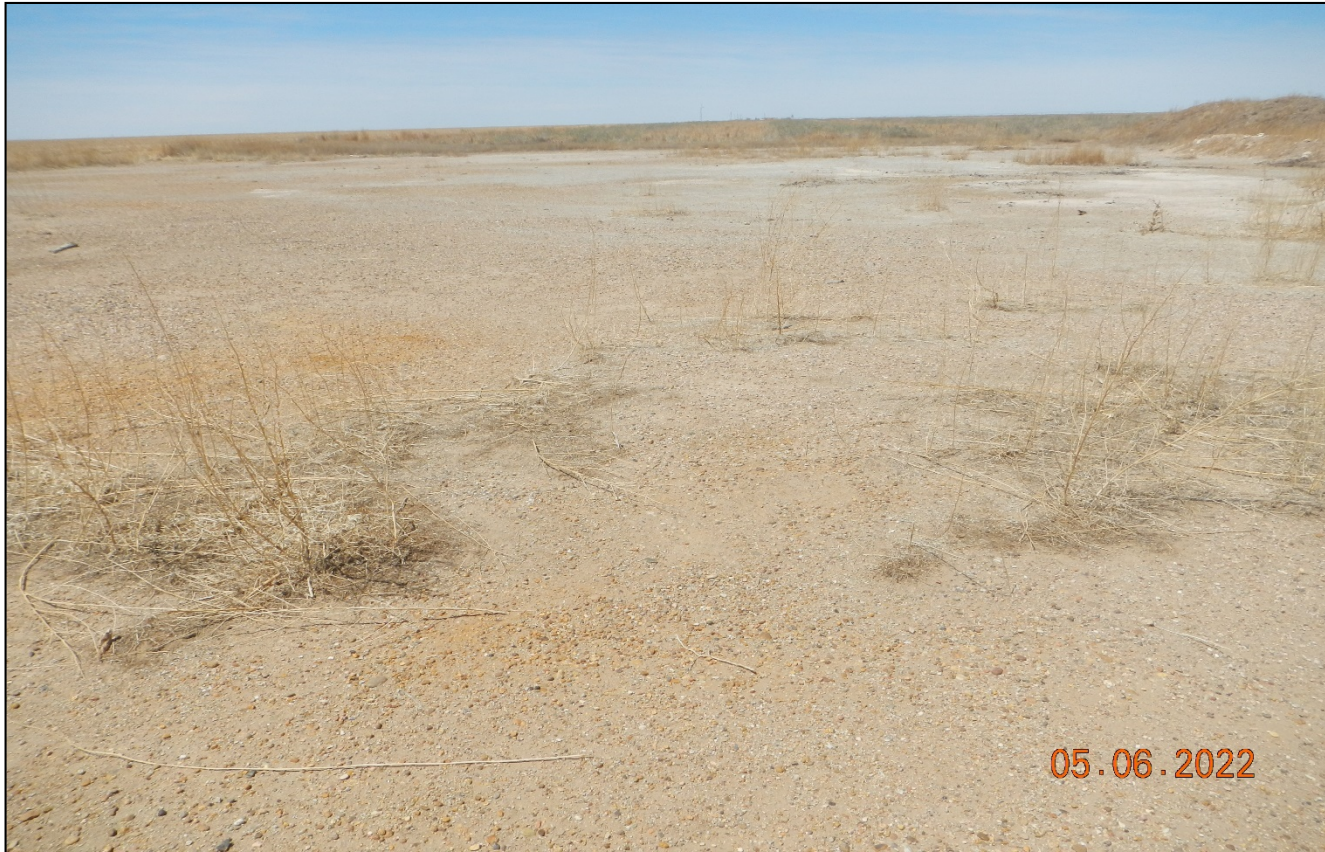
Photo 6. Facing west at the location. Soils are compacted and the location has not been reclaimed. Previous corrective actions were not performed.

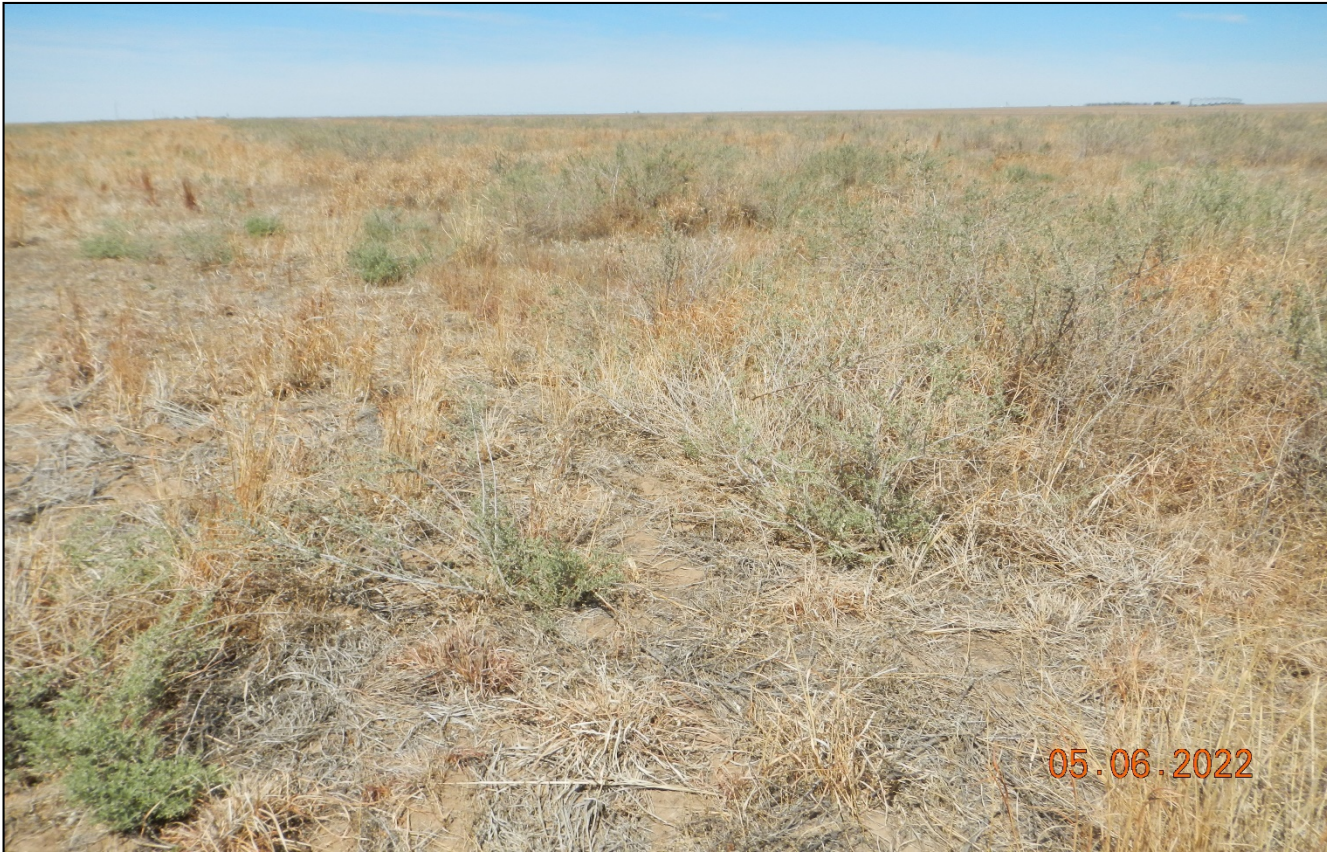
Photo 8. Facing east toward the surrounding reference vegetation which consists of desirable vegetation cover.
