Final Reclamation Inspection

Operator: PDC ENERGY INC - 69175

Location ID: 331171

Inspection Photos
Location Name: BOUGE #1
Location ID: 331171

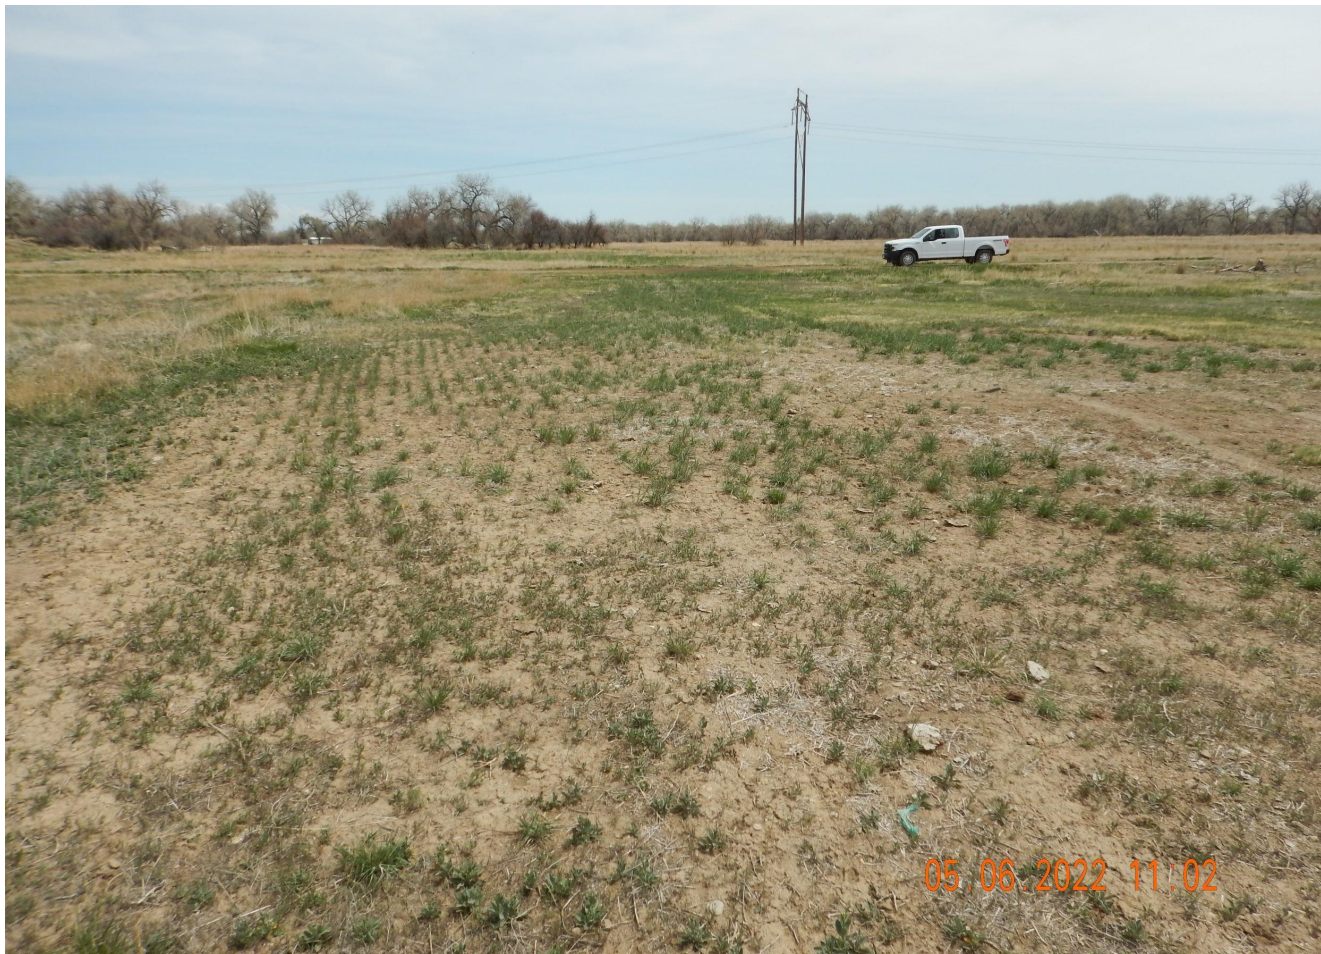
Photo 1. Photo taken from the well location, facing East. Photo illustrates Operator has removed equipment and gravel from all disturbance areas. Photo illustrates the establishment of desirable plant species but it has not met Rule 1004 standards.

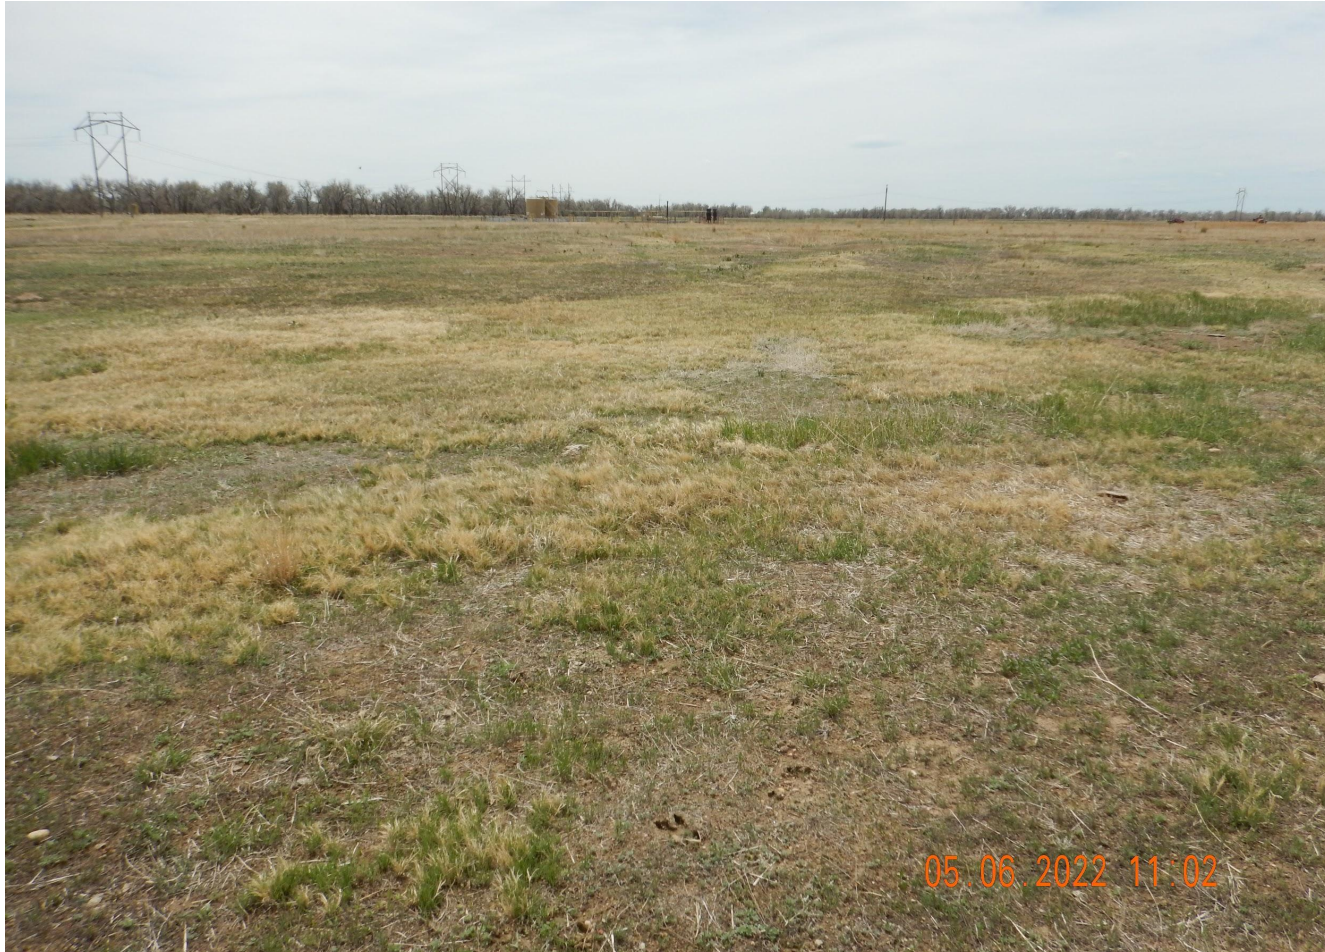
Photo 2. Reference photo taken south of the well location, facing South.

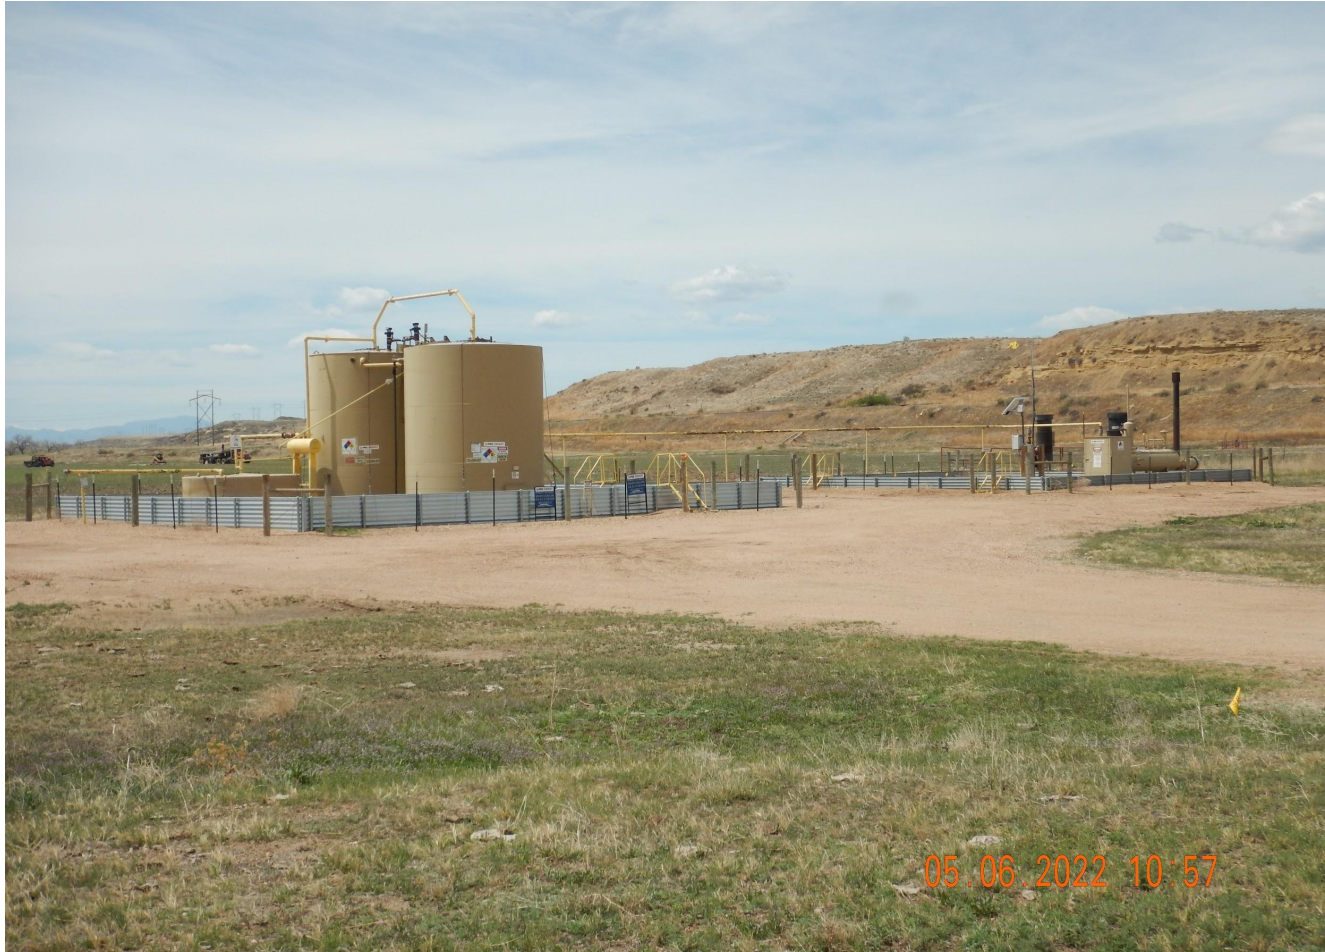
Photo 3. Photo taken from the associated tank battery, facing West. Photo illustrates the tank battery is still in use for other nearby wells.
