# Inspection Photos

Operator: Chevron USA Inc - #16700

Location Name: Wilson Creek Unit-62N94W /2NESE

Inspection Document #: 702800188

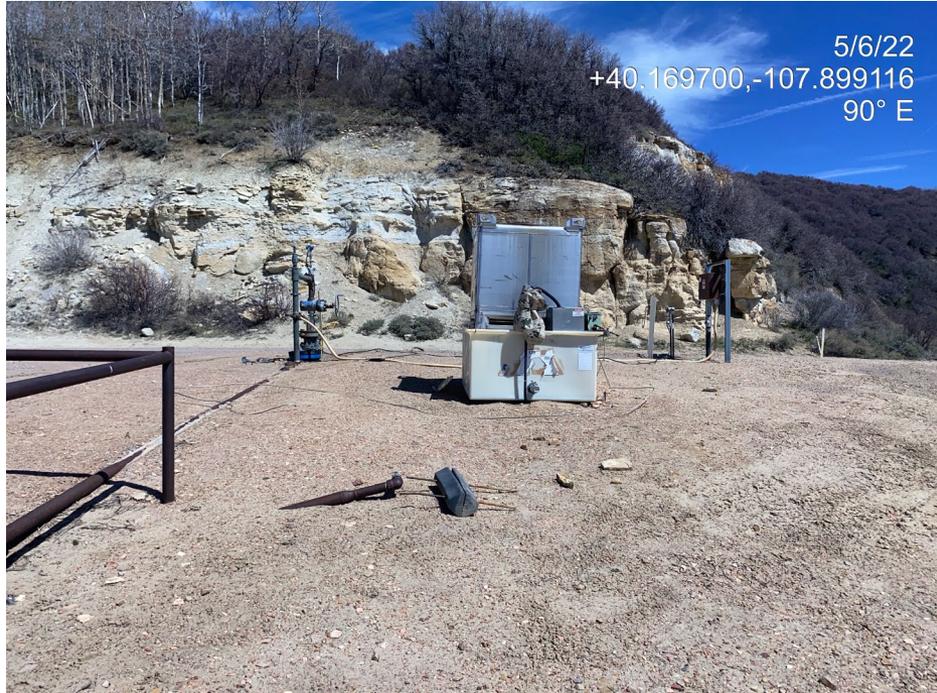
**Photo 1.** Photo taken from the center of the Location shows an overview of production equipment.

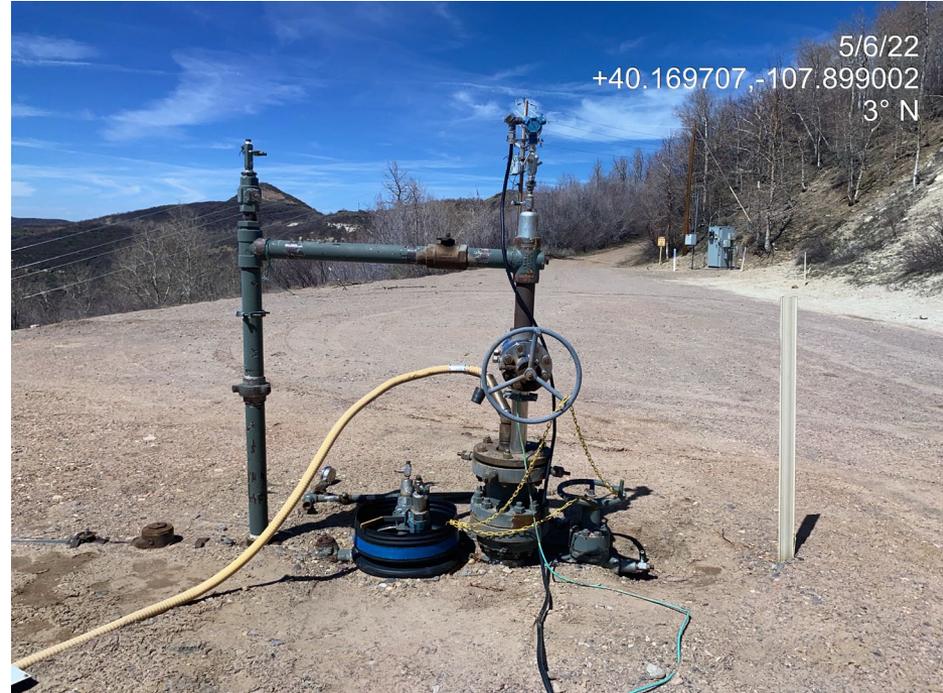
**Photo 2.** Photo taken from the center of the Location shows the wellhead.

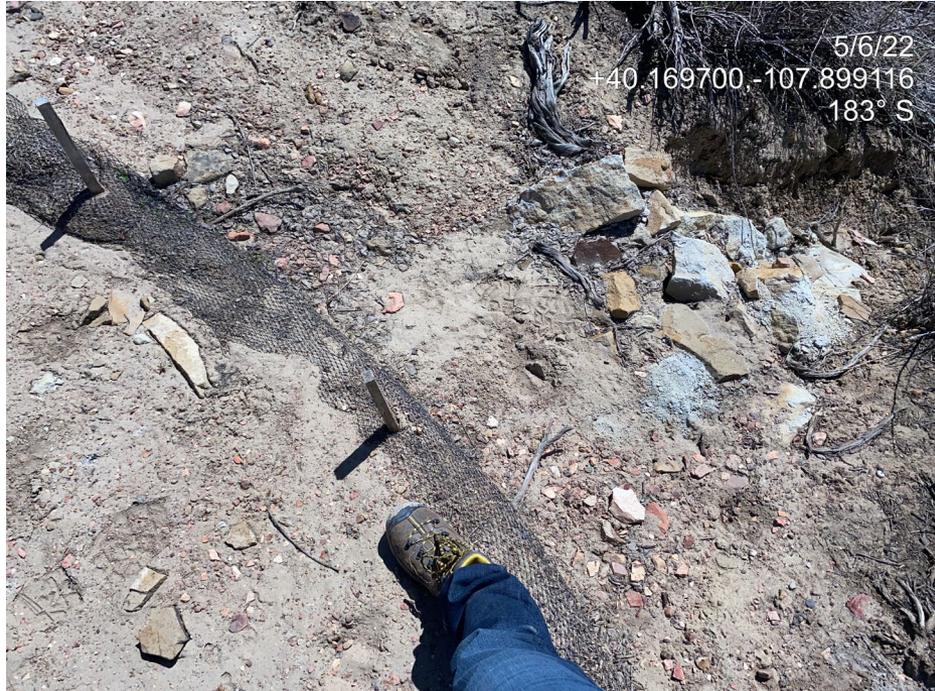
**Photo 3.** Photos taken from the western perimeter of the Location shows a straw wattle which is not in proper functioning condition to minimize erosion and transport of sediment offsite.

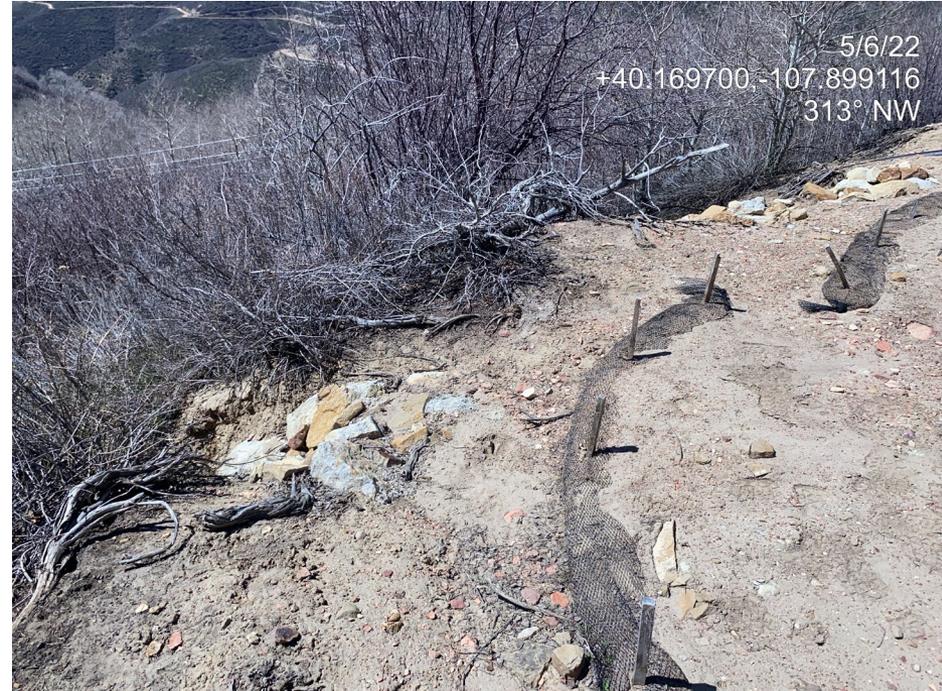
**Photo 4.** Refer to Photo 3 comment.

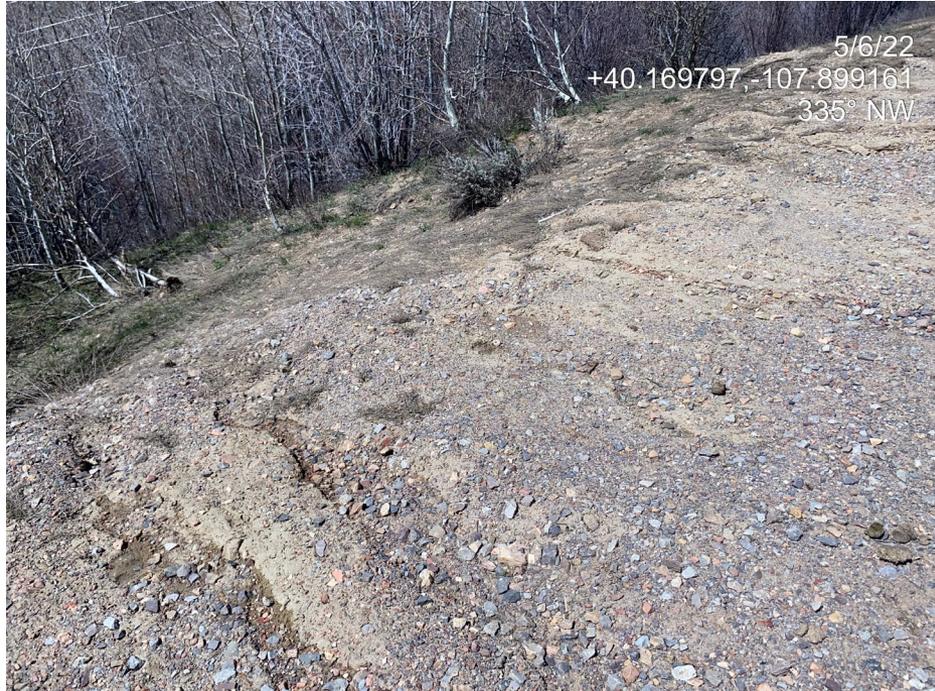
**Photo 5.** Photos taken from the western perimeter of the Location shows erosion occurring at the edge of the Location, resulting in transport of sediment offsite and offsite degradation.

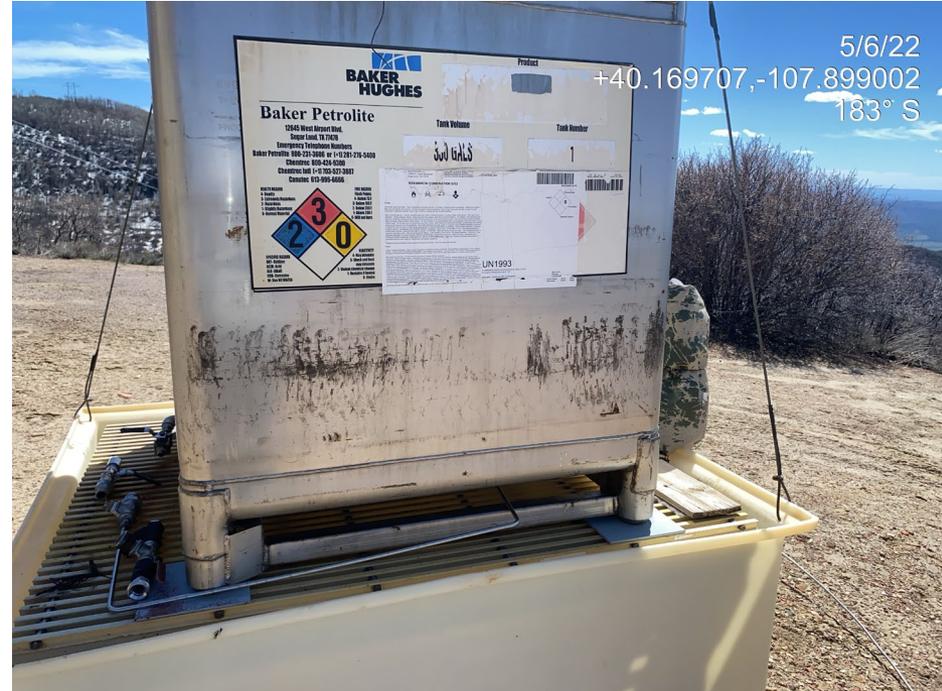
**Photo 6.** Photo shows a secondary containment BMP. Wildlife protection BMPs to enable wildlife egress were missing or insufficient.
