Inspection Photos

May 6, 2022

Location Name: Wilson Creek Unit-62N94W/2SWNE

Inspection Document #: 702800192

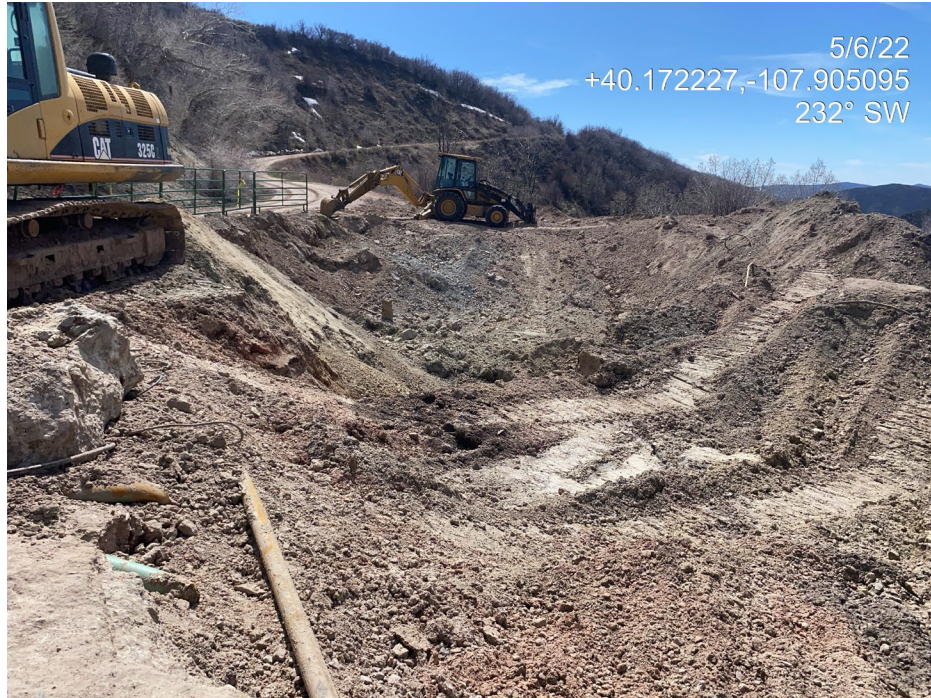
Photo 1. Photo taken from the well area shows the excavated area around the well. Photo also shows multiple underground pipes and flowlines which will need to be removed for final reclamation.

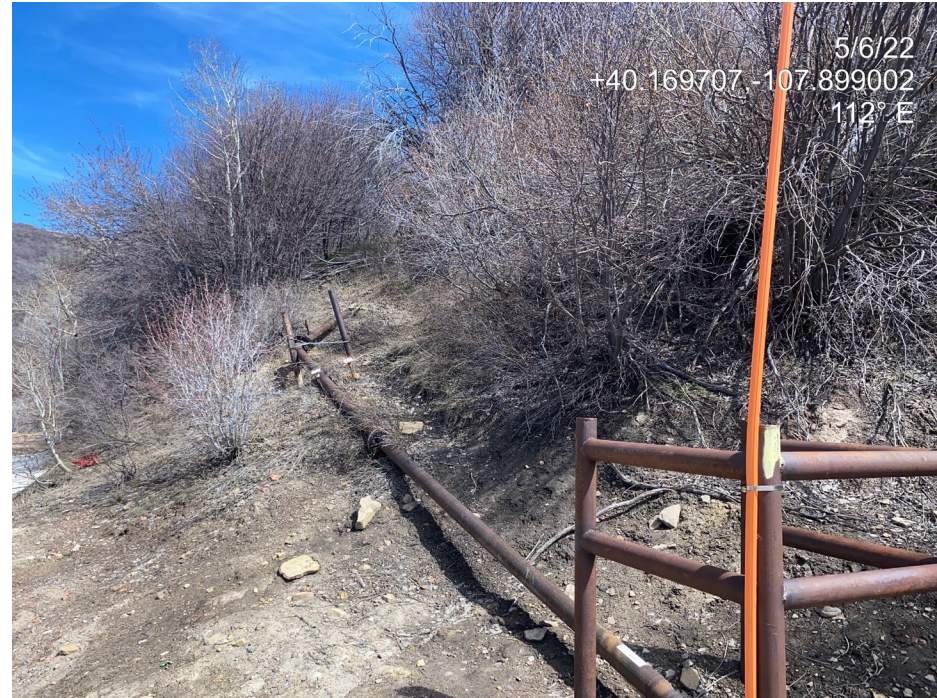
Photo 2. Photo shows flowlines adjacent to the Location which will need to be removed for final reclamation. Note, GPS coordinates are incorrect due to phone GPS malfunction.

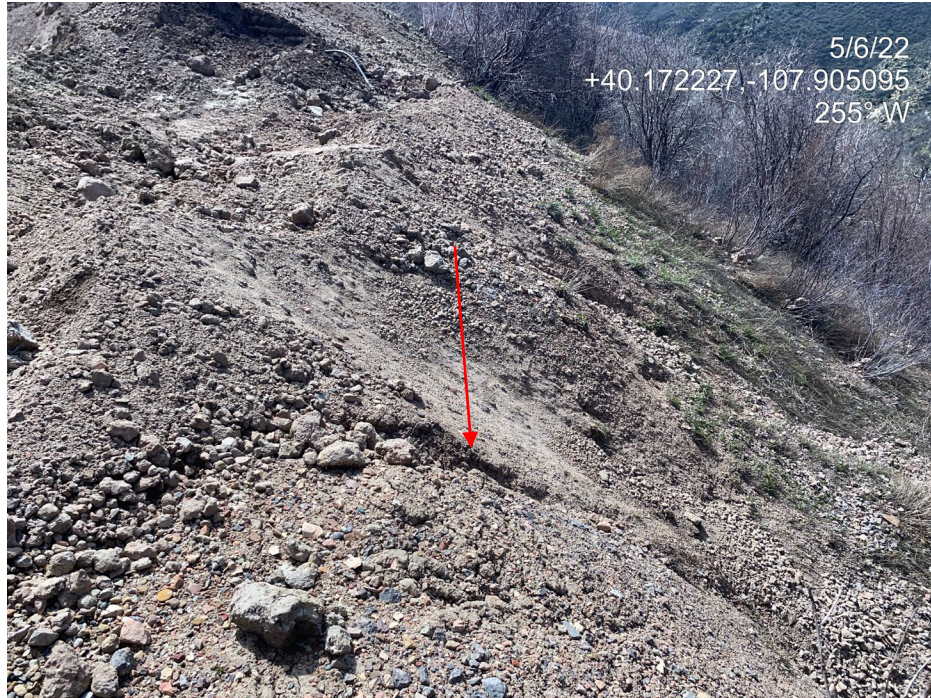
Photo 3. Photo shows piles of excavated material at the edge of the Location. No BMPs were observed to prevent soils potentially contaminated with E&P waste from migrating off the Location. Also note the rill occurring (red arrow) due to inadequate stormwater controls.

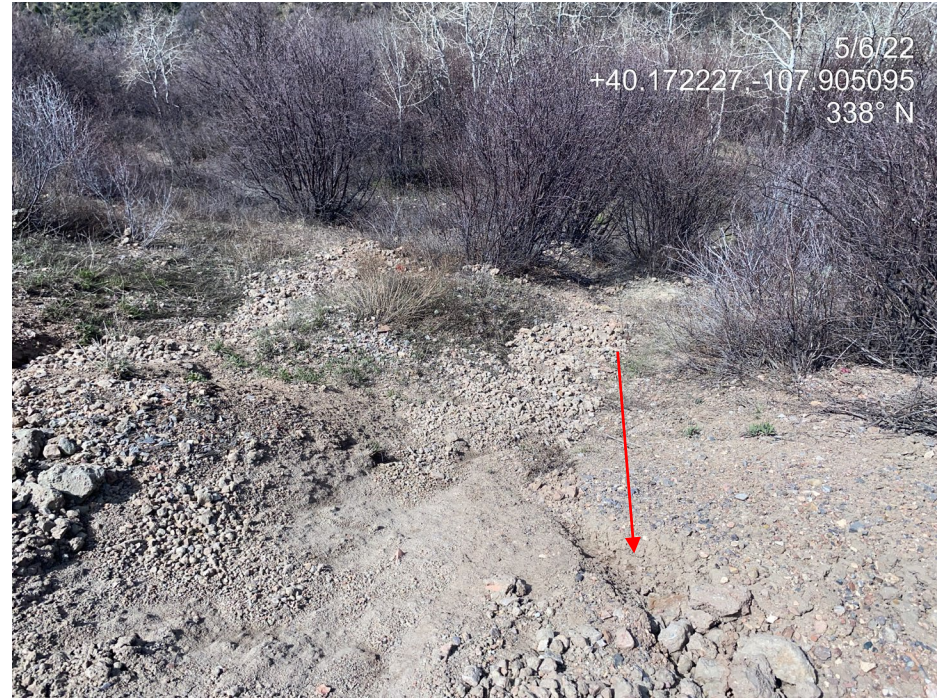
Photo 4. Photo shows a rill occurring (red arrow) due to inadequate stormwater controls. Photo also shows sediment and gravel from the Location is present offsite.

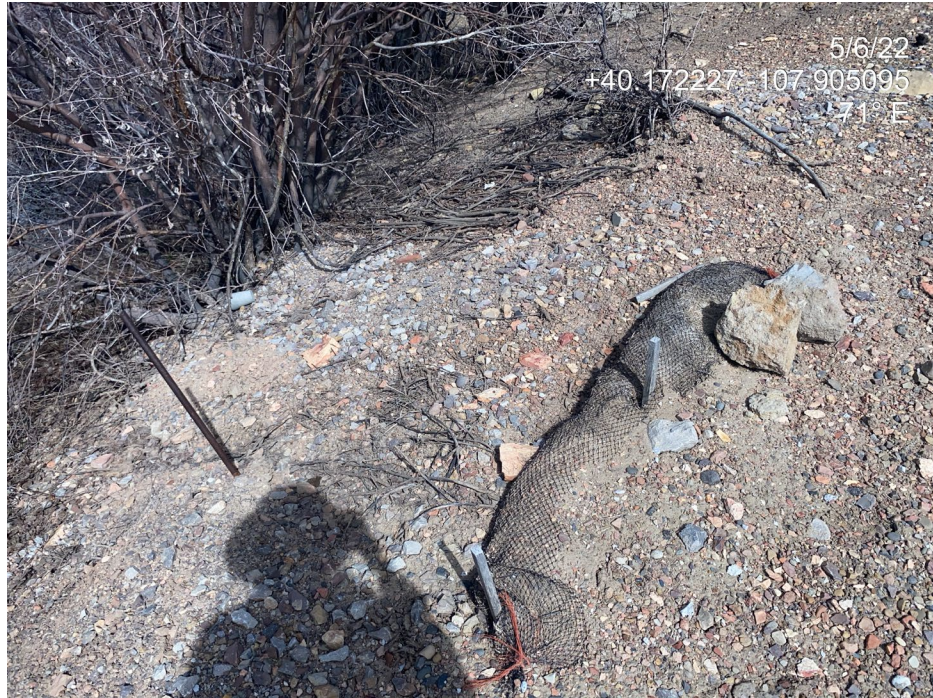
Photo 5. Photo shows a properly functioning straw wattle. In other locations at the northwestern edge of the Location erosion was occurring resulting in soil movement offsite.

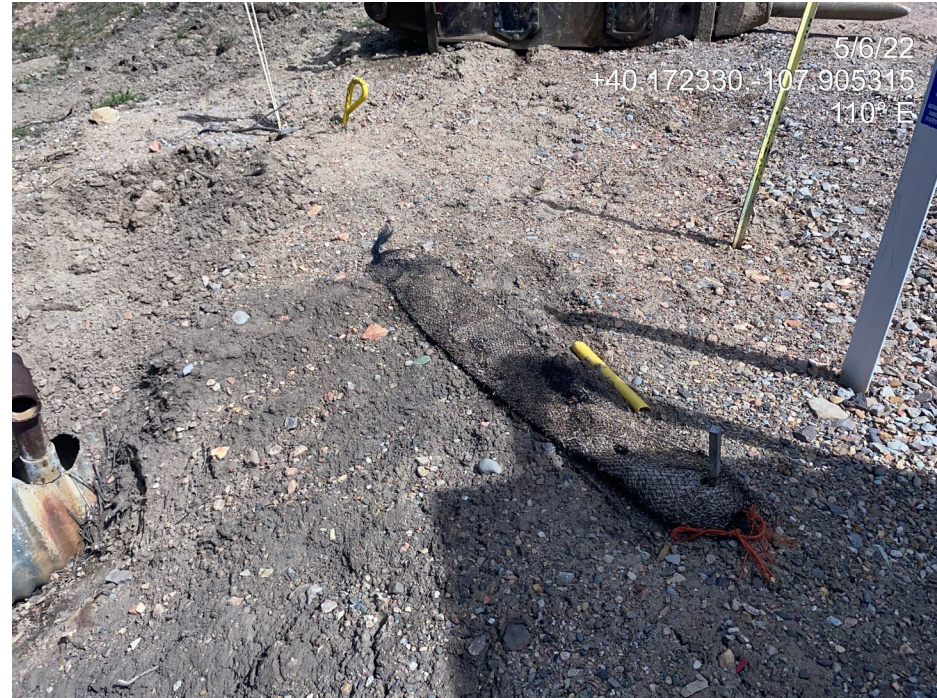
Photo 6. Photo shows a straw wattle not properly maintained. Some erosion was occurring at the edge of the Location resulting in soil movement offsite.
