Inspection Photos

Operator: KOCH EXPLORATION COMPANY LLC
- 49100

Location ID: 391071
Mesa County, CO

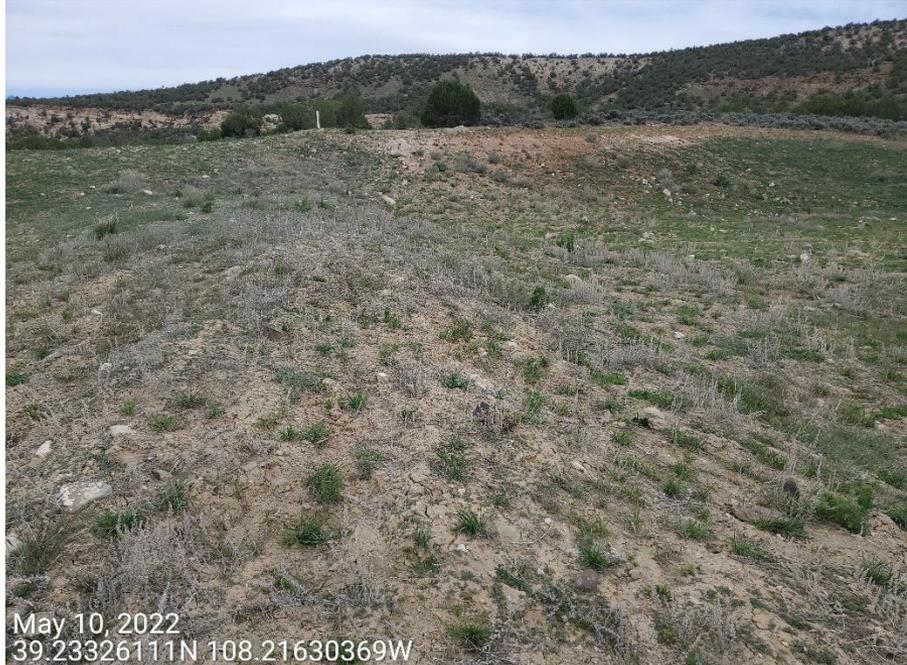
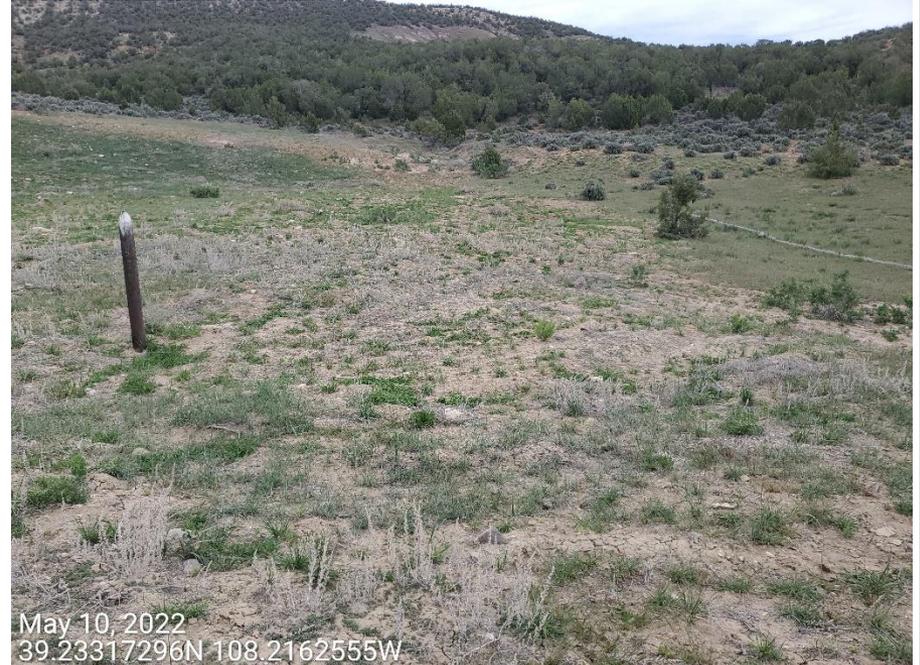
Photo 1: Photos taken from the south end of the Location facing northwest and northeast. Photo provides overview of the Location.

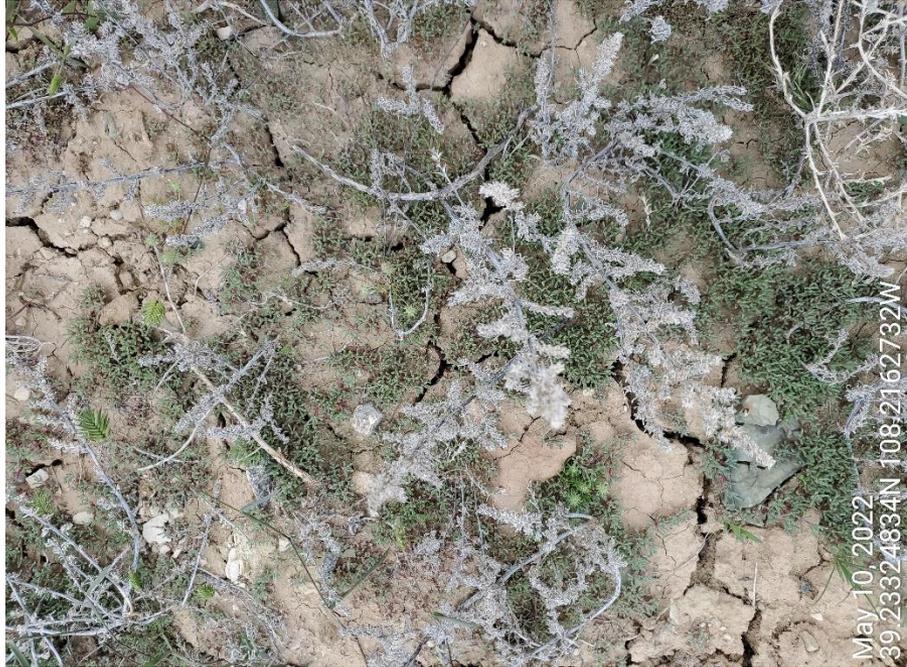
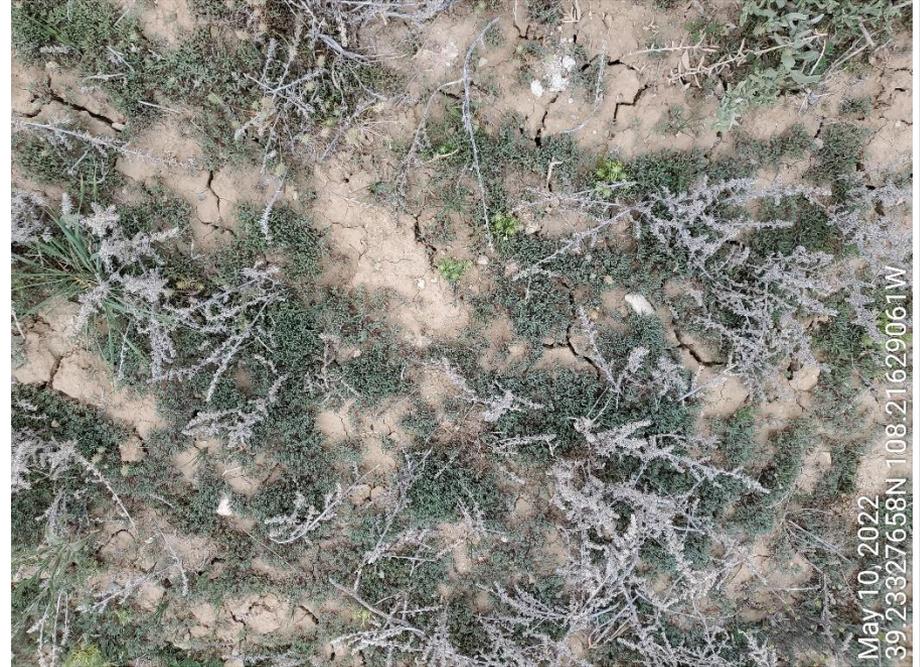
Photo 2: Photo shows example of vegetation establishment throughout majority of the Location. Green vegetation observed is Halogeton, a Colorado State listed noxious weed.

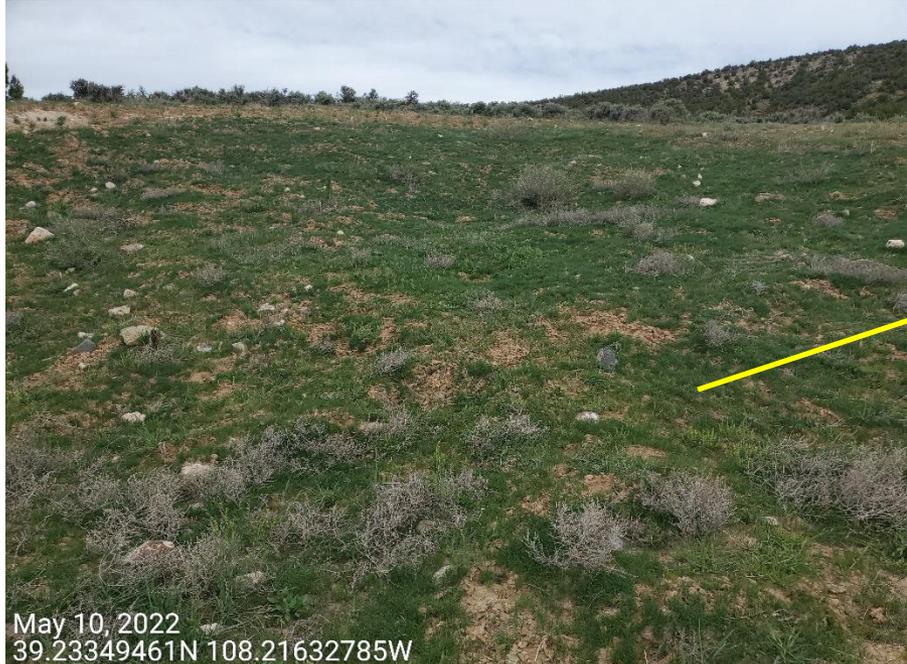
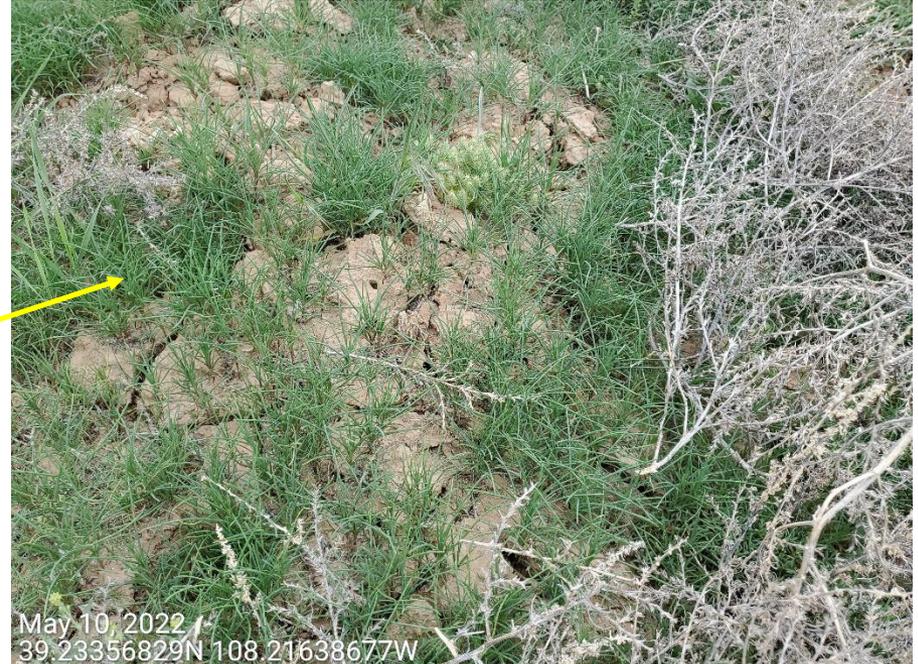
Photo 3: Photo taken from the west end of the Location, facing west. Photo shows example of vegetation establishment throughout majority of the Location. Green vegetation observed in photos are predominantly undesirable annual plant species such as Russian thistle (*Salsola* sp.)

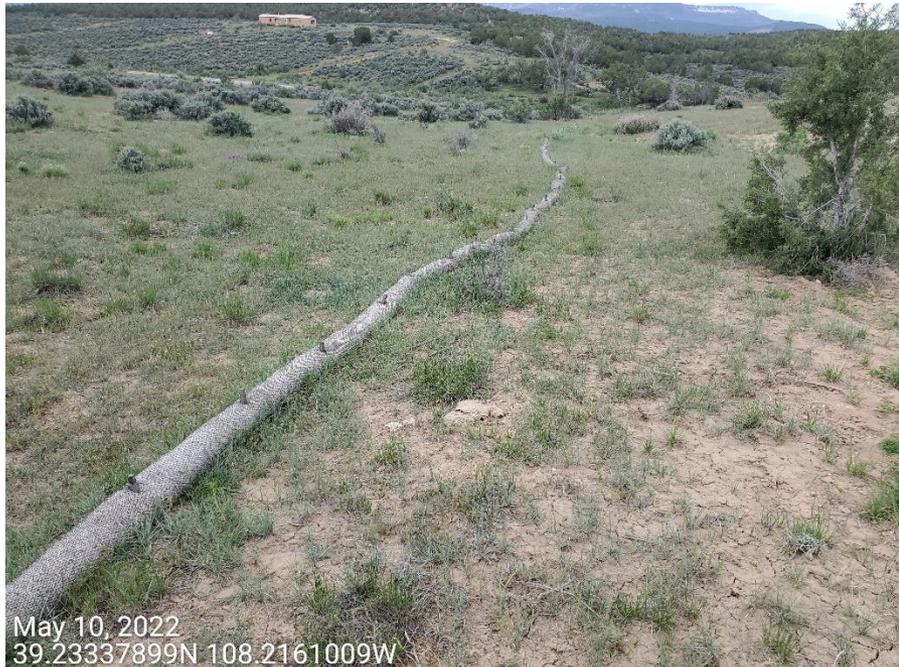
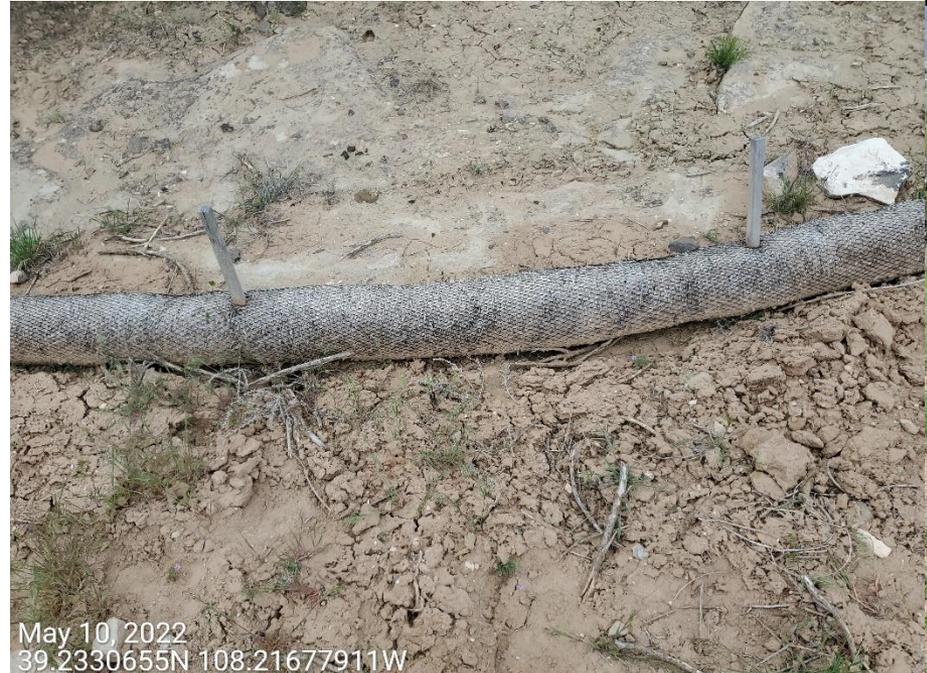
Photo 4: Photos examples showing the single row of straw wattle implemented along perimeter of the Location; erosion logs are the only control measure on site to manage runoff. Photos show BMP has not been installed per good engineering practices (trench and backfilled) or maintained in proper functioning condition.

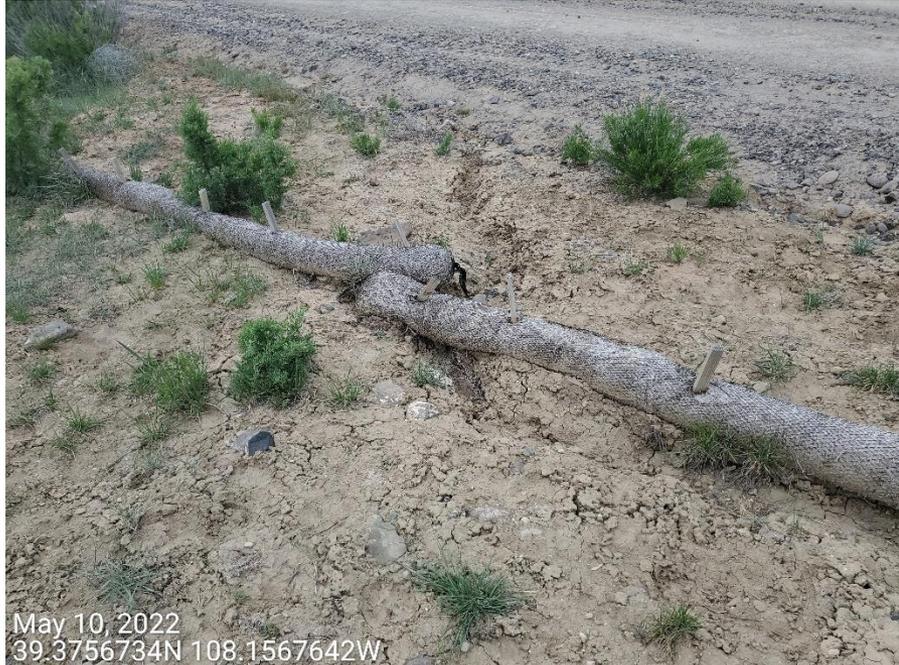
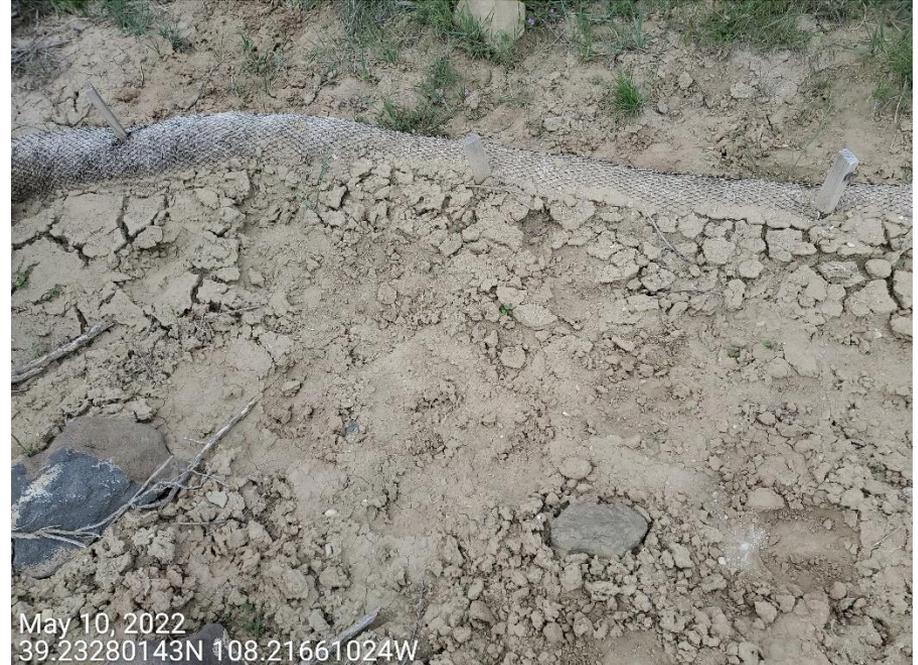
Photo 5: See comments under photo 4.
