Inspection Photos

5/10/2022

Operator: LARAMIE ENERGY LLC #10433

Location ID: 312433

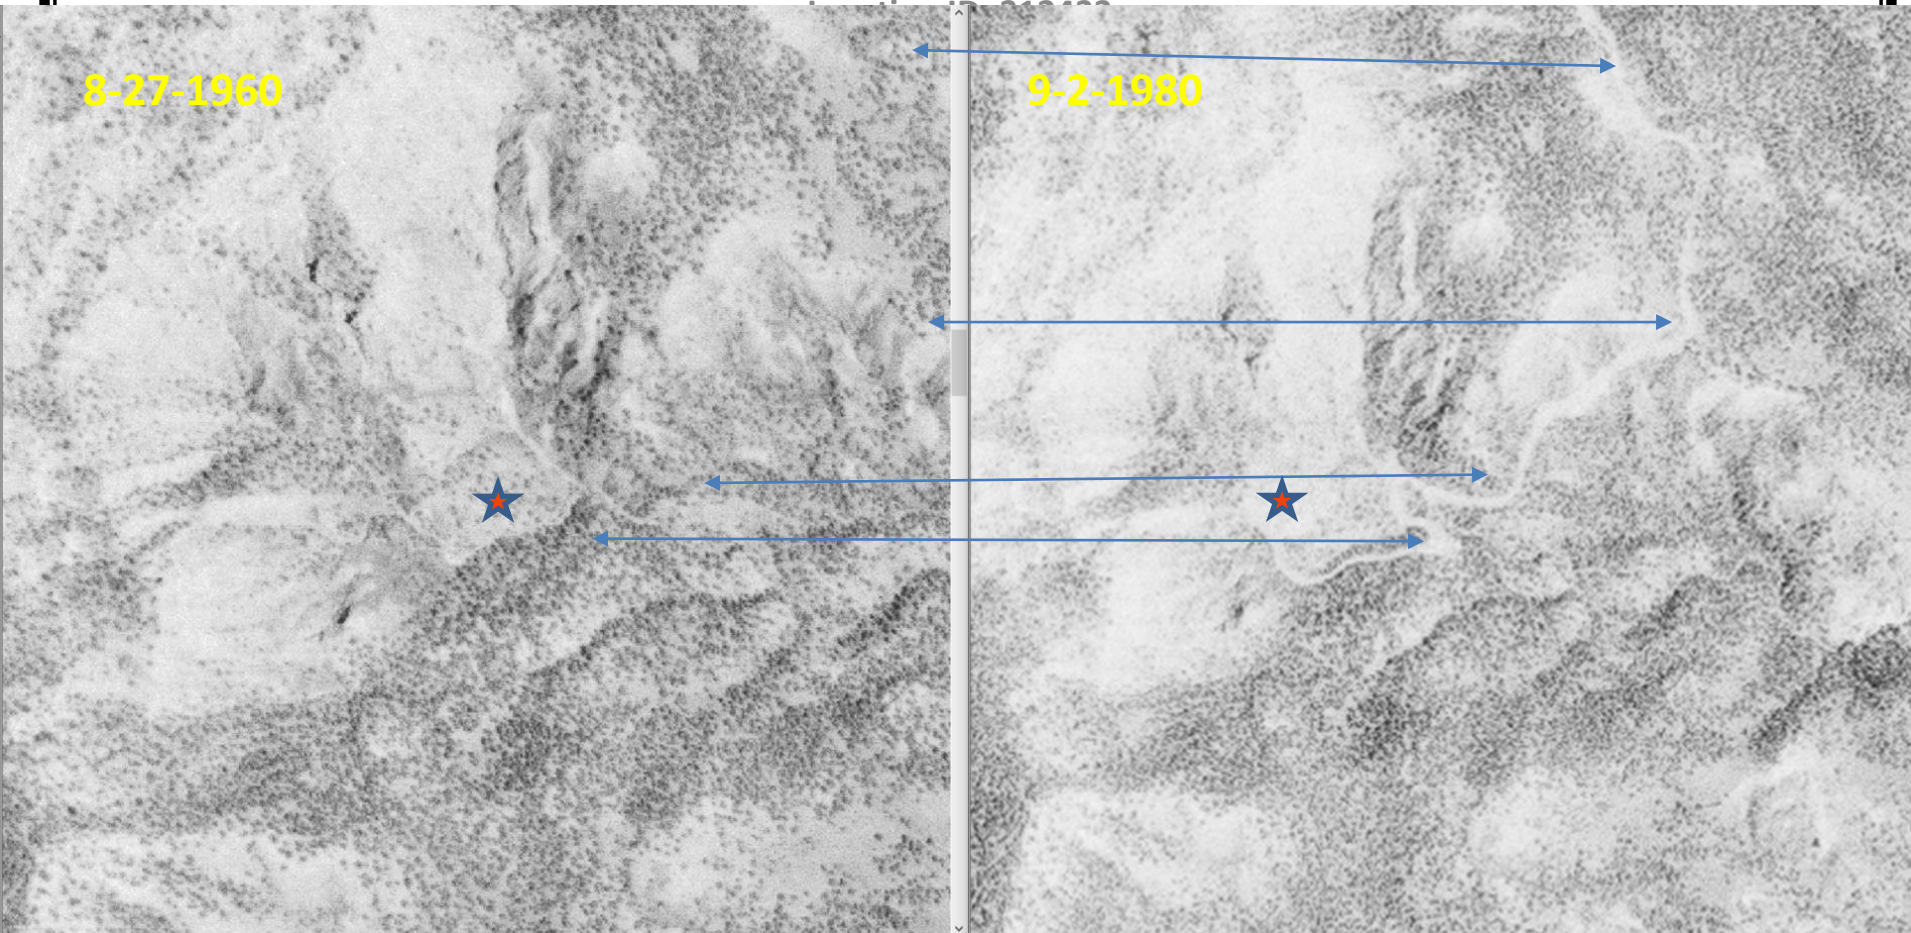
Photo 1: Records show well was completed 4/30/1979. Photo left 1960 USGS aerial image showing area of the Location (star) prior to O&G disturbance. Photo right shows location and access road post construction and drilling.

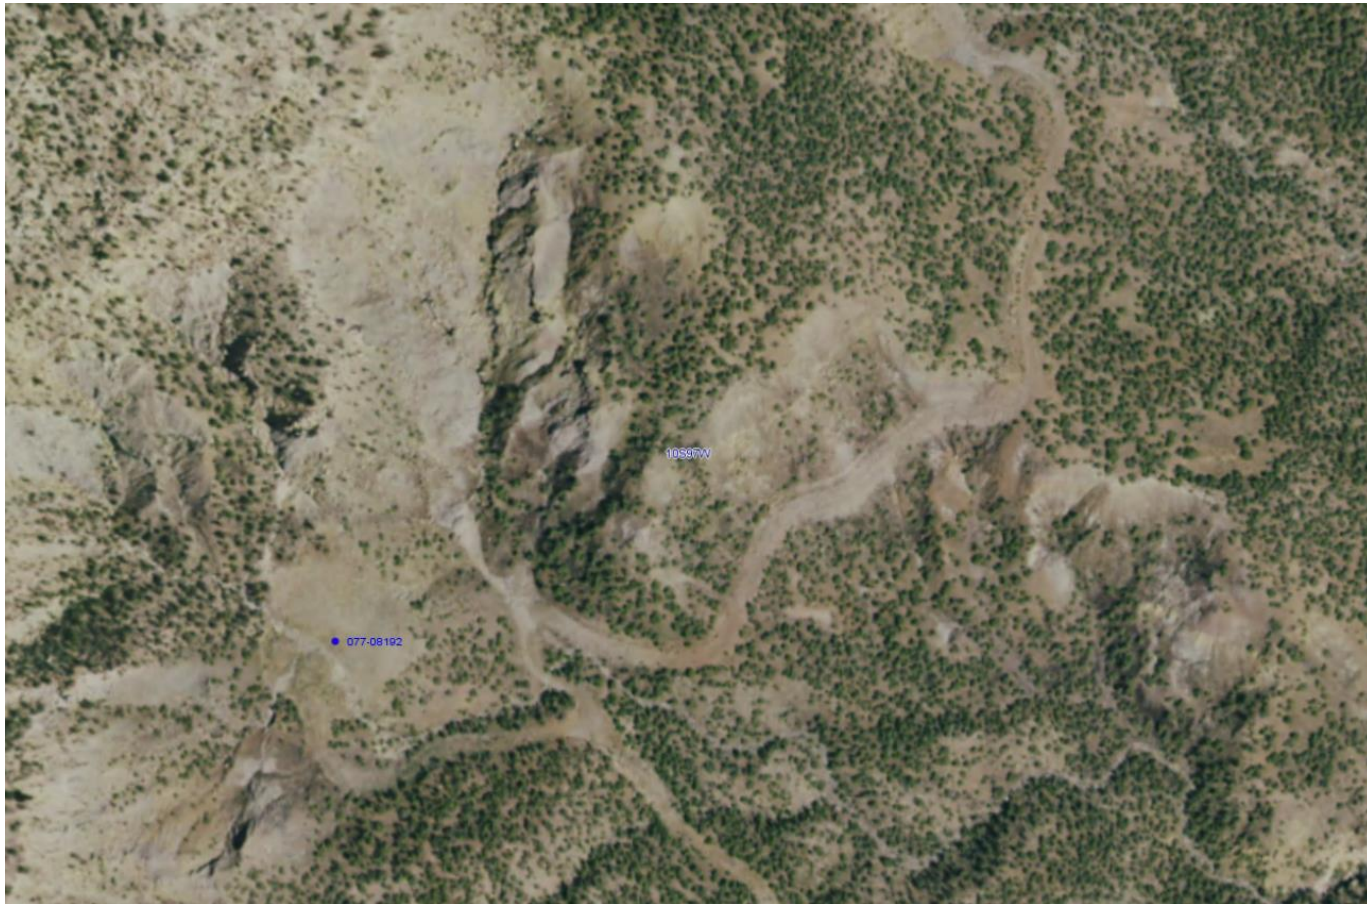
Photo 2: 2019 COGIS aerial image of the Location and access road. Access road did not pre-exist the O&G Location.

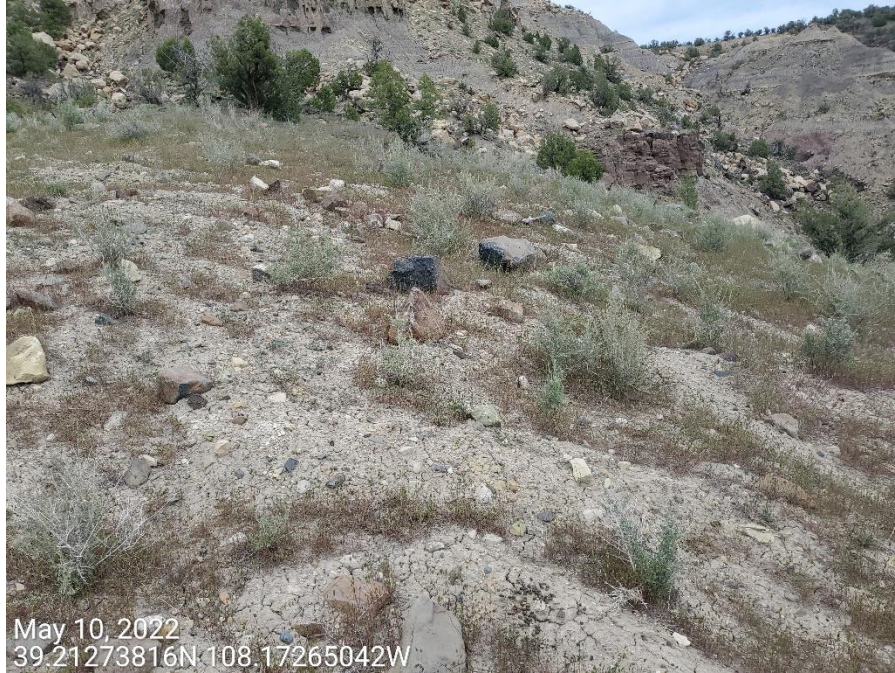
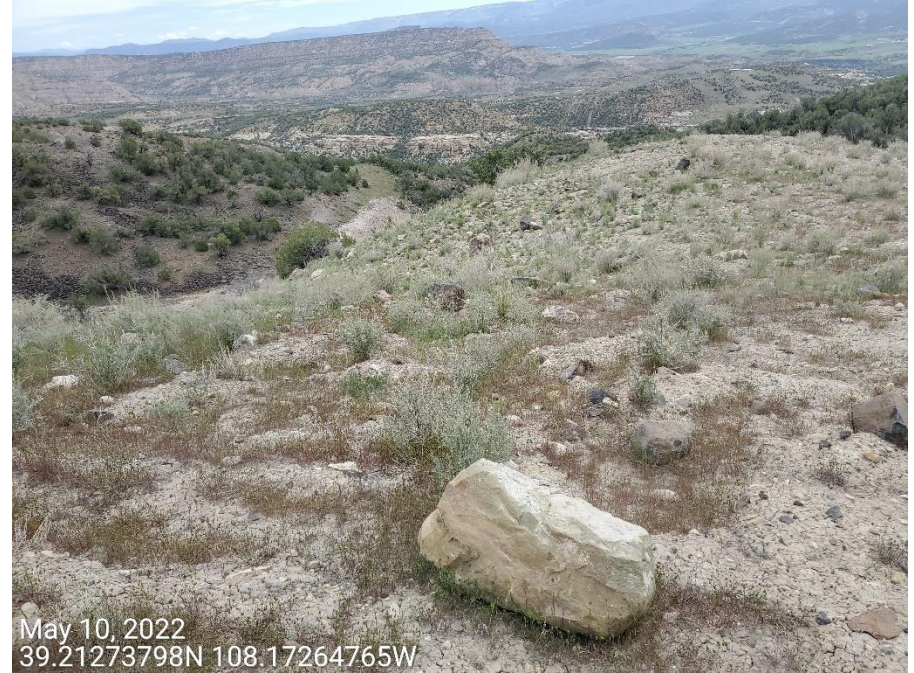
Photo 3: Photos 3-4 taken from the Location. Photos provide an overview of the Location facing north, east, south and west. Shrub establishment evident, however Location remains predominantly bare with undesirable and noxious weeds such as cheatgrass, annual wheatgrass and Halogeton.

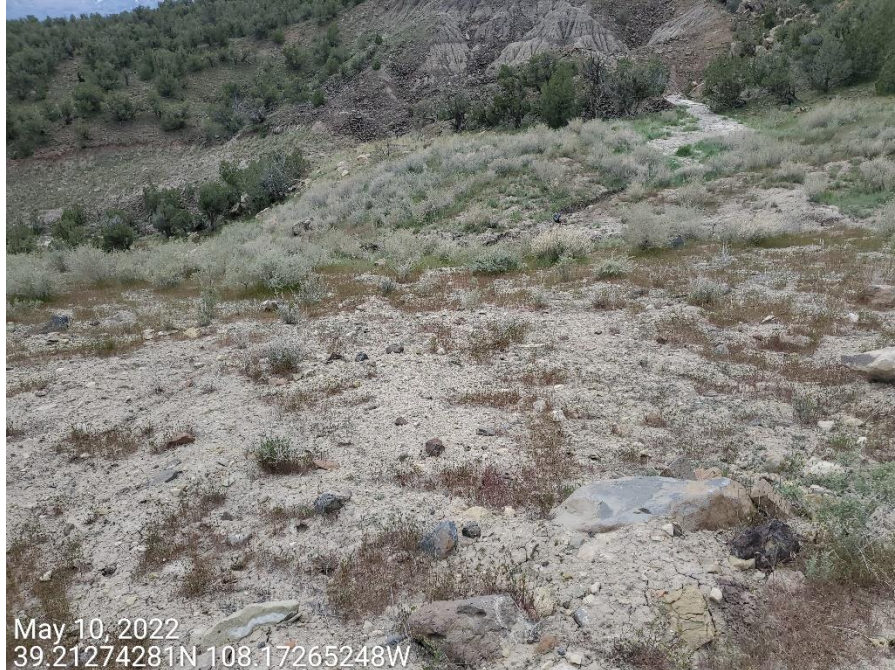
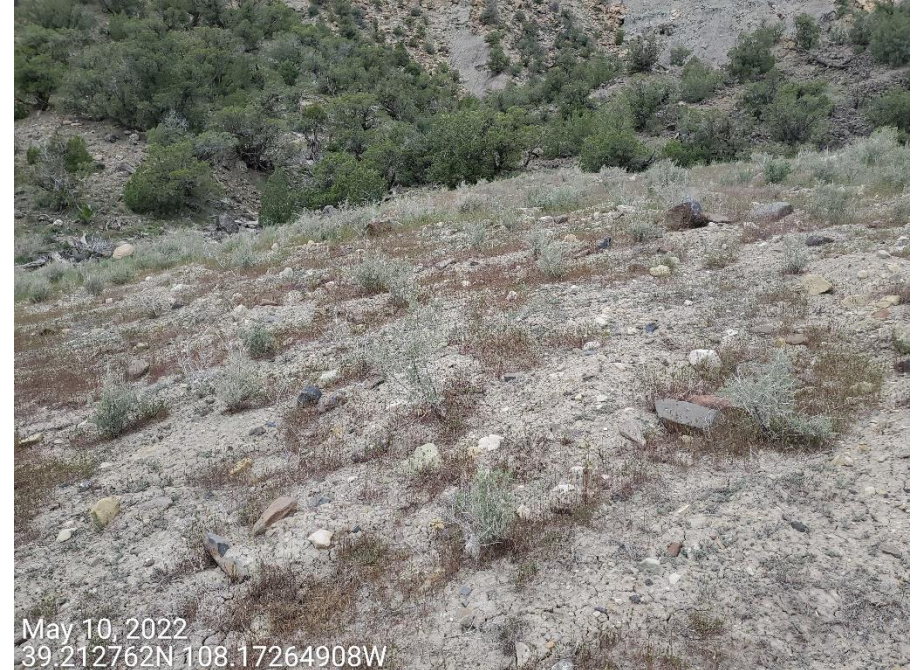
Photo 4: See comments under photo 3.

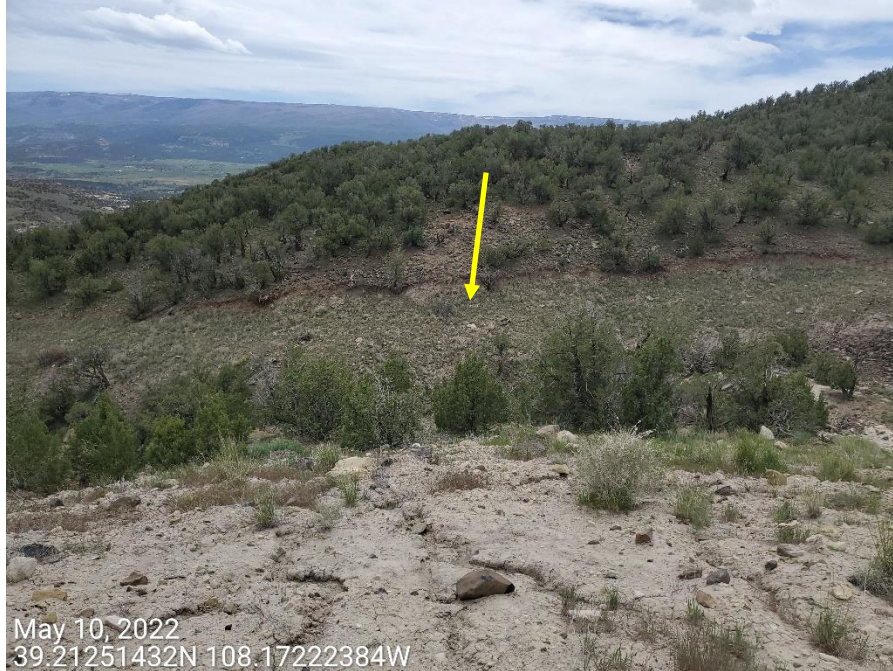
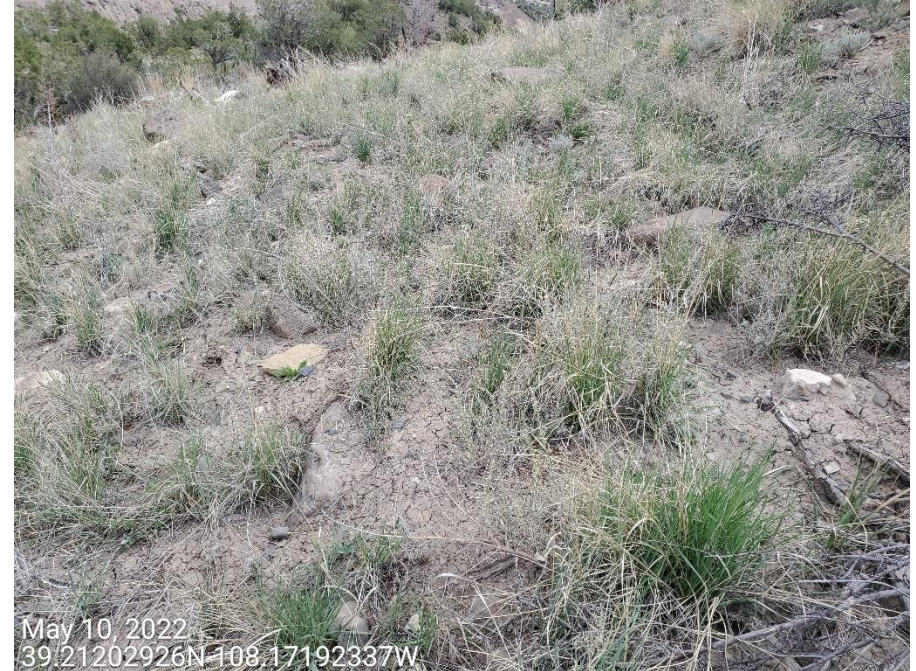
Photo 5: Photo left taken from the Location, facing south. Photo shows ~600 stretch of access road that was recontoured/regraded and reclaimed in accordance with 1004 rules. Photo right shows vegetation at reclaimed access road appears to meet 1004 standards.

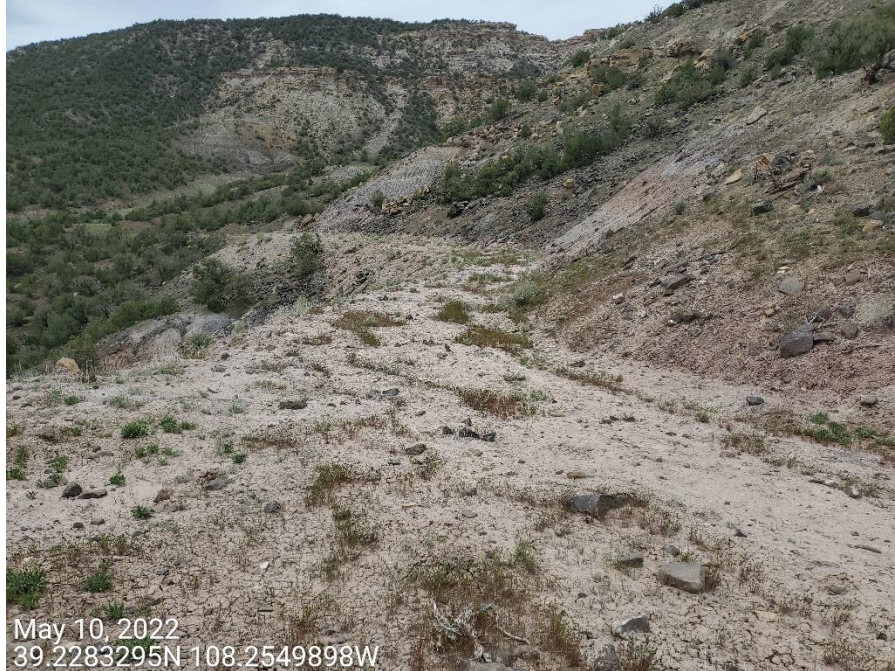
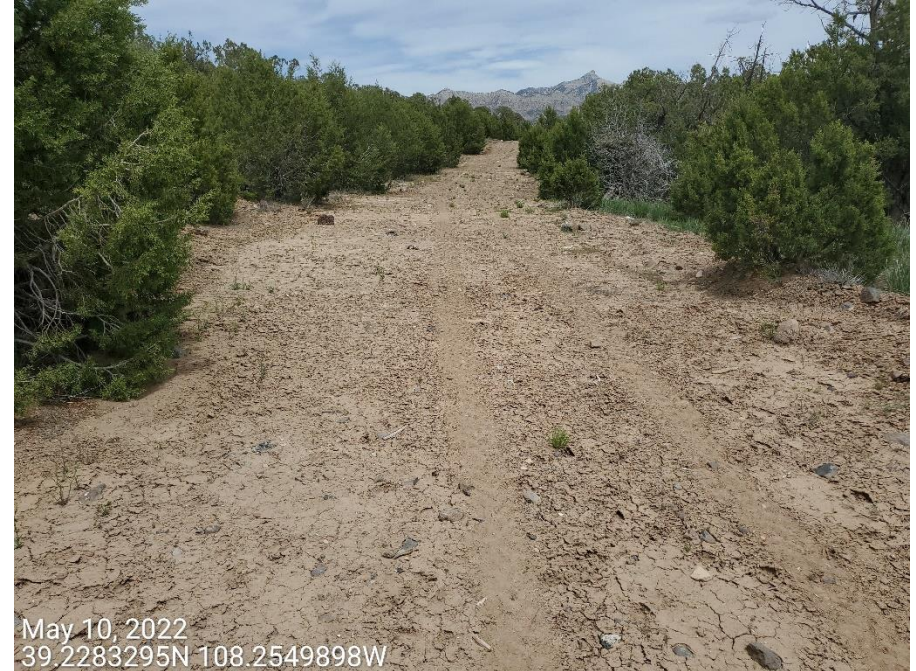
Photo 6: Photos examples showing remaining access road has not been recontoured/regraded and reclaimed in accordance with 1004 rules.

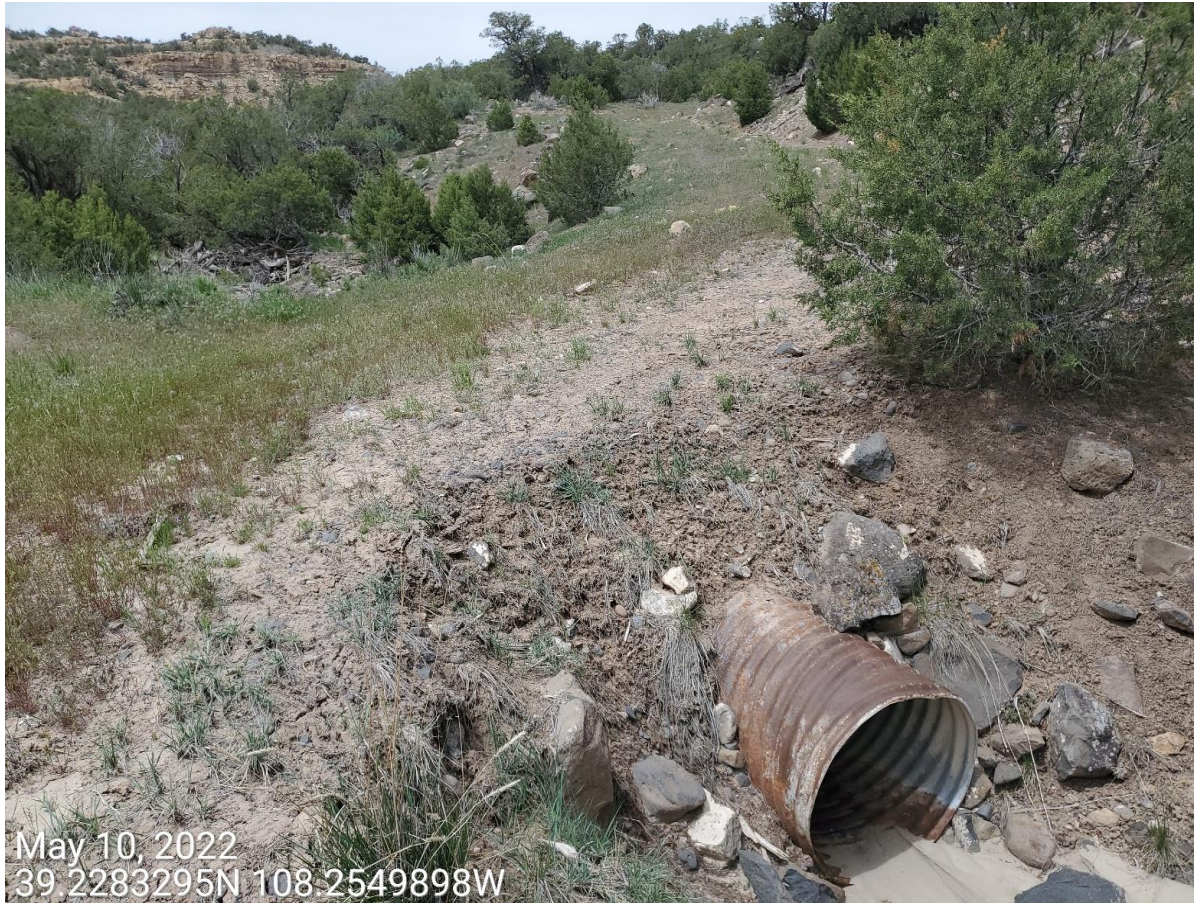
Photo 7: Photo example showing culvert remaining at access road.
