Inspection Photos

5/16/2022

Operator: CAERUS PICEANCE LLC # 10456

Location ID: 335594

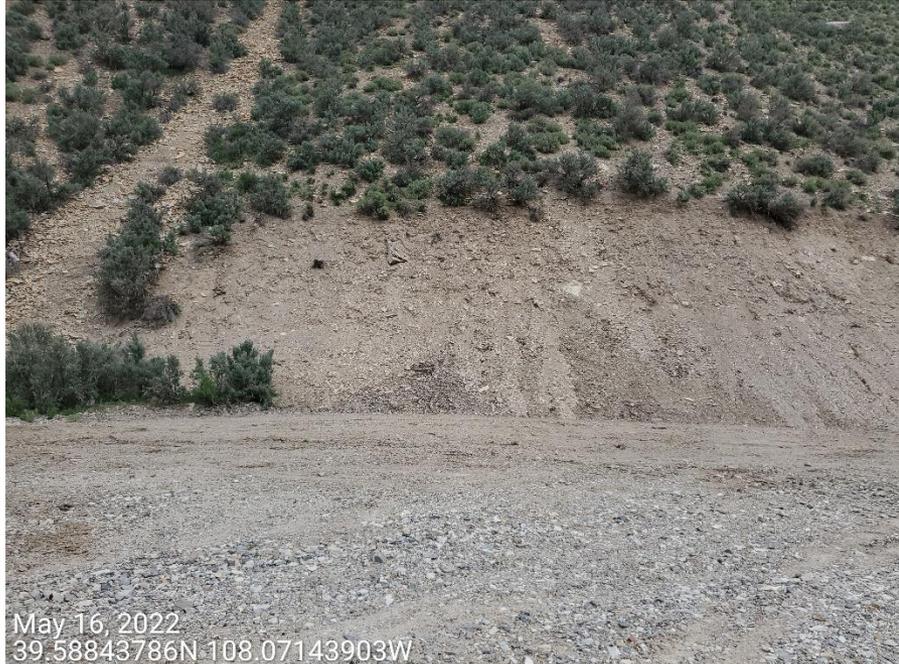
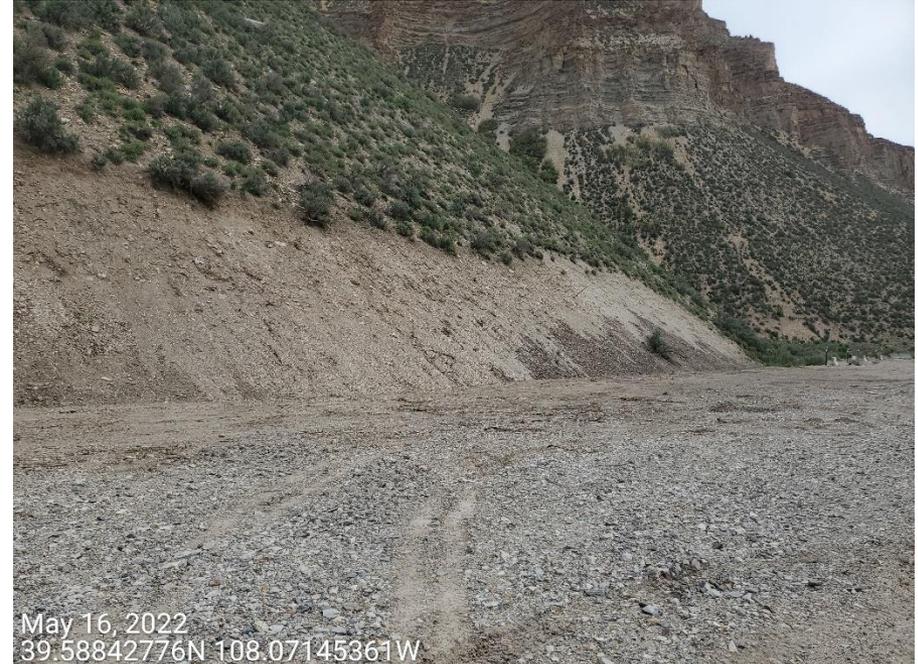
Photo 1: Photos taken from the north end of the Location, facing north/ northeast. Photos provide an overview of the un-stabilized slopes. BMPs to minimize erosion, degradation, and to stabilize the slopes have not been installed or maintained in proper functioning condition; erosion degradation to the slopes has persisted.

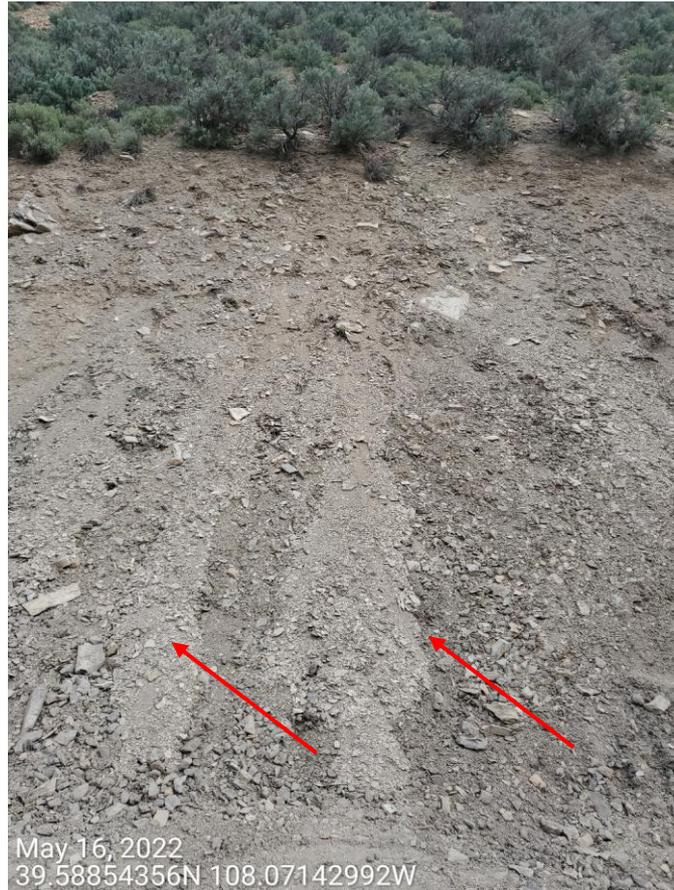
Photo 2: Photo taken from the disturbed slopes on the north end of the Location. Photo shows BMPs to minimize erosion , degradation and to stabilize the slopes have not been installed or maintained. Arrow shows example areas where additional erosion is apparent.

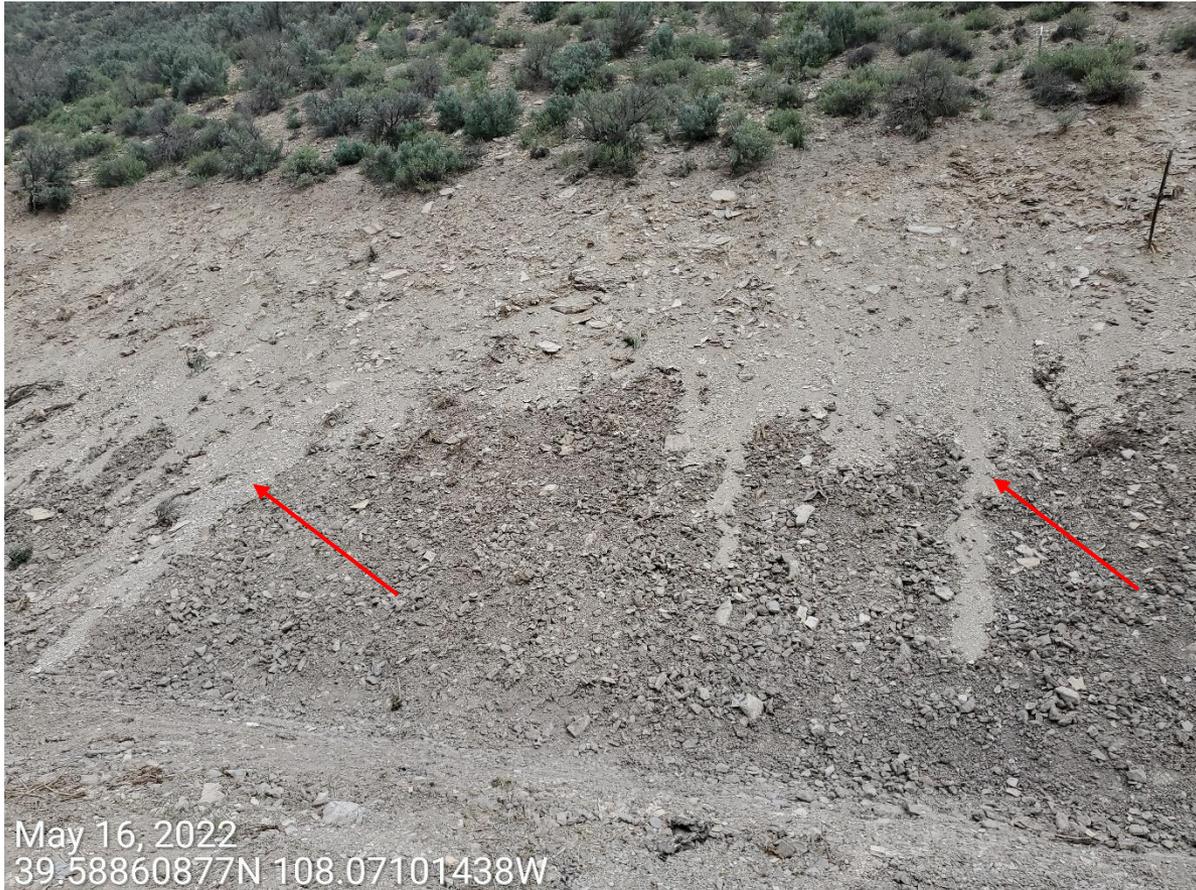
Photo 3: Photo taken from the disturbed slopes on the north end of the Location. Photo shows BMPs to minimize erosion , degradation and to stabilize the slopes have not been installed or maintained. Arrow shows example areas where additional erosion is apparent.

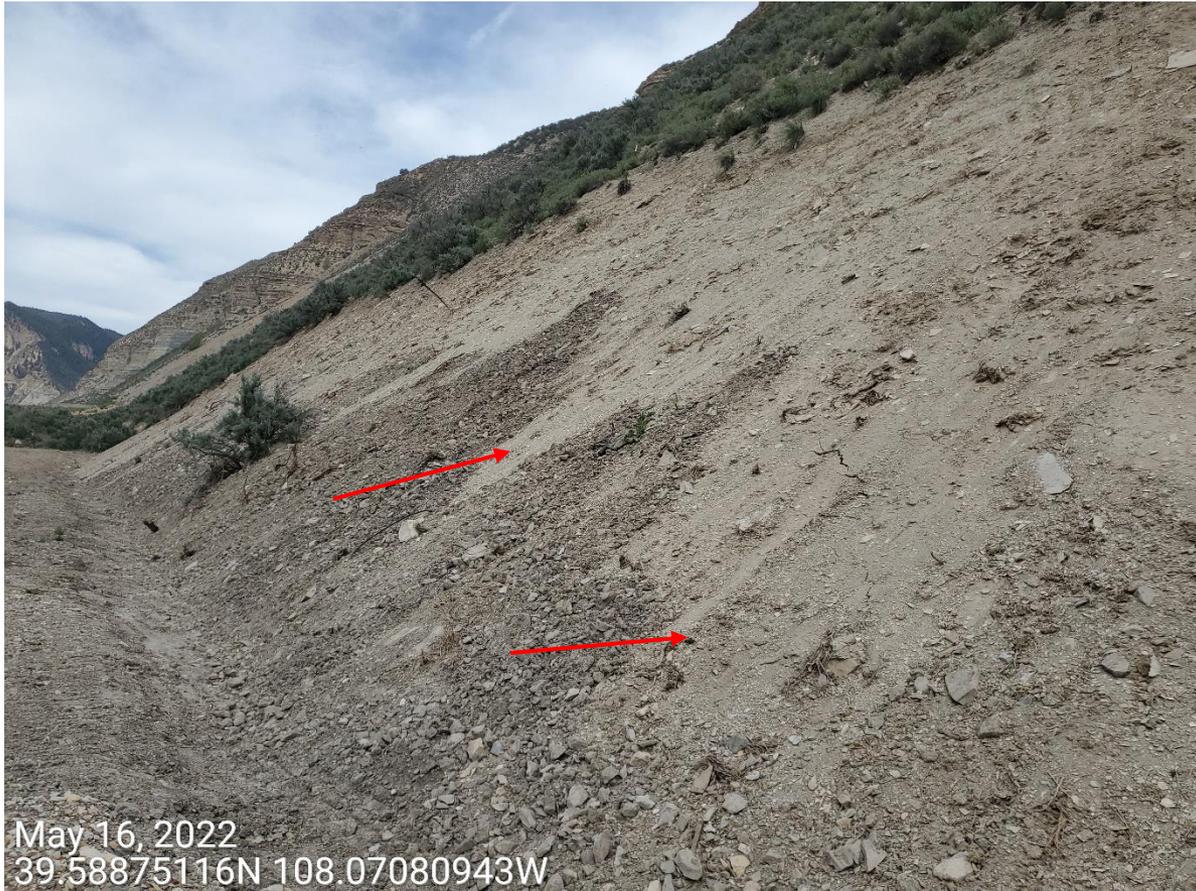
Photo 4: Photo taken from the disturbed slopes on the north end of the Location. Photo shows BMPs to minimize erosion , degradation and to stabilize the slopes have not been installed or maintained. Arrow shows example areas where additional erosion is apparent.

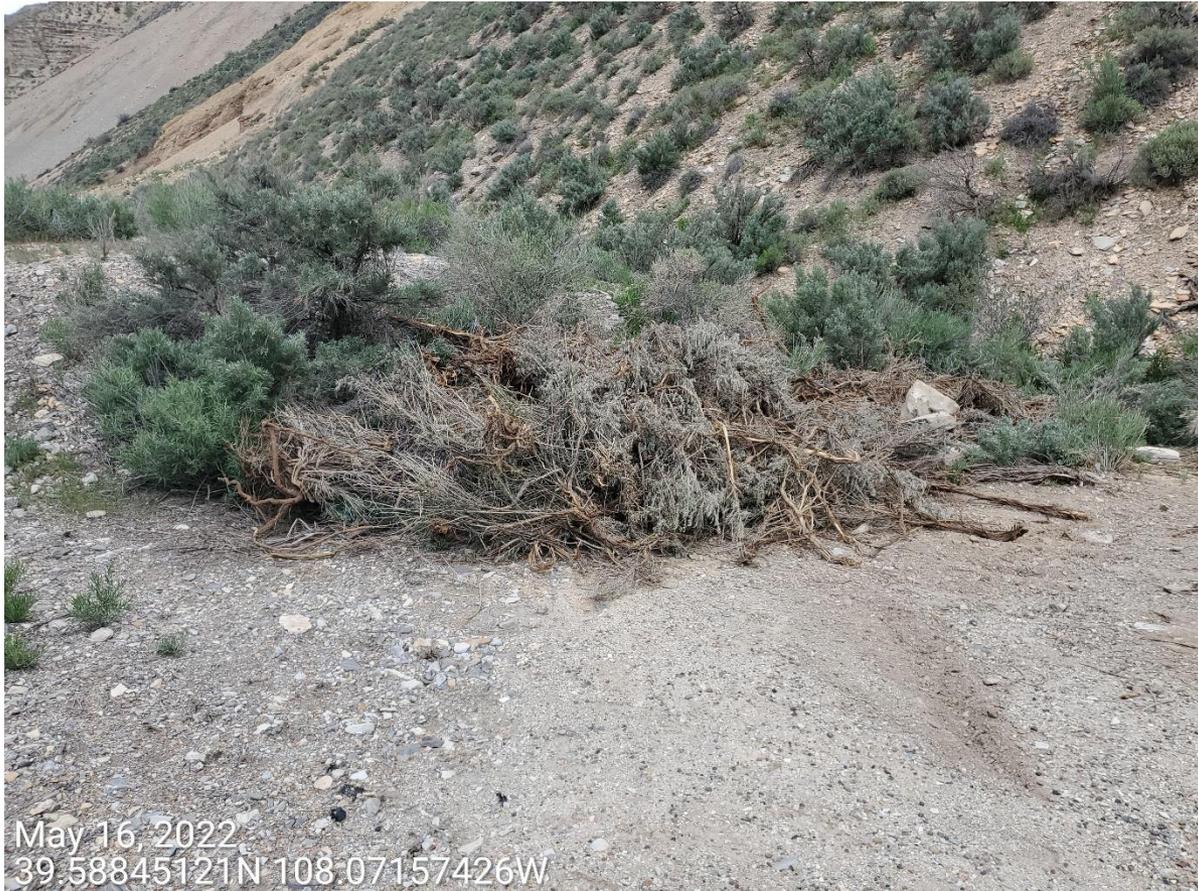
Photo 5: Operator appears to have removed shrub vegetation from areas on the north end of the Location, including the slopes. Vegetation has been piled on the west end of the Location, is considered debris and requires removal.
