Inspection Photos

5/16/2022

Operator: CAERUS PICEANCE LLC - 10456

Location ID: 458475

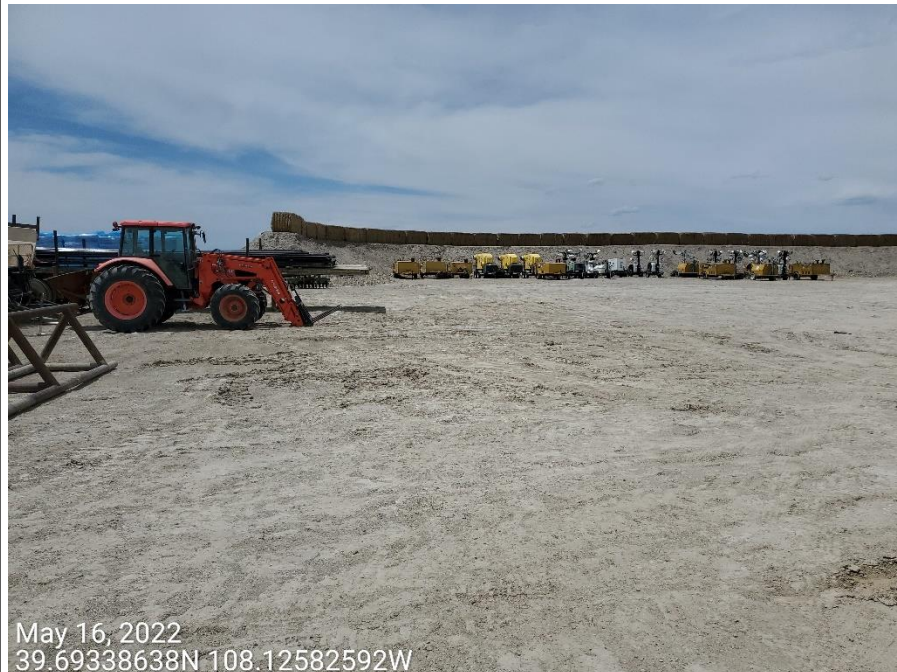
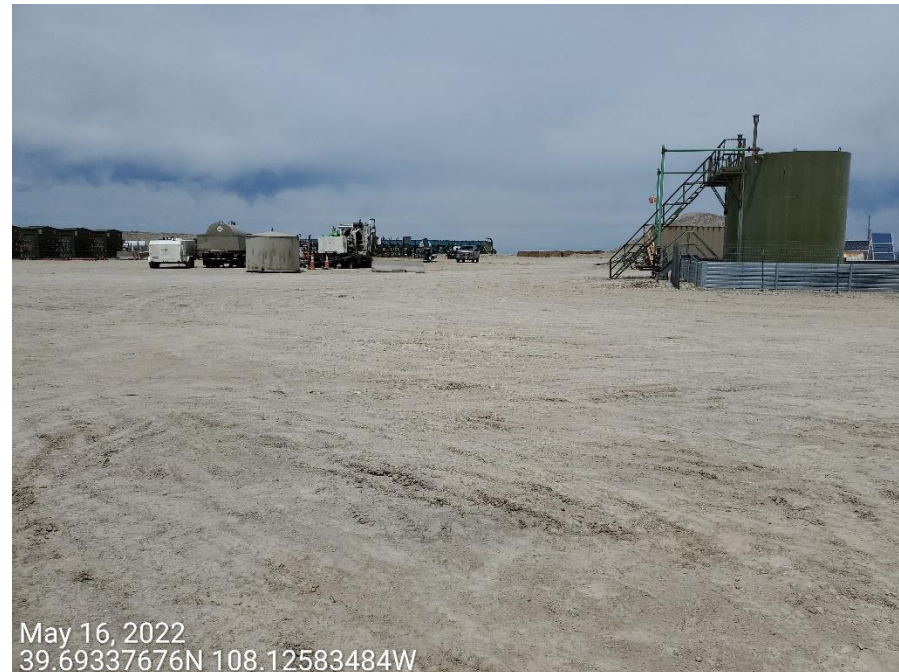
Photo 1: Photos taken from southwest end of the Location, facing west and north. Photos provide overview of the Location. Photos also show interim reclamation of the Location has not been conducted in accordance with 1003 rules; records show all wells on the location have either been plugged, or have been drilled and producing since 11/3/2020; pursuant to Rule 1003.b, interim reclamation required by 5/3/2021.

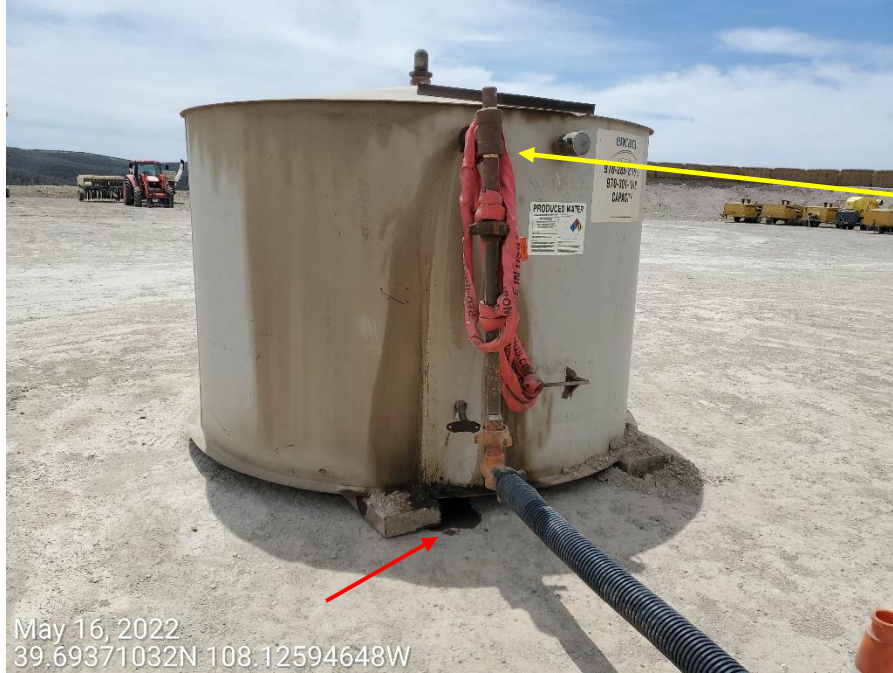
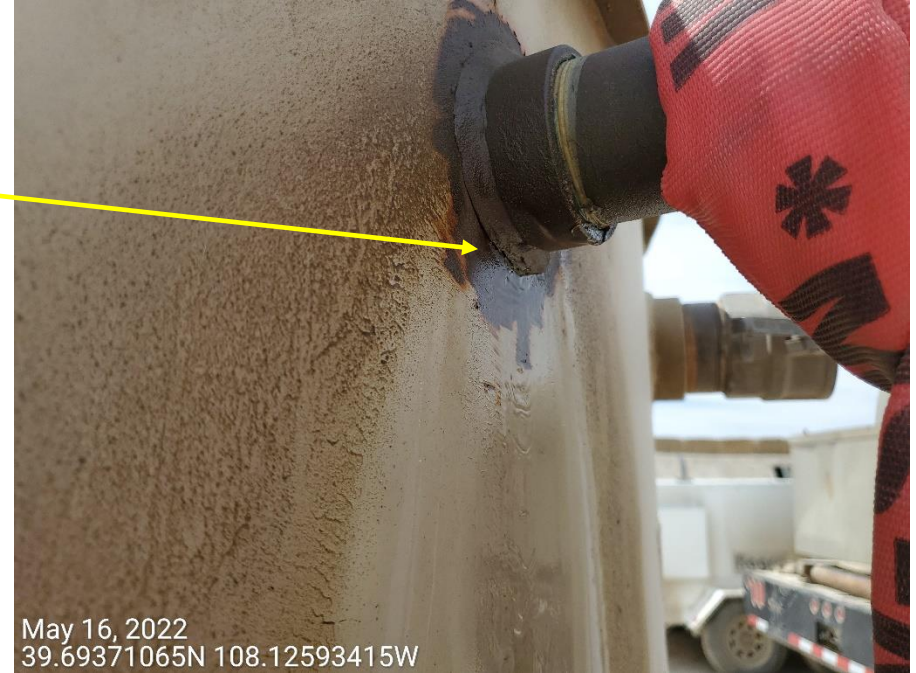
Photo 2: Fluids observed spilling from connection point of the line and tank (yellow arrow) onto the working pad surface. Stained soils also evident beneath the tank. (red arrow).

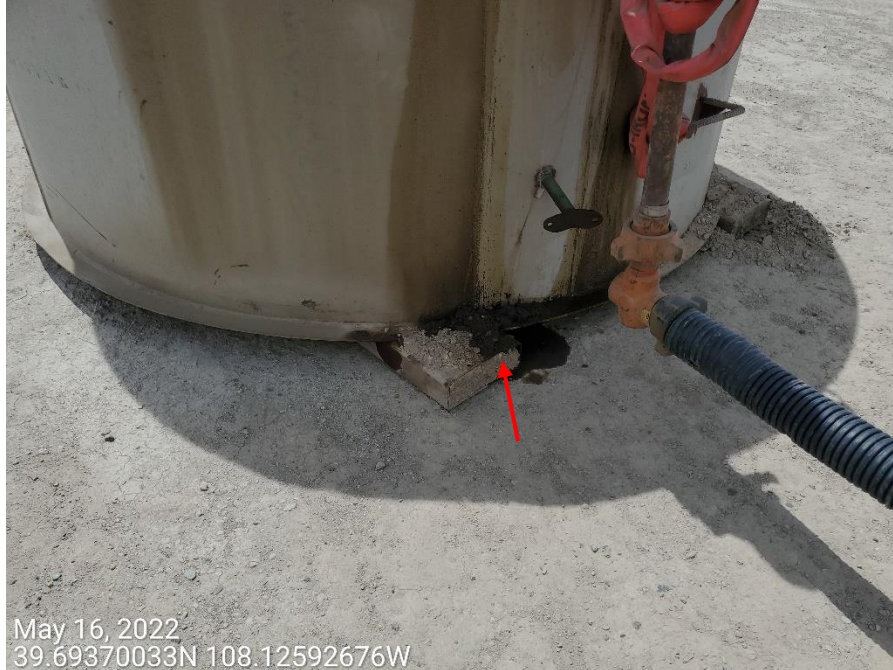
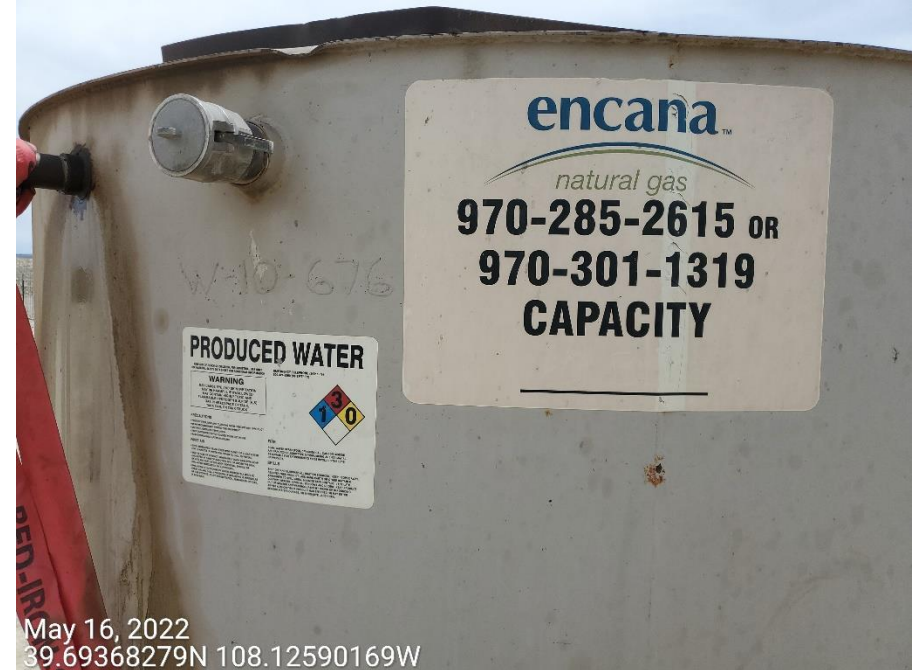
Photo 3: Continued from photo 2. Photo left shows stained soils beneath tank. Photo right show incorrect Operator information and missing capacity labeling.

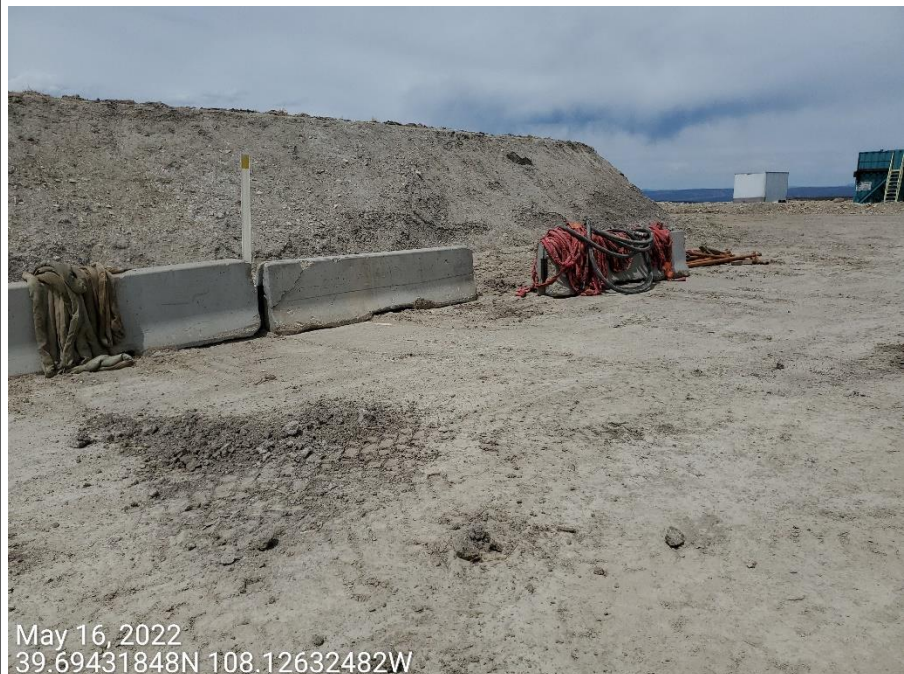
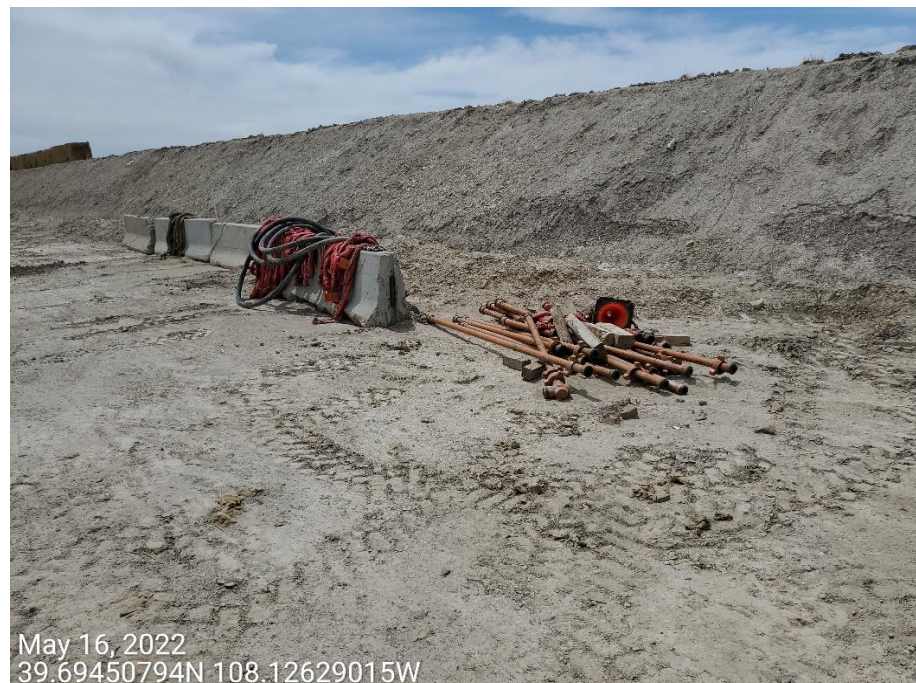
Photo 4: Photos 4-7 taken throughout the Location. Photos show examples of various trash, debris and unused equipment stored on the Location. Photos also provide examples showing interim reclamation of the Location has not been completed in accordance with 1003 rules.

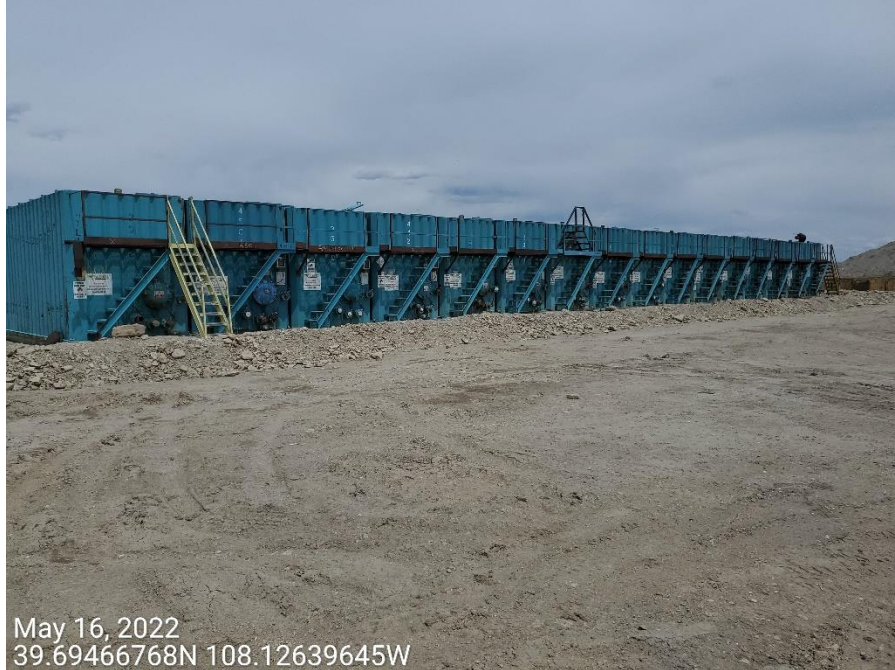
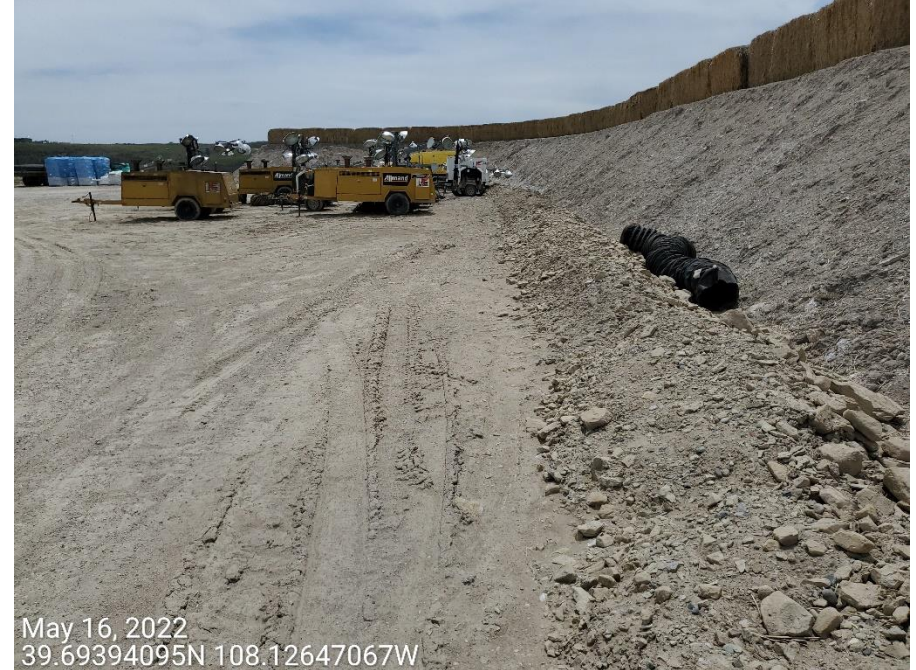
Photo 5: See comments under photo 4.

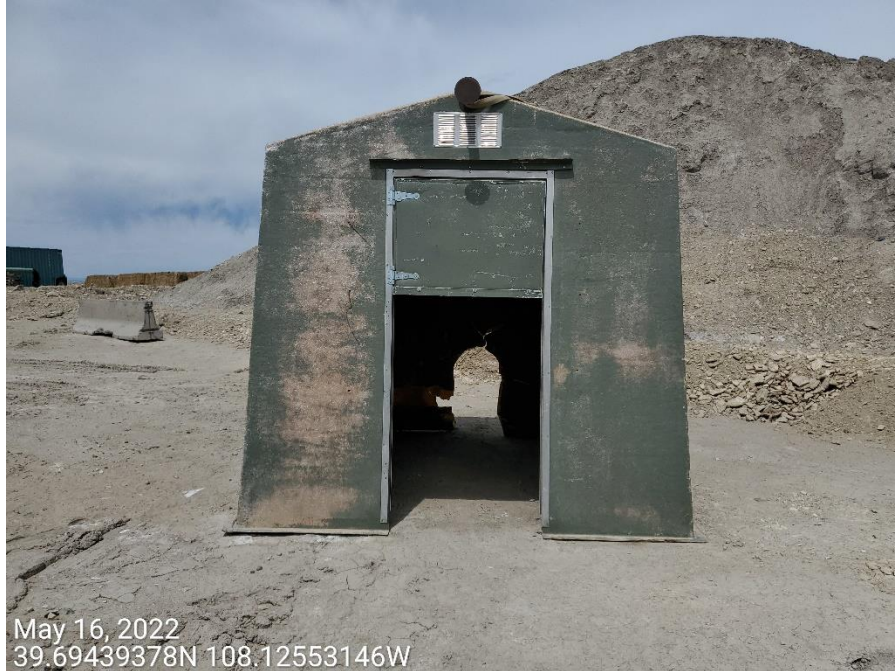
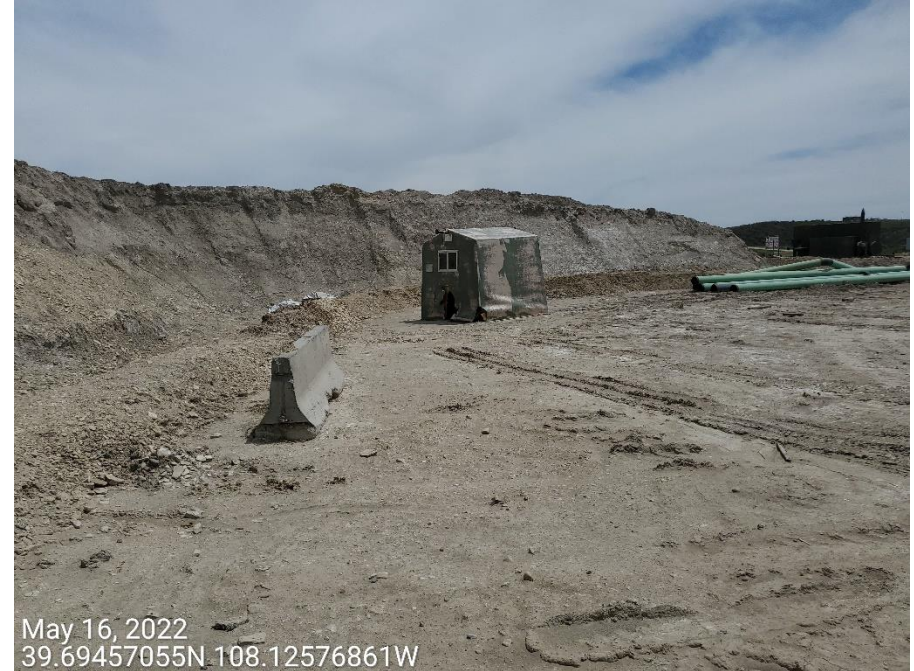
Photo 6: See comments under photo 4.

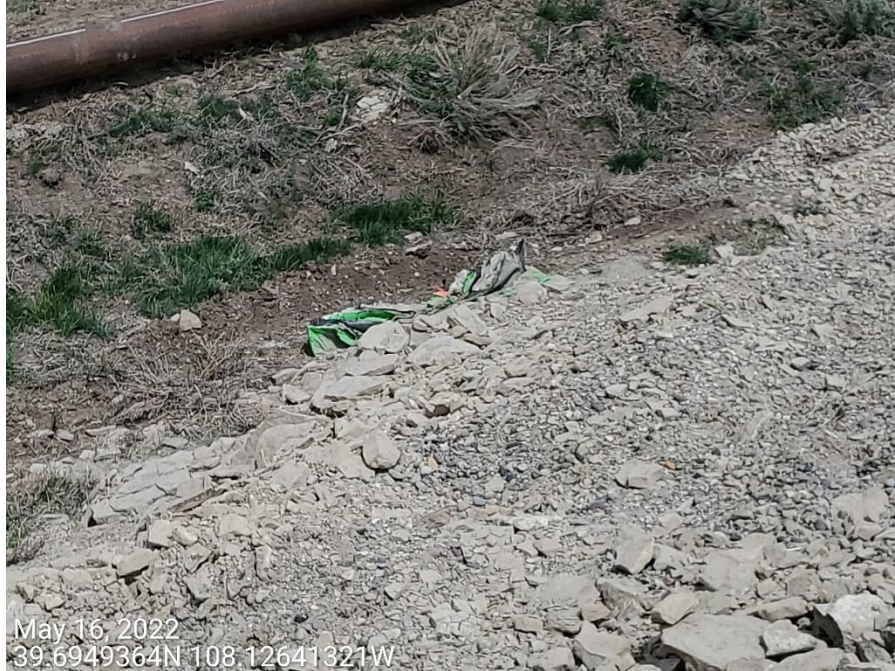
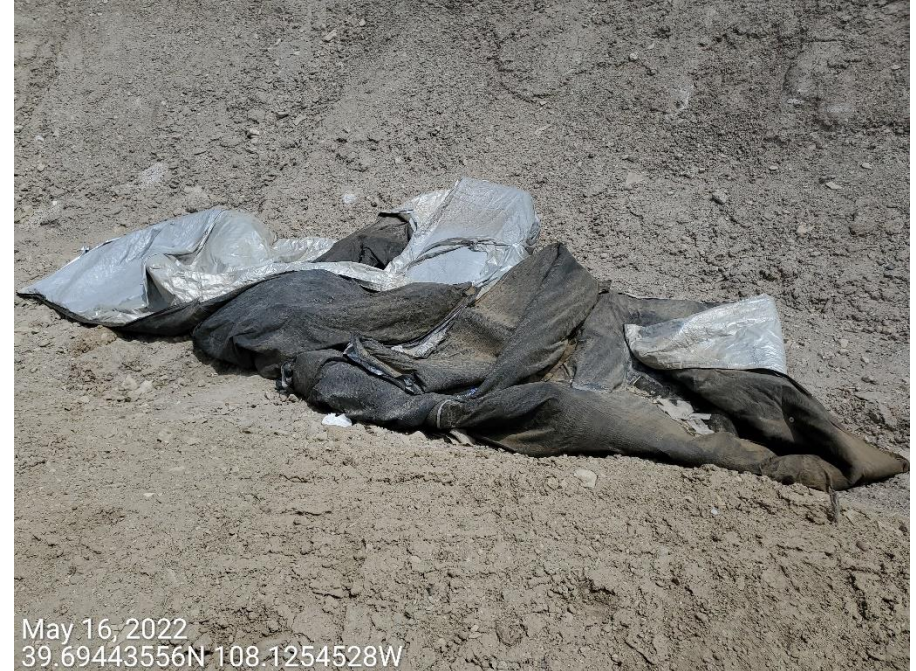
Photo 7: See comments under photo 4.

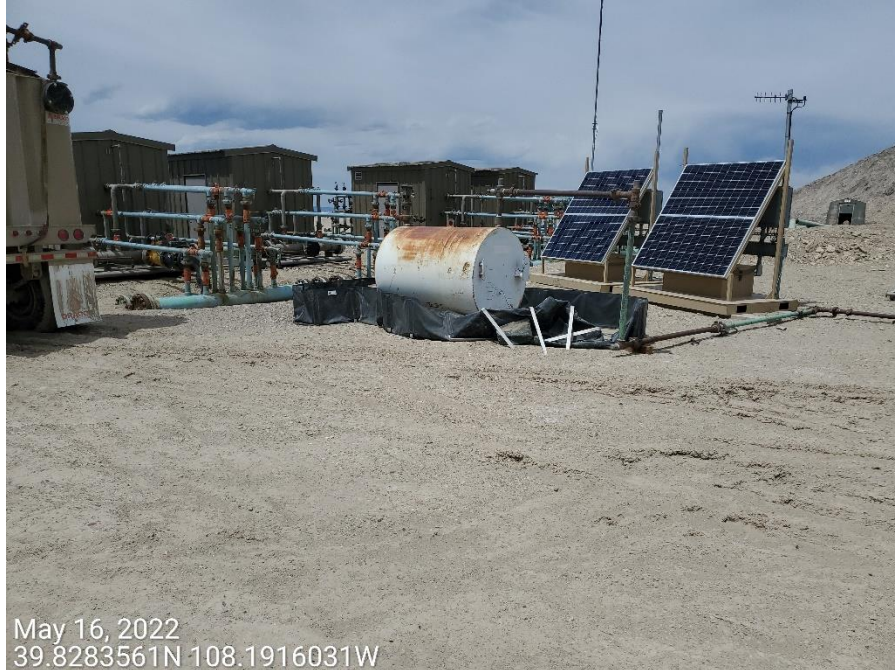
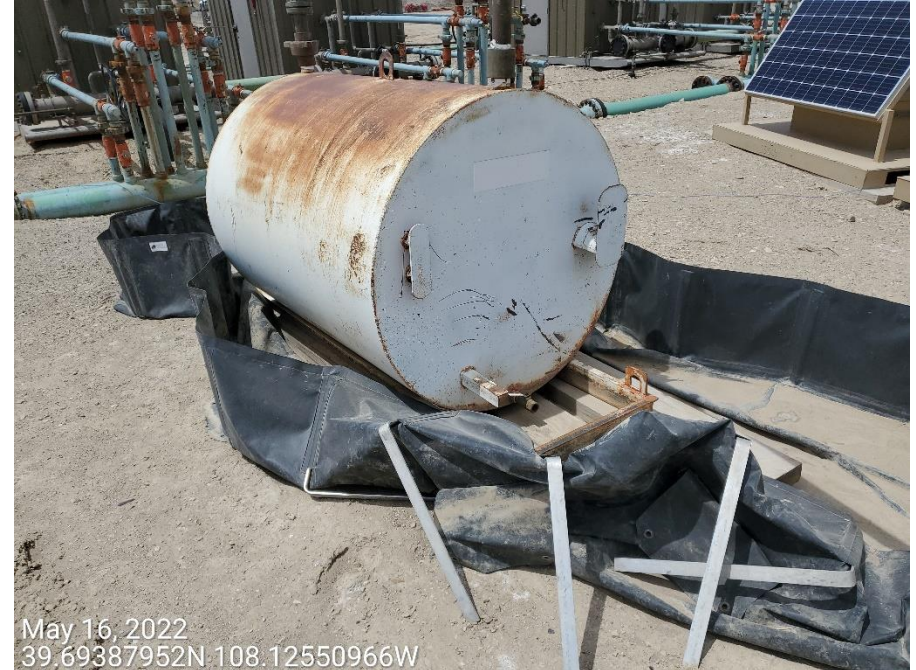
Photo 8: Photo shows tank next to the Location entrance, on the east end of the Location. Photo show containment BMP has not been maintained in proper functioning condition.

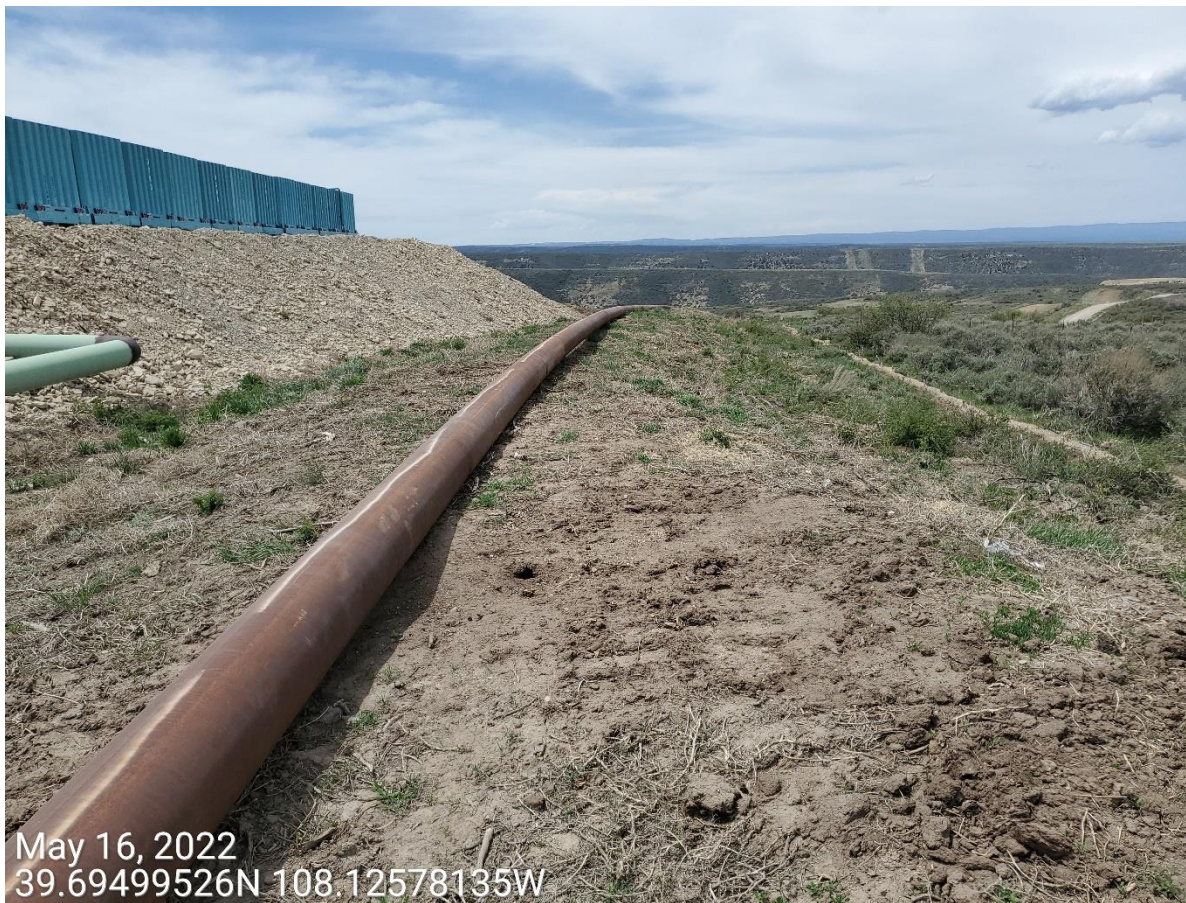
Photo 9: Photo taken from the topsoil stockpile on the north end of the Location. Photo shows Operator has constructed a pipeline that runs on the east, and north end of the Location; pipeline has been constructed directly upon the topsoil stockpiles along the perimeter of the Location. This does not appear to be protective of soils per with Rule 1002.c. Additionally, soils are exposed and at risk to erosion.
