Inspection Photos

Operator: Argali Exploration Company - #3975

Location Name: N.E. Craig State-68N90W /27SENE

Inspection Document #: 702800219

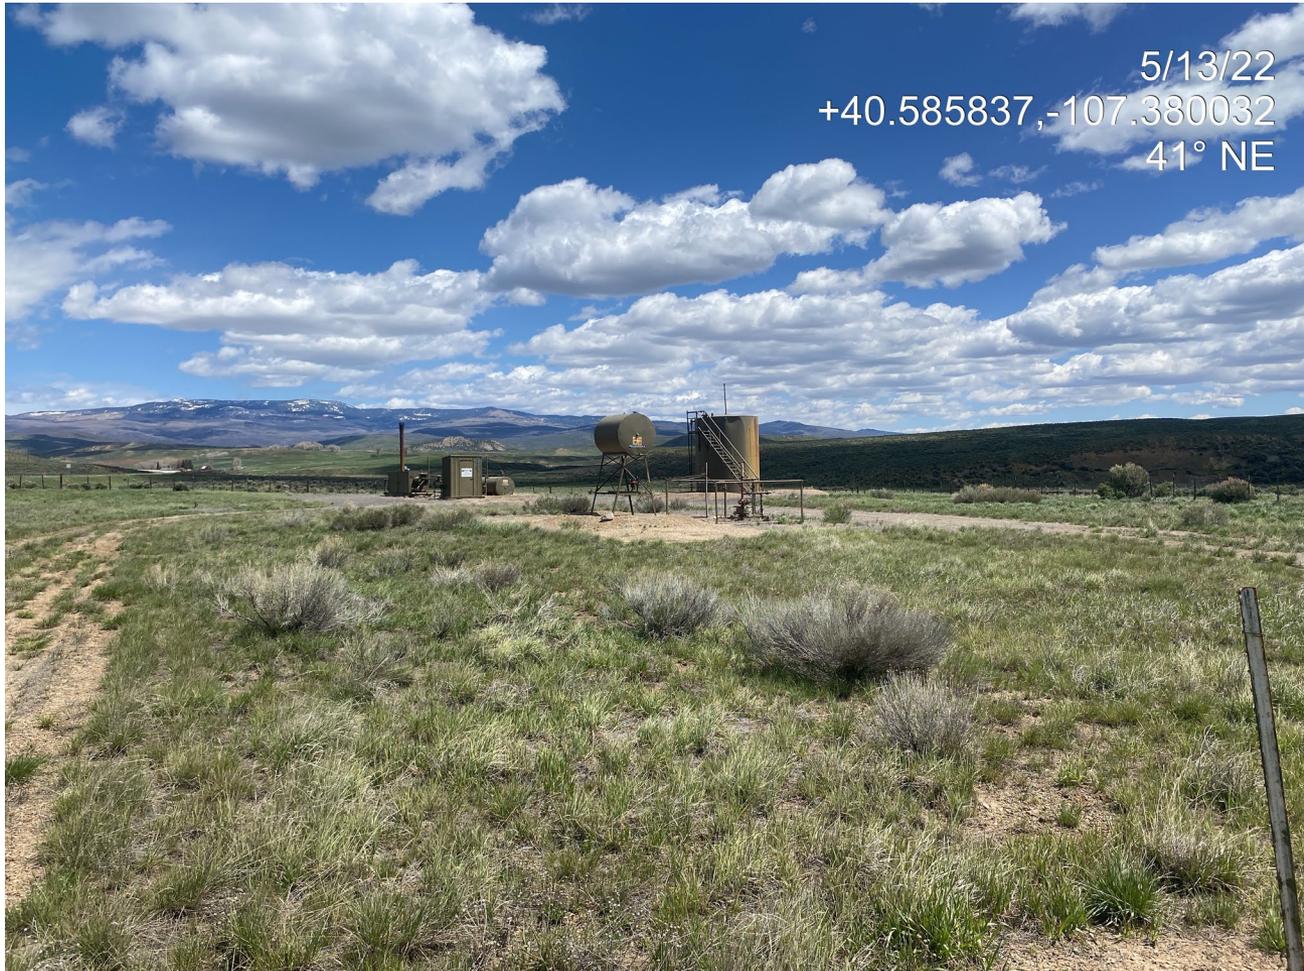
Photo 1. Photo taken from the south of the Location shows an overview of the Location. Photo also shows southern interim areas of the Location are dominated by perennial grasses. Note, GPS coordinates are incorrect due to phone GPS malfunction.

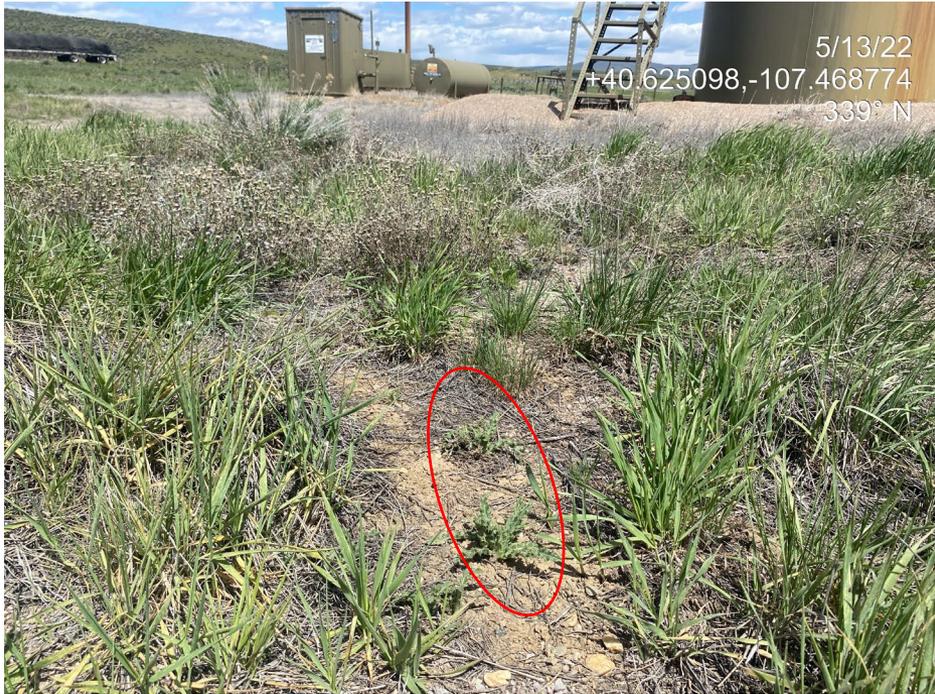
Photo 2. Photo taken from the interim area at the center of the Location shows the area is dominated by perennial grasses. Photo also shows Canada thistle, a CO List B Noxious weed.

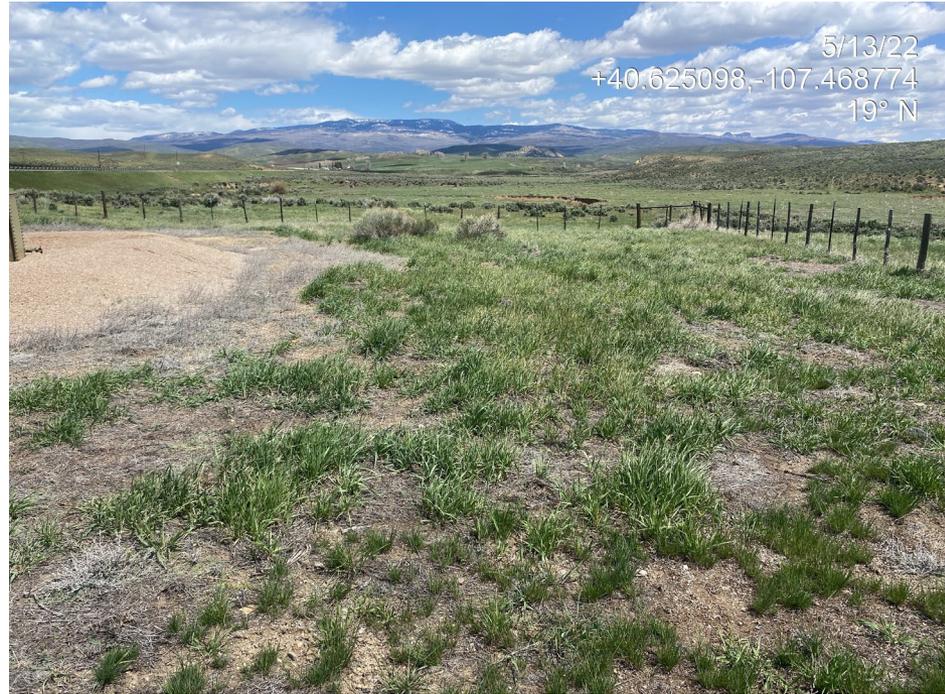
Photo 3. Photo taken from the northeast of the Location shows interim areas dominated by perennial grasses.

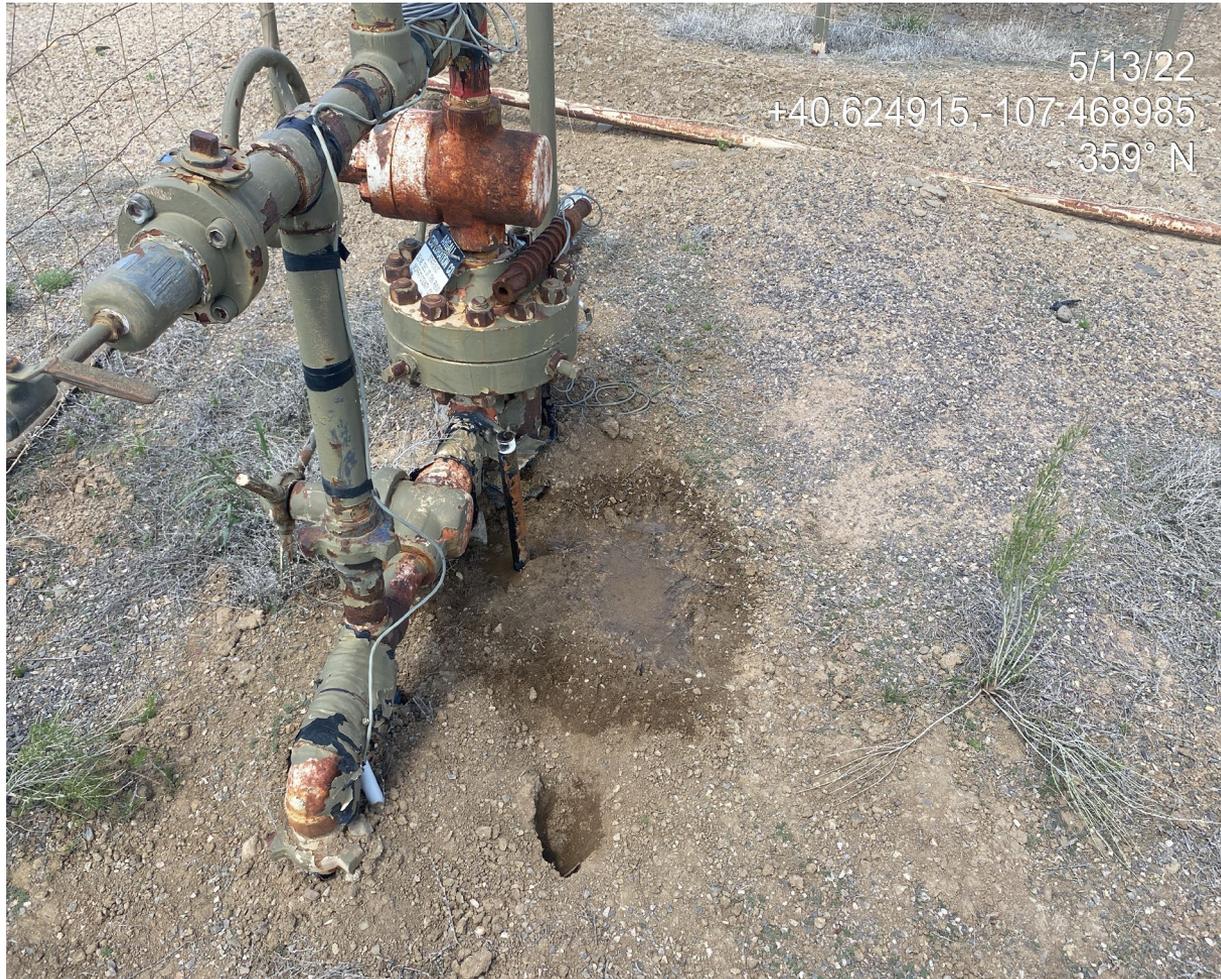
Photo 4. Photo taken from the wellhead shows water and gas bubbling up through a pipe.
