# Inspection Photos

Operator: Beeman Oil & Gas LLC - #7125

Location Name: Simoes /22-30

Inspection Document #: 702800238

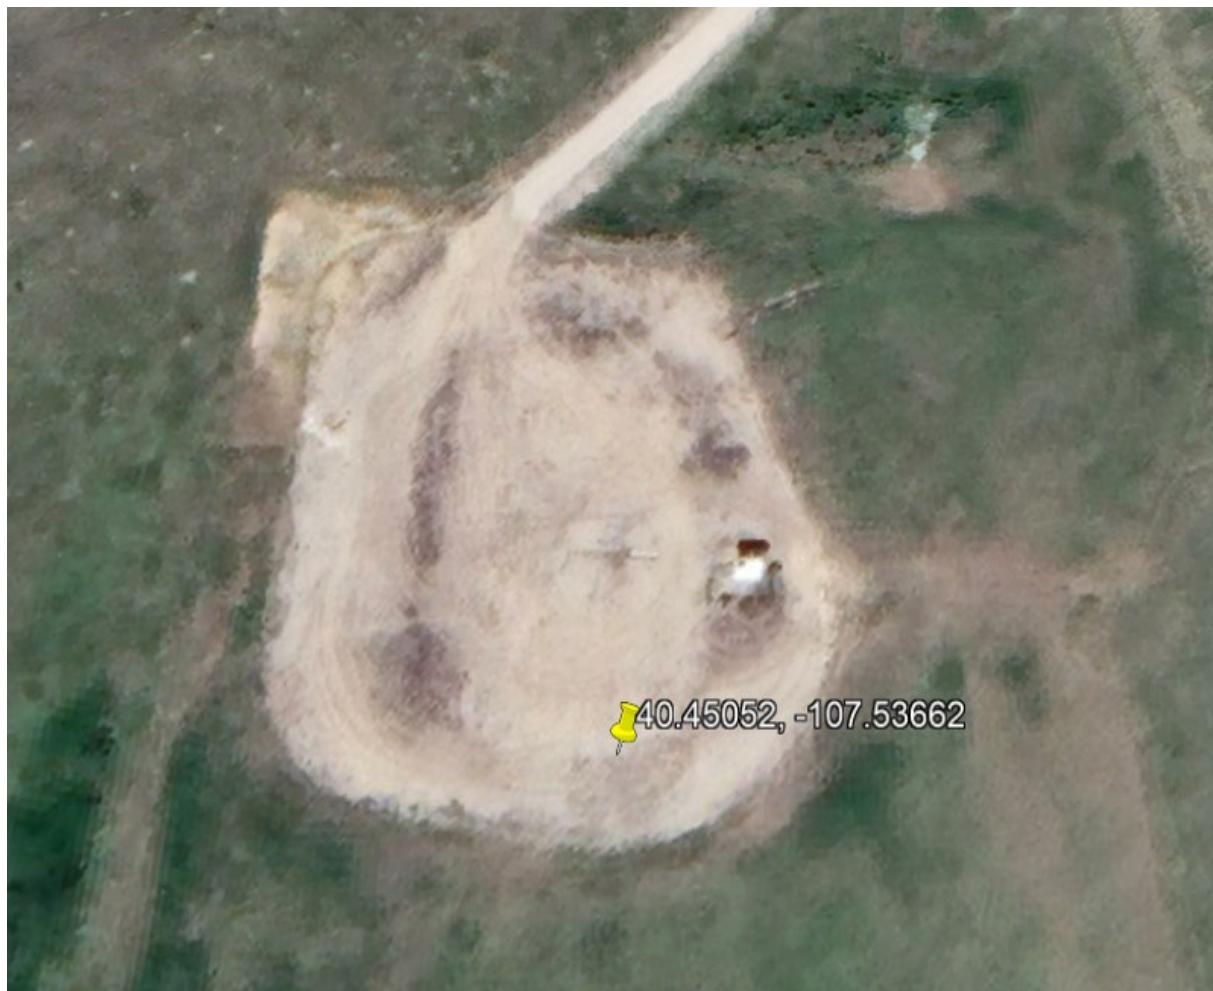
**Photo 3.** Map shows the Location of a ground nesting bird at the southern edge of the production pad. Implementing BMPs to avoid disturbing the nest advised.

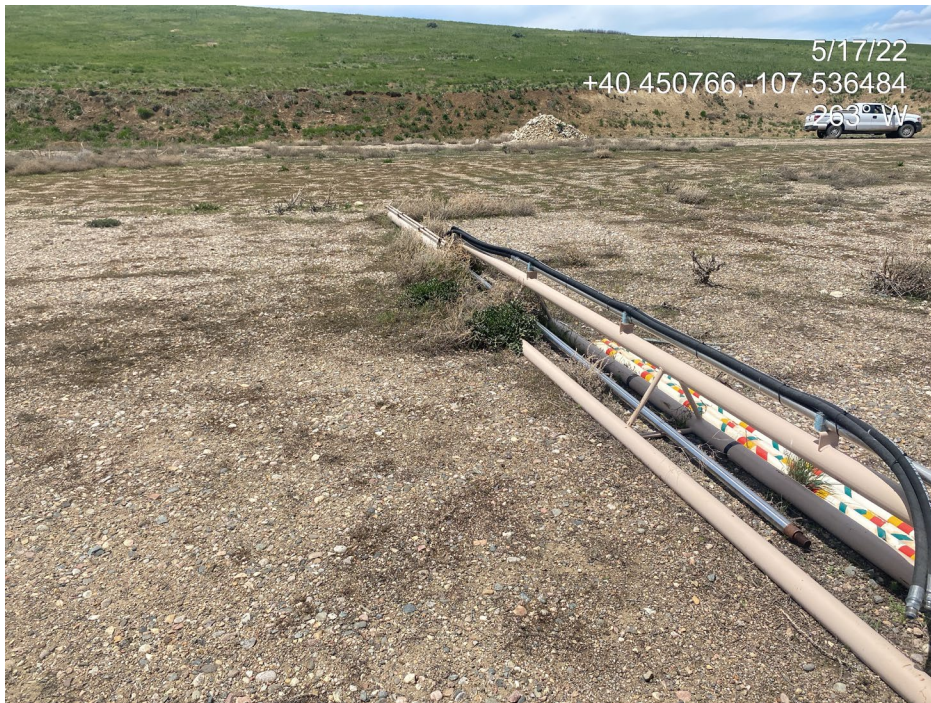
**Photo 4.** Photo taken from the center of the Location shows storage of unused equipment.

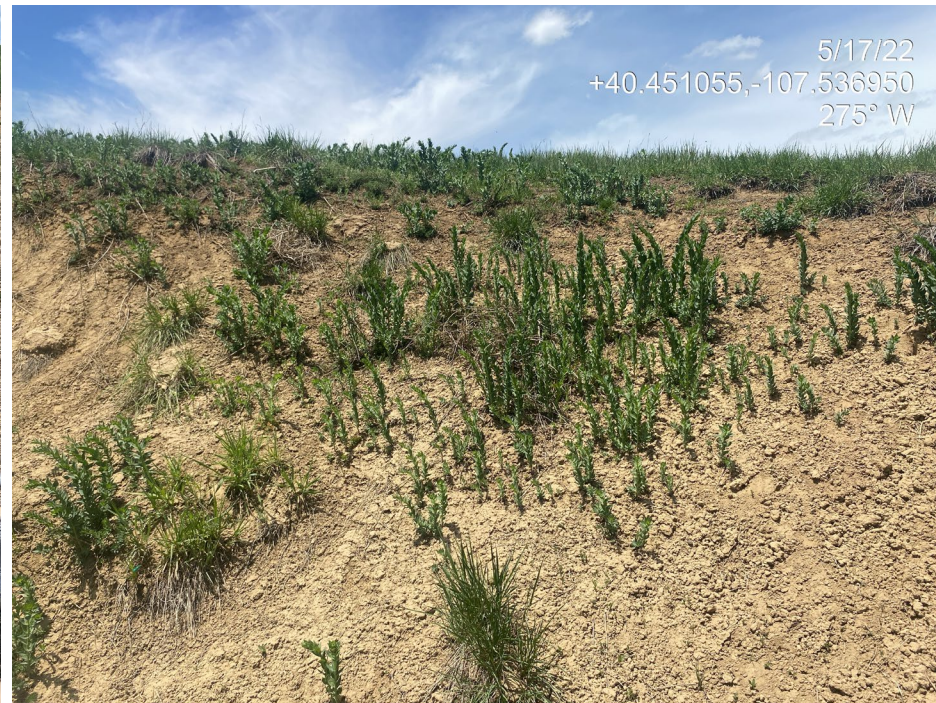
**Photo 5.** Photo taken from the cut slope at the northwest of the Location shows Dalmatian toadflax, a CO List B Noxious Weed.

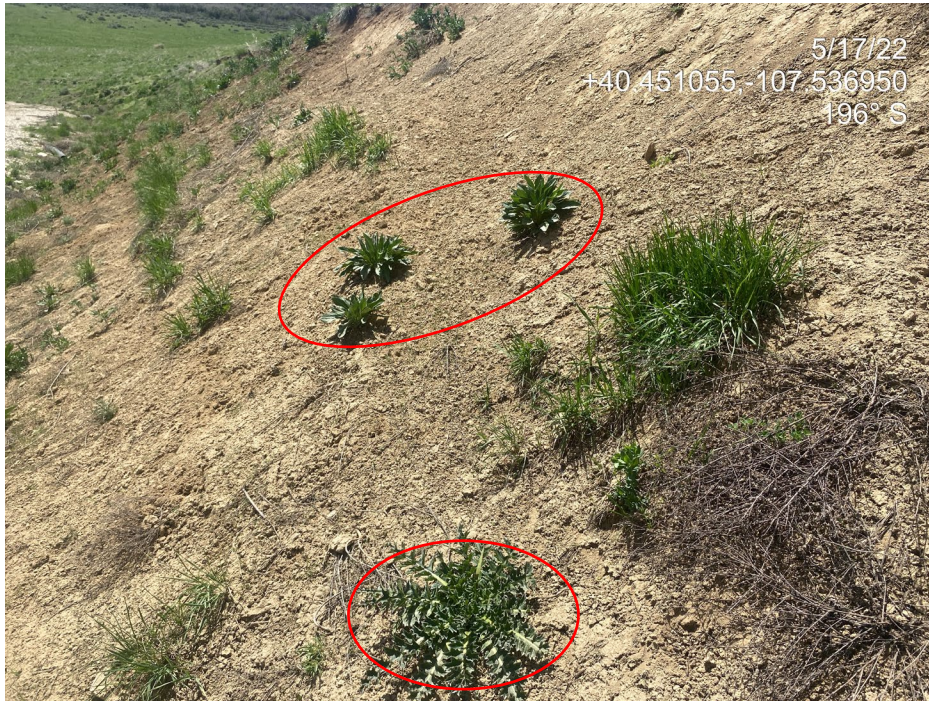
**Photo 6.** Photo taken from the cut slope at the west of the Location shows musk thistle and houndstongue, both CO List B Noxious Weeds.

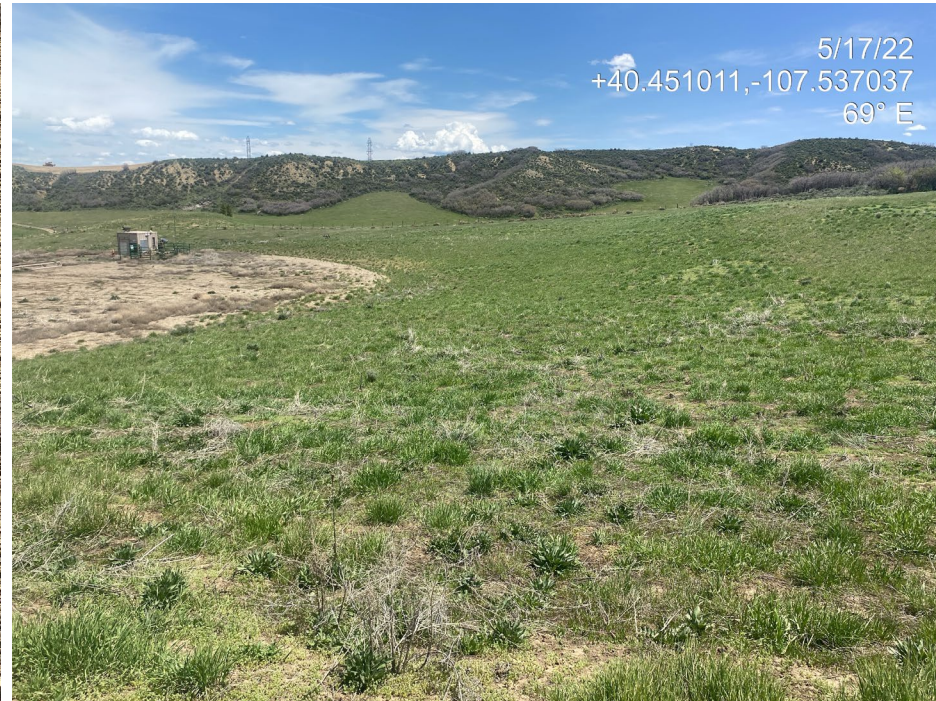
**Photo 7.** Photo taken from the southwest of the Location in the interim area shows an area of poor perennial grass establishment with annual undesirable plant species/weeds and noxious weeds. The forb throughout the foreground is houndstongue.

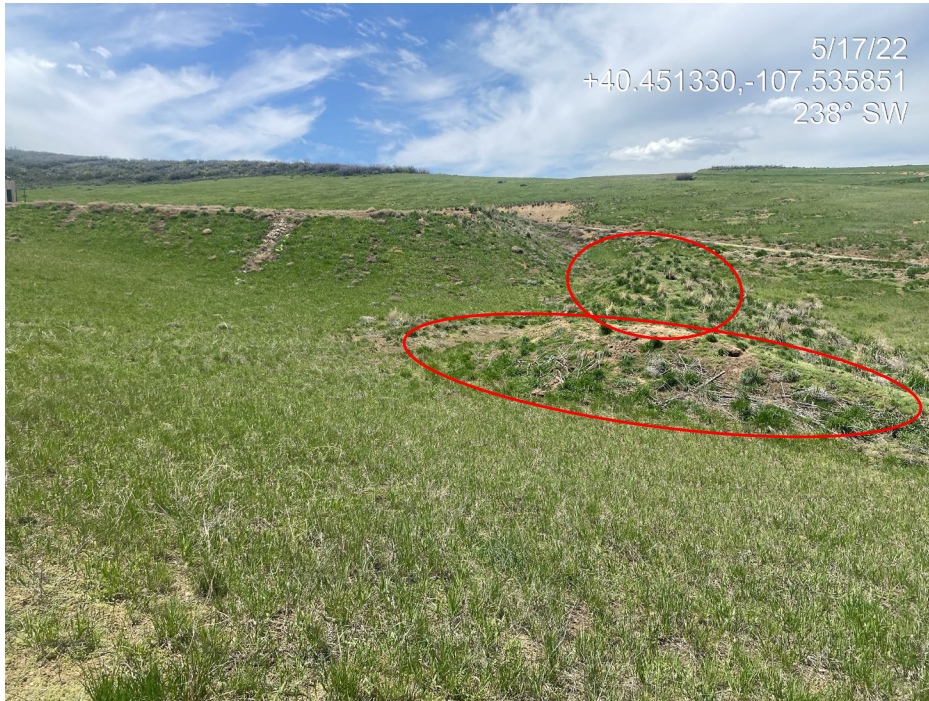
**Photo 8.** Photo taken from the northeast of the Location shows interim areas dominated by perennial grasses. Photo also shows berms with poor perennial grass establishment and greater density of annual undesirable plant species/weeds and noxious weeds.

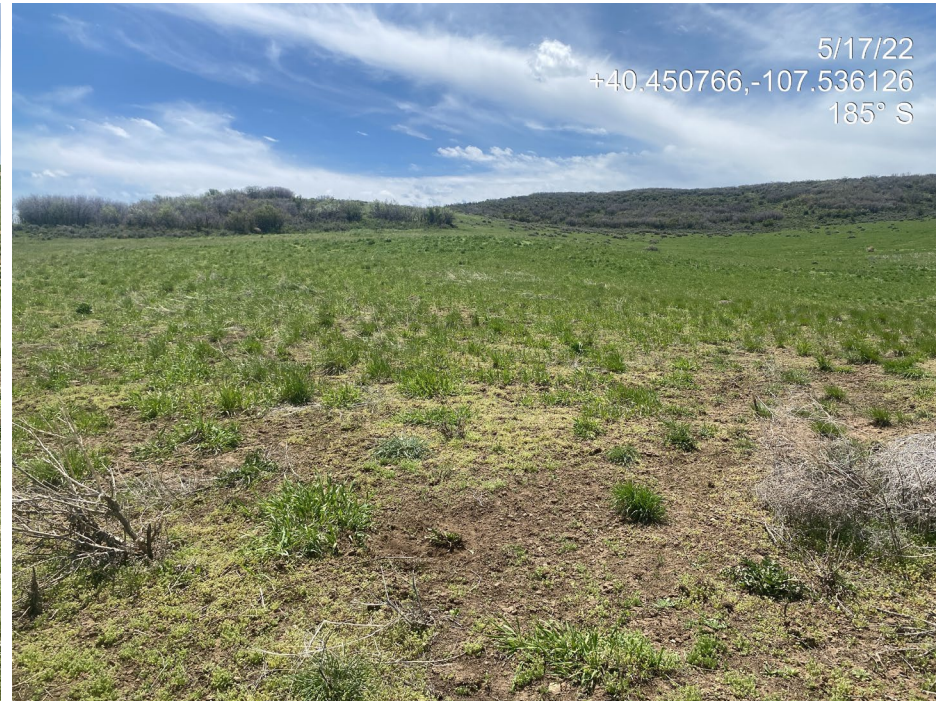
**Photo 9.** Photo taken from the east of the Location in the interim area shows interim areas in the middleground dominated by perennial grasses. The foreground shows areas of poor perennial grass establishment and greater density of annual undesirable plant species/weeds and noxious weeds.

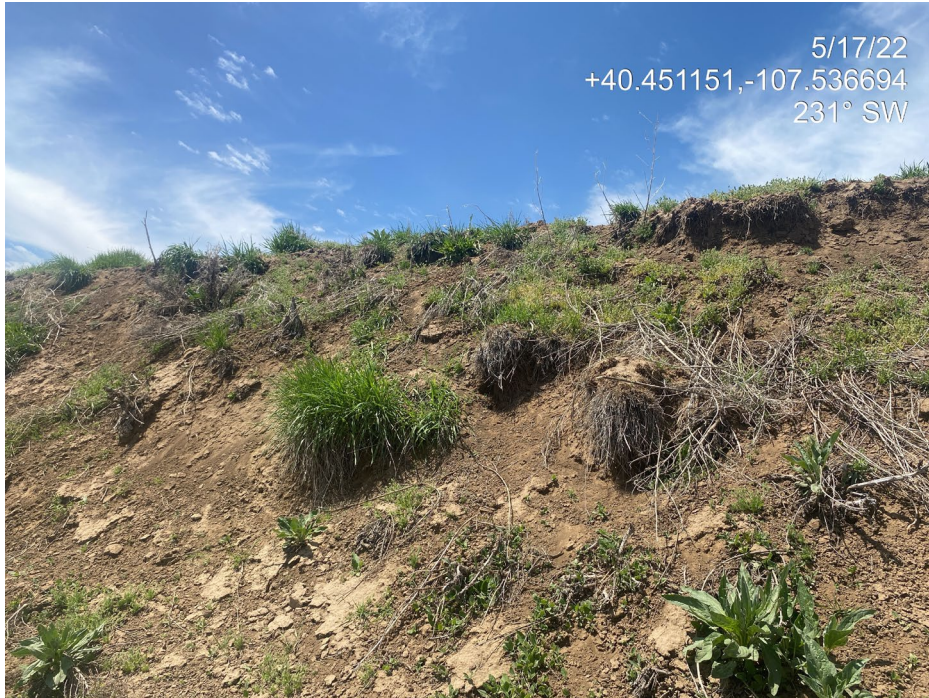
**Photo 10.** Photo taken from the cut slope to the west of the Location shows erosion. Pedestals are forming on the slope and undercutting and lateral erosion is resulting in exposed roots and vegetation and soil loss from the area above/to the west of the cut. Photo also shows noxious weeds.

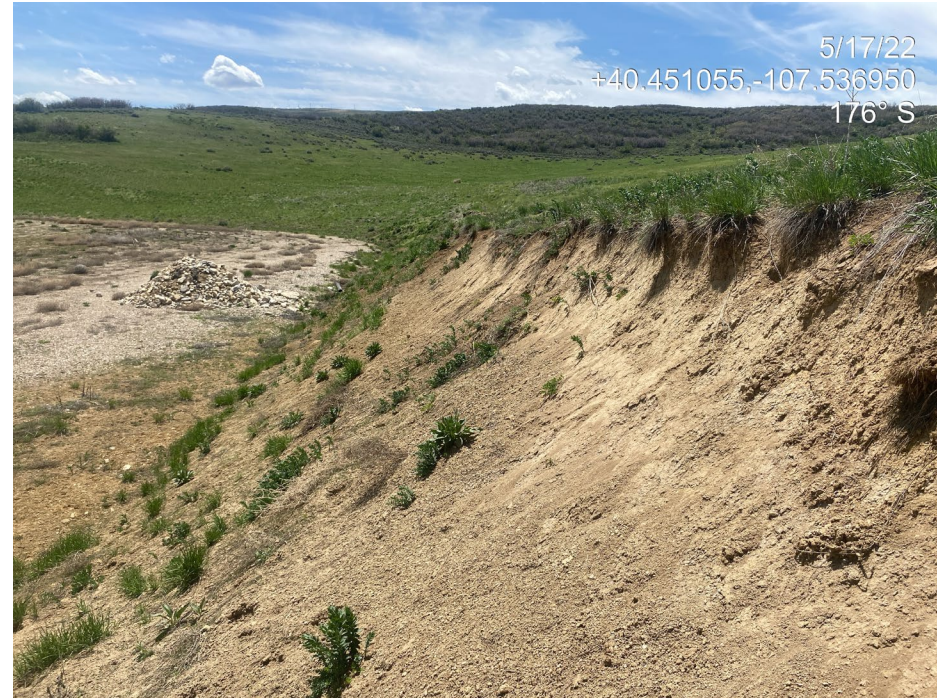
**Photo 11.** Refer to Photo 10 comment.
