# Inspection Photos

Operator: SWN Production Company LLC - #10396

Location Name: Stoddard /CTB

Inspection Document #: 702800240

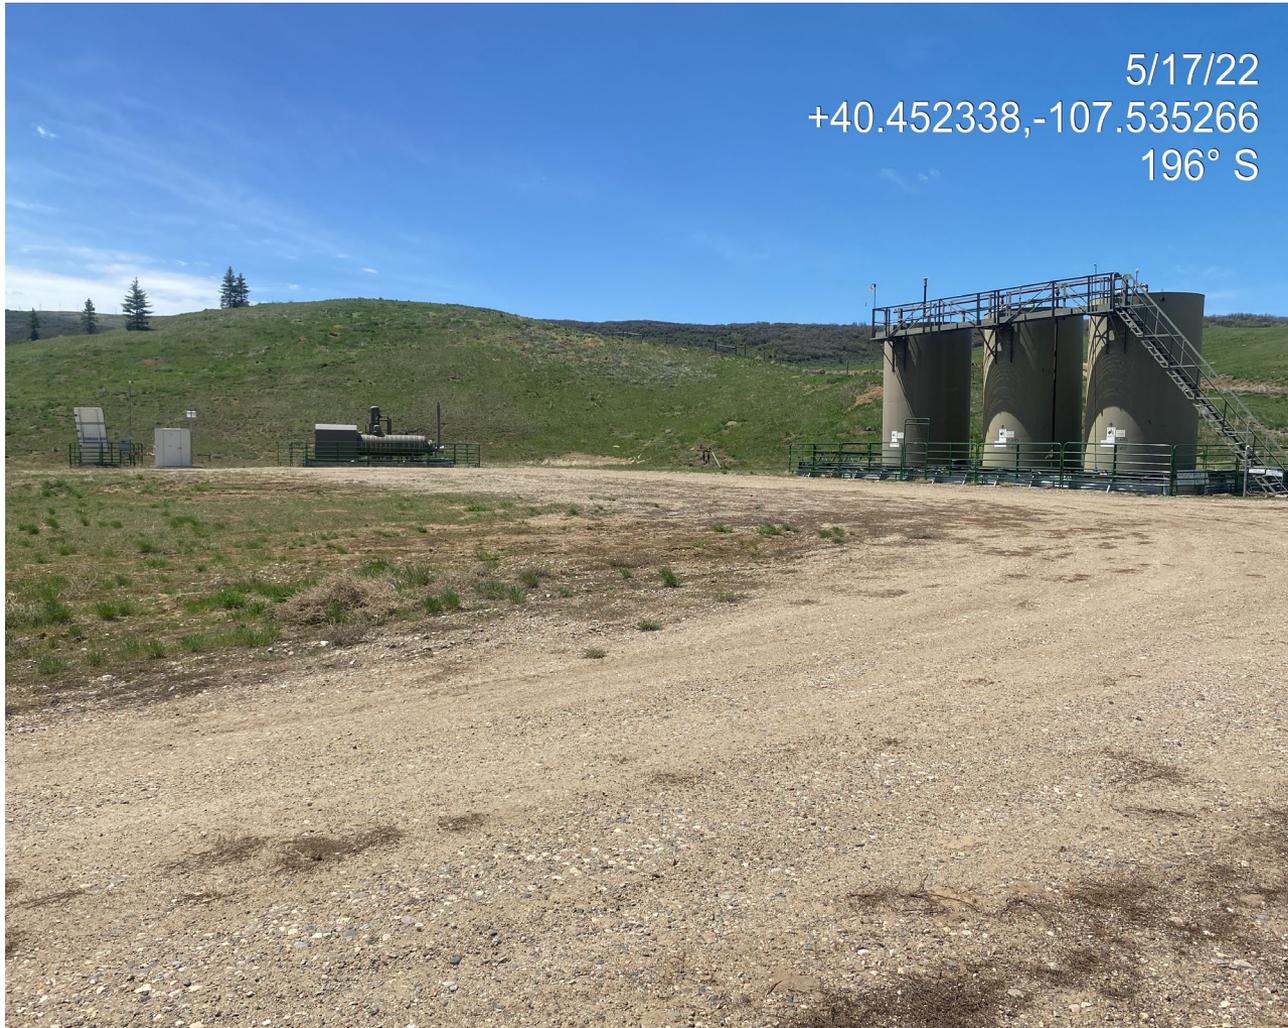
**Photo 1.** Photo taken from the north shows an overview of the Location.

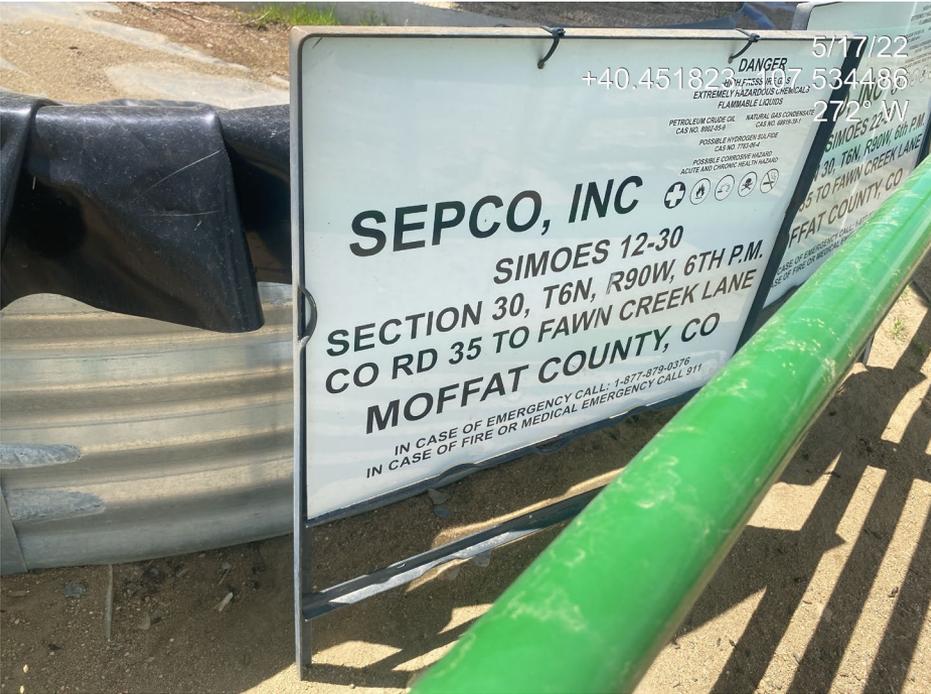
**Photo 2.** Photo taken from the tank battery shows signage with incorrect Operator information.

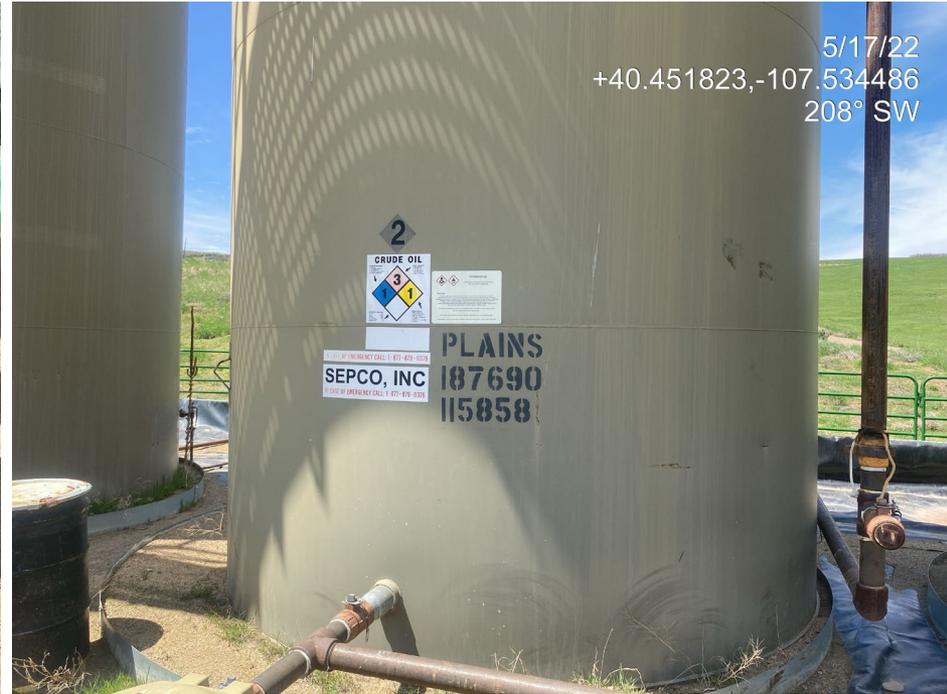
**Photo 3.** Photo taken from the tank battery shows signage with incorrect Operator information on tanks.

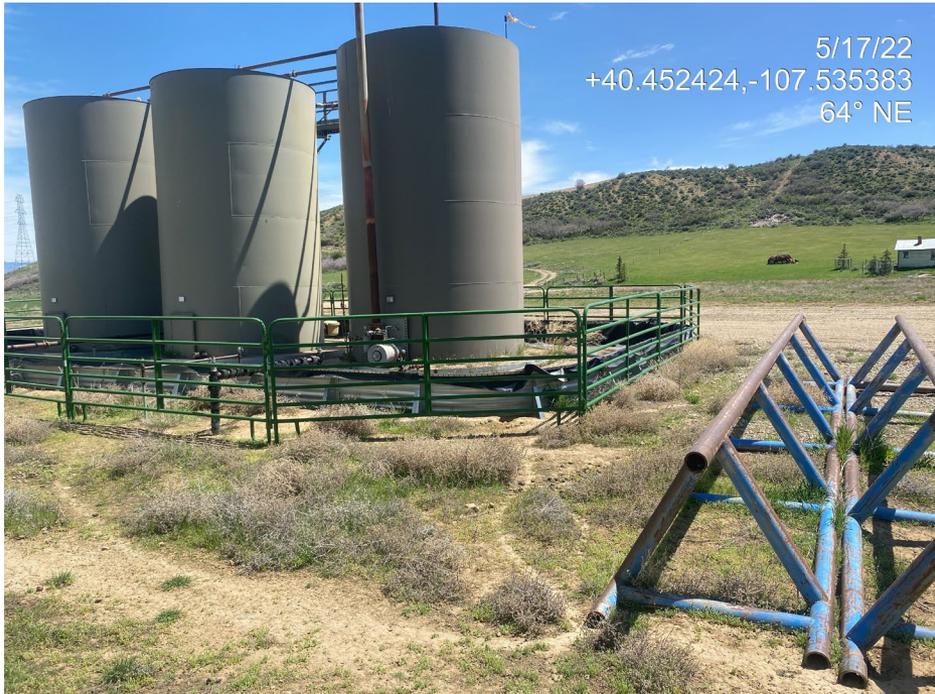
**Photo 4.** Photo taken from the west of the Location shows weed debris accumulating around equipment. Photo also shows storage of unnecessary equipment (pipe racks).

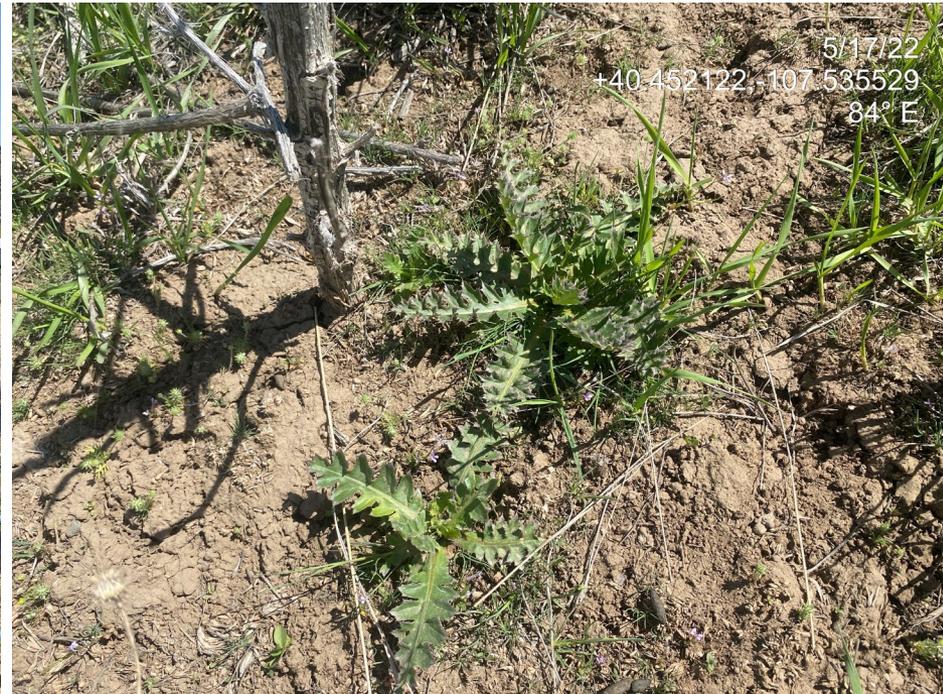
**Photo 5.** Photo taken from the interim area to the south of the Location shows musk thistle, a CO List B Noxious Weed.

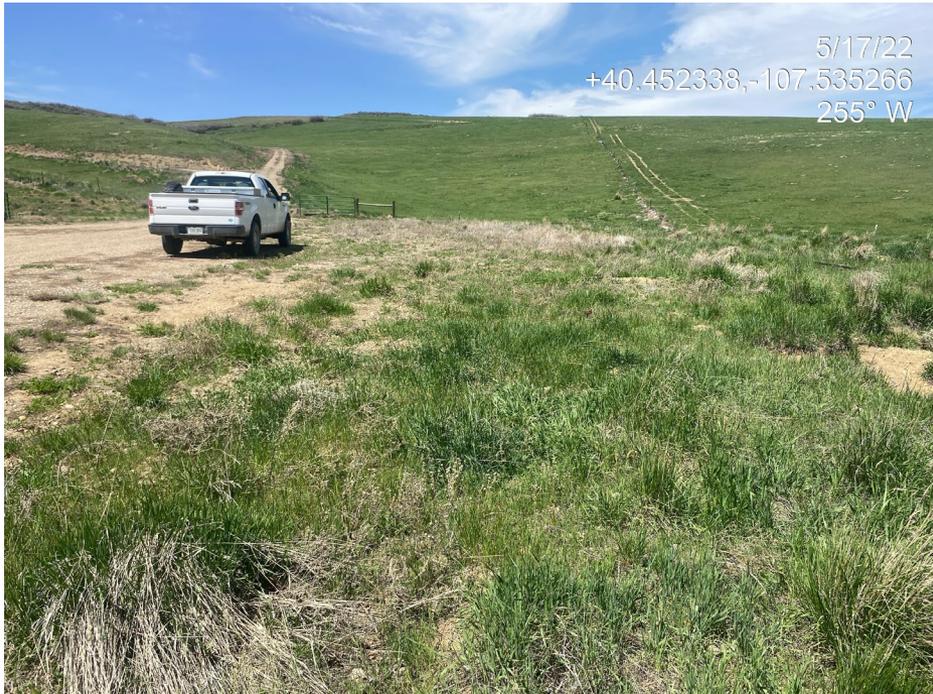
**Photo 6.** Photo taken from the north of the Location shows the interim area dominated by perennial grasses.

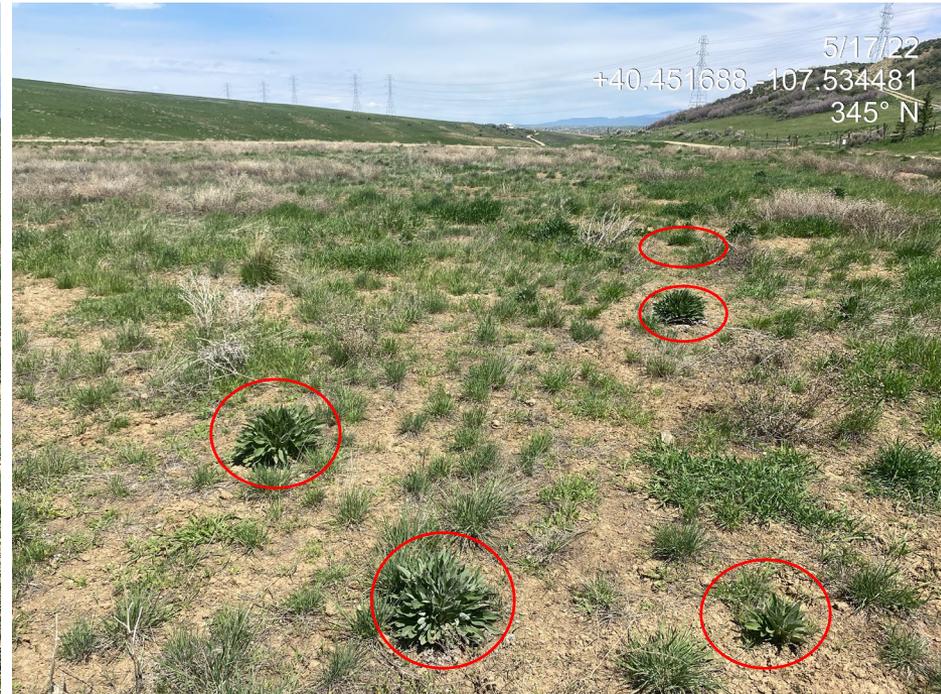
**Photo 7.** Photo taken from the east of the Location shows the interim area dominated by perennial grasses. Areas of poor perennial grass colonization are vegetated with annual undesirable plant species/weeds and noxious weeds. Red circles indicate the noxious weed houndstongue.

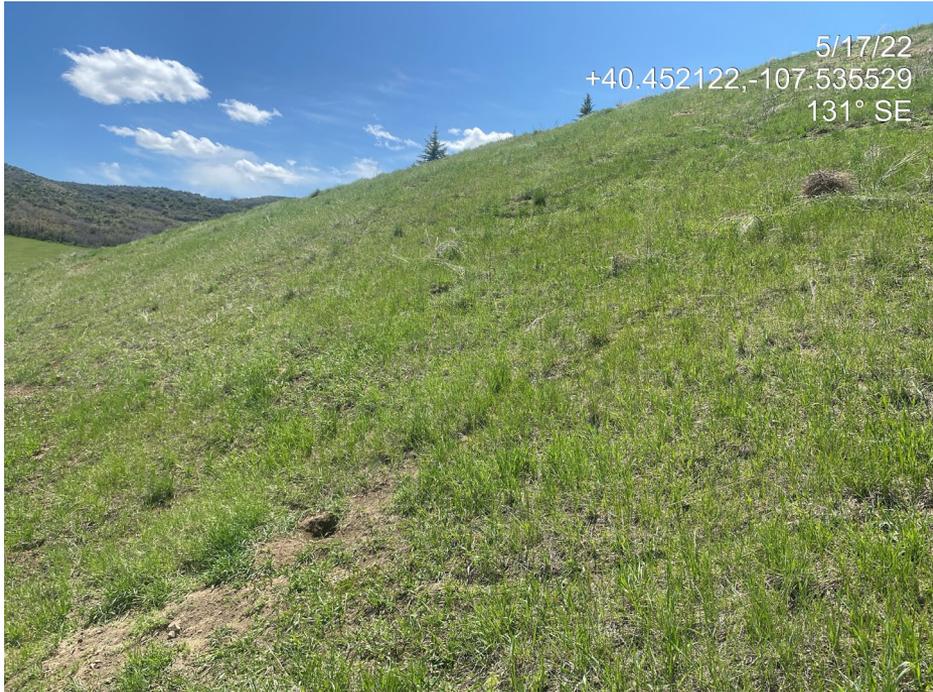
**Photo 8.** Photo taken from the cut at the south of the Location shows the slope well vegetated and stabilized by perennial grasses.
