# Inspection Photos

Location Name: Simoes /12-30

Inspection Document #: 702800242

Anna O'Malley  
Reclamation Specialist, COGCC

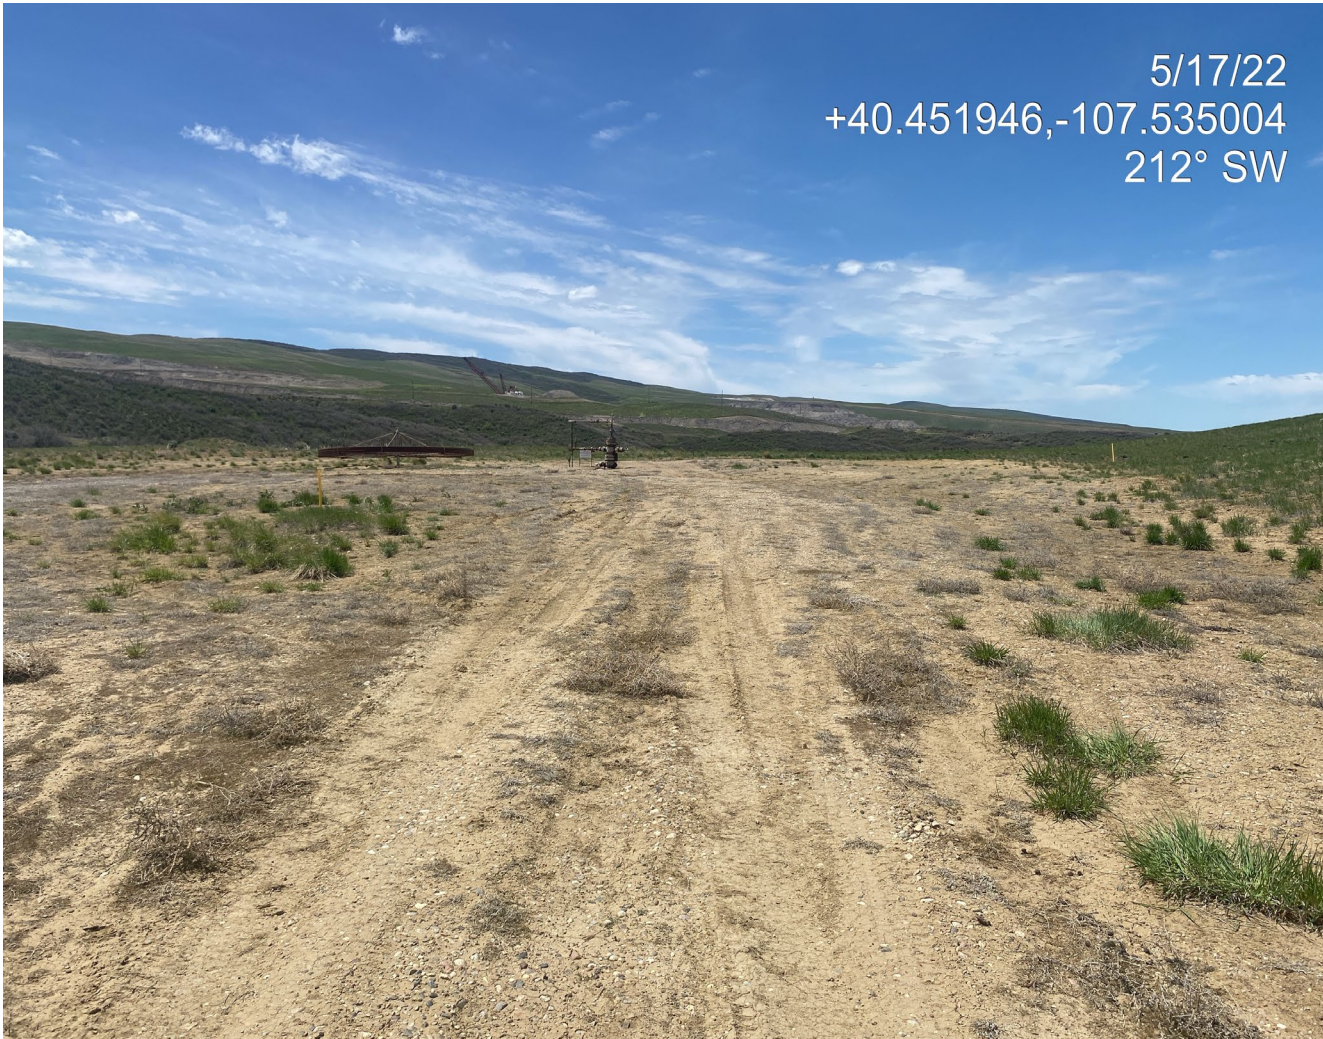
5/17/22  
+40.451946,-107.535004  
212° SW

**Photo 1.** Photo taken from the Location entrance to the north shows an overview of the production area.

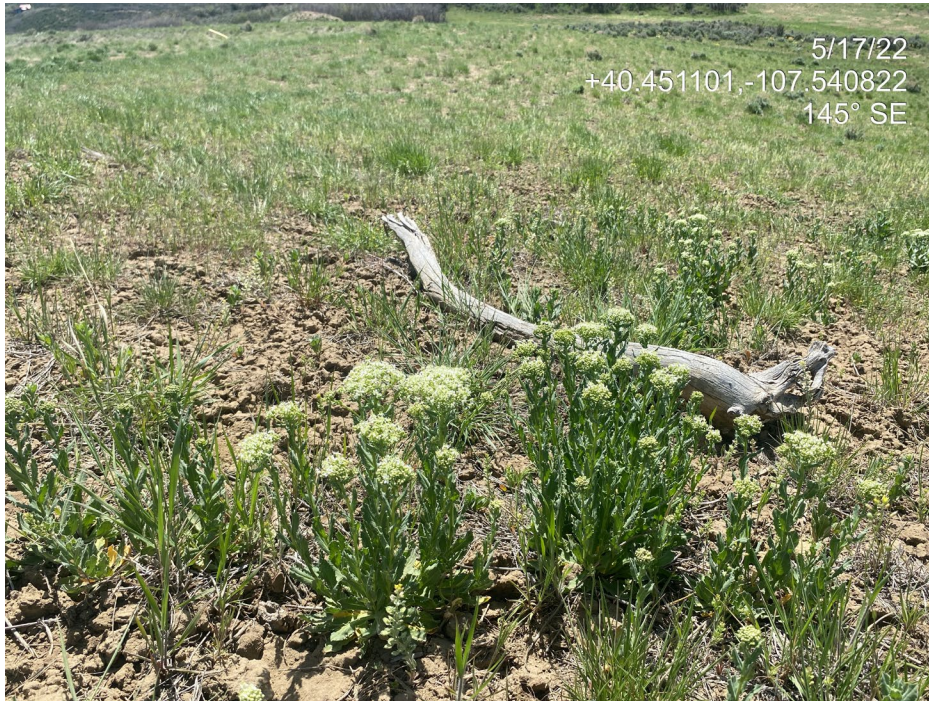
**Photo 2.** Photo taken from the interim area to the west of the Location shows a patch of hoary cress/whitetop. A CO List B Noxious weed.

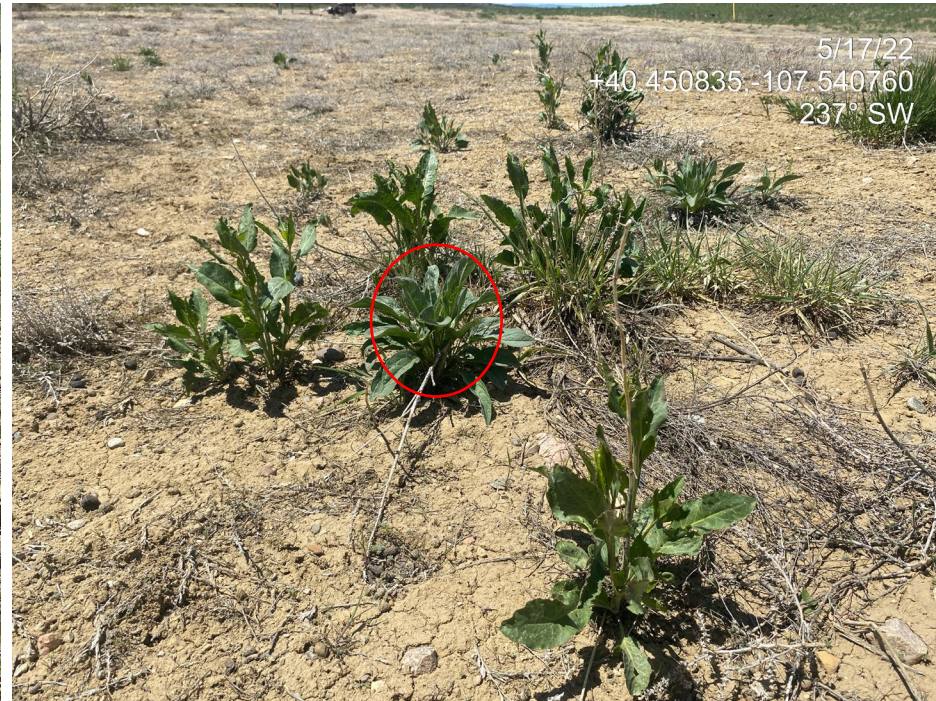
**Photo 3.** Photo taken from the north of the working pad area shows the “extremely invasive” species, perennial pepperweed, throughout the photo and one houndstongue (red circle). Both are CO List B Noxious Weeds.

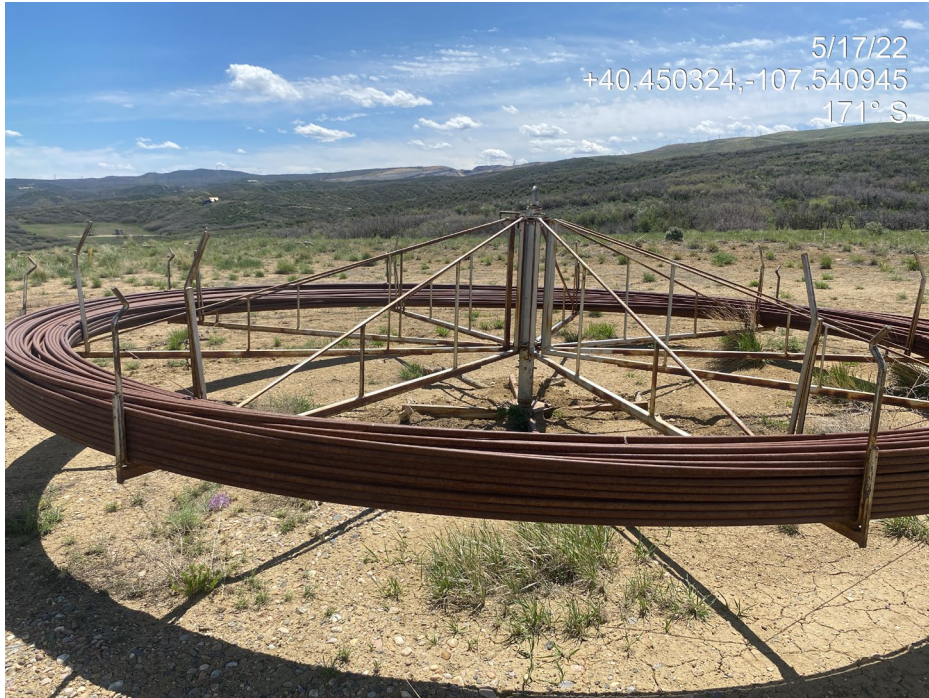
**Photo 4.** Photo taken from the production area shows storage of unused pipe equipment.

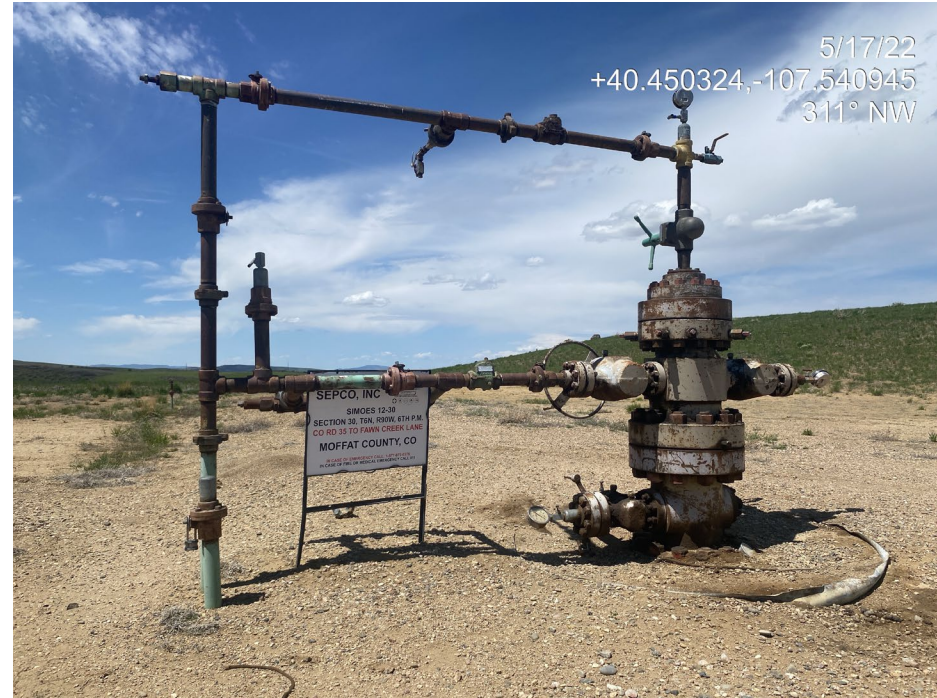
**Photo 5.** Photo taken from the wellhead shows signage with incorrect Operator information.

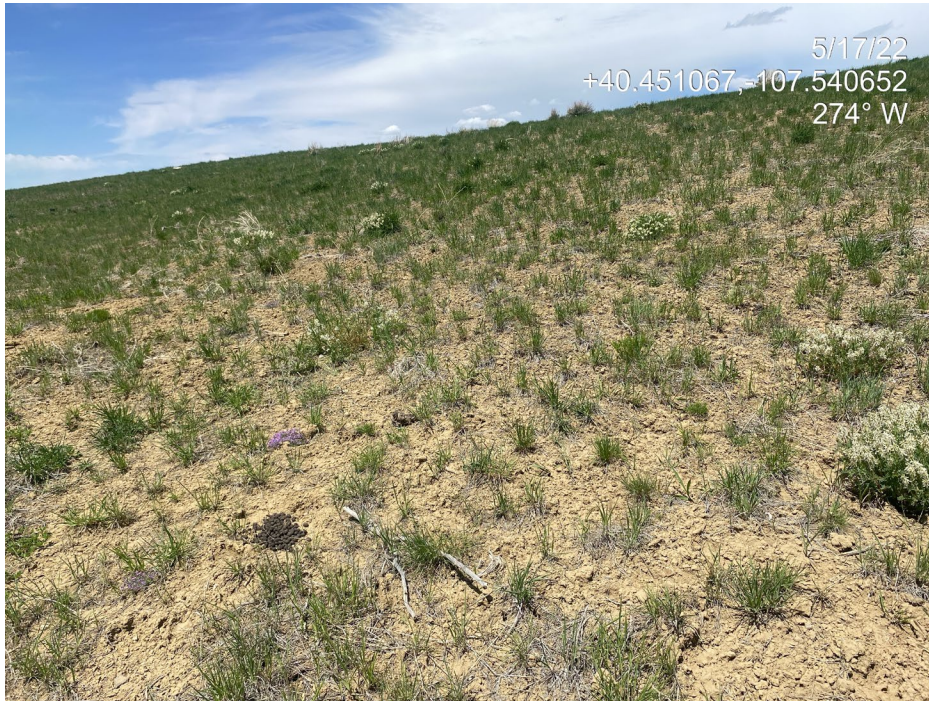
**Photo 6.** Photo taken from the cut slope at the north of the Location shows the slope is well vegetated with desirable perennial species.

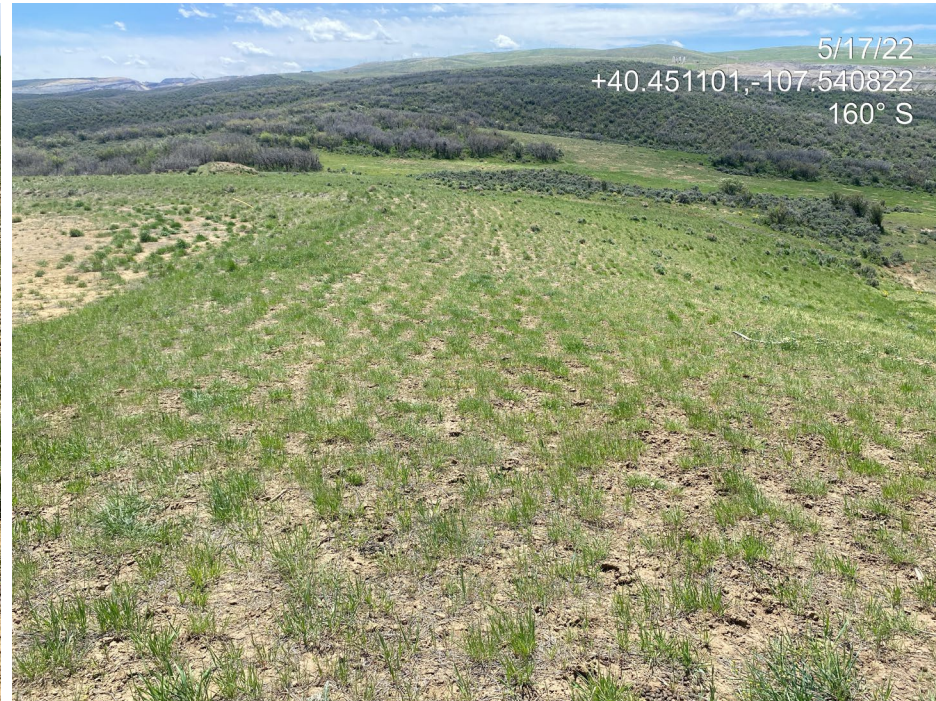
**Photo 7.** Photo taken from the west of the Location shows the interim area is well vegetated with desirable perennial species.

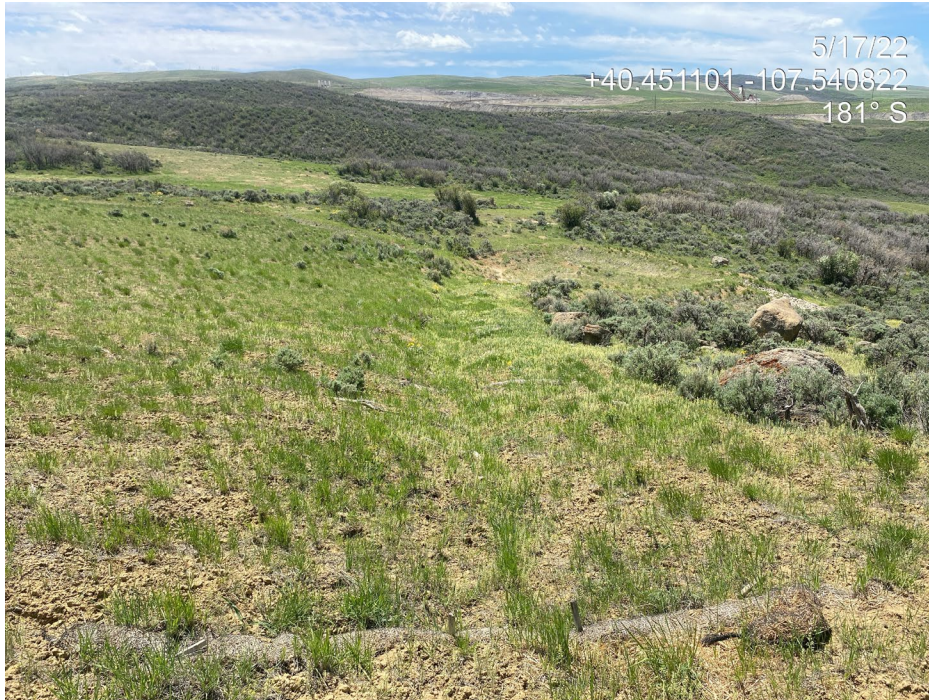
**Photo 8.** Photo taken from the west of the Location shows a stormwater swale installed with straw wattles. The swale is well vegetated with perennial grasses and appears to be sufficient to manage stormwater on the Location in conjunction with perennial plant establishment.

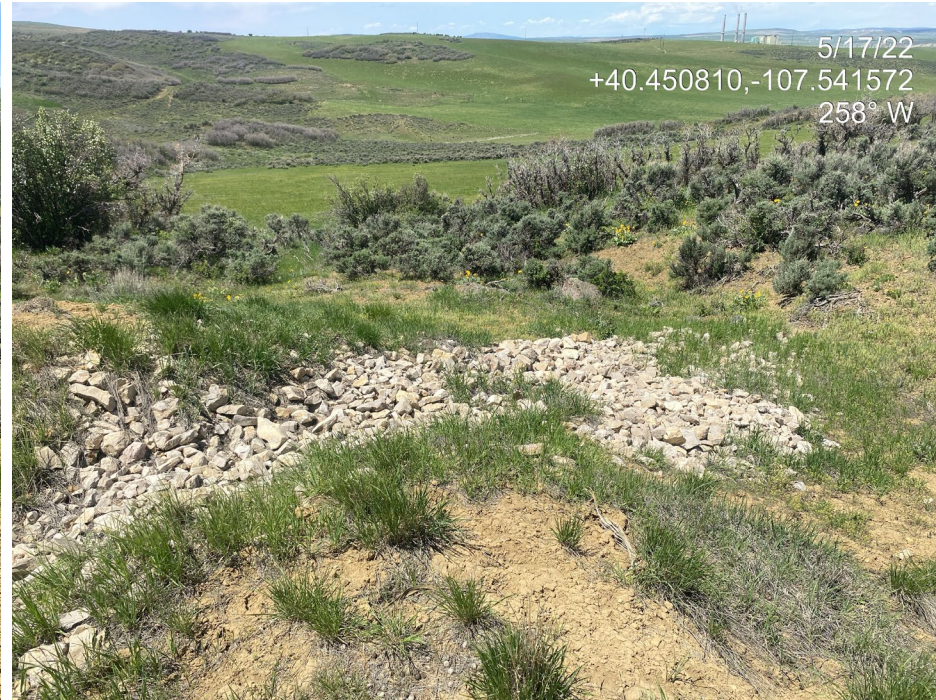
**Photo 9.** Photo taken from the southwest of the Location shows a rip-rap lined stormwater outlet. The BMP appears to be functioning to manage stormwater on the Location in conjunction with perennial plant establishment.

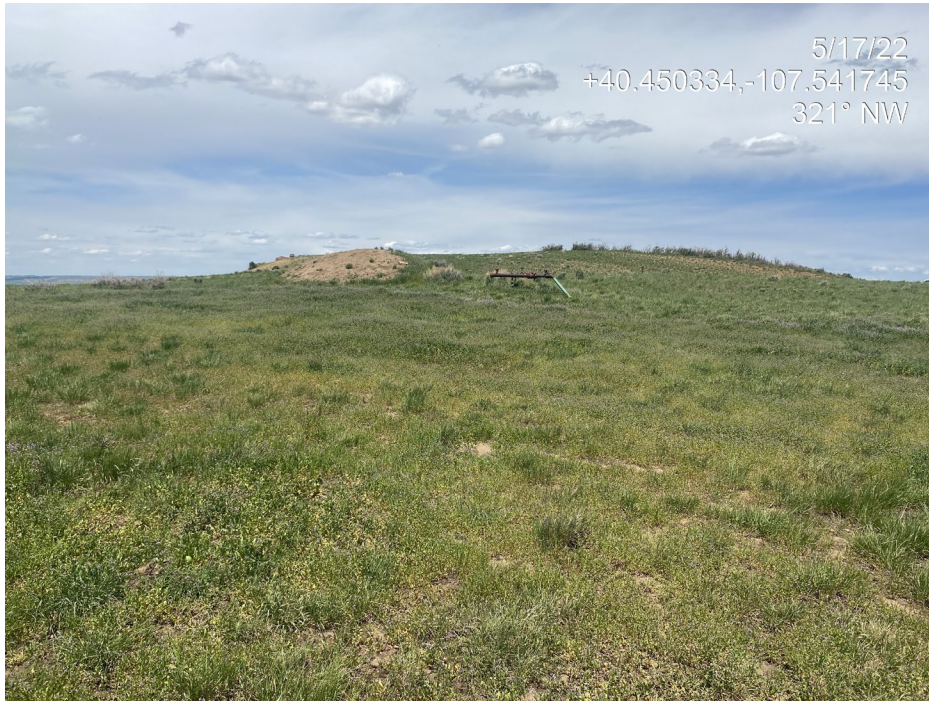
**Photo 10.** Photo taken from the south of the Location shows areas with poor perennial plant establishment. While perennial grasses are common, the annual weed purple mustard is very dense and is the only plant in some areas.
