Inspection Photos

Operator: Jetta Operating Company Inc - #44645

Location Name: Craig-66N90W /7NENW

Inspection Document #: 702800250

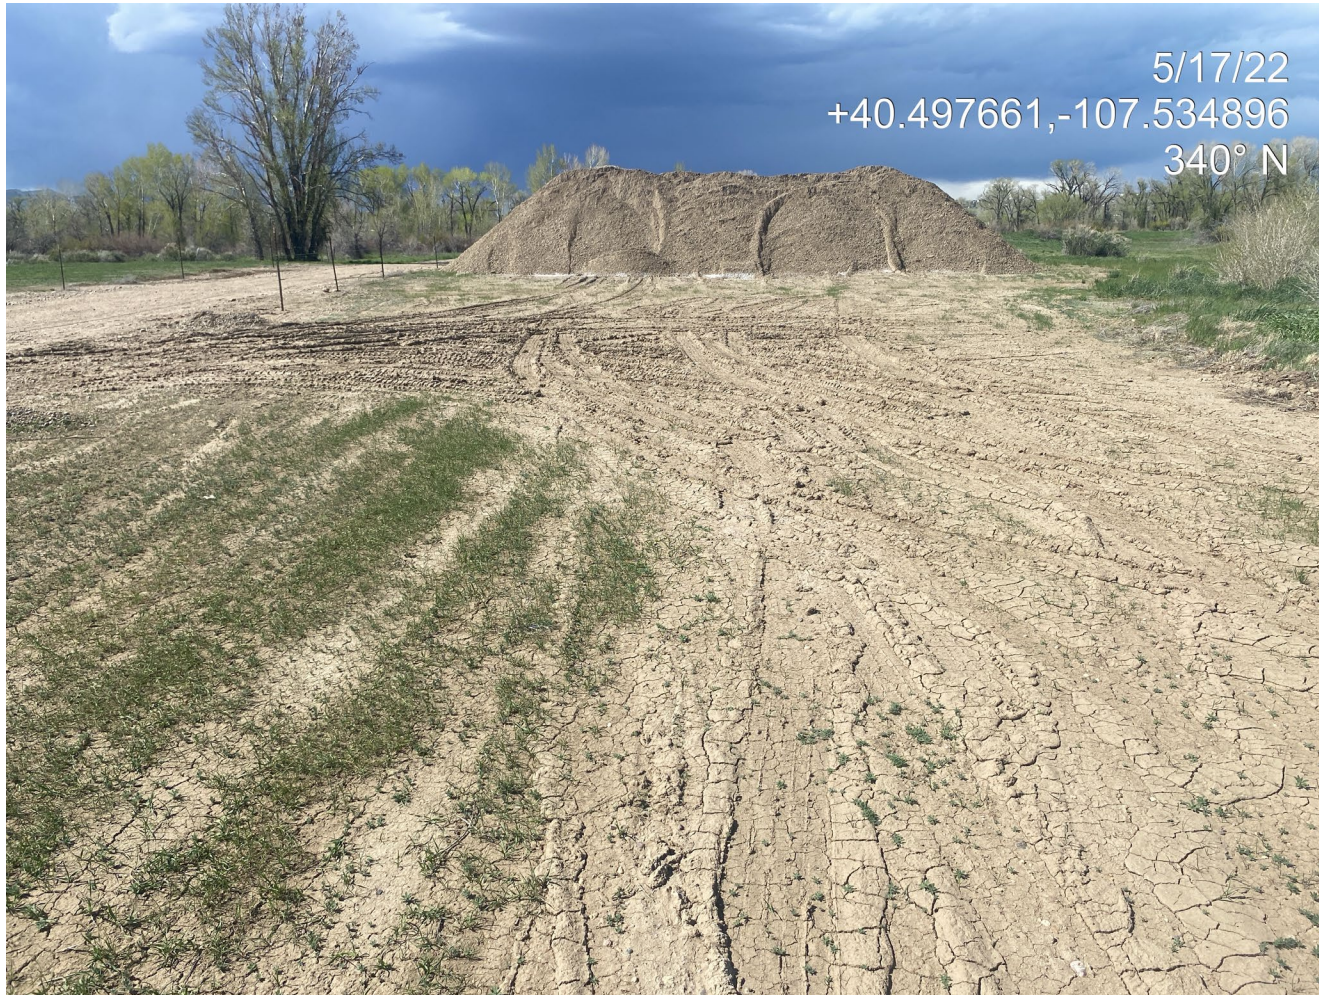
Photo 1. Photo taken from the east of the Location shows a pile of gravel being stored on the reclaimed area. Tire tracks are widespread in the area and are impacting revegetation.

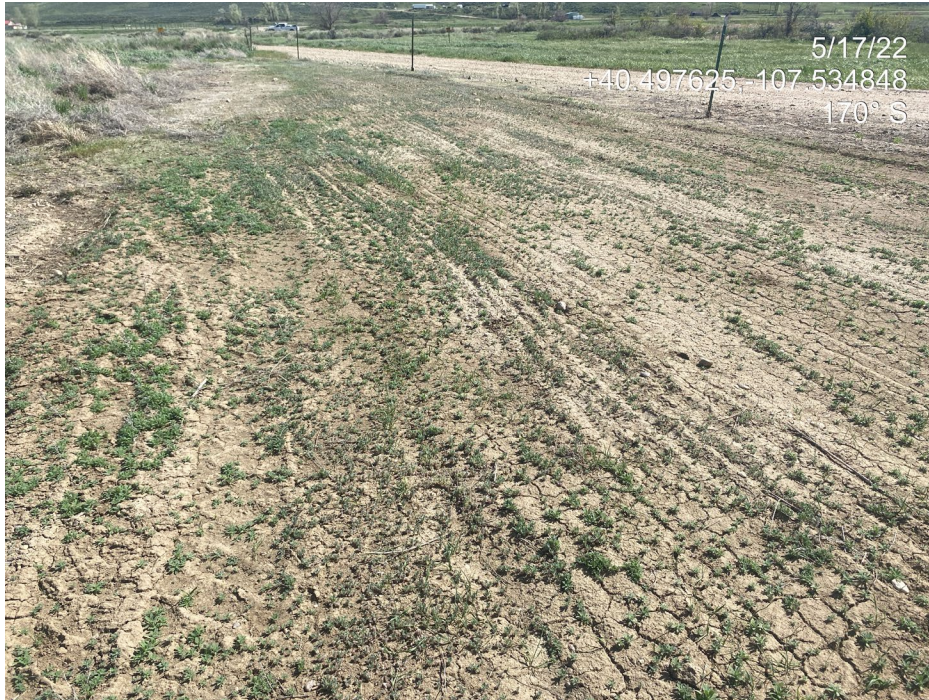
Photo 2. Photo taken from the east of the Location shows bare ground, sparse germinating grasses and widespread cover of kochia, an annual weed.

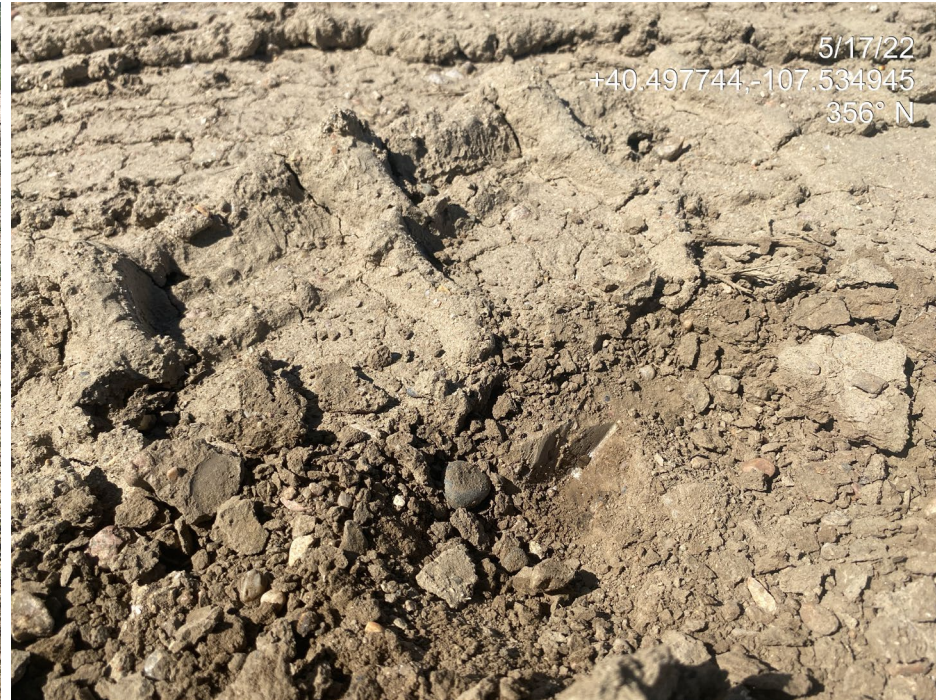
Photo 3. Photo taken from the east of the Location shows heavily compacted soils.

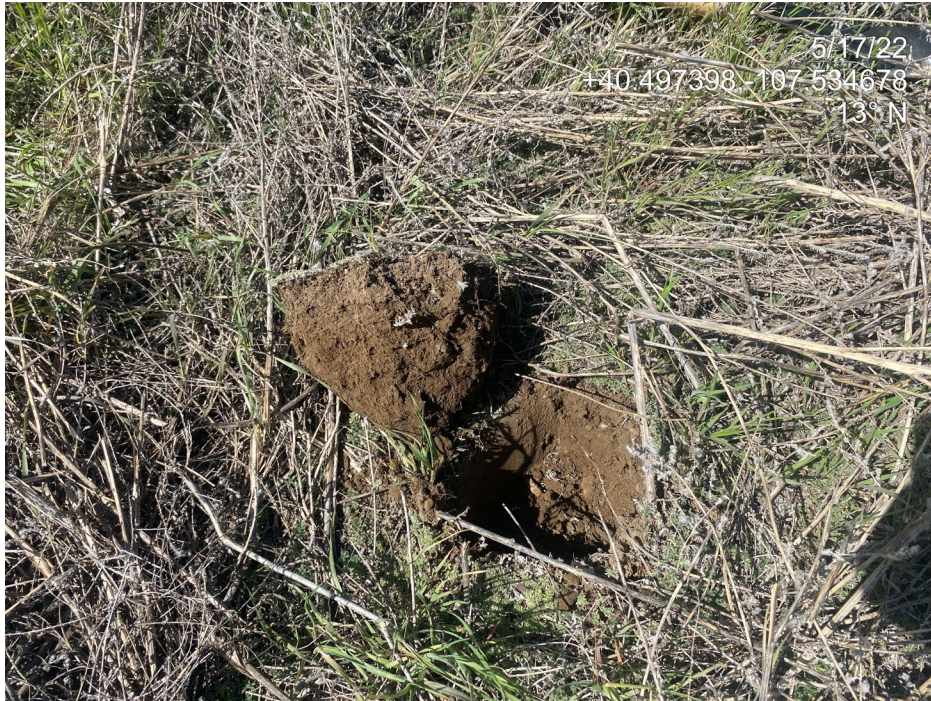
Photo 4. Photo taken from the southeast of the Location shows the difference in soil compaction from Photo 3. Soils at the southeast of the Location are not as compacted. Vegetation is dominated by the annual weed kochia and the CO List C Noxious weeds cheatgrass and bulbous bluegrass.

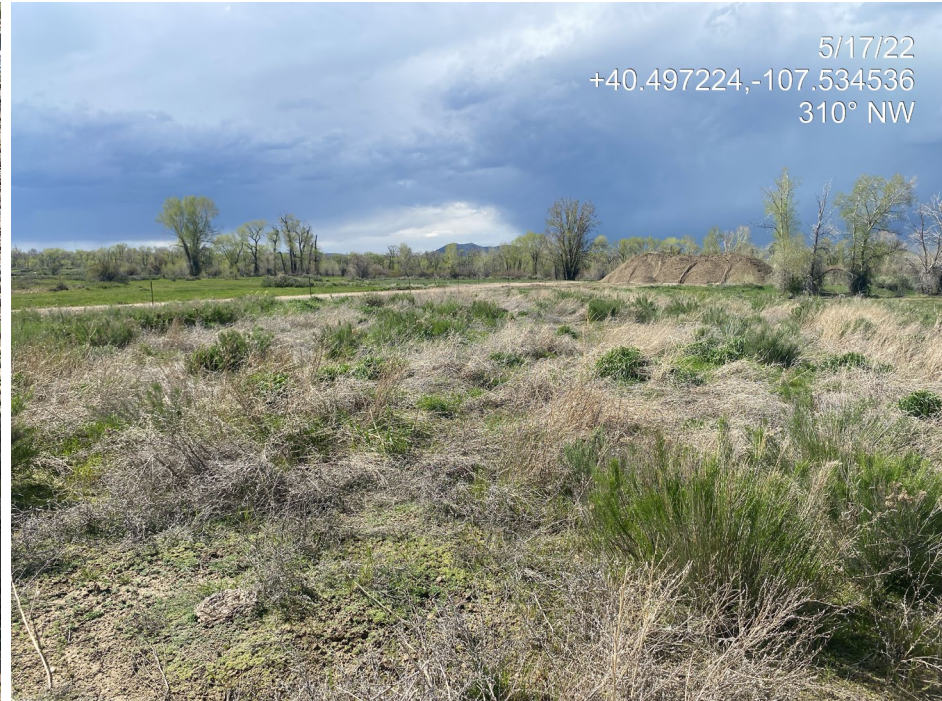
Photo 5. Photo taken from the southeast of the Location shows the vegetation community is dominated by the annual weed kochia and the CO List C Noxious weeds cheatgrass and bulbous bluegrass.

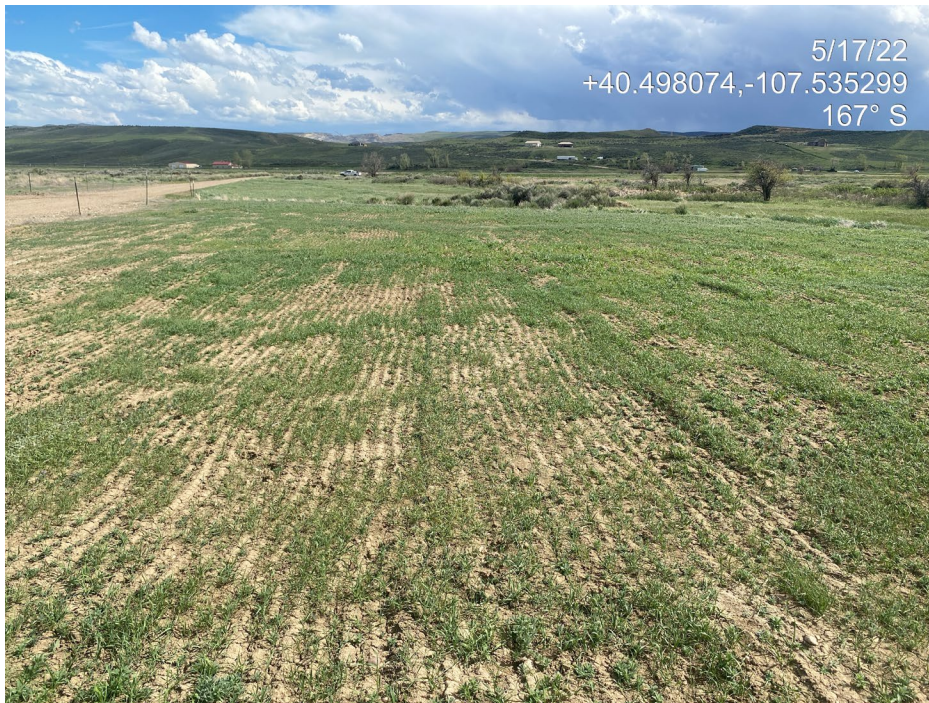
Photo 6. Photo taken from the west of the Location shows areas of the Location not disturbed by vehicles have good germination and coverage of perennial grass seedlings. This area is still densely colonized by the annual weed kochia.

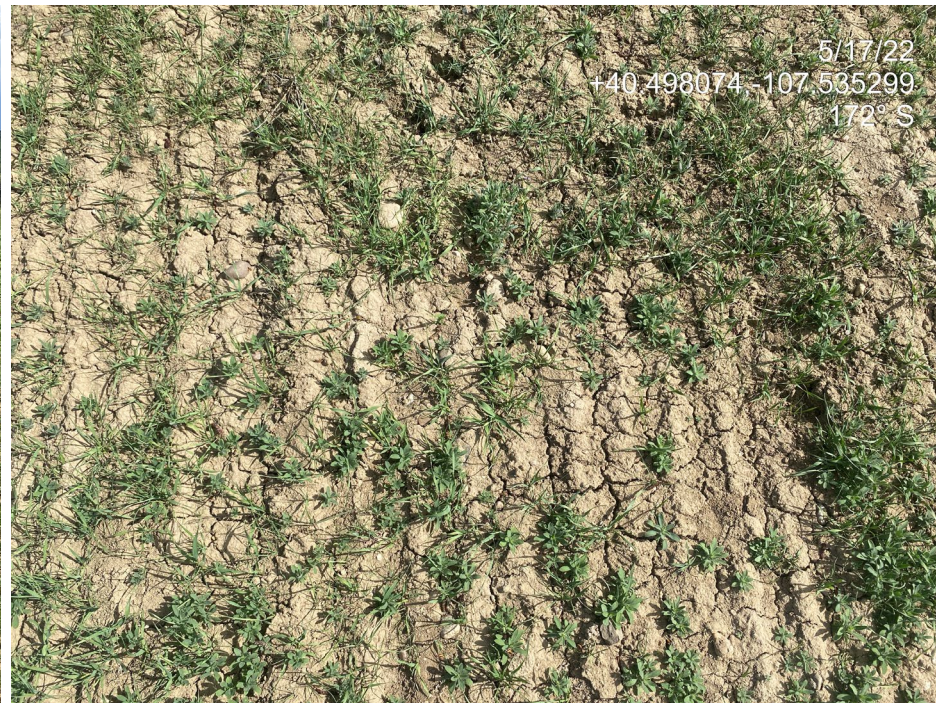
Photo 7. Photo taken from the west of the Locations shows a close-up of the germinating plant community. Seeded perennial grasses are codominant with the annual weed kochia.

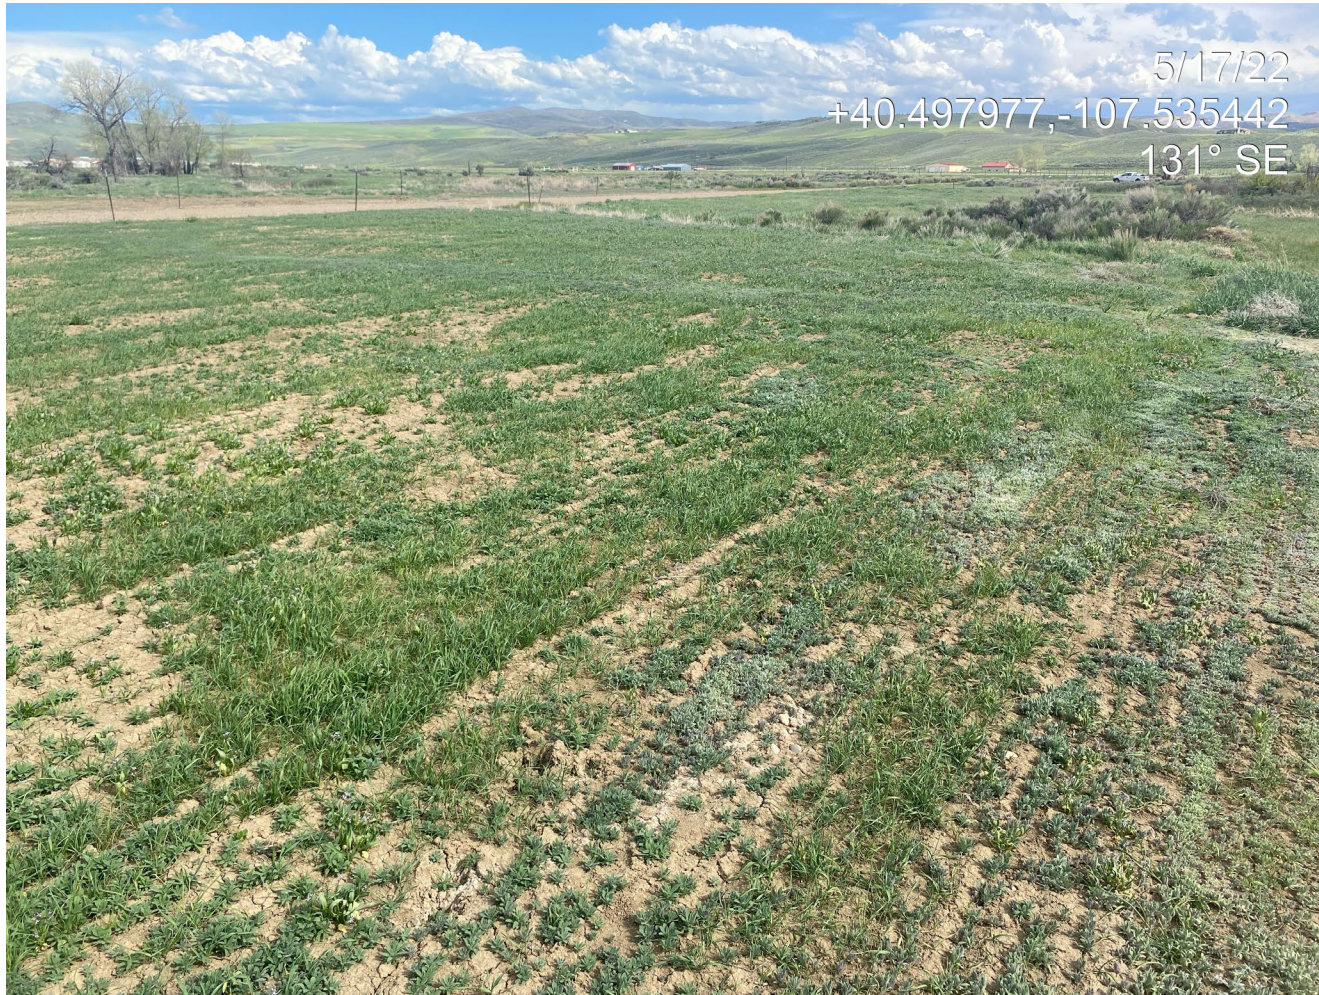
Photo 8. Photo taken from the west of the Location shows germination of perennial grasses as well as patches of the annual weed kochia.

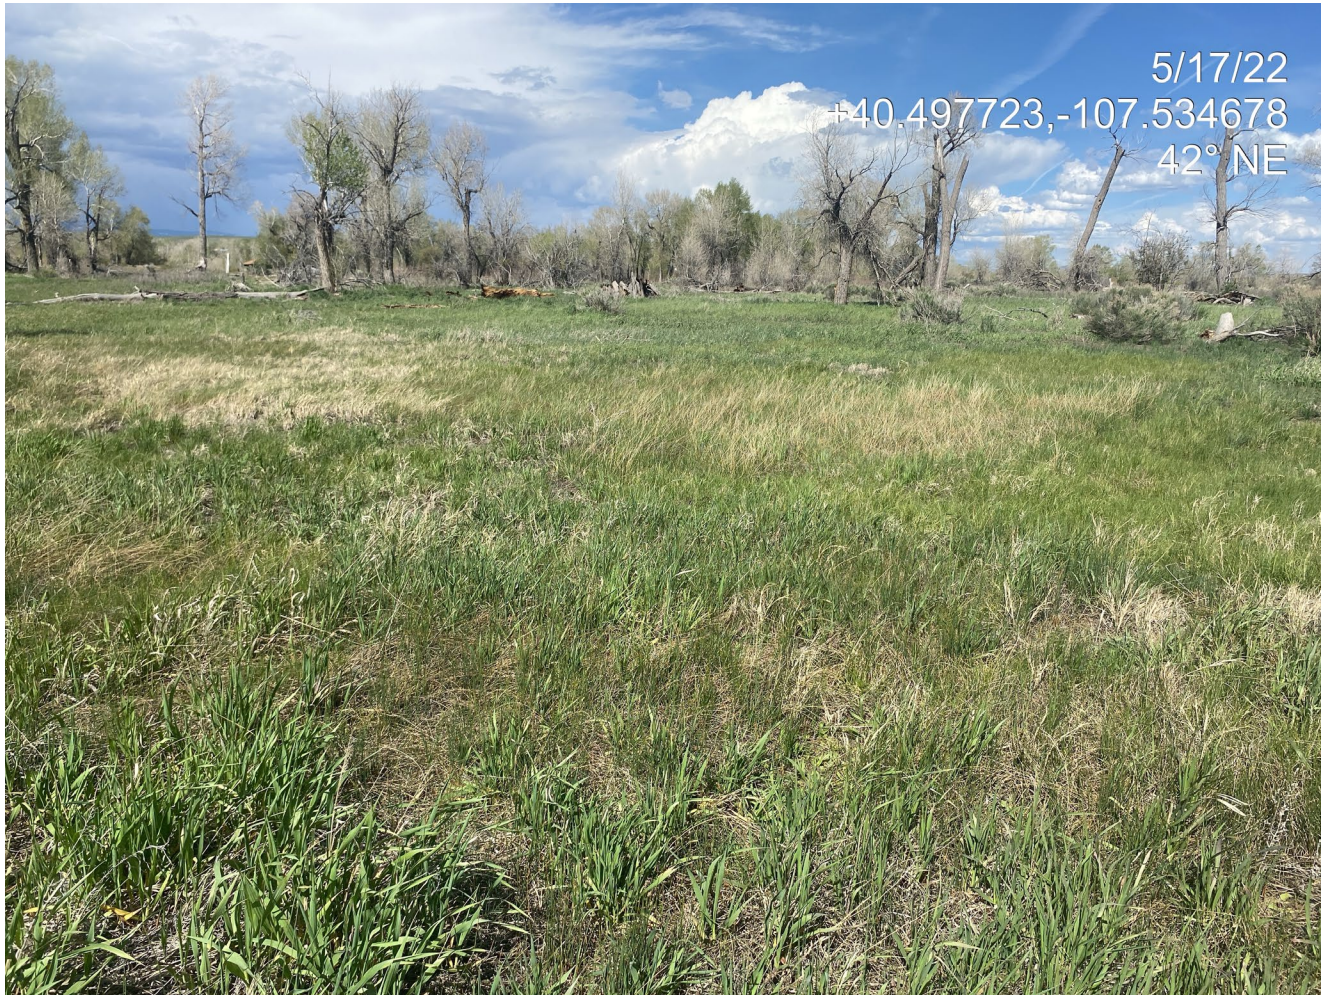
Photo 9. Photo taken from the east of the Location shows the reference area is a perennial graminoid meadow consisting of dense cover of smooth brome and arctic rush. Noxious and annual weeds are absent.
