WELLHEAD ABANDONMENT FORM

SITE NAME: West Farms 2-14 A							DATE: 9/8/2021		REM. PROJECT #:		WEATHER:	
SITE DIRECTIONS: CR 23 and 23.5, west 0.2 and north 0.2 into							CLIENT: Oxy					
LEGALS AND LAT/LONG: 40.2279486, -104.8547085							TASMAN PERSONNEL: Brandon LeVasseur					
SOIL TYPES: Well Graded Sand - SW							SURFACE GRADIENT: North					
SOIL SAMPLING							FACILITY INFRASTRUCTURE					
Date/Time	Soil Sample ID	PID (ppm)	Visual	Olfactory	Photo?	Grab or Lab Sample?	EQUIPMENT		Quantity			
							Above Ground Storage Tank (AST)					
9/8/2021 12:43	WH-B01 @4'	31.8	No Staining	No Odor	Yes	Lab	Buried or Partially Buried Vessel					
9/8/2021 12:44	WH-N01 @2'	38.9	Organic Content	Slight Organic Odor	Yes	On-Hold	Separator					
9/8/2021 12:45	WH-S01 @2'	28.7	No Staining	No Odor	Yes	On-Hold	Emission Control Device (ECD)					
9/8/2021 12:46	WH-E01 @2'	30.9	No Staining	No Odor	Yes	On-Hold	Dump Line					
9/8/2021 12:47	WH-W01 @2'	46.9	Organic Content	Slight Organic Odor	Yes	Lab	Wellhead

FLOWLINE ABANDONMENT FORM

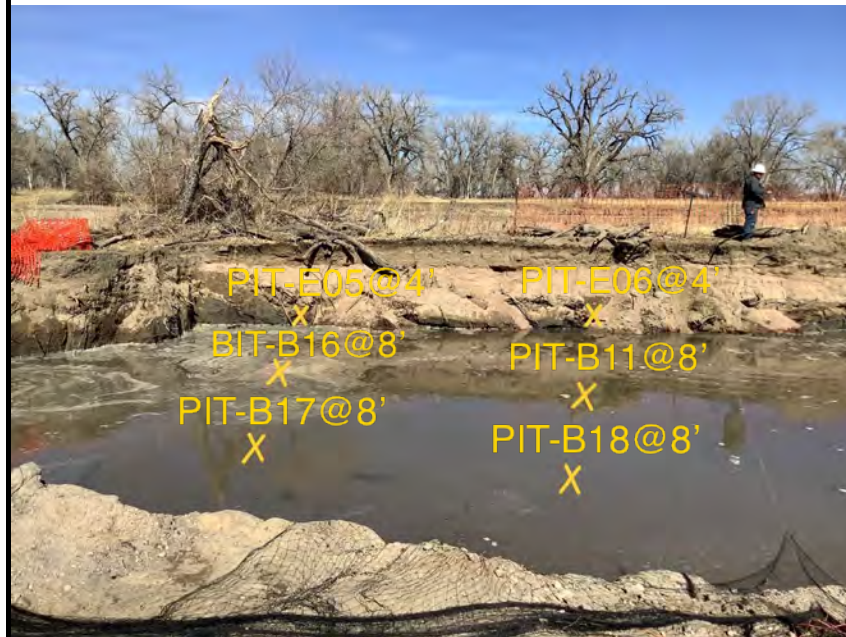
Equipment ID:		Equipment Type:		Equipment ID:		Equipment Type:	
Material:	Volume:	Contents:		Material:	Volume:	Contents:	
Notes/Conditions:				Notes/Conditions: Soil sampling and screening locations 3/15/22

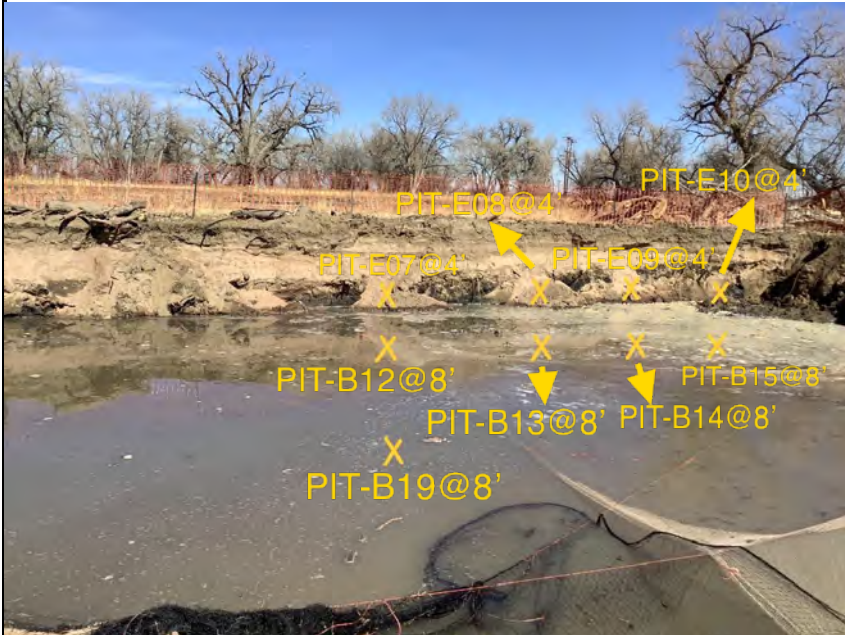
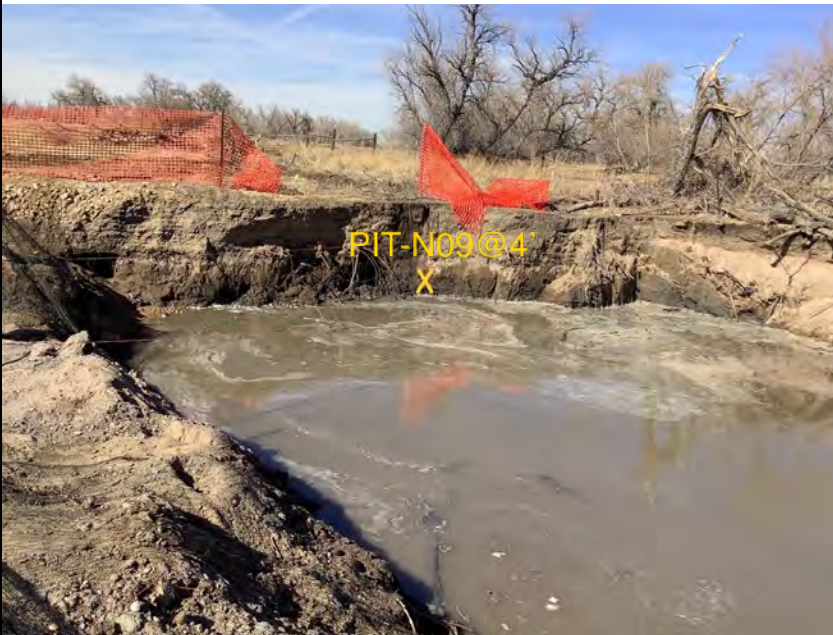
Equipment ID:		Equipment Type:		Equipment ID:		Equipment Type:	
Material:		Volume:		Material:		Volume:	
		Contents:				Contents:	
Notes/Conditions: Soil sampling and screening locations 3/15/22				Notes/Conditions: Soil sampling and screening location 3/15/22
