Inspection Photos

API: 071-09919

Operator: TWIN BRIDGES RESOURCES LLC

Inspection Date: 5/31/2022

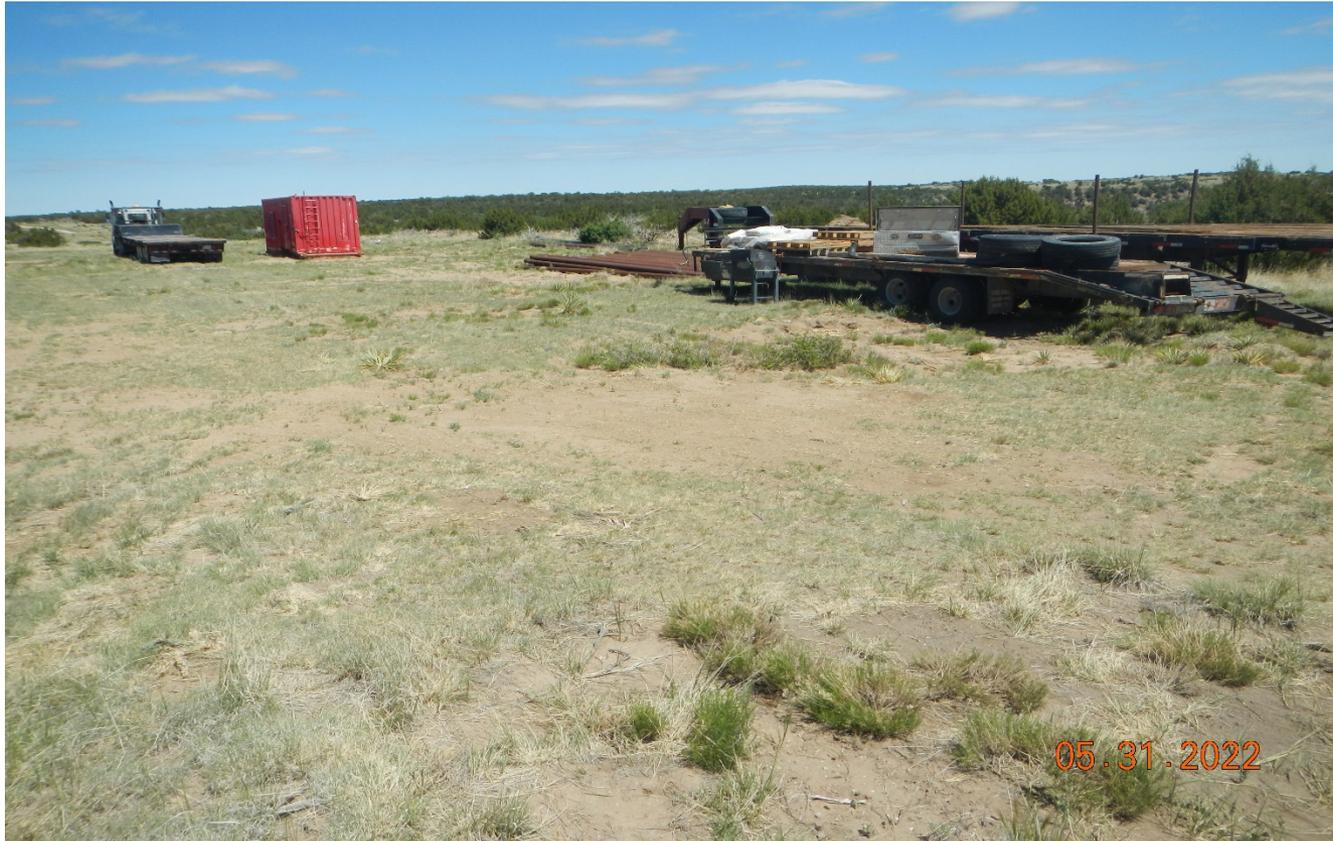
Photo 1. Facing northwest near the location. Equipment is being stored near the location. All equipment will need to be removed and disturbance reclaimed.

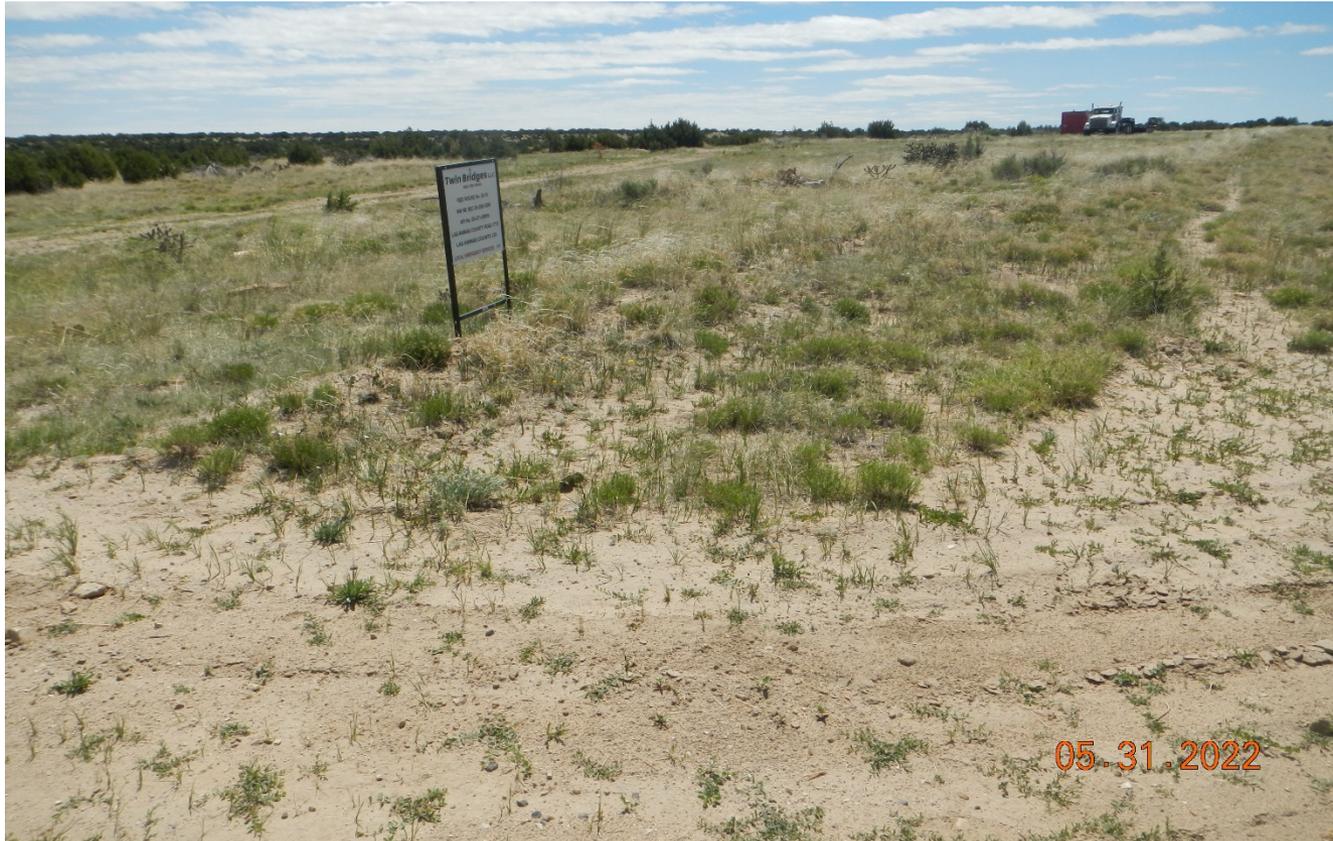
Photo 2. Facing southeast at the entrance of the access road. Sign is posted at entrance.

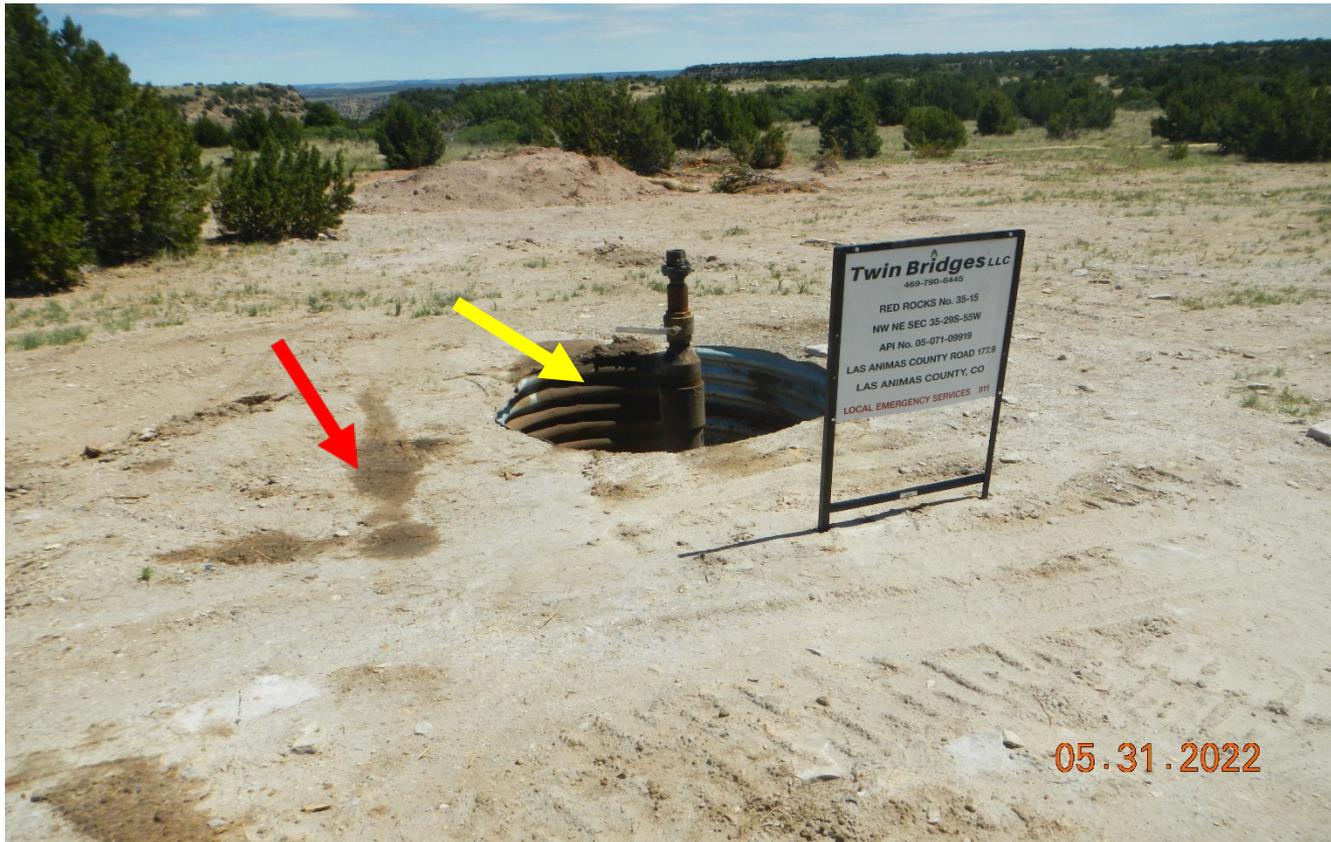
Photo 4. The well has been drilled at the location. The wellhead cellar (yellow arrow) needs to be covered to prevent entry. There is oil stained soils (red arrow) that need to be cleaned up.

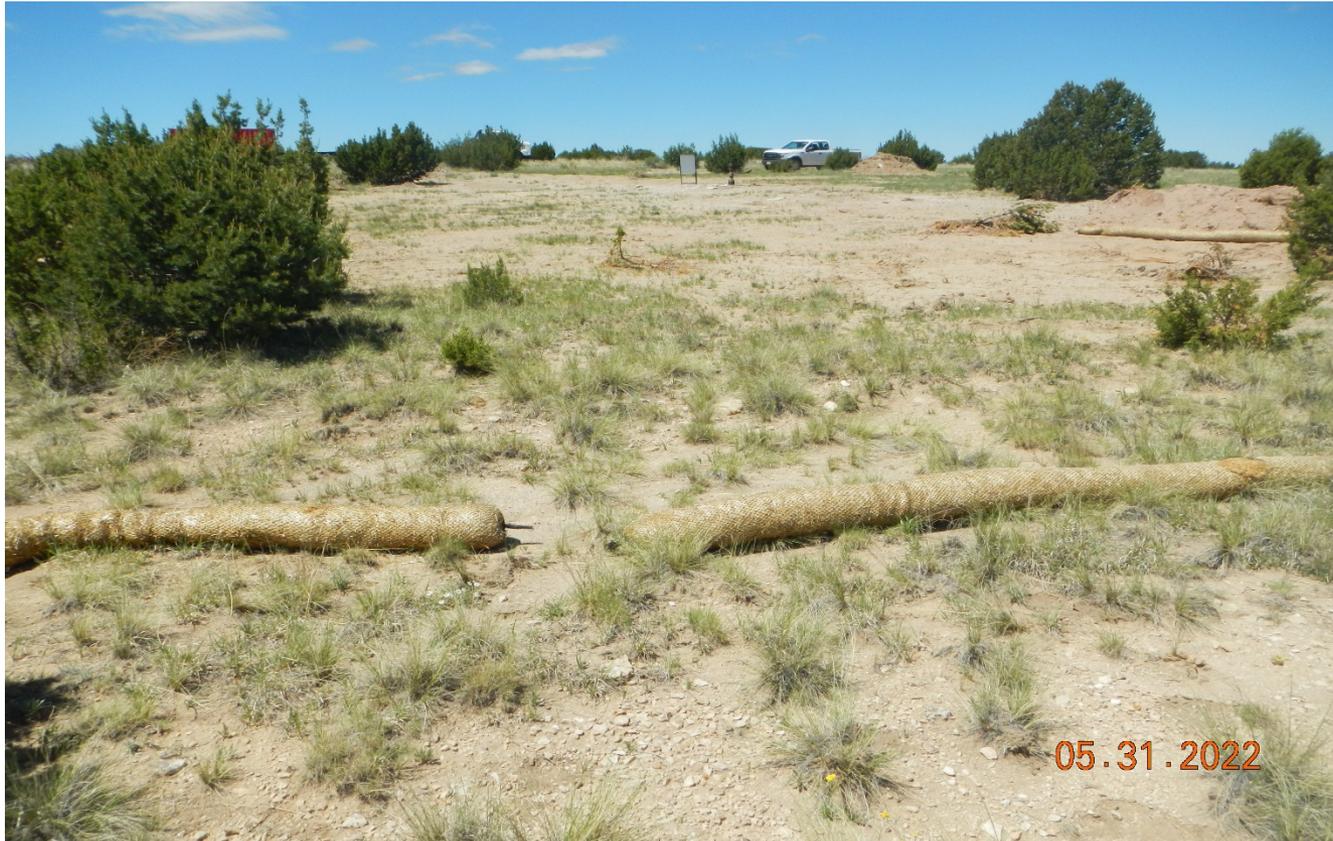
Photo 5. The down gradient straw wattles are not installed correctly. There is a gap between the ends of the wattles and there is no staking to hold them in place.

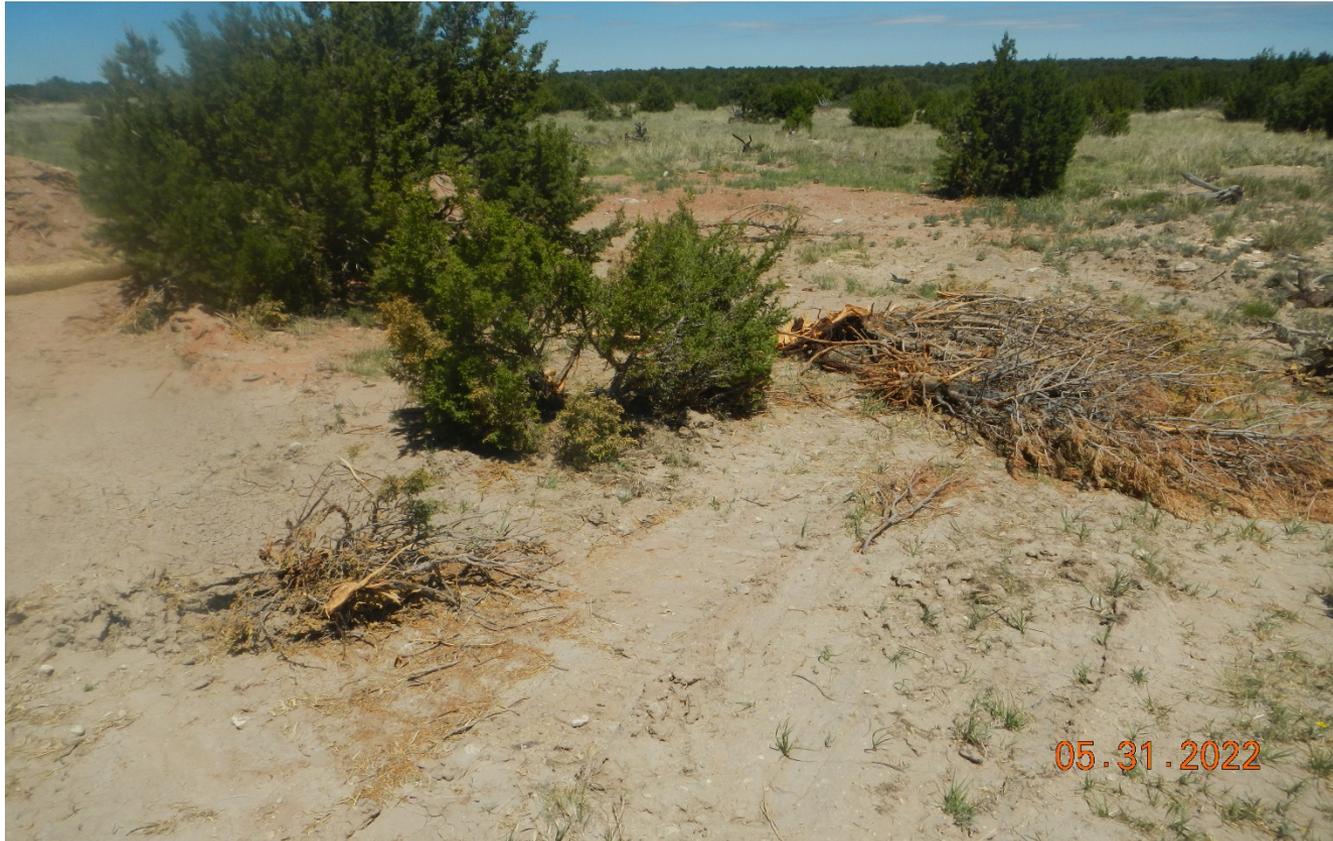
Photo 6. The disturbed tree debris around the location will need to be removed.

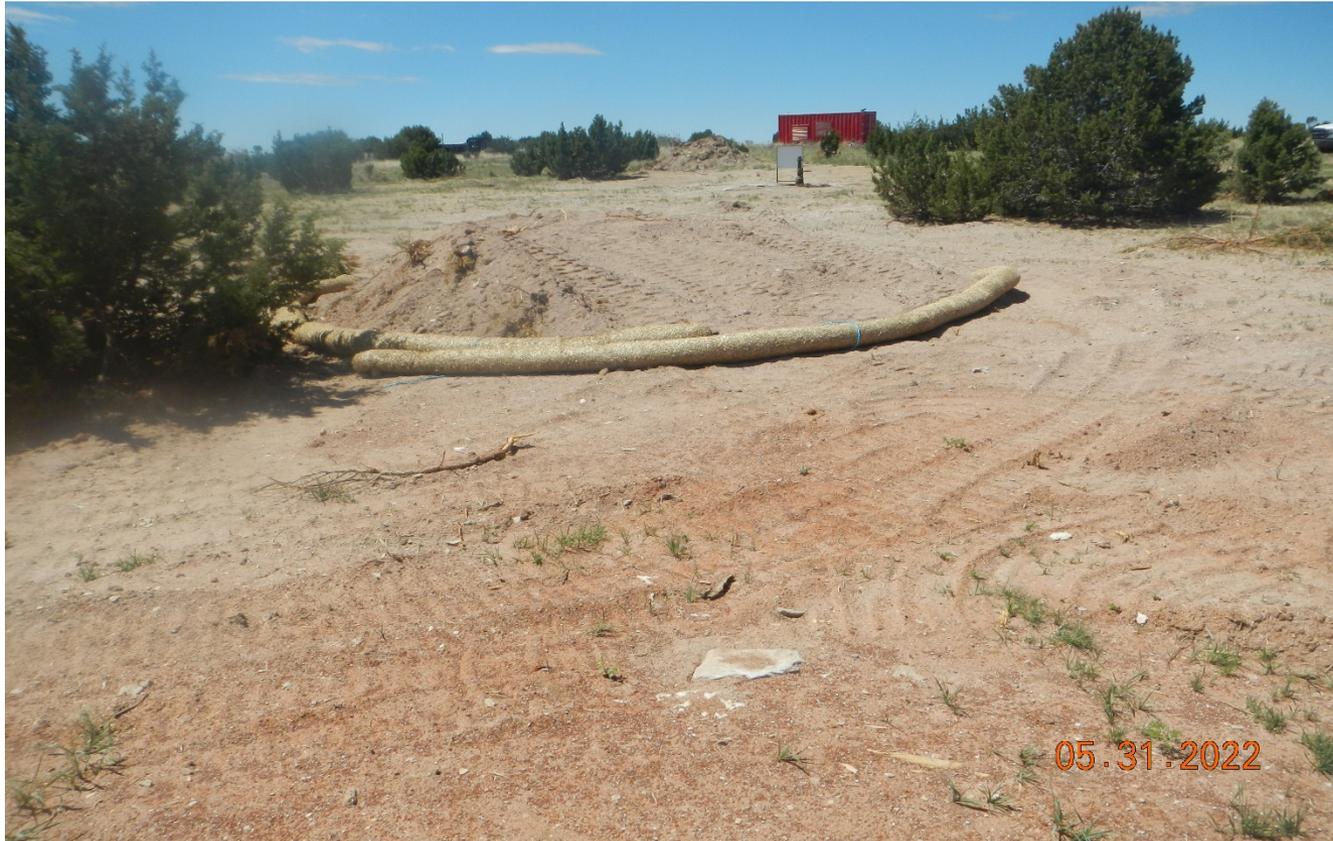
Photo 7. It is unknown which pile of material is the cuttings pile. It appears some cuttings is on the surface in photo. The wattles are not staked down around the pile.

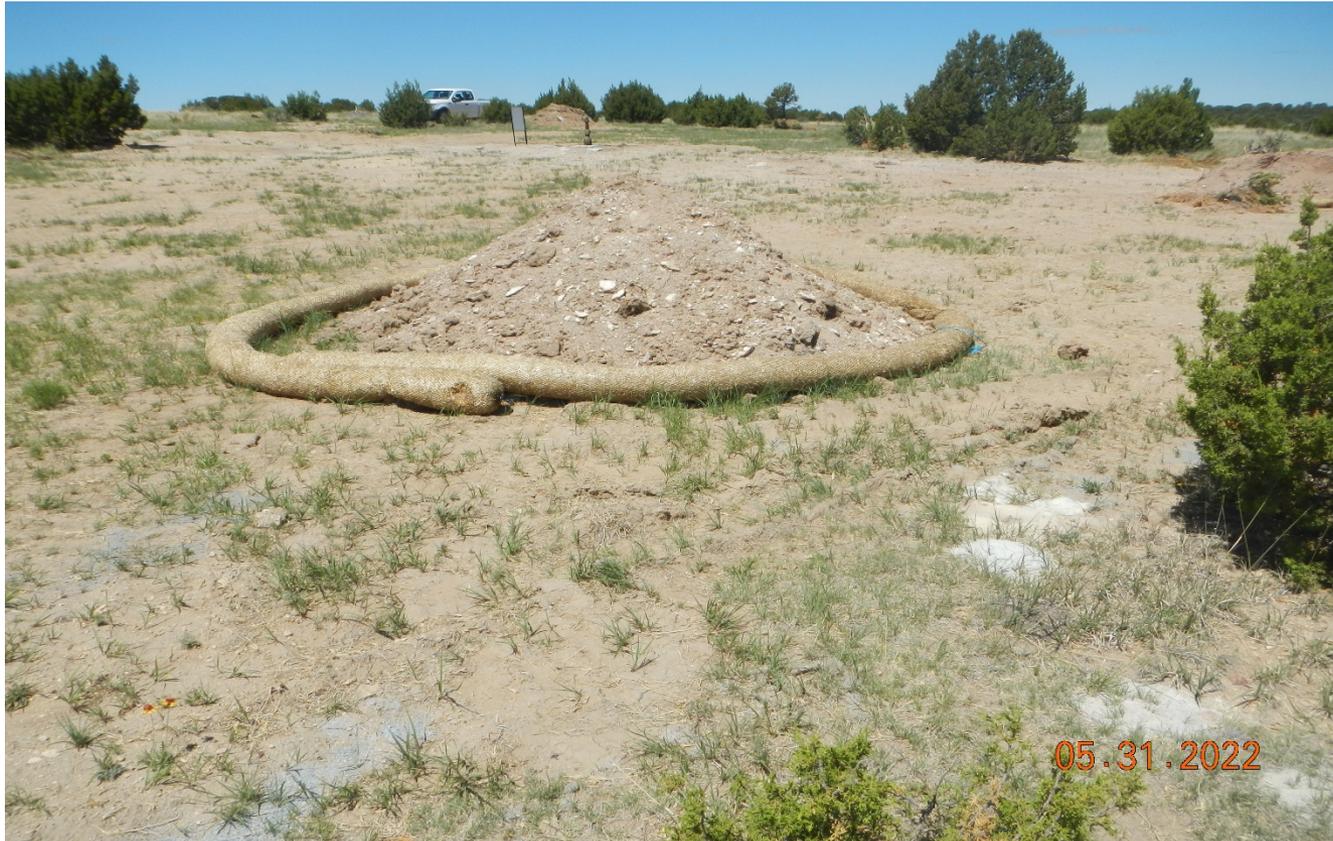
Photo 8. There are a multiple soil piles around the location. The wattles are not staked down around the pile.
