Inspection Photos

May 25, 2022

Location Name: Wilson Creek Unit-63N94W/34NWNW

Inspection Document #: 702800265

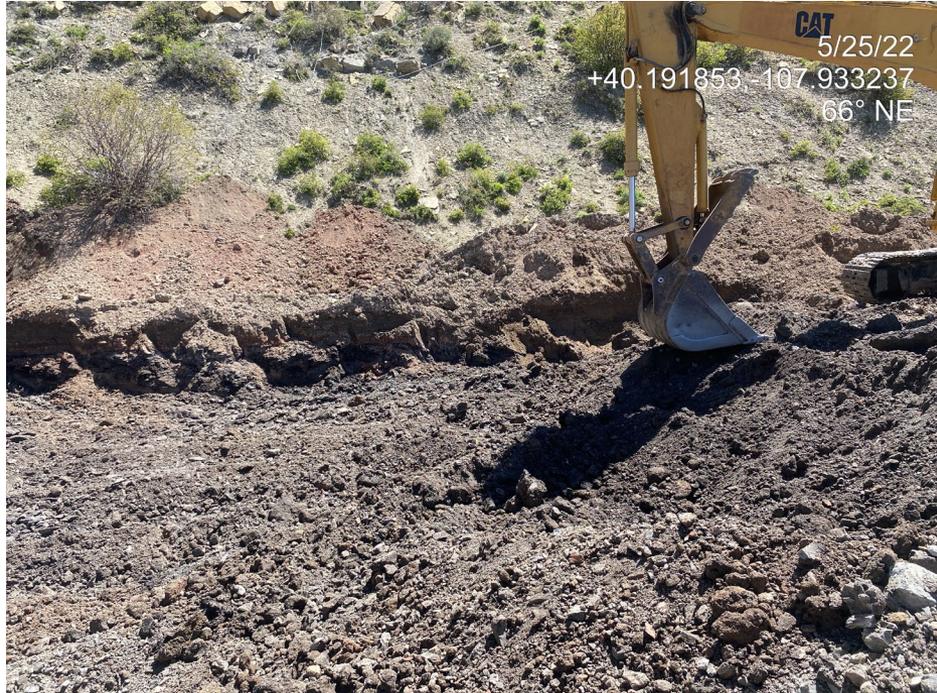
Photo 1. Photo taken from the well area shows the excavated area around the well.

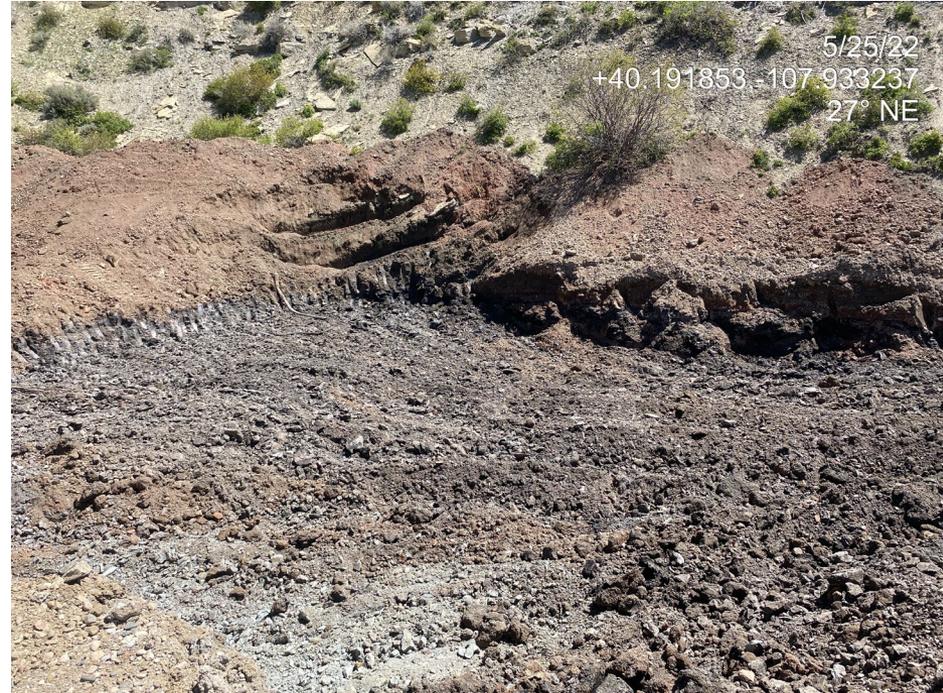
Photo 2. Refer to Photo 1 comment.

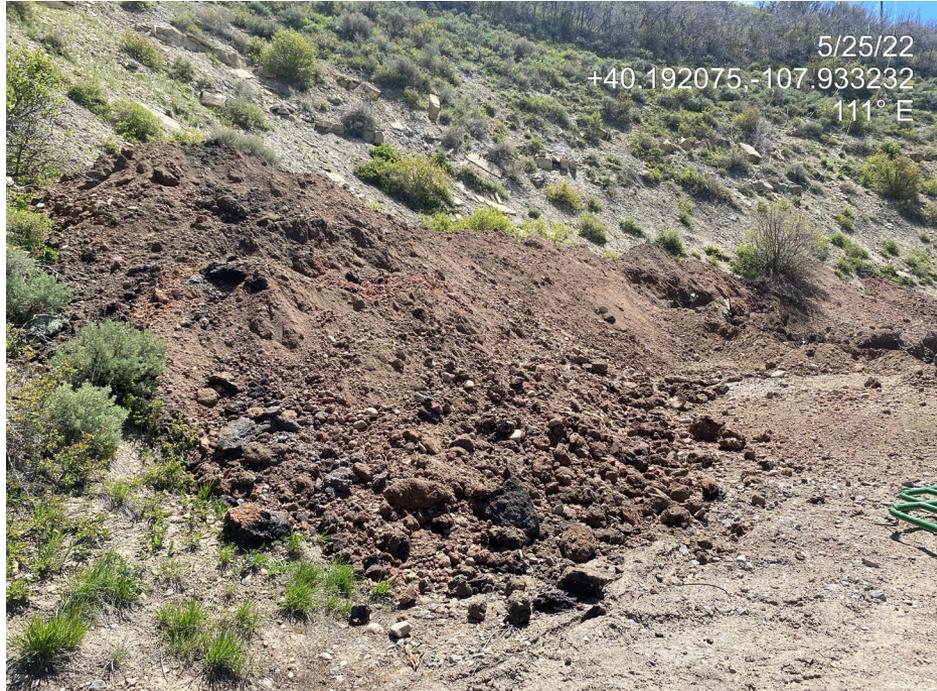
Photo 3. Photo taken from the north of the Location shows a pile of soil which may be impacted by E&P waste stored without sufficient control measures to prevent sediment and E&P waste from migrating off site.

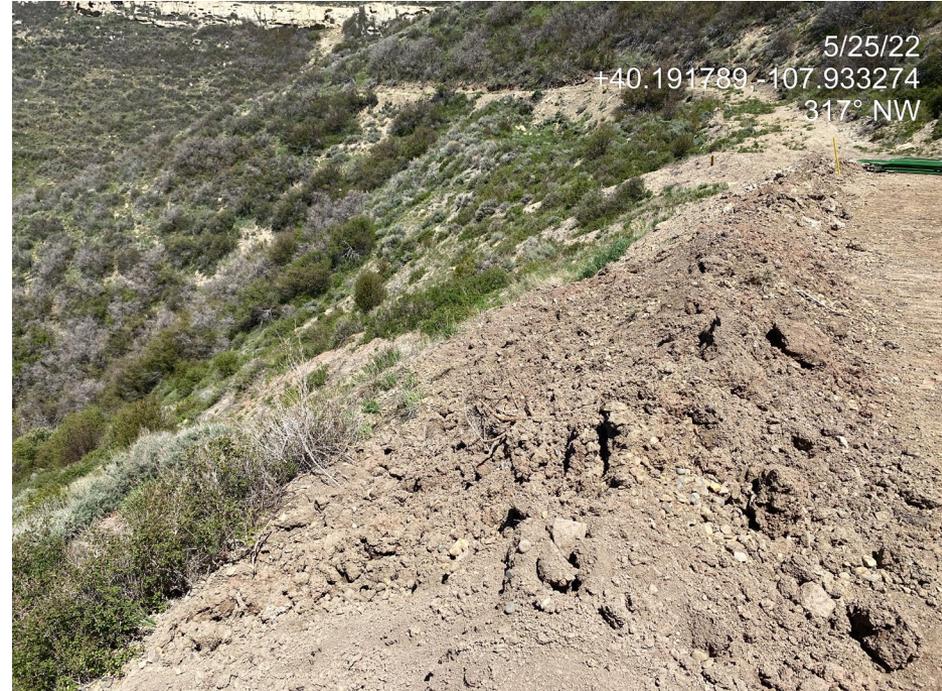
Photo 4. Photo taken from the west of the Location shows a soil berm at the edge of the Location intended as a temporary measure to prevent migration of E&P waste off site. The berm may act as a sediment source/stormwater pollutant.
