Inspection Photos

Operator: Chevron USA Inc - #16700

Location Name: Wilson Creek Unit-62N94W/2SWNE

Inspection Document #: 702800269

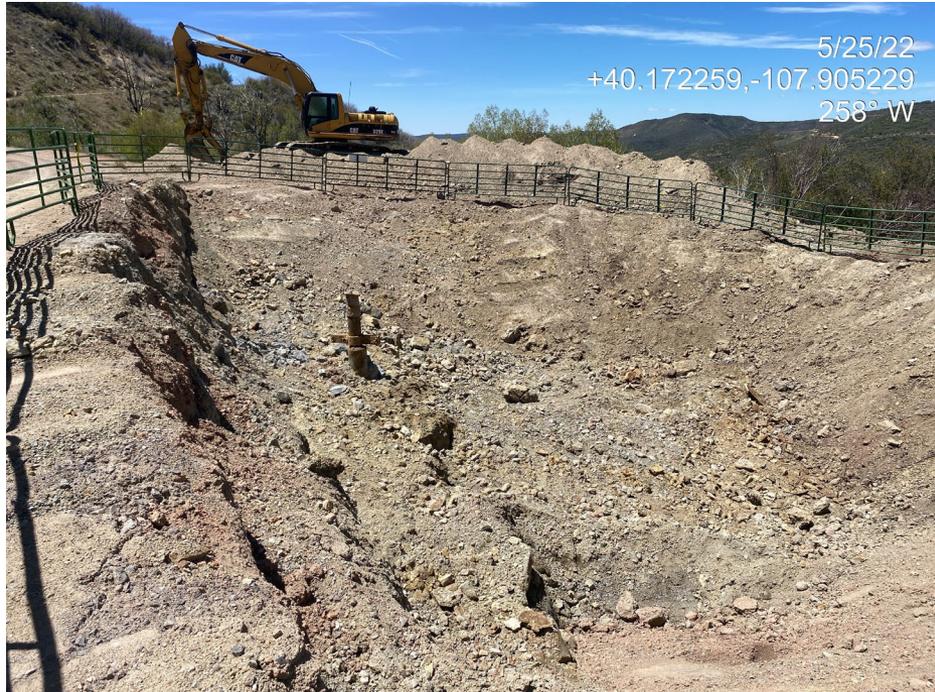
Photo 1. Photo taken from the well area shows the excavation around the wellhead. The slope of the sides is gentle enough to allow for wildlife egress. Fence panels are present around the entire excavated area.

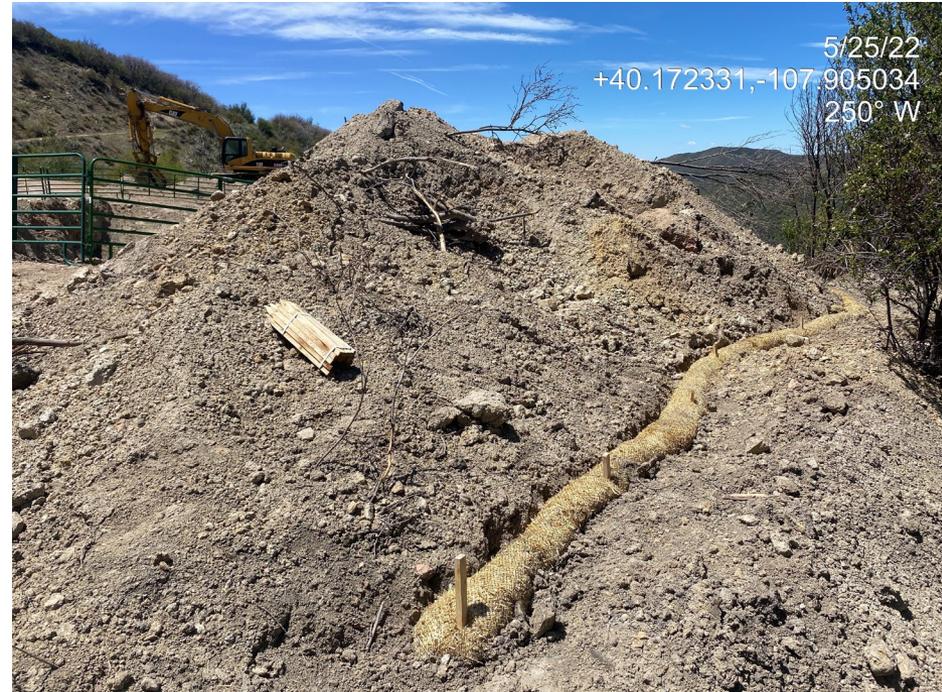
Photo 2. Photo taken from the east of the Location shows a soil pile. A straw wattle has been added around the downslope perimeter of the pile.

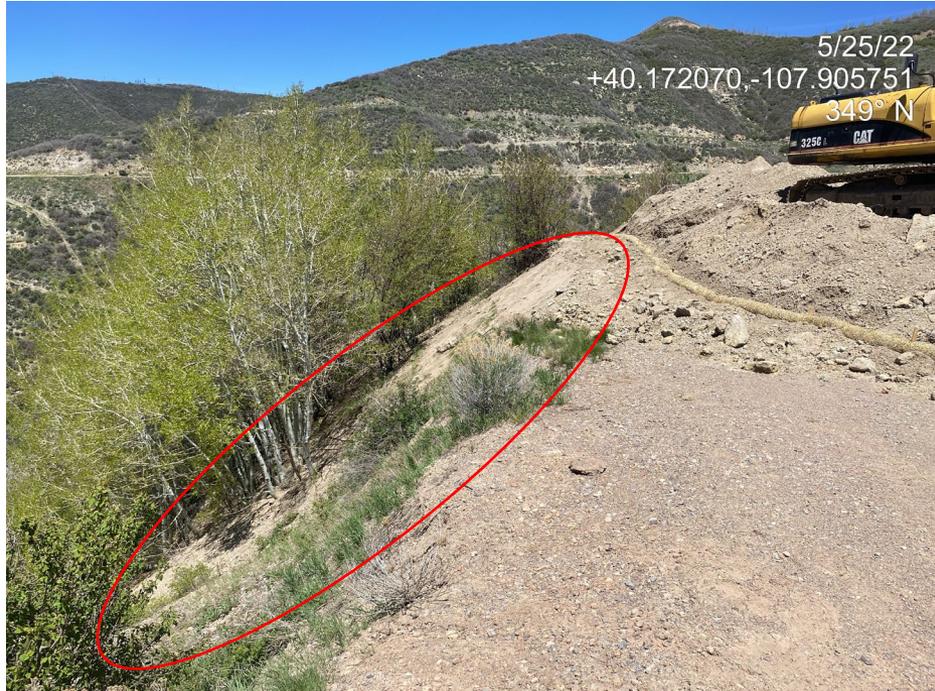
Photo 3. Photo taken from the west of the Location shows a soil pile to the right. A straw wattle has been added around the downslope perimeter of the pile. Piles of soil from the Location are present downslope of the wattle and off site.

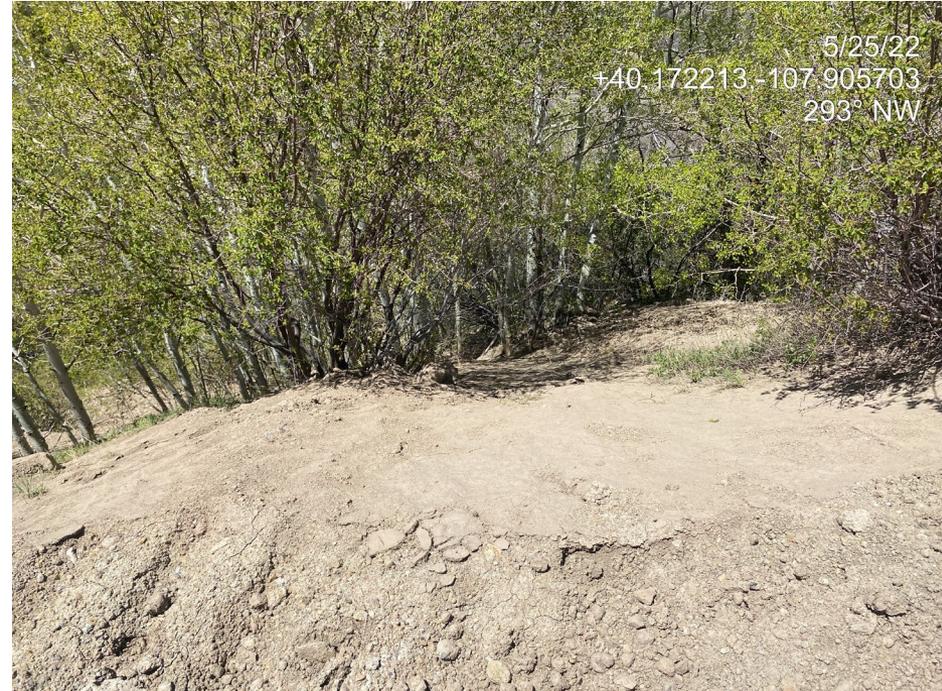
Photo 4. Photo taken from the west of the Location shows a soil pile from the Location present offsite. Soil continues down the hillside approximately 30 yards from the Location edge.

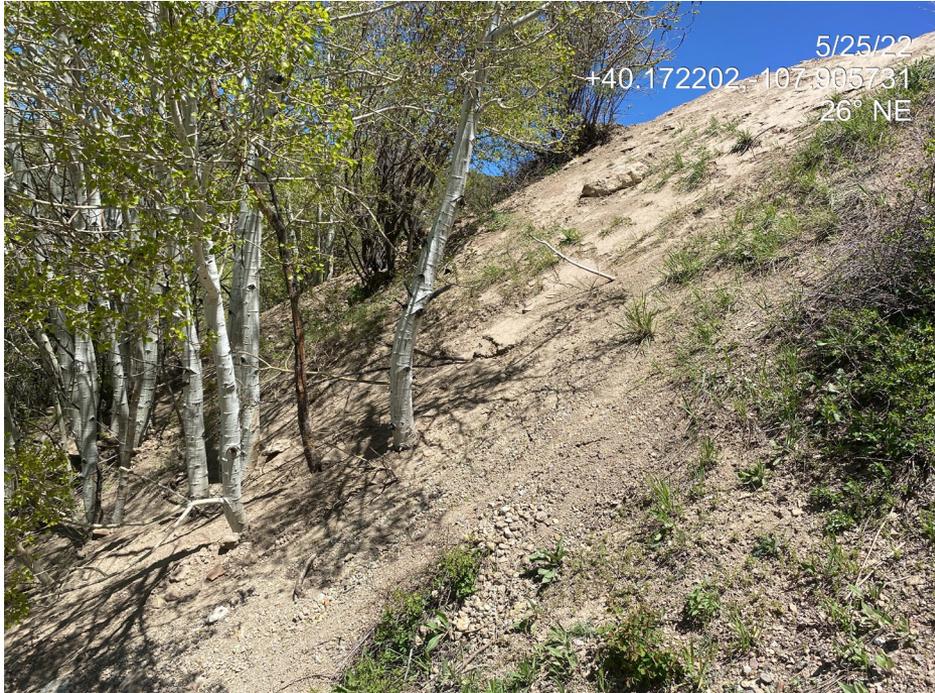
Photo 5. Refer to Photo 4 comments.

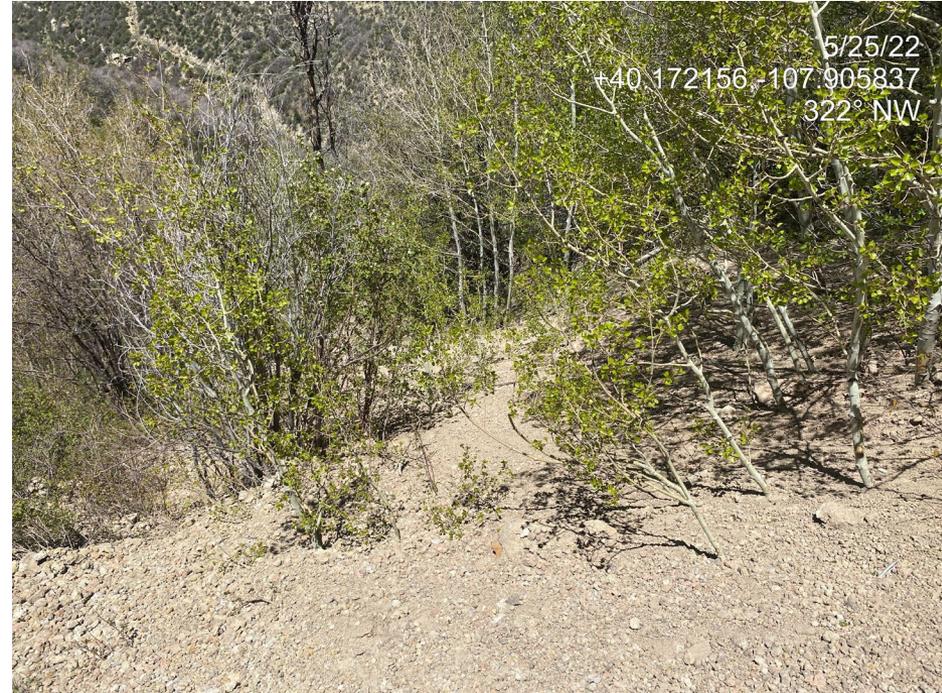
Photo 6. Refer to Photo 4 comments.
