Inspection Photos

Operator: Chevron USA Inc - #16700

Location Name: Wilson Creek Morrison Unit-62N94W
/2NWNE

Inspection Document #: 702800278

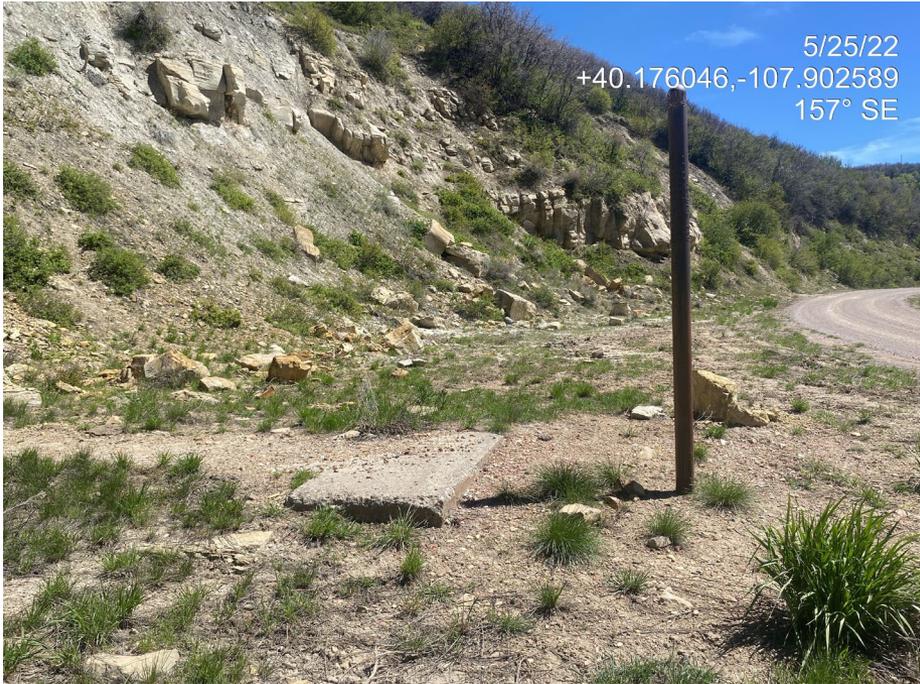
Photo 1. Photos taken at the well marker shows an overview of the southern portion of the Location. A concrete slab is present and must be removed per 1004 rules.

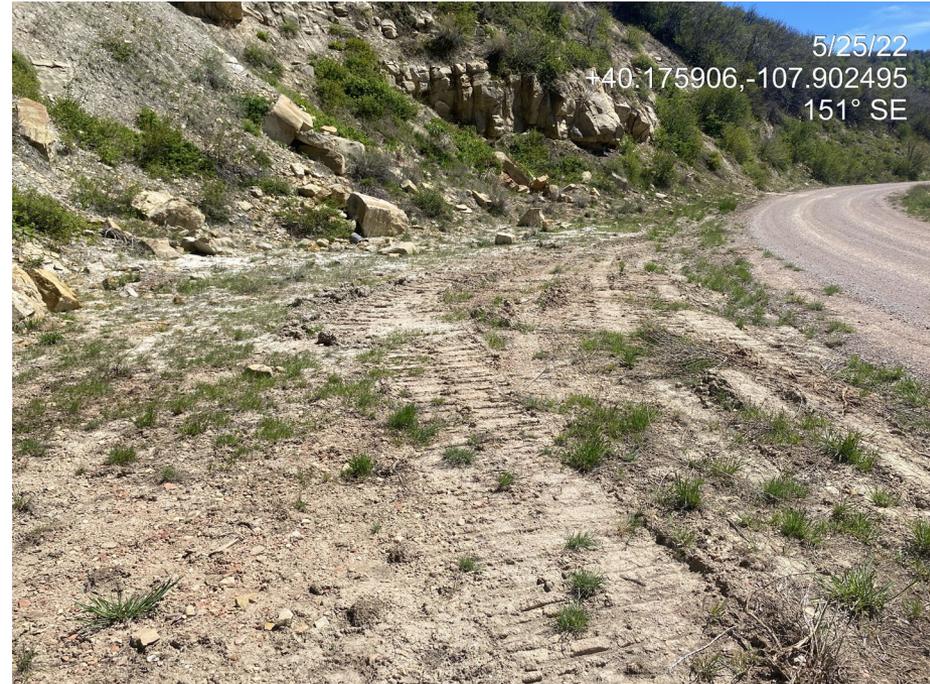
Photo 2. Photos taken from the south of the Location shows evidence of vehicle traffic and a high proportion of bare ground.

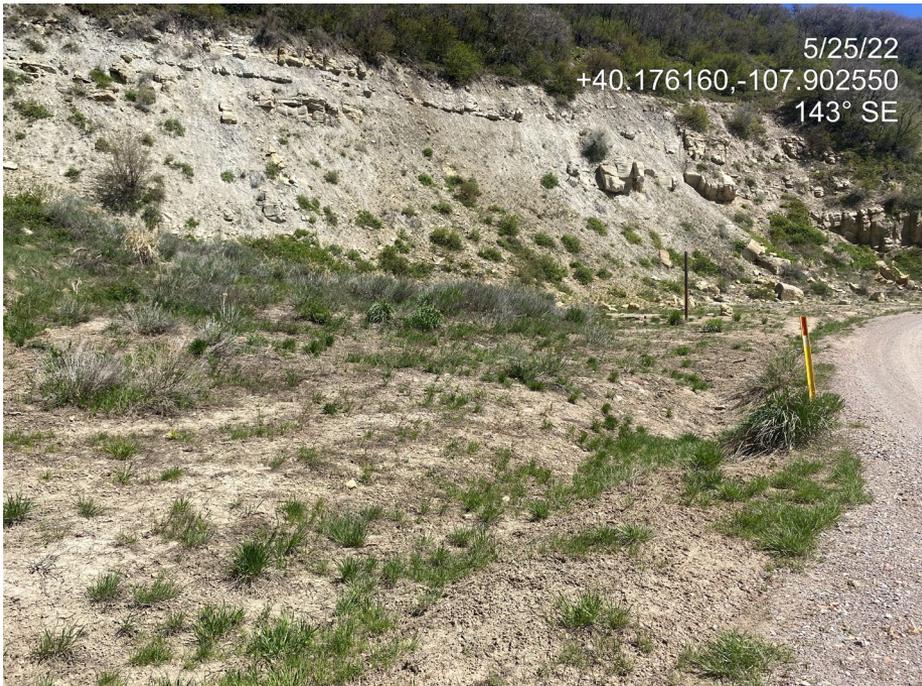
Photo 3. Photos taken from the north of the Location shows an overview of the Location and vegetation community.

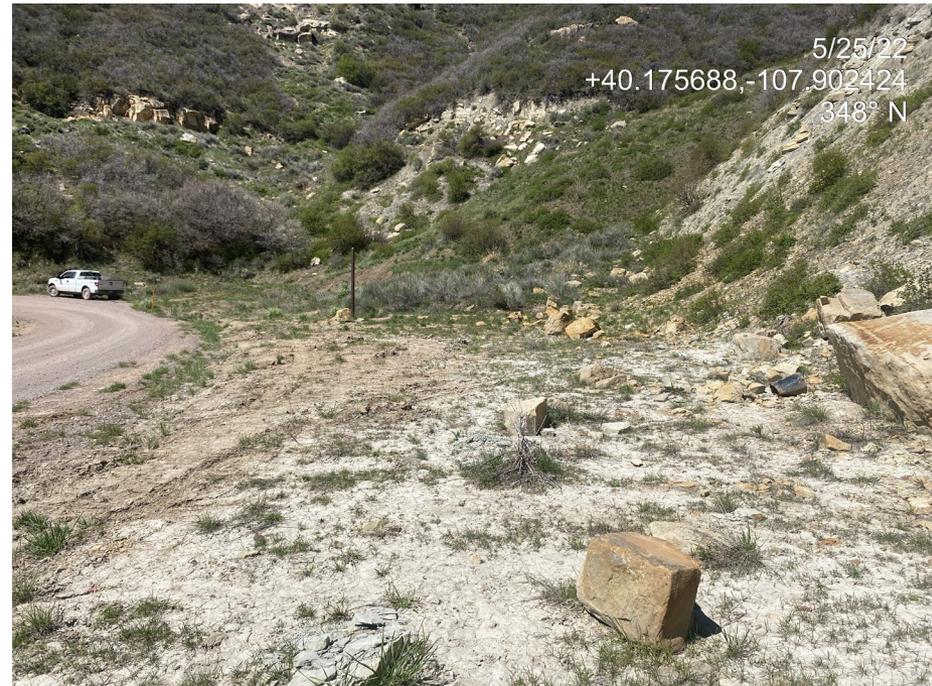
Photo 4. Photos taken from the south of the Location shows the vegetation community consisting of perennial grasses and a high proportion of bare ground, compared to reference areas levels.

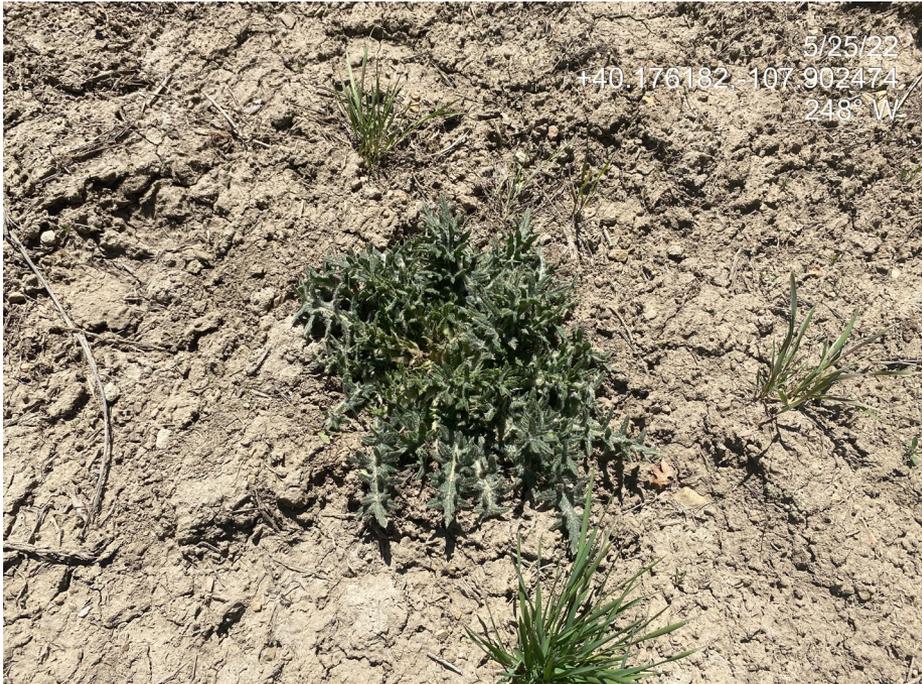
Photo 5. Photos shows bull thistle, a CO State List B Noxious Weed.

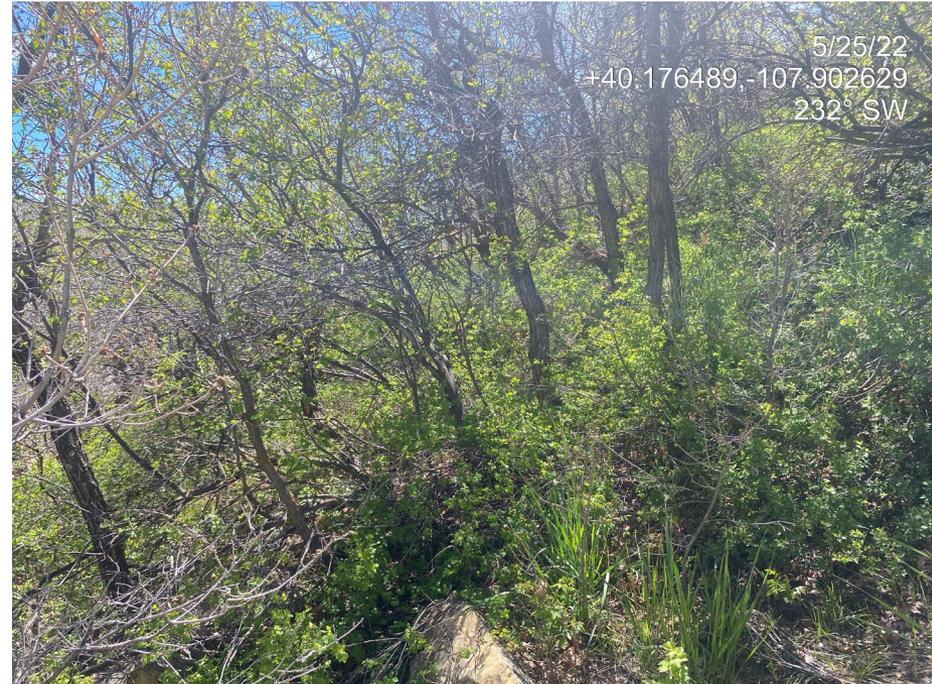
Photo 6. Photos taken to the northwest of the Location shows reference area vegetation.
