Inspection Photos

Operator: Caerus Piceance LLC- #10456

Location Name: Shideler-66S92W /32SWNE

Inspection Document #: 702800286

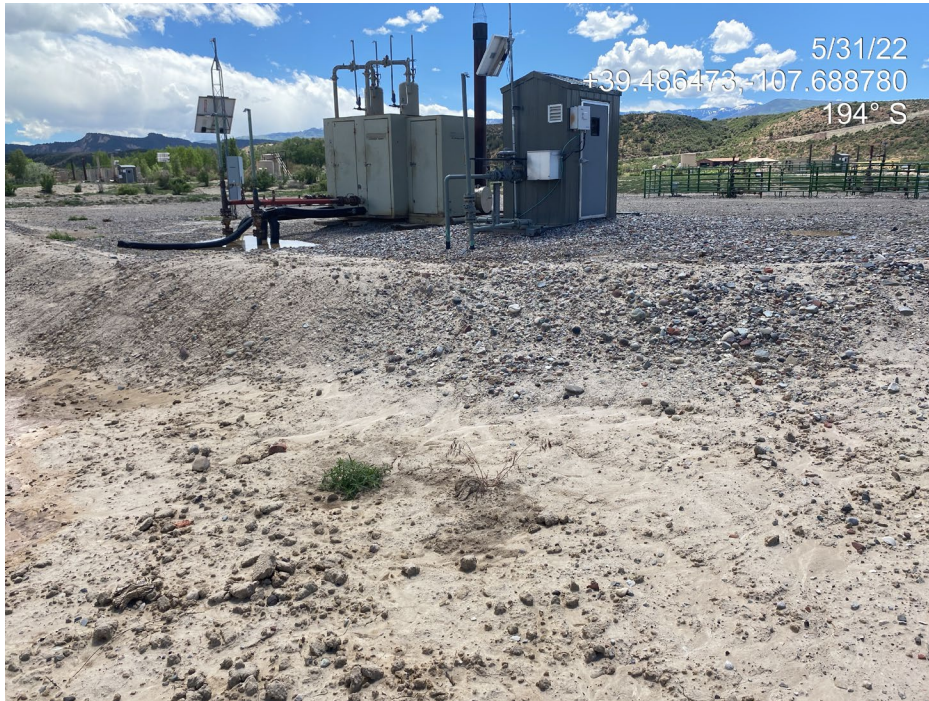
Photo 1. Photo taken from the east of the Location behind the separator shows the previously undermining berm is intact. Photo shows the view from the outside of the berm.

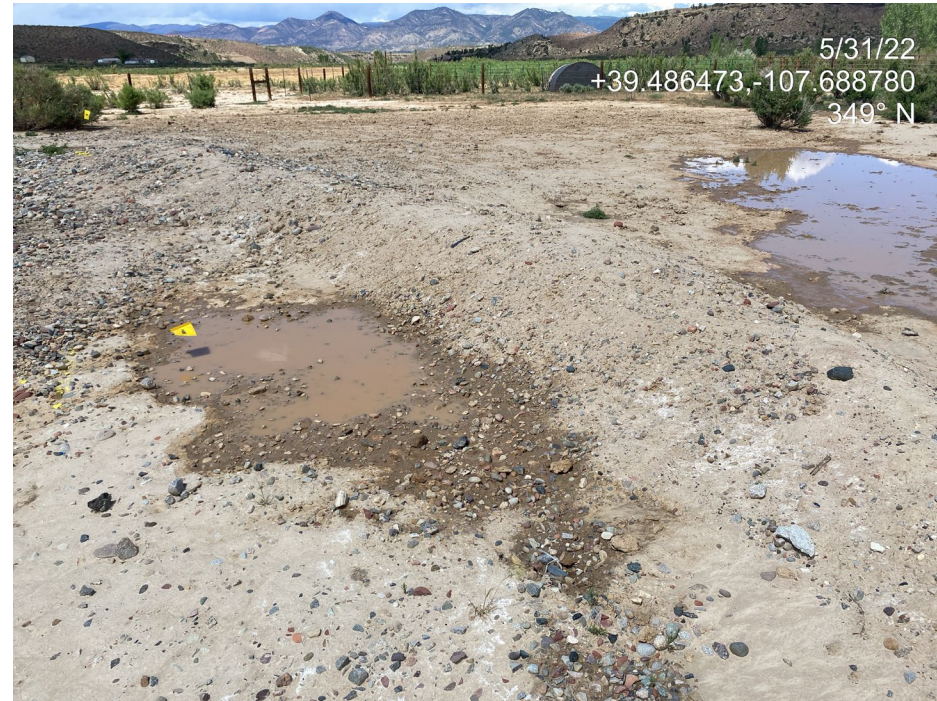
Photo 2. Photo taken from the east of the Location behind the separator shows the previously undermining berm is intact. Photo shows the view from the inside of the berm.

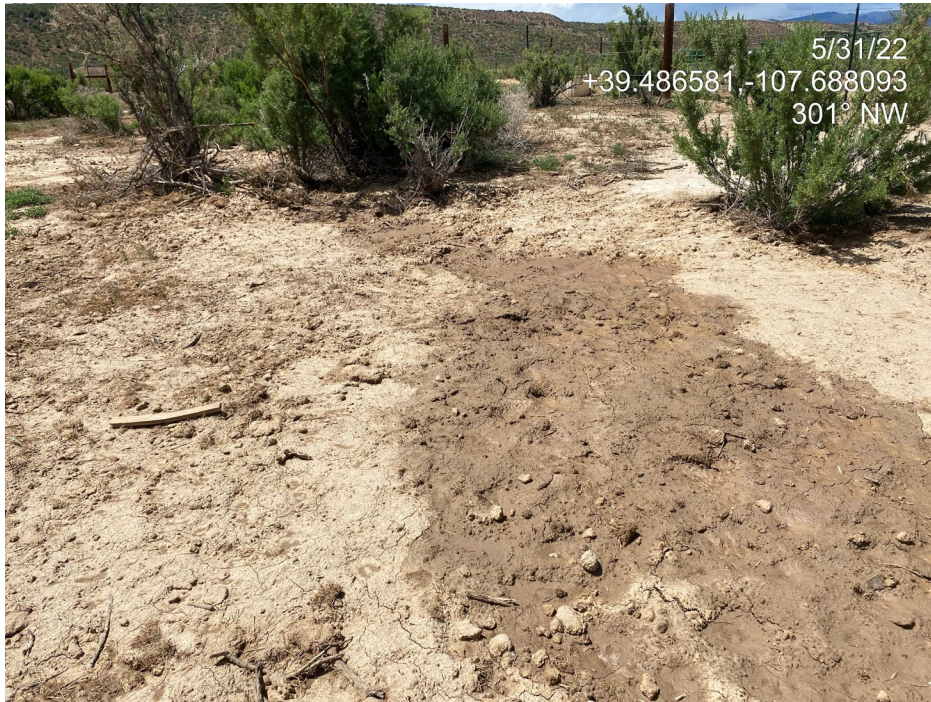
Photo 3. Photo taken from the east of the Location shows where erosion was raked. Erosion continues at the site, as no control measures were implemented to stabilize soils.

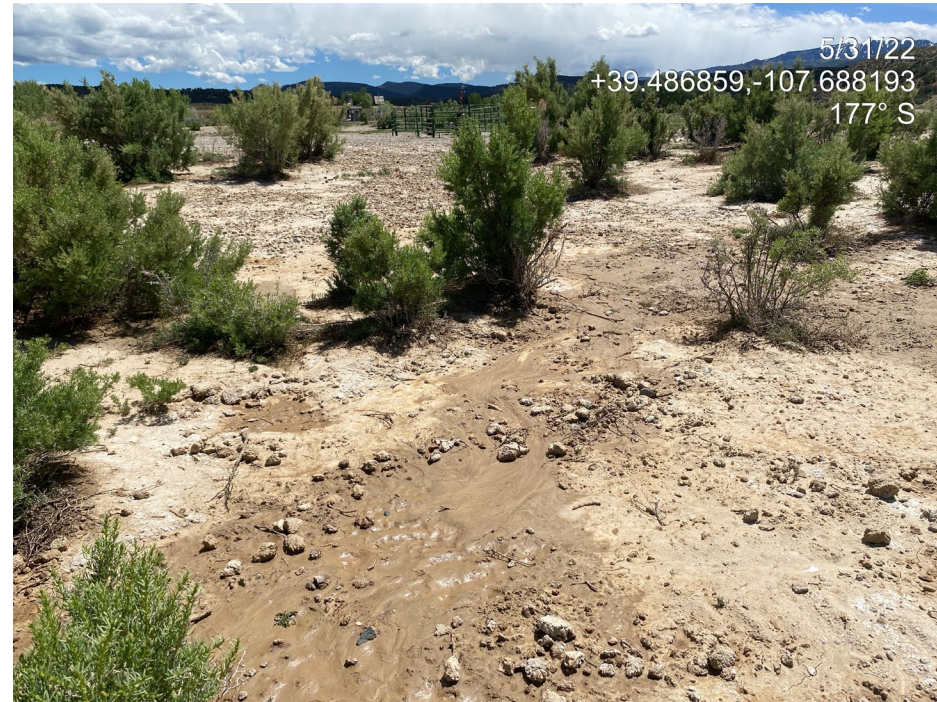
Photo 4. Refer to Photo 3 comment.

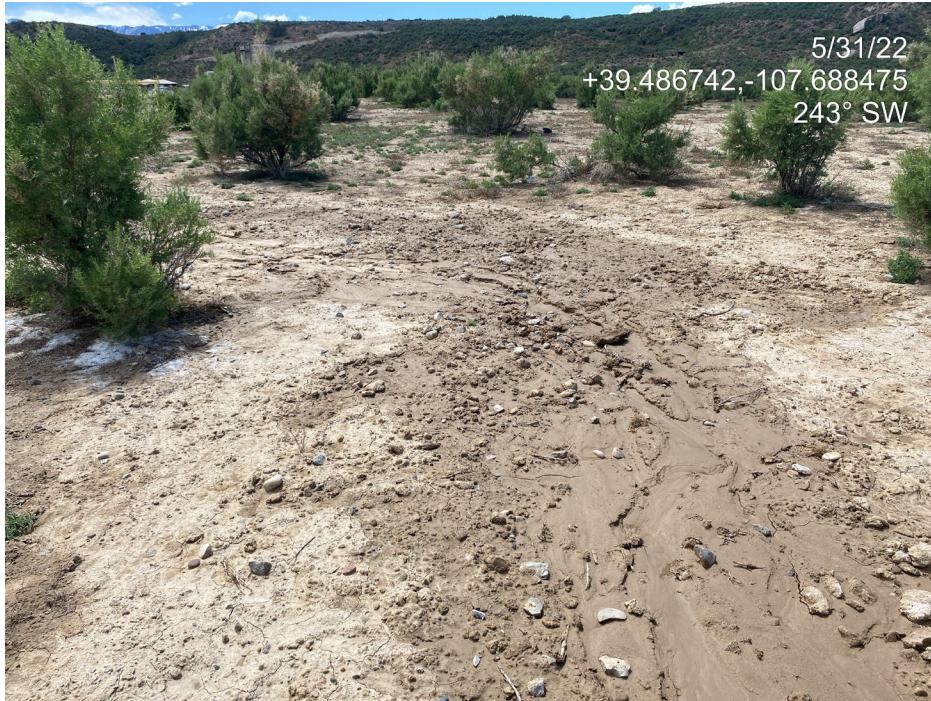
Photo 5. Photo taken from the north of the Location shows where a gully was raked. Erosion continues at the site, as no control measures were implemented to stabilize soils.

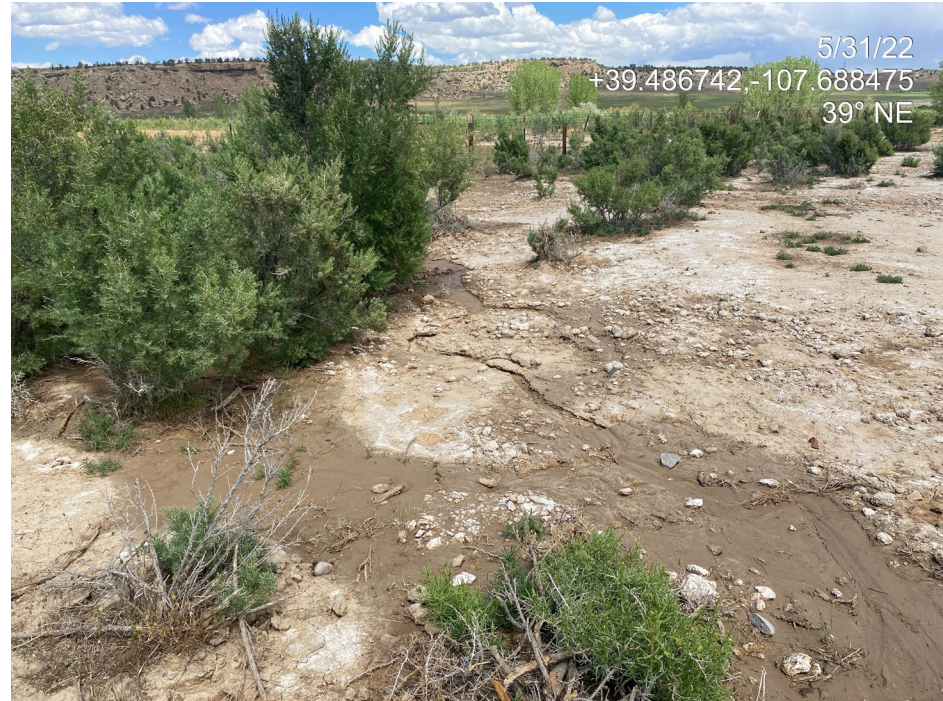
Photo 6. Refer to Photo 5 comment.
