Inspection Photos

Operator: Caerus Piceance LLC - #10456

Location Name: Benzel Disposal-66S93W /36NWNE

Inspection Document #: 702800296

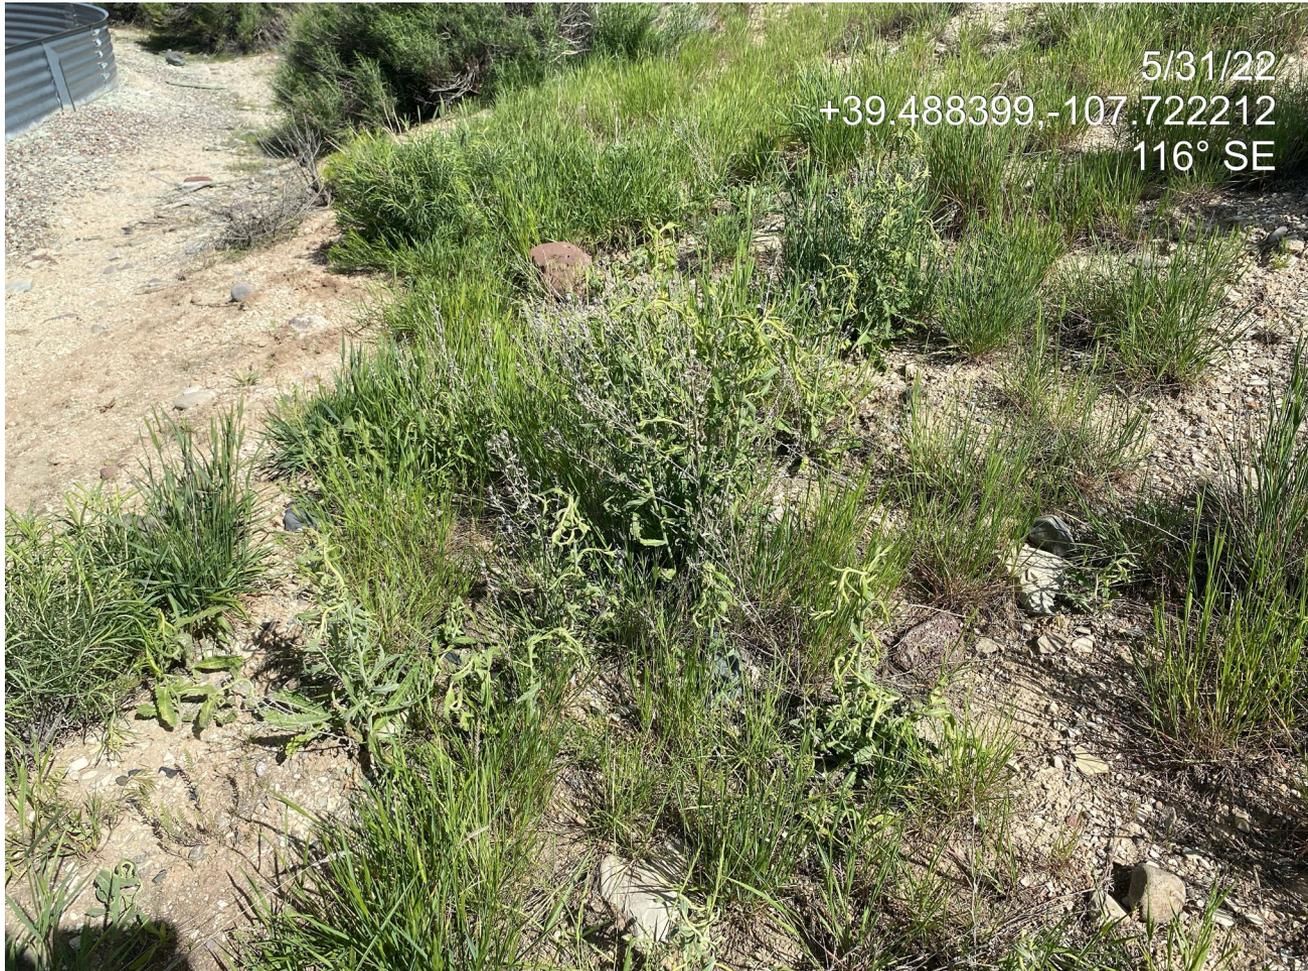
Photo 1. Photo taken from the southwest of the Location shows knapweed which appears to have been treated with herbicide.

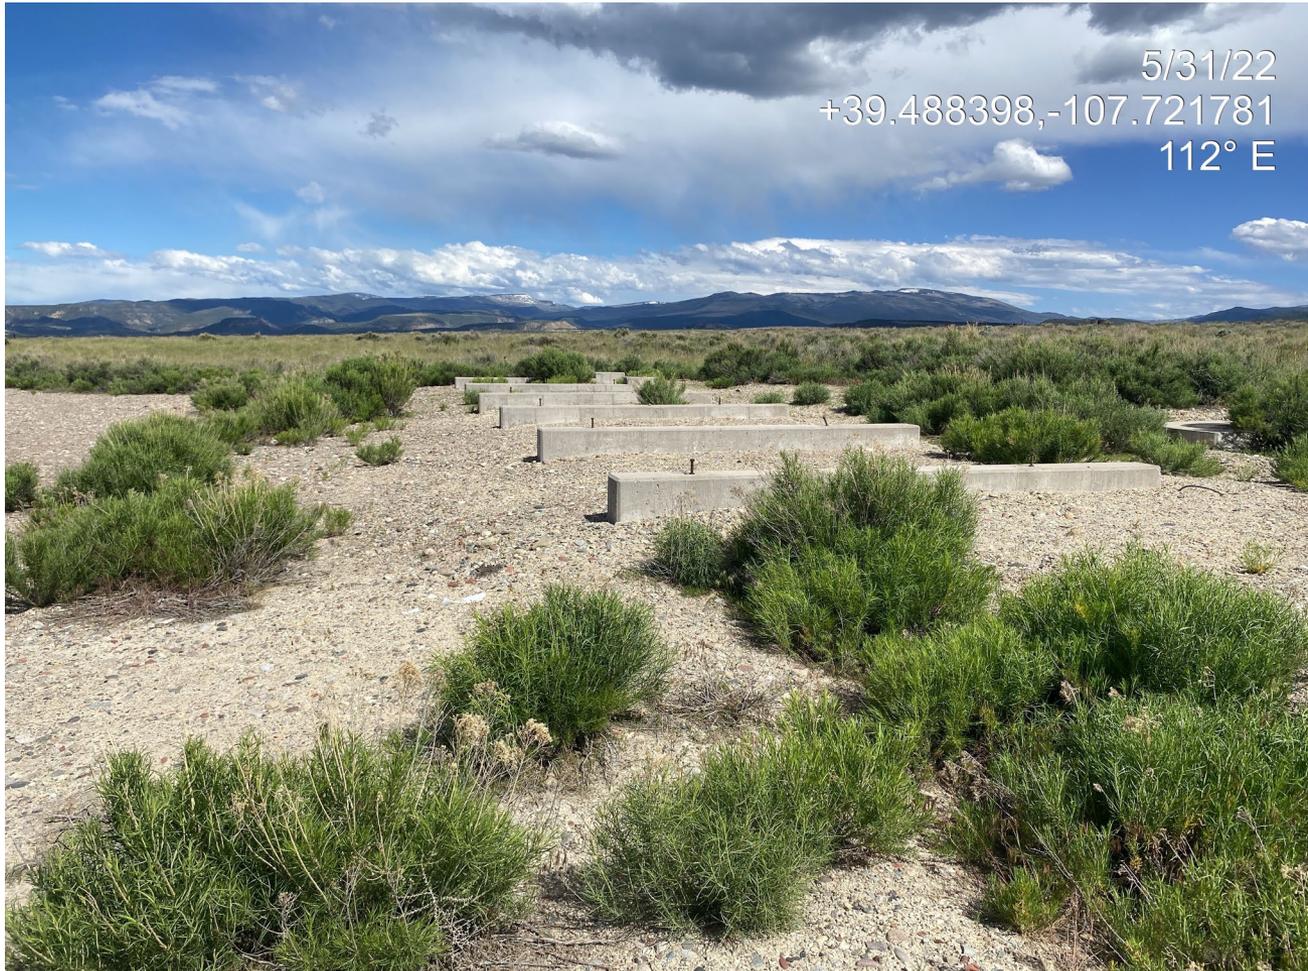
Photo 2. Photo taken from the south of the Location shows concrete forms no longer in use and adjacent areas requiring interim reclamation.

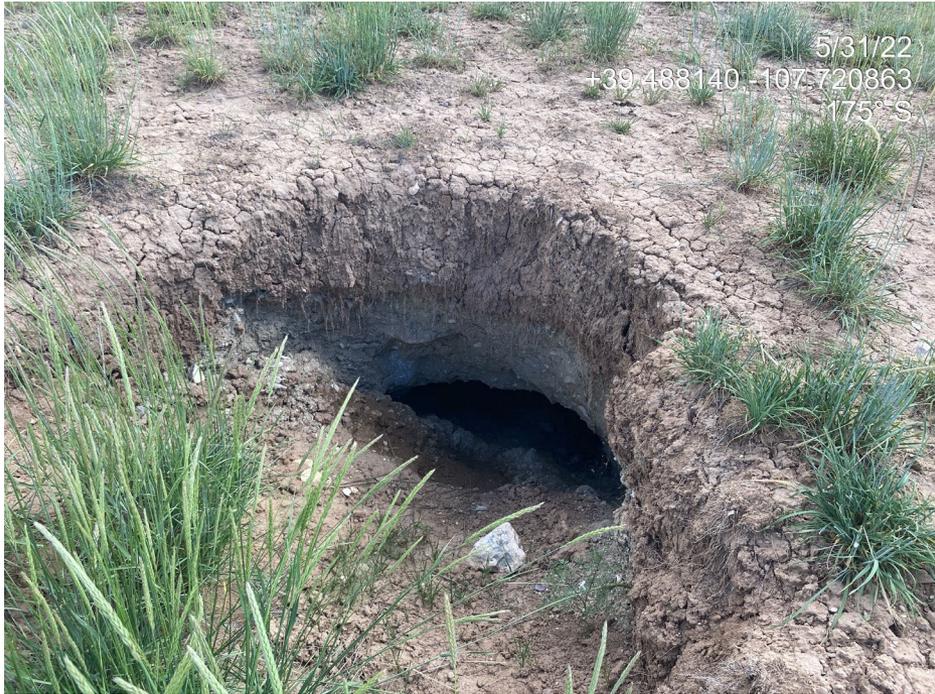
Photo 3. Photo taken from the east of the Location shows subsidence resulting in dangerous holes.

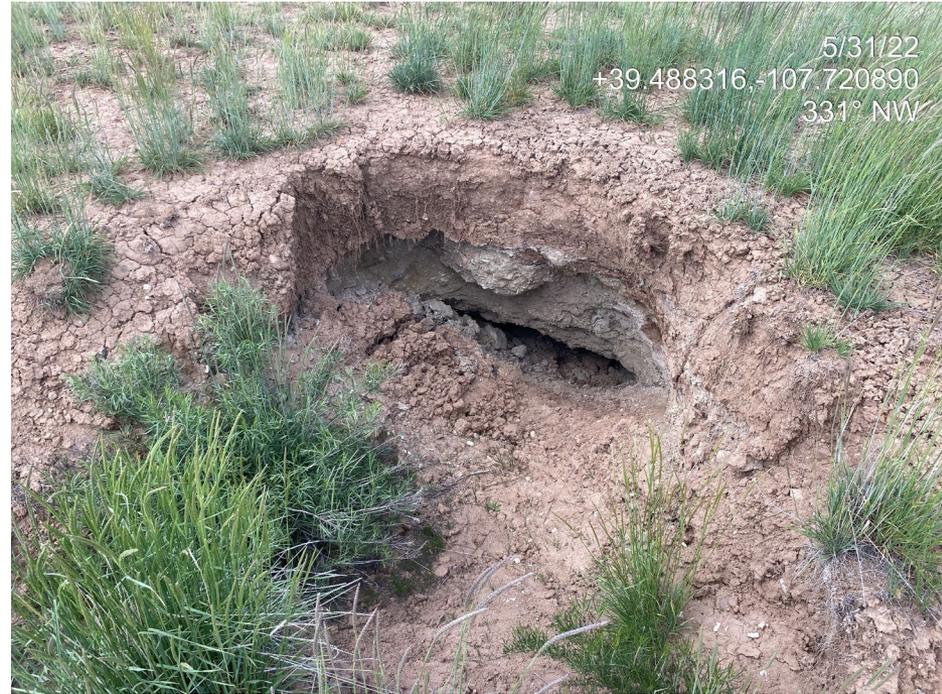
Photo 4. Refer to Photo 3 comment.
