Inspection Photos and Issue Report

Operator: LARAMIE ENERGY LLC - 10433

Location ID: 312741

Mesa County, CO

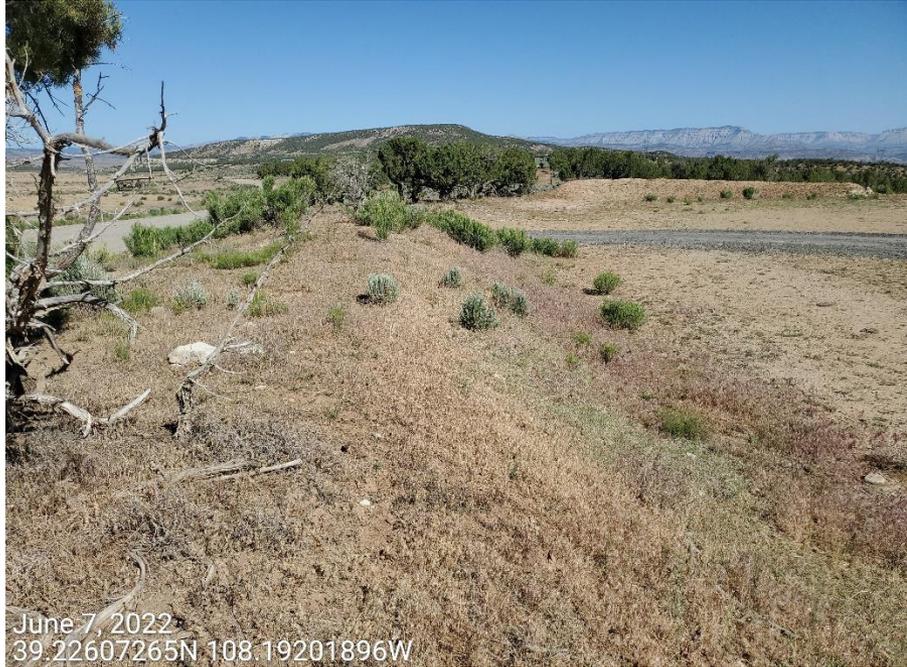
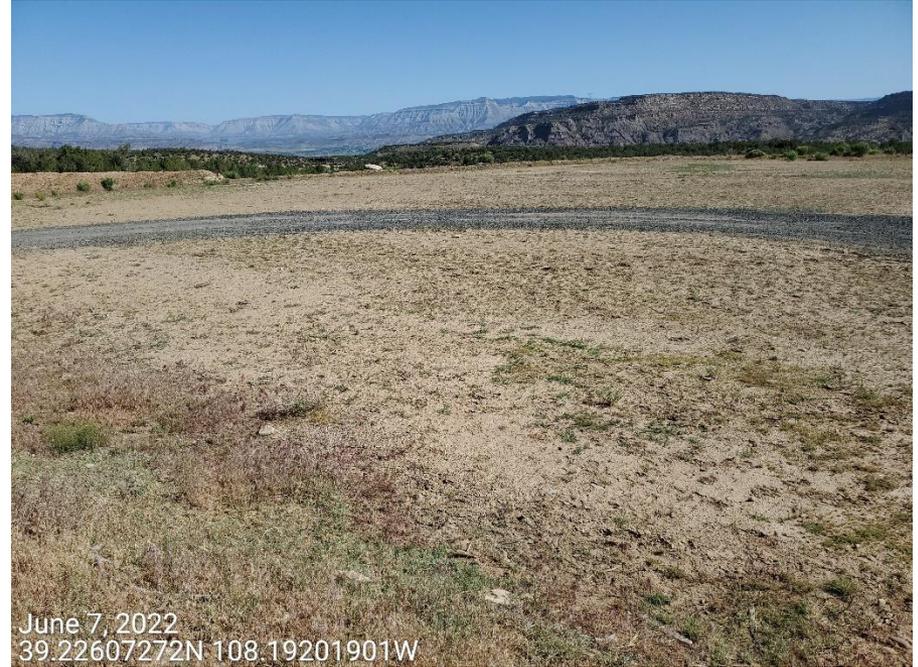
Photo 1: Photos taken from the south end of the Location. Photos 1-2 provide an overview of the Location from west, northwest, northeast to east. Photos show Location has not been reclaimed in accordance with 1004 rules, including but not limited to, removal of gravel, compaction alleviation, recontouring/regrading, and revegetation activities.

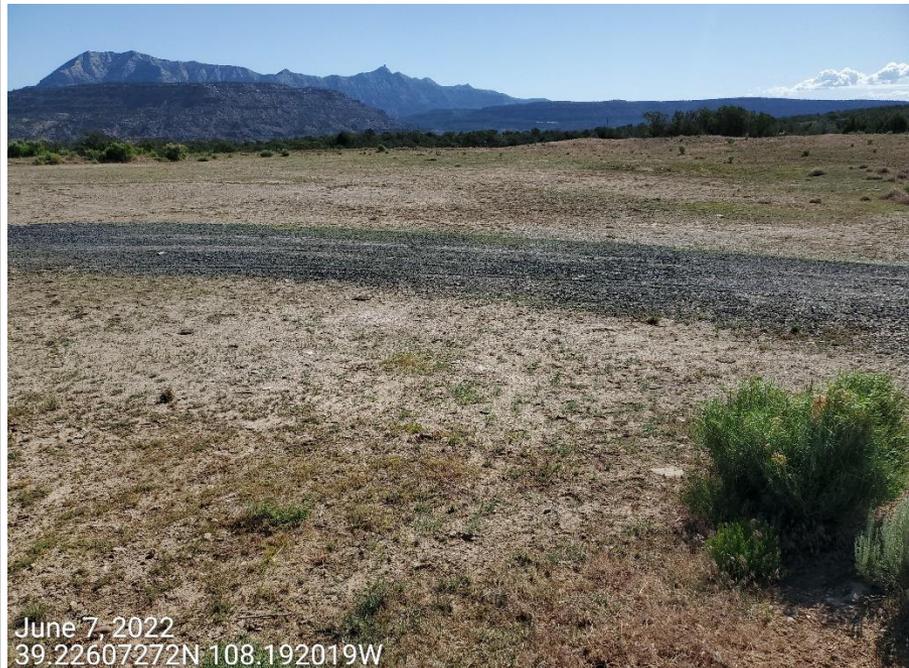
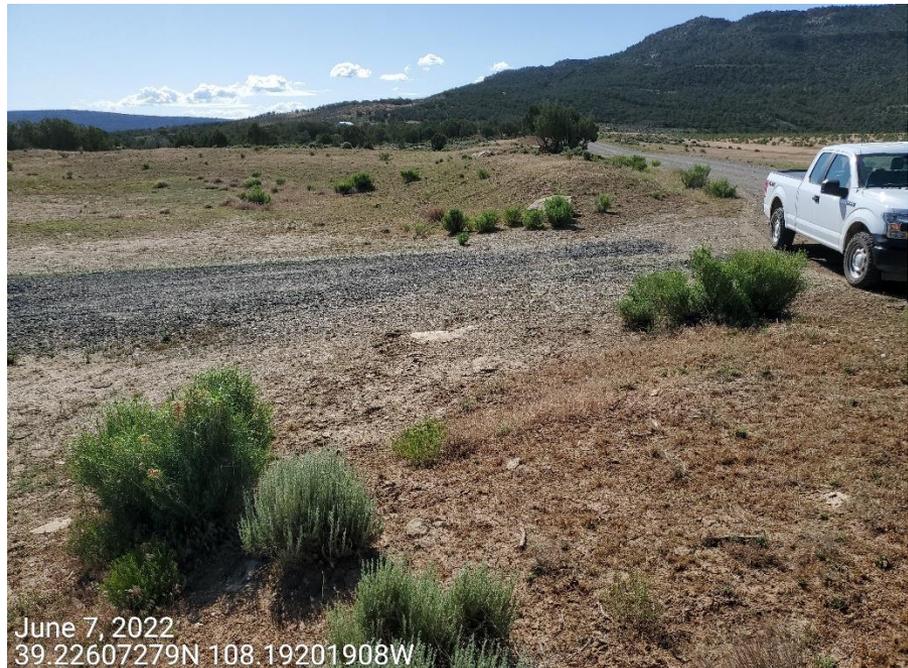
Photo 2: See comments under photo 1.

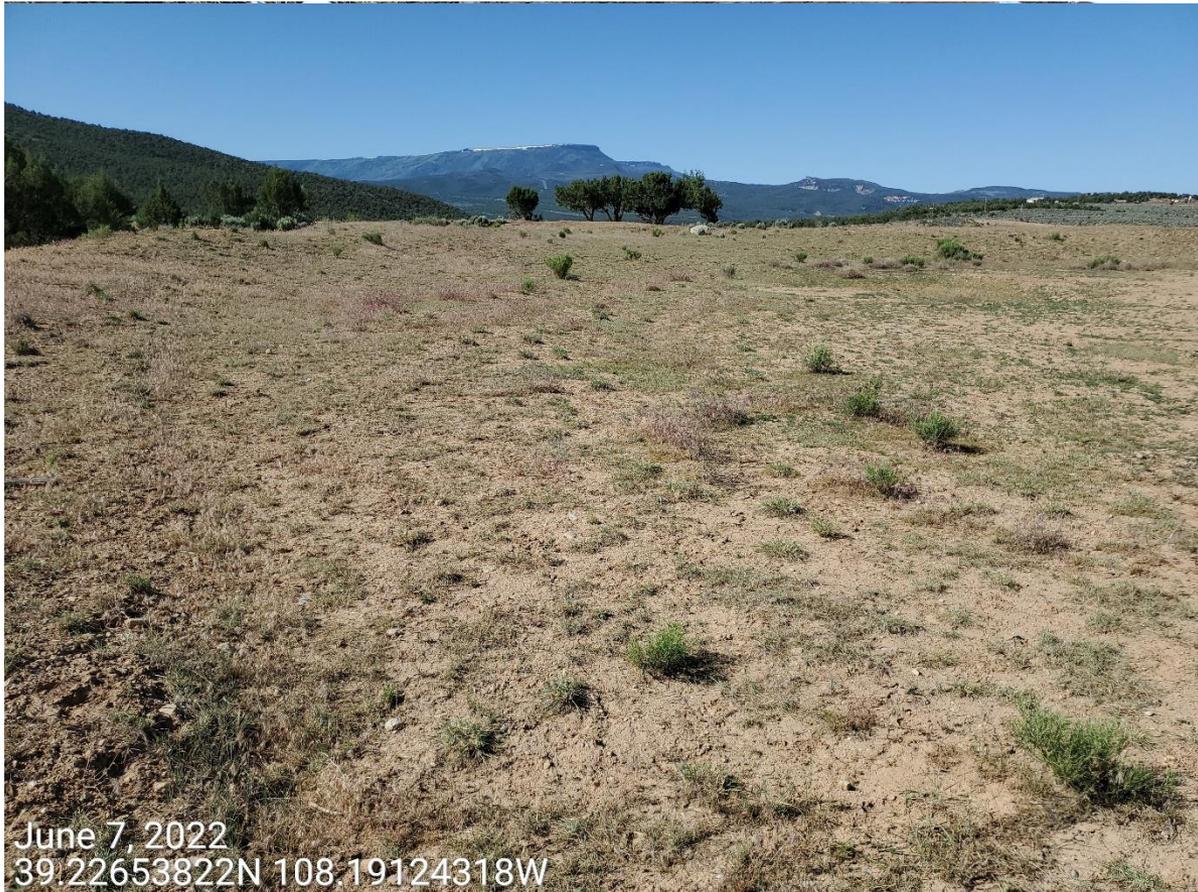
Photo 3: Photo taken from the east end of the Location. Photos 3-5 provide an overview of the Location from southwest, west and northwest. Photos show Location has not been reclaimed in accordance with 1004 rules, including but not limited to, removal of gravel, compaction alleviation, recontouring/regrading, and revegetation activities.

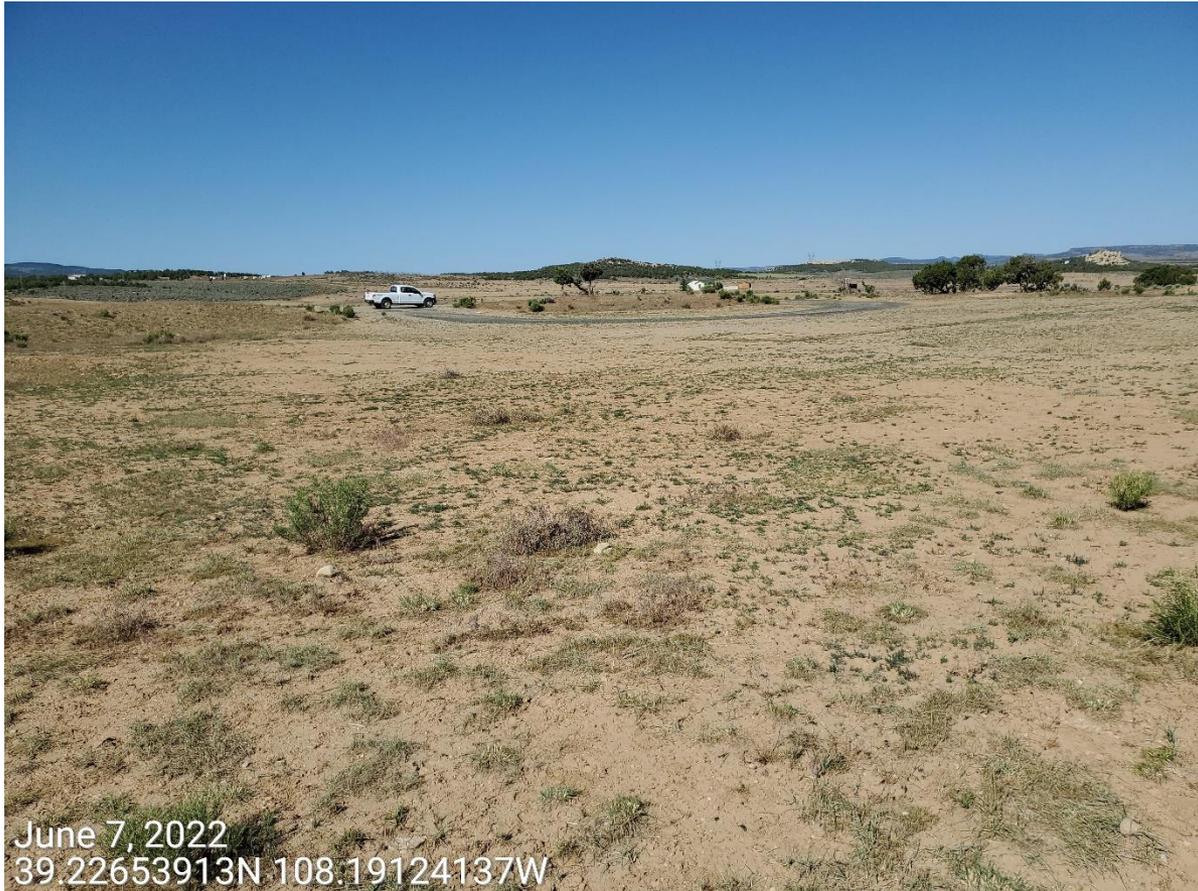
Photo 4: See comments under photo 3.

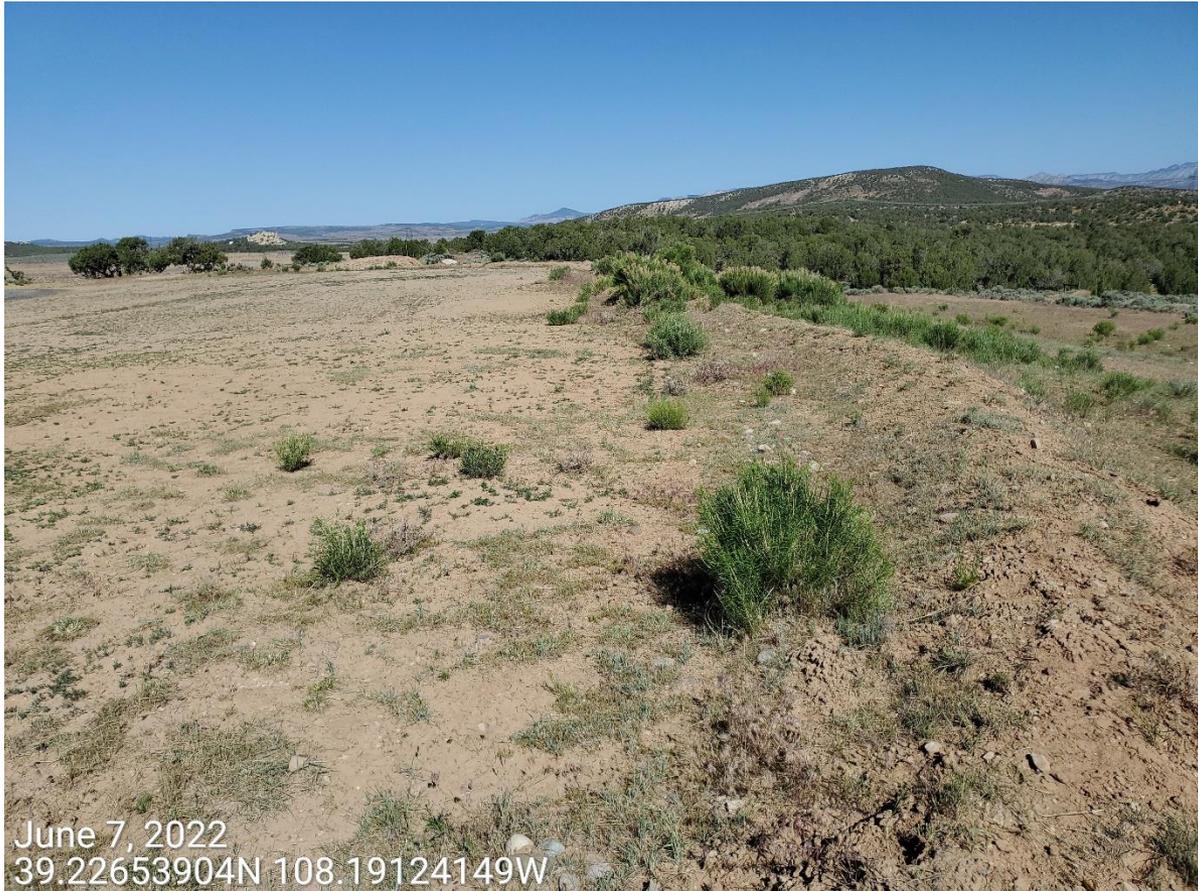
Photo 5: See comments under photo 3.

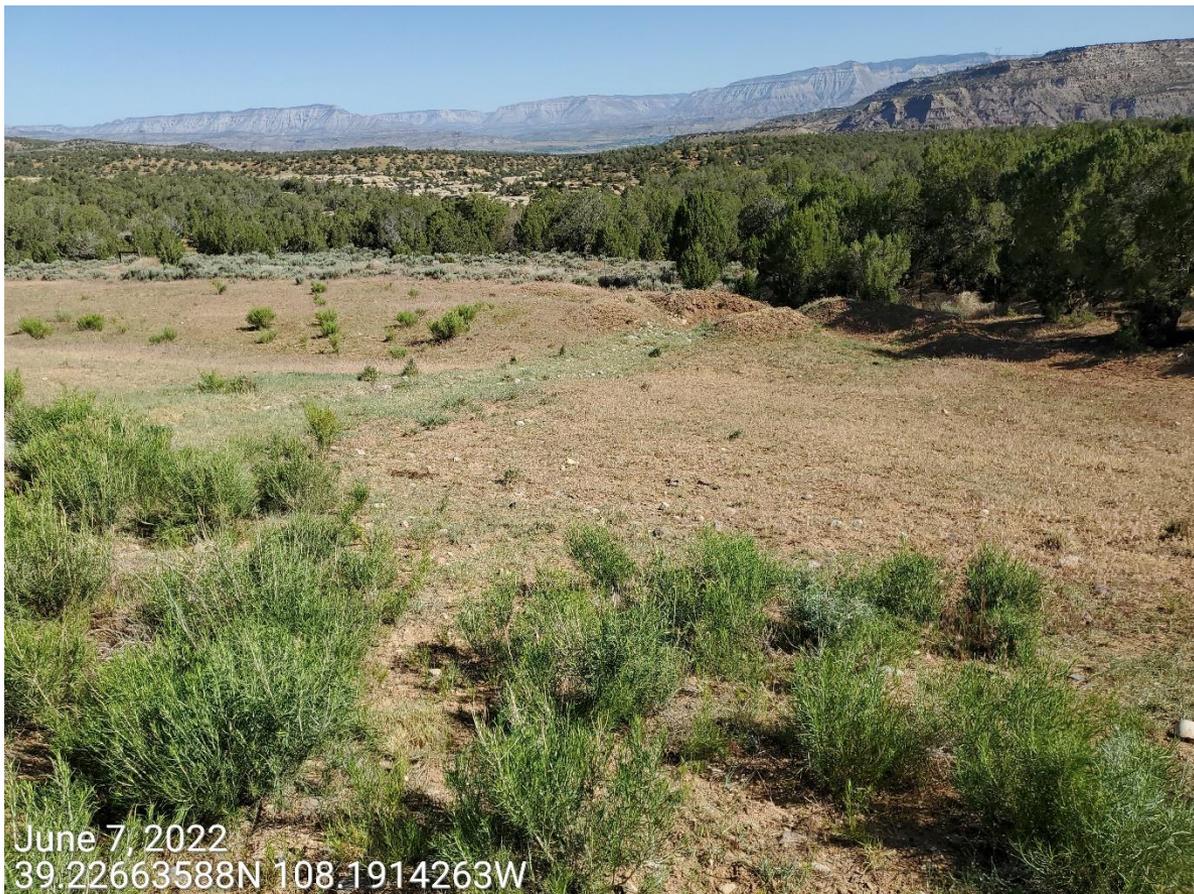
Photo 6: Photo shows stormwater control measures (sediment trap) on the north end of the Location that also has not been reclaimed.
