Inspection Photos

API: 055-06201

Operator: EVERGREEN NATURAL RESOURCES

Inspection Date: 6/7/2022

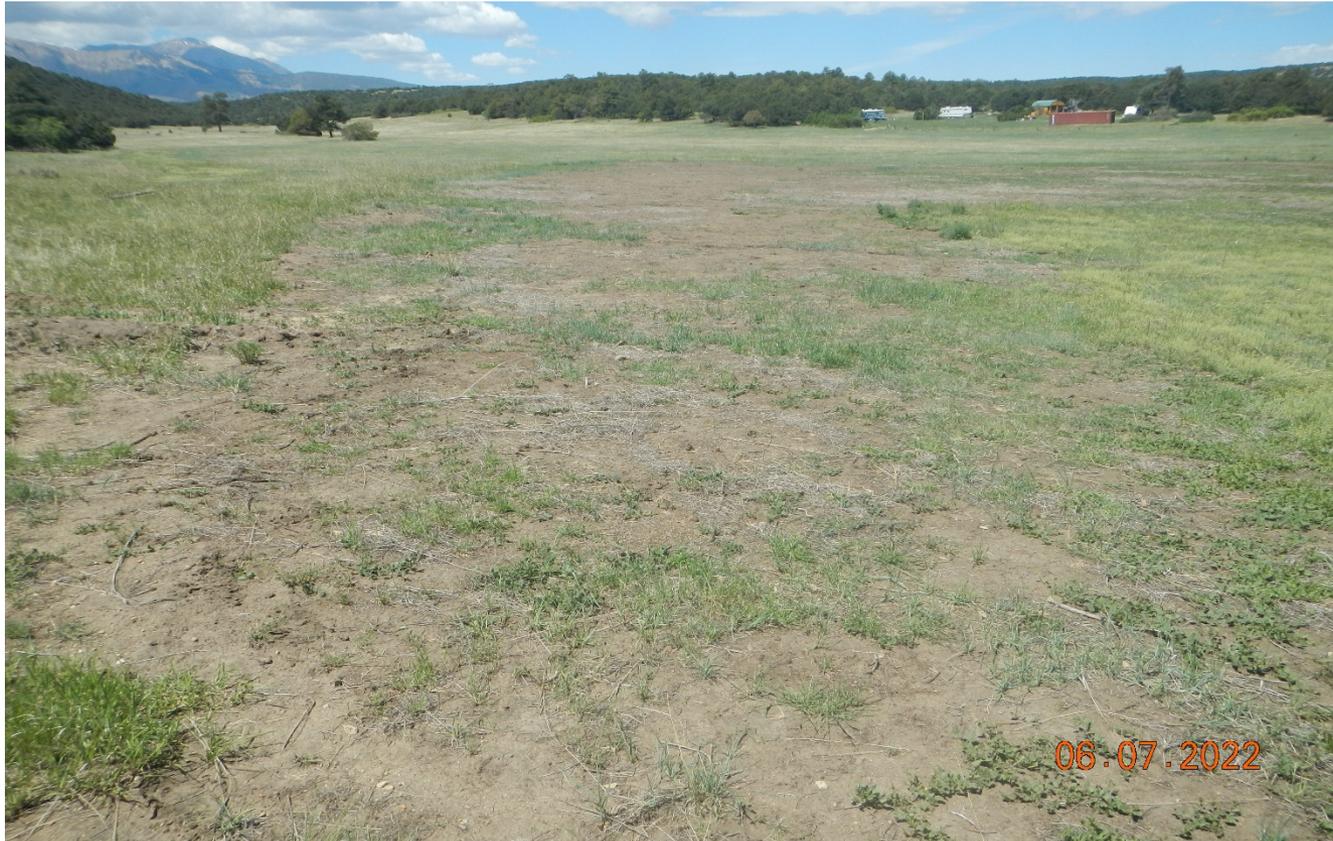
Photo 1. Facing west along the former access road. It appears weed control was performed due to bare ground. There are still noxious weeds present including Field bindweed, Red stem filaree, and Jointed goatgrass.

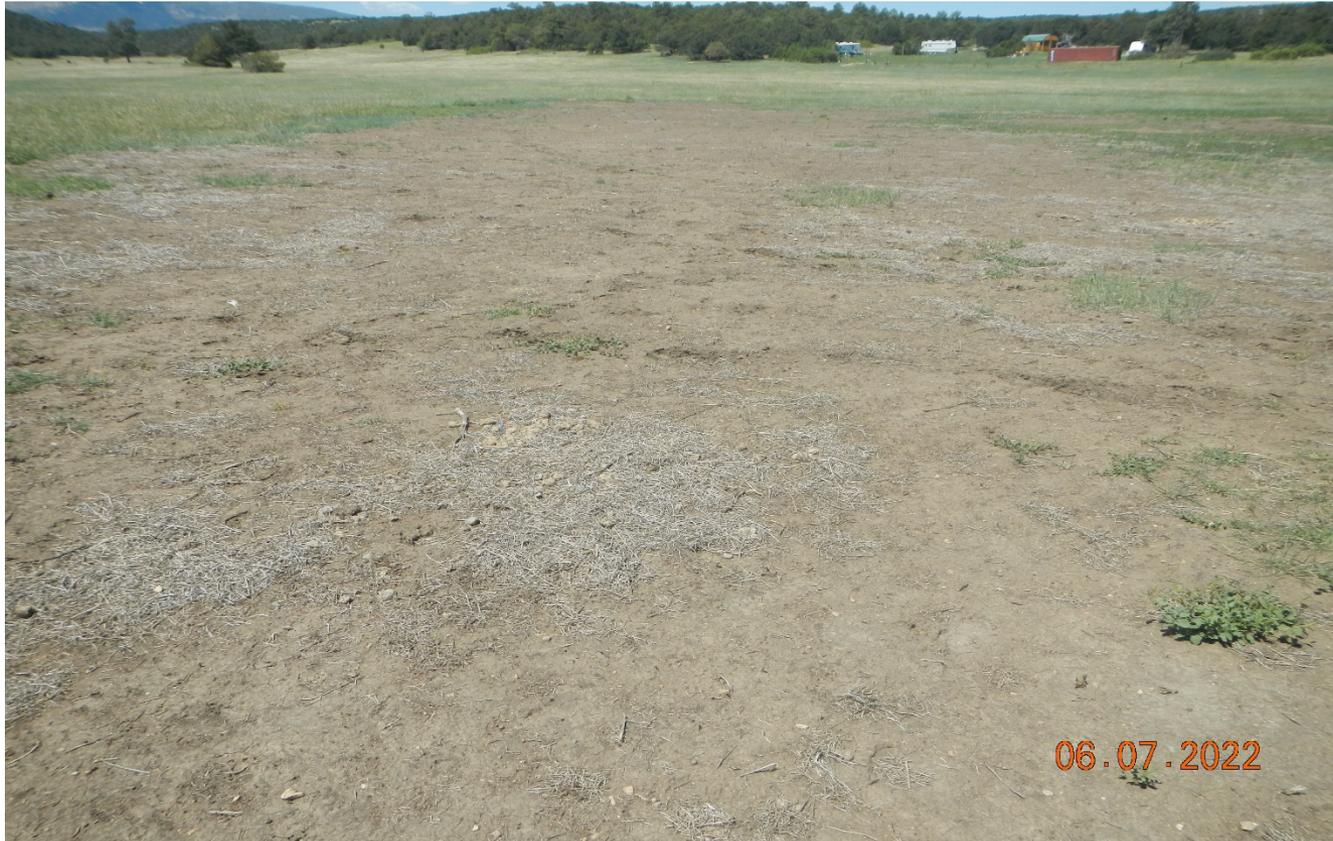
Photo 2. Facing west at the location. It appears weed control was performed due to bare ground. There are still noxious weeds present including Field bindweed, Red stem filaree, and Jointed goatgrass. Noxious weeds need to be controlled and the location reseeded.

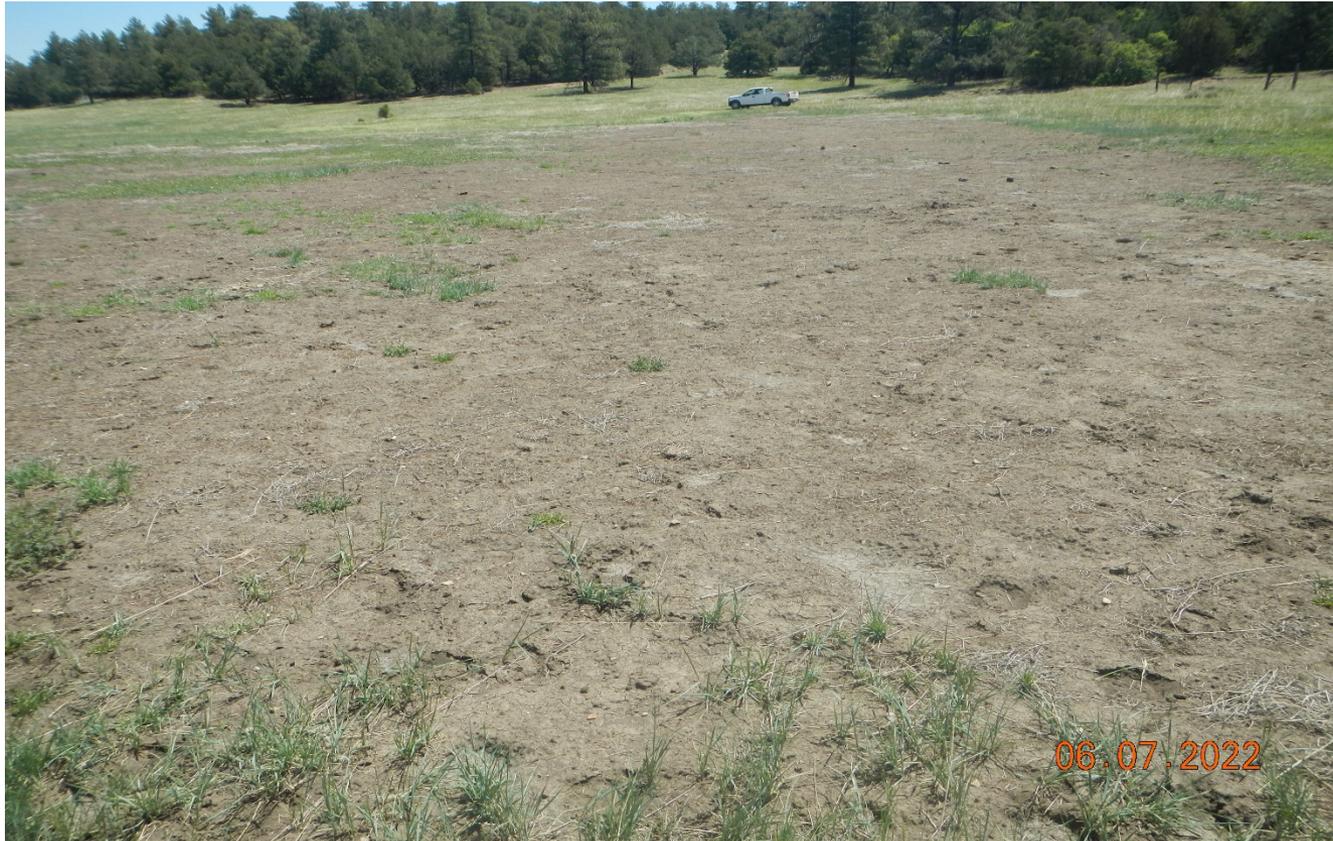
Photo 3. Facing east at the location. It appears weed control was performed due to bare ground. There are still noxious weeds present including Field bindweed, Red stem filaree, and Jointed goatgrass. Noxious weeds need to be controlled and the location reseeded.

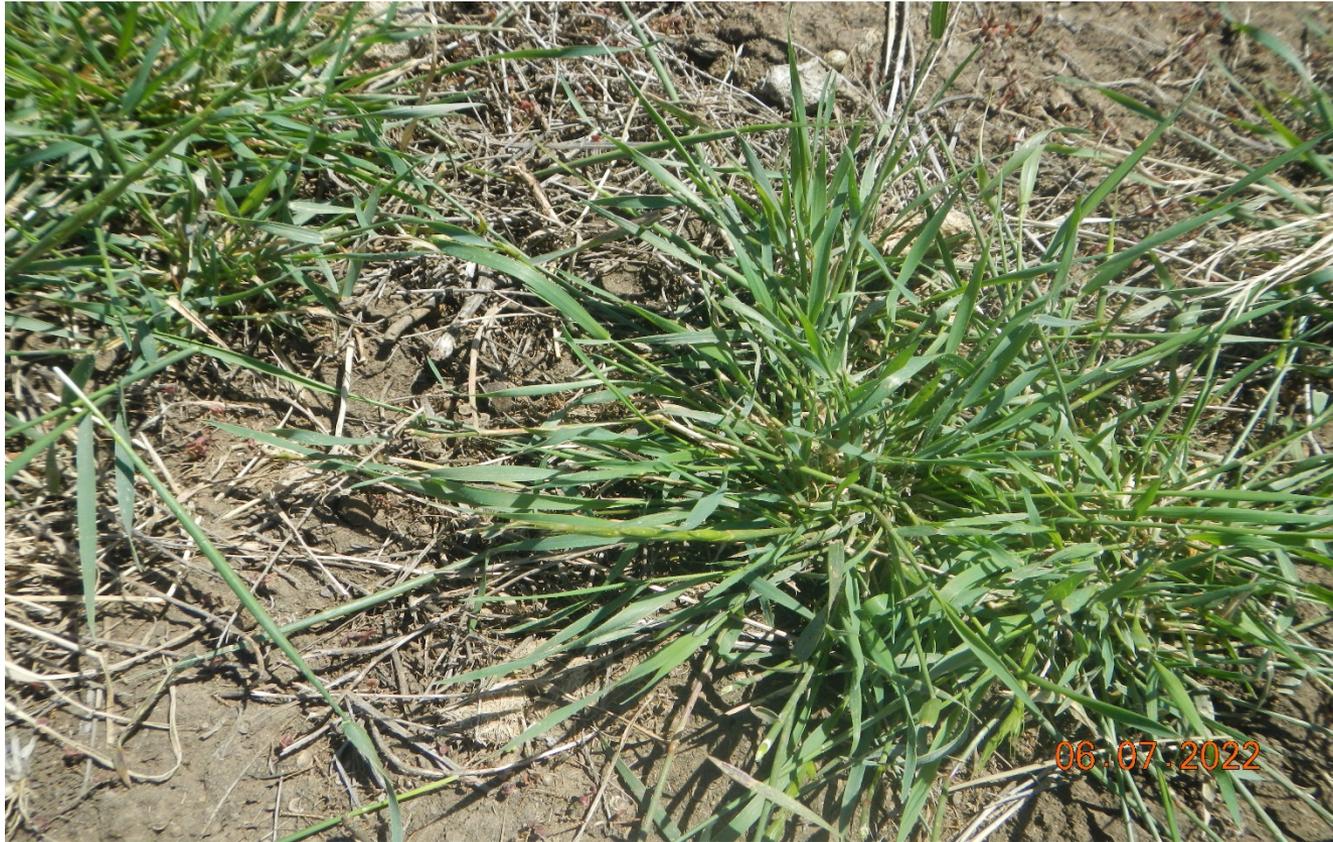
Photo 4. There is still some Jointed goat grass found on location that needs to be controlled.

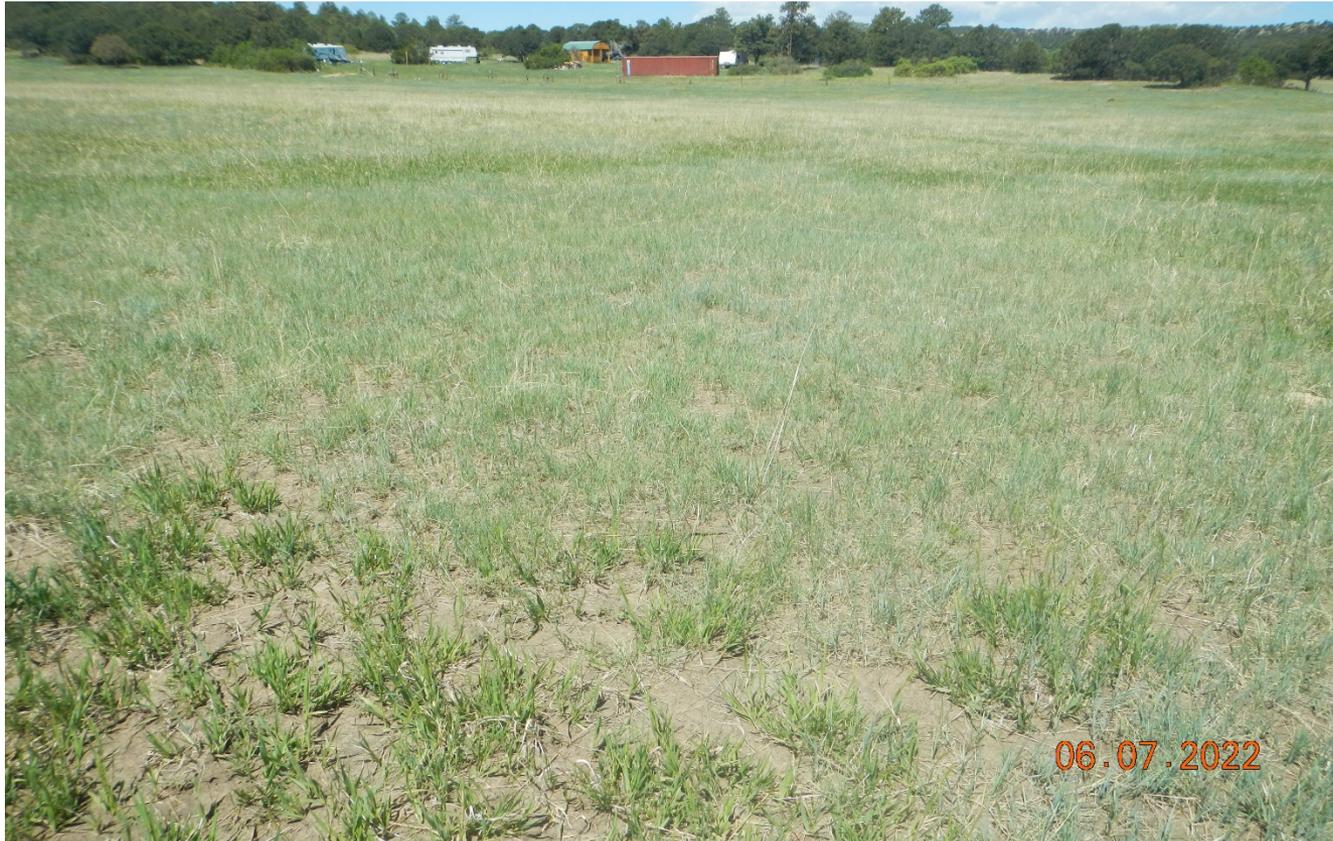
Photo 5. Facing west toward the surrounding undisturbed reference area which consists of desirable vegetation Western wheat grass, Smooth brome among other species.
