Inspection Photos and Issue Report

Operator: LARAMIE ENERGY LLC - 10433 /
BLACK HILLS PLATEAU PRODUCTION LLC -
10150

Location ID: 312504
Mesa County, CO

Aaron Trujillo
NW Reclamation Specialist
COGCC

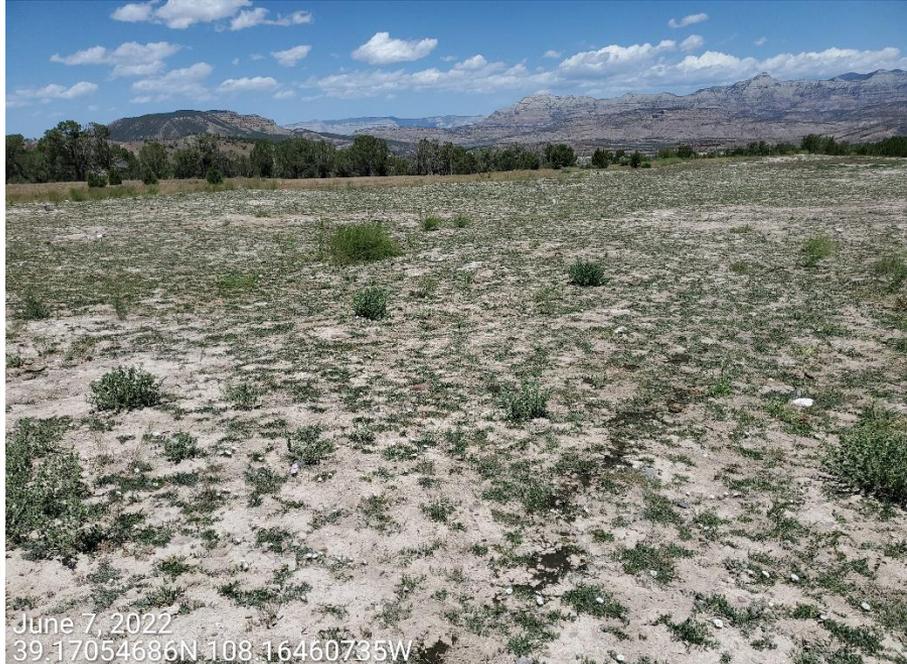
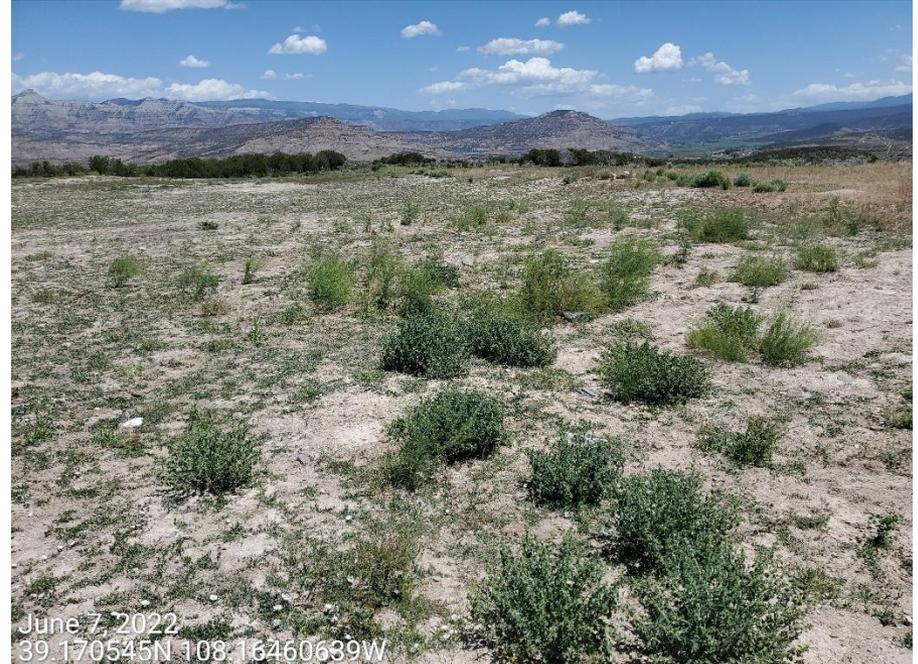
Photo 1: Photos taken from the south end of the Location, facing northwest, and northeast. Photos provide an overview of the Location. Location is predominantly undesirable plant species (Field Bindweed) and is not progressing towards 1004 requirements.

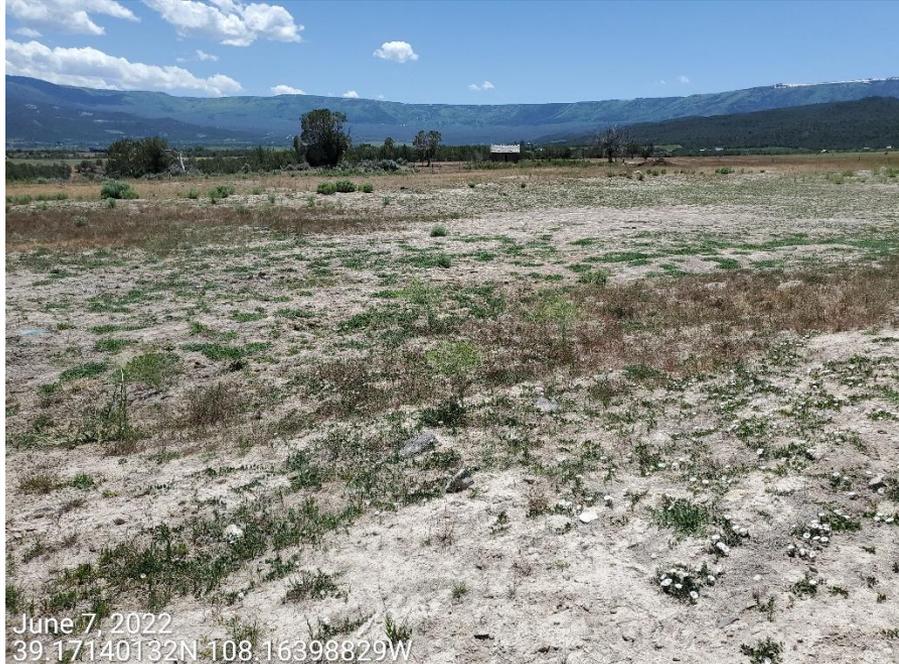
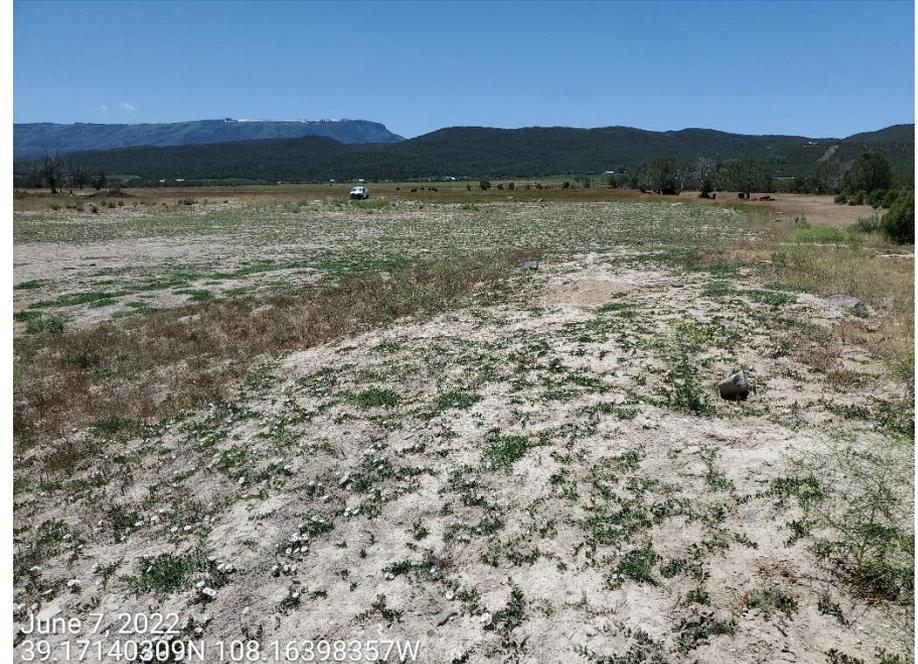
Photo 2: Photos taken from the northwest end of the Location, facing southeast and south. Photos provide an overview of the Location. Location is predominantly undesirable plant species (Field Bindweed) and is not progressing towards 1004 requirements.

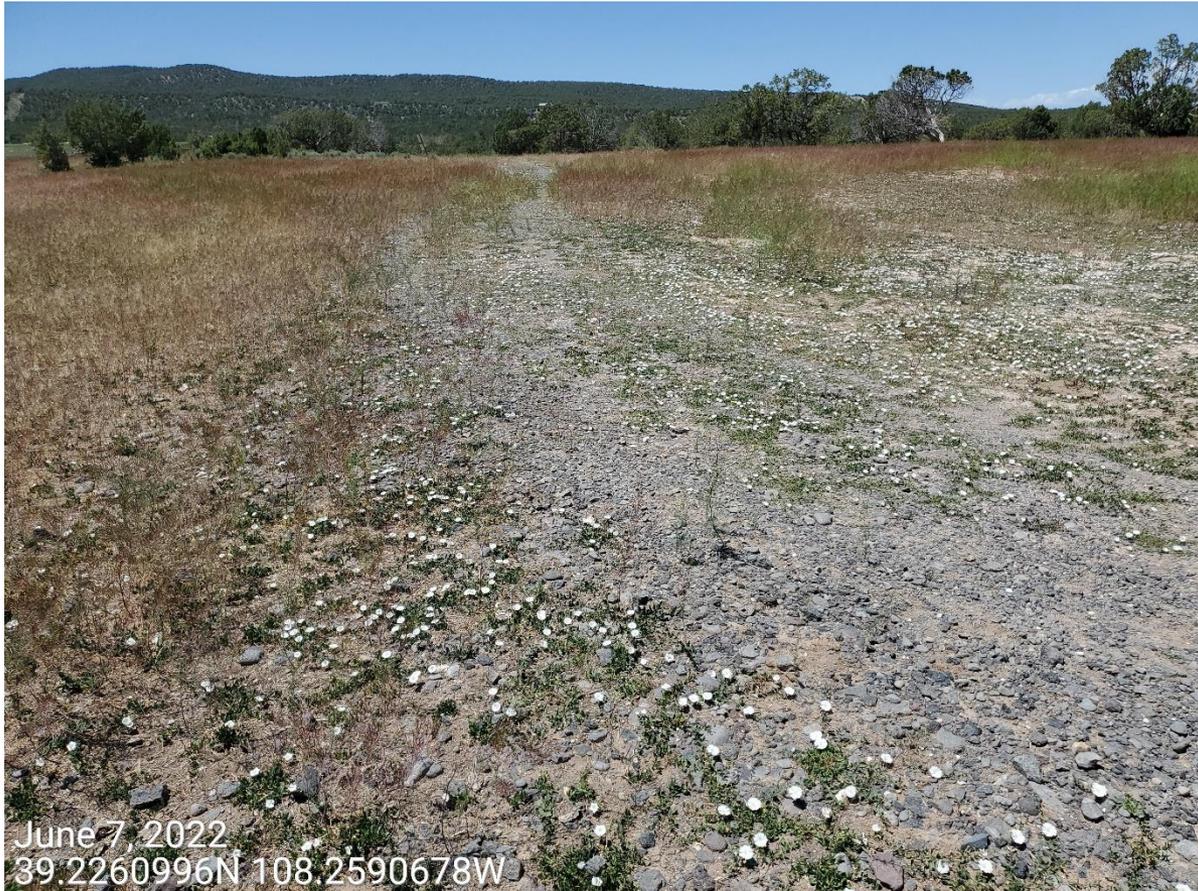
Photo 3: Photo shows access road through Location has not bene reclaimed.

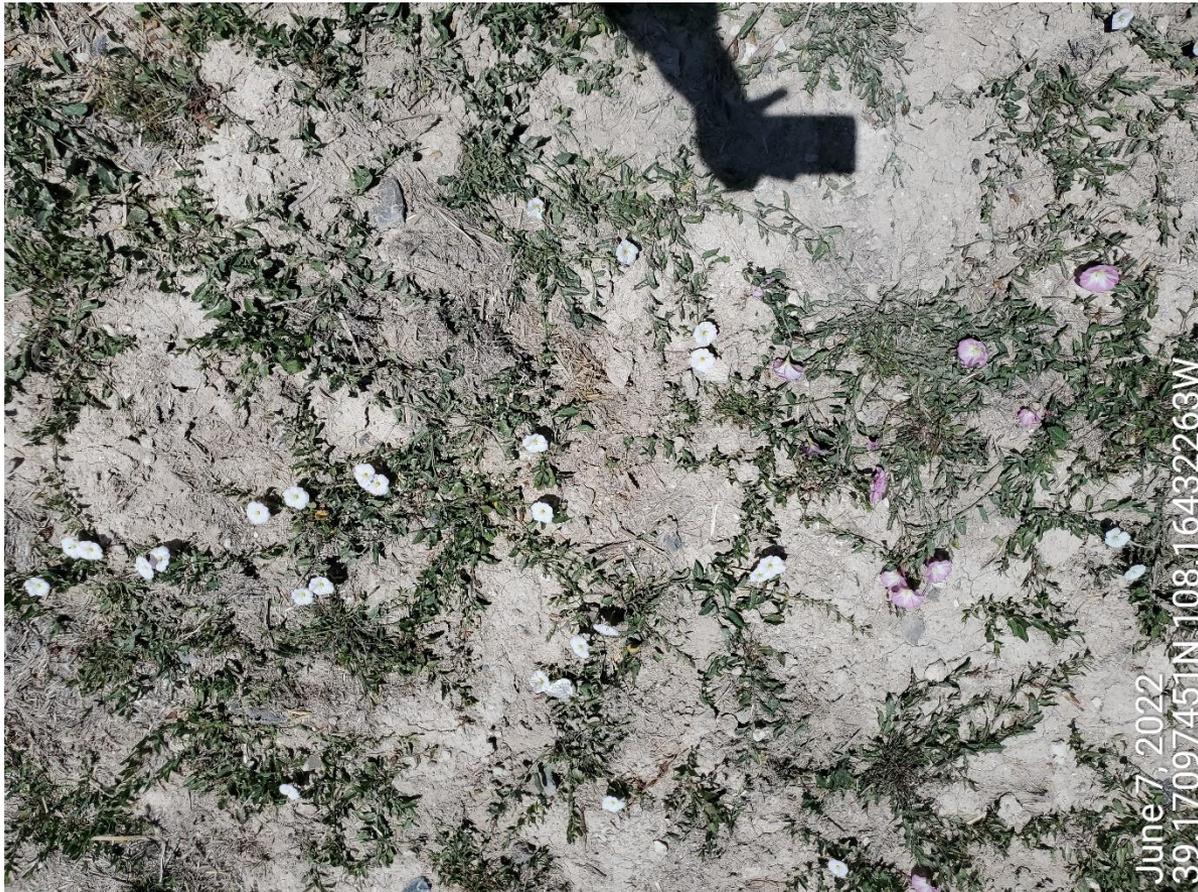
Photo 4: Photo Location is predominantly undesirable plant species (Field Bindweed) and is not progressing towards 1004 requirements.

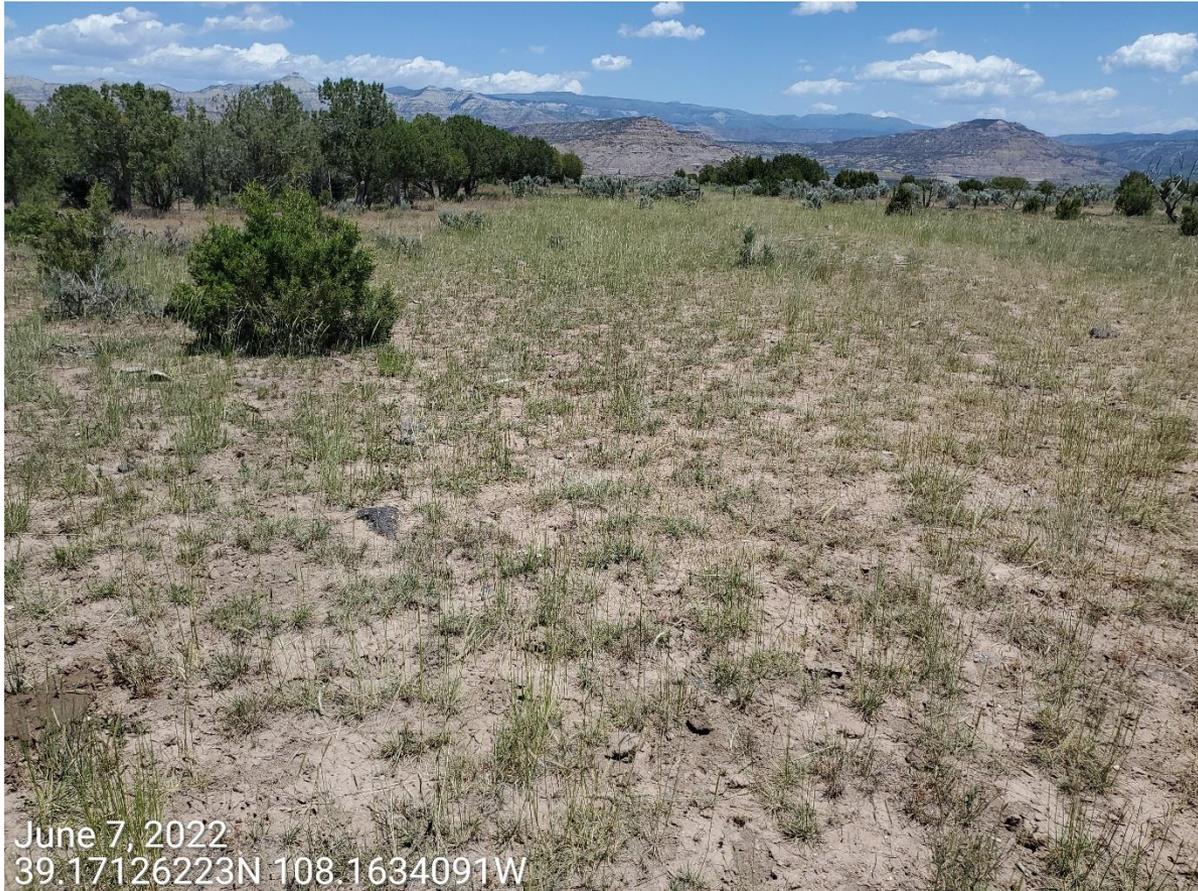
Photo 5: Photo example of vegetation on the adjacent reference area.
