Inspection Photos and Issue Report

Operator: LARAMIE ENERGY LLC - 10433

Location ID: 312733

Mesa County, CO

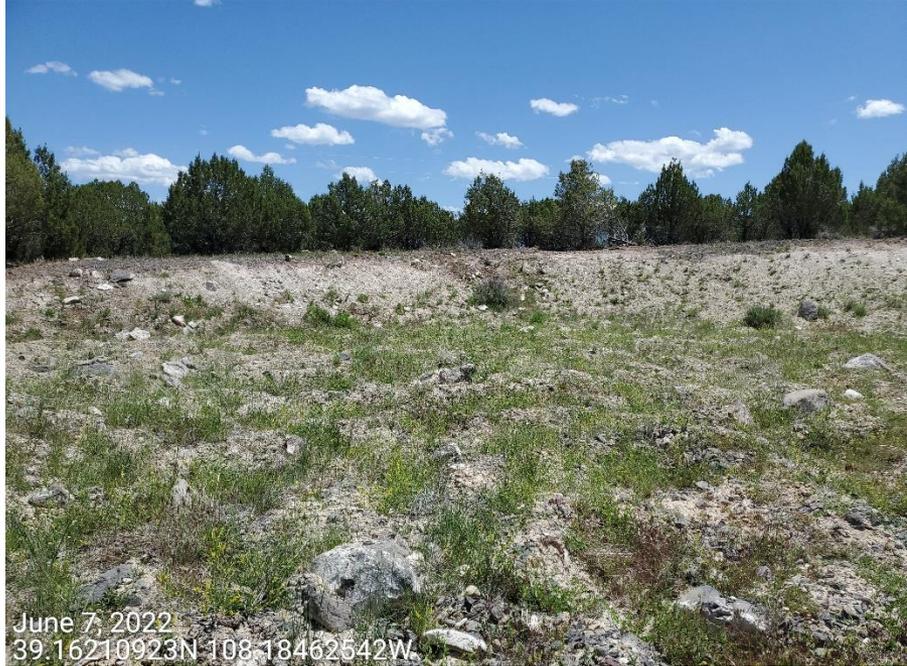
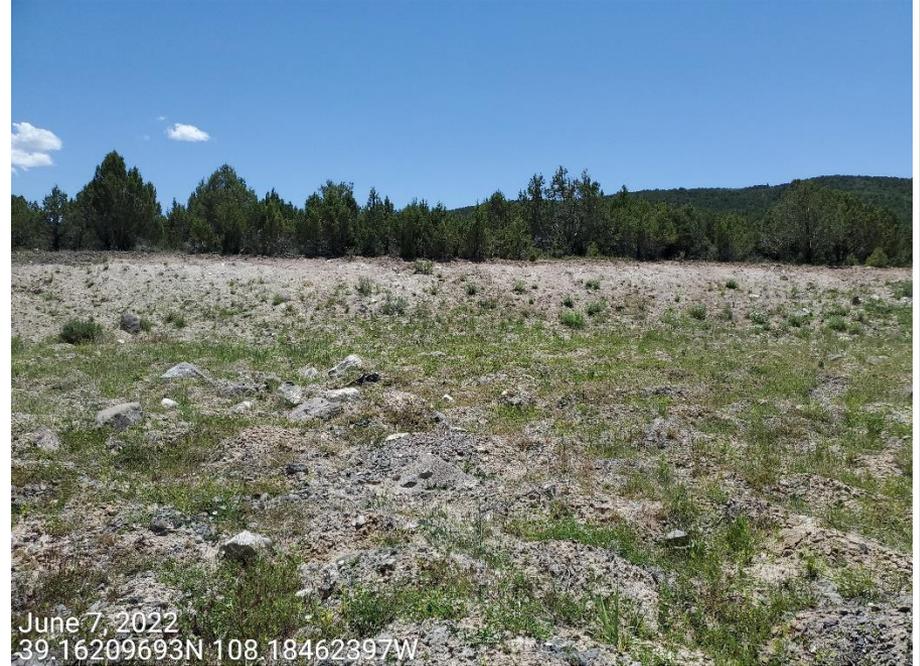
Photo 1: Photos taken from the Location, facing south. Photos show Location has not been recontoured/regraded; cut slopes evident. Reclamation of the Location has not been completed in accordance with 1004 requirements.

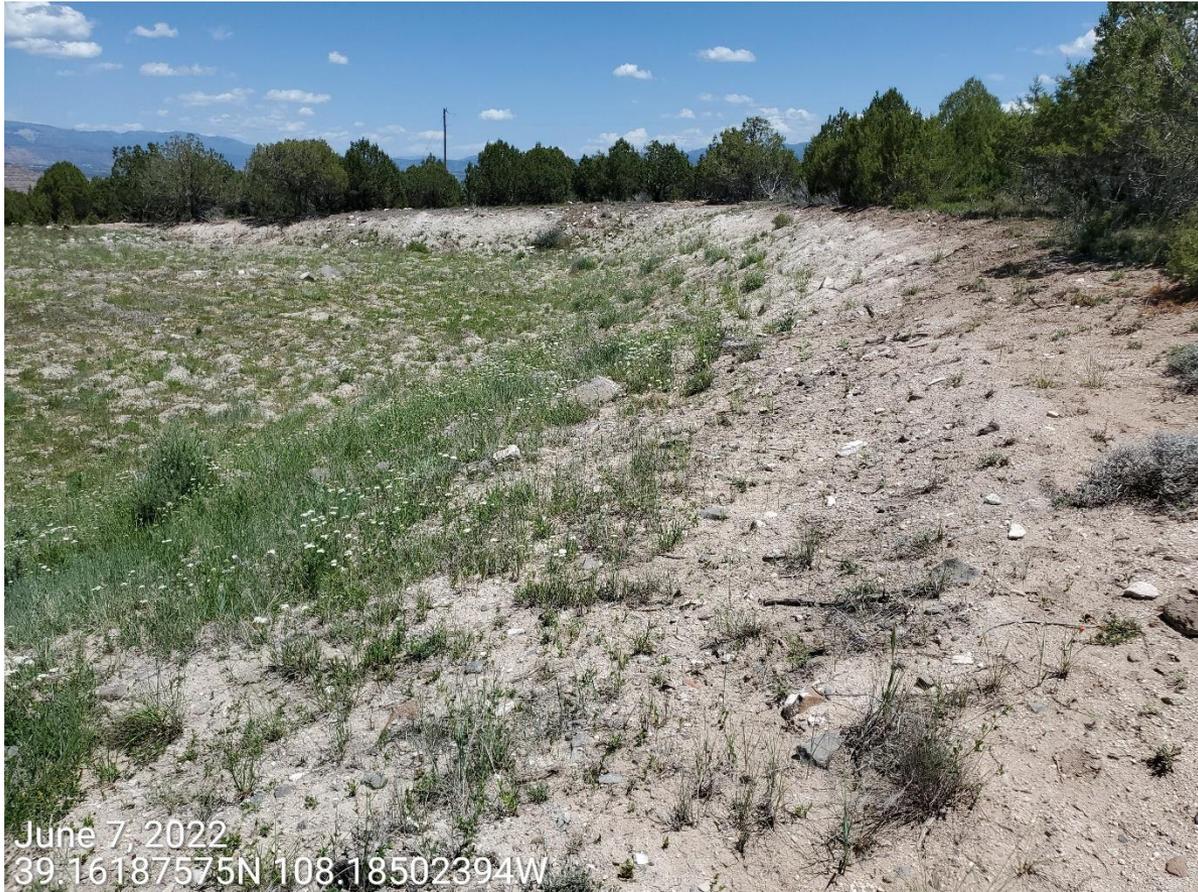
Photo 2: Photos show Location has not been recontoured/regraded; cut slopes evident. Reclamation of the Location has not been completed in accordance with 1004 requirements.

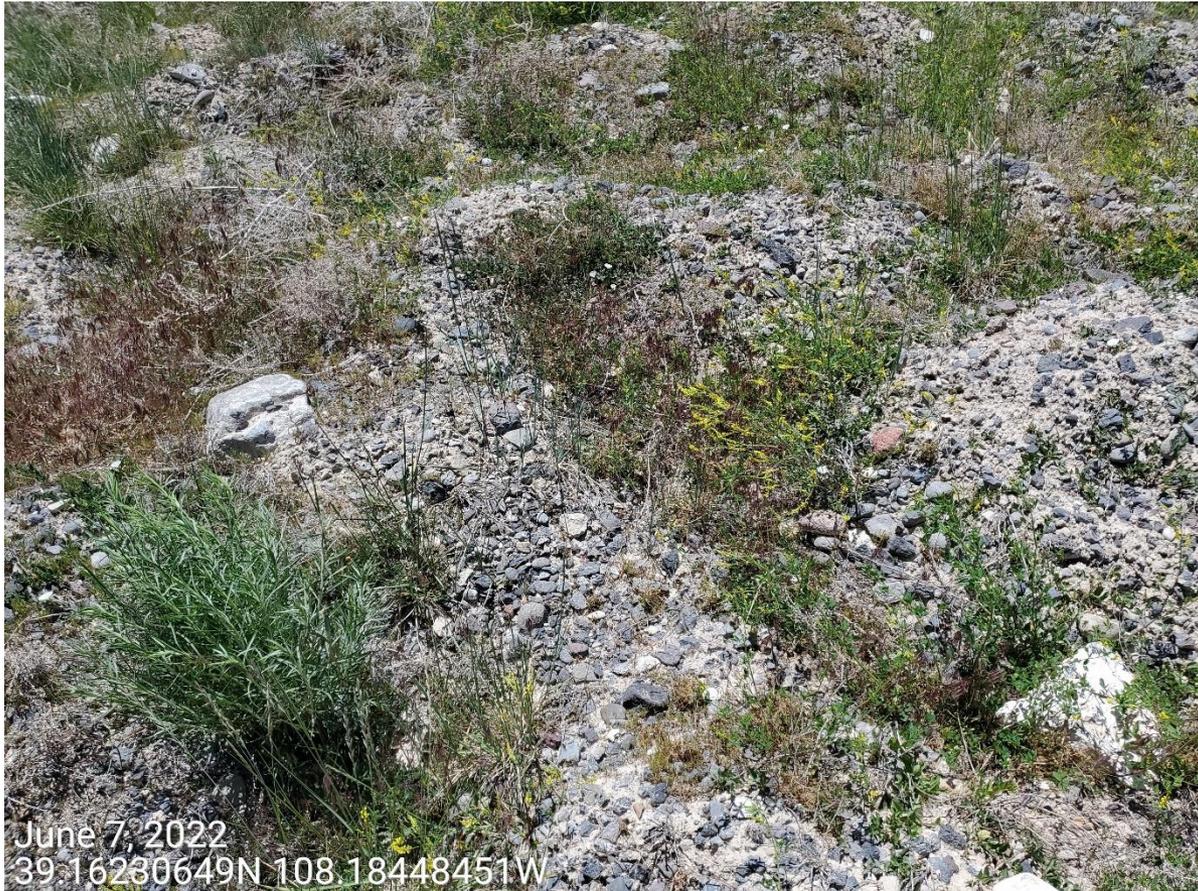
Photo 3: Photo shows Operator did not remove gravel/base material from the Location, but rather mixed it with the soils, this does not comport with 1002.c and 1004.a (1003.e.(2)), as soils did not remain properly segregated, and horizons were not replaced to their original relative positions.

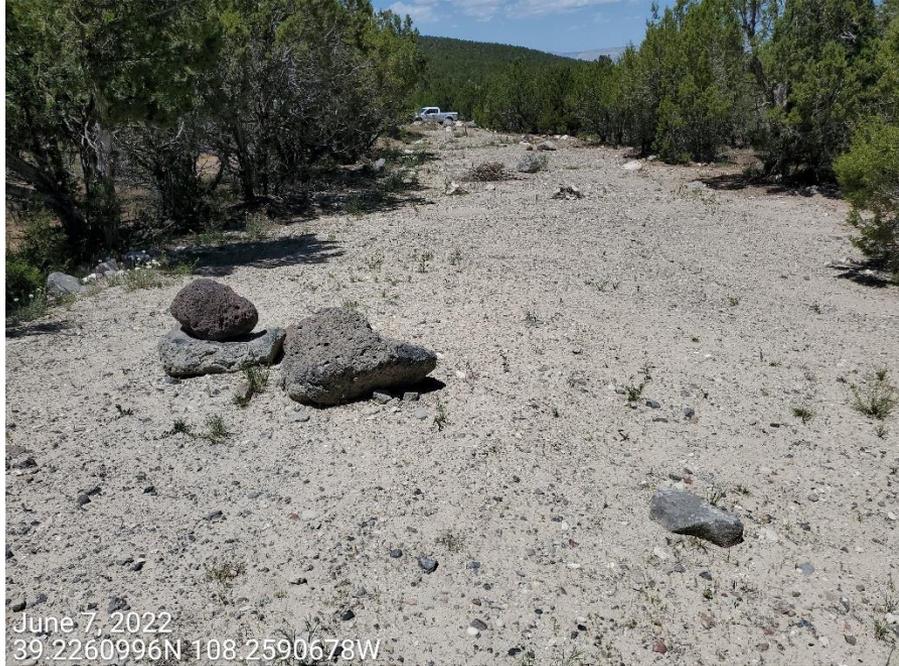
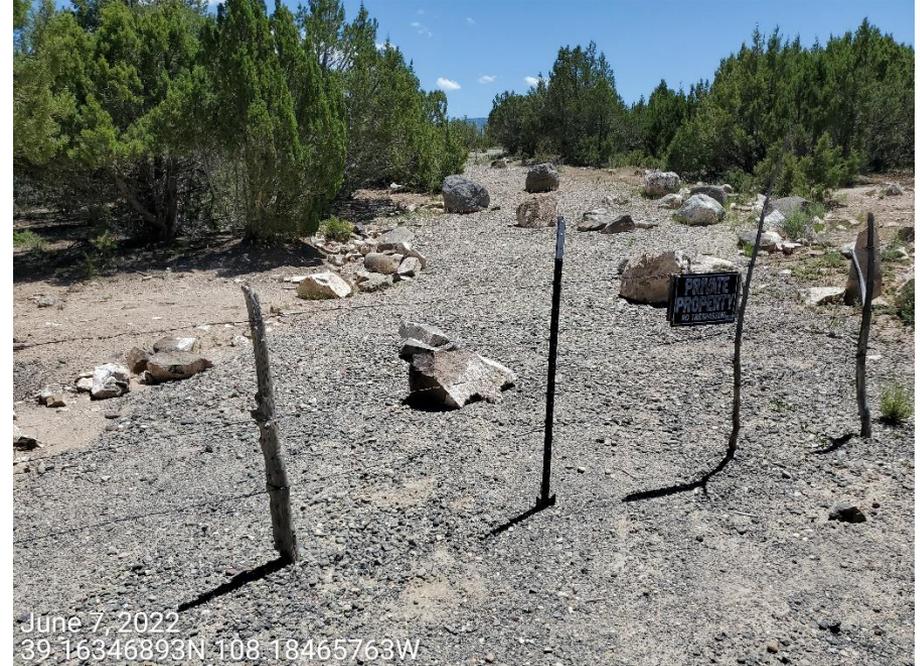
Photo 4: Photos show reclamation of the access road has not been completed; gravel has not been removed, road has not been decompacted and reclaimed.
