Inspection Photos

API: 055-06101

Operator: MANZANO LLC

Inspection Date: 6/7/2022

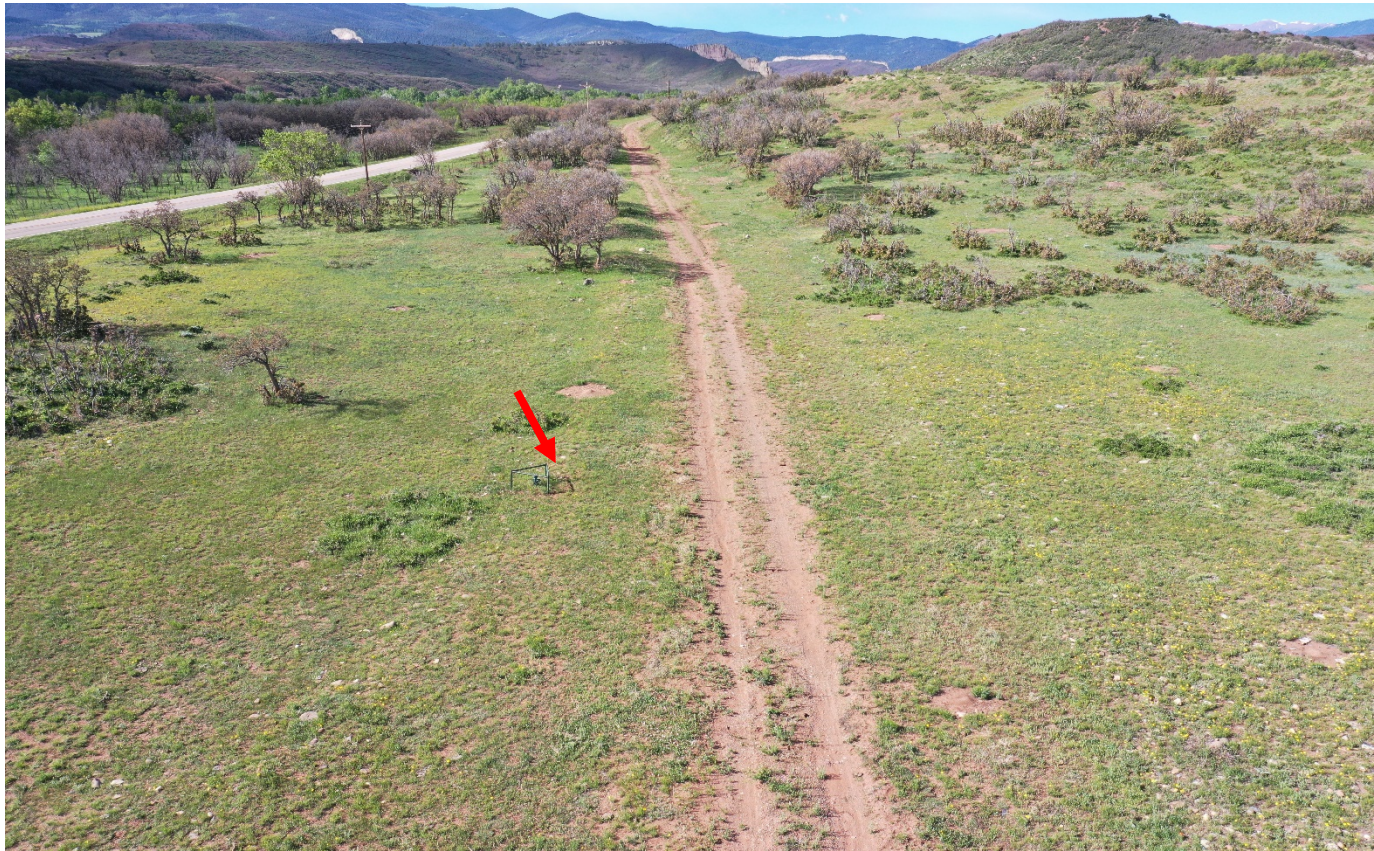
Photo 1. Drone aerial photo facing southwest along the access road. A pipe riser remains at the red arrow. The access road has not been reclaimed.

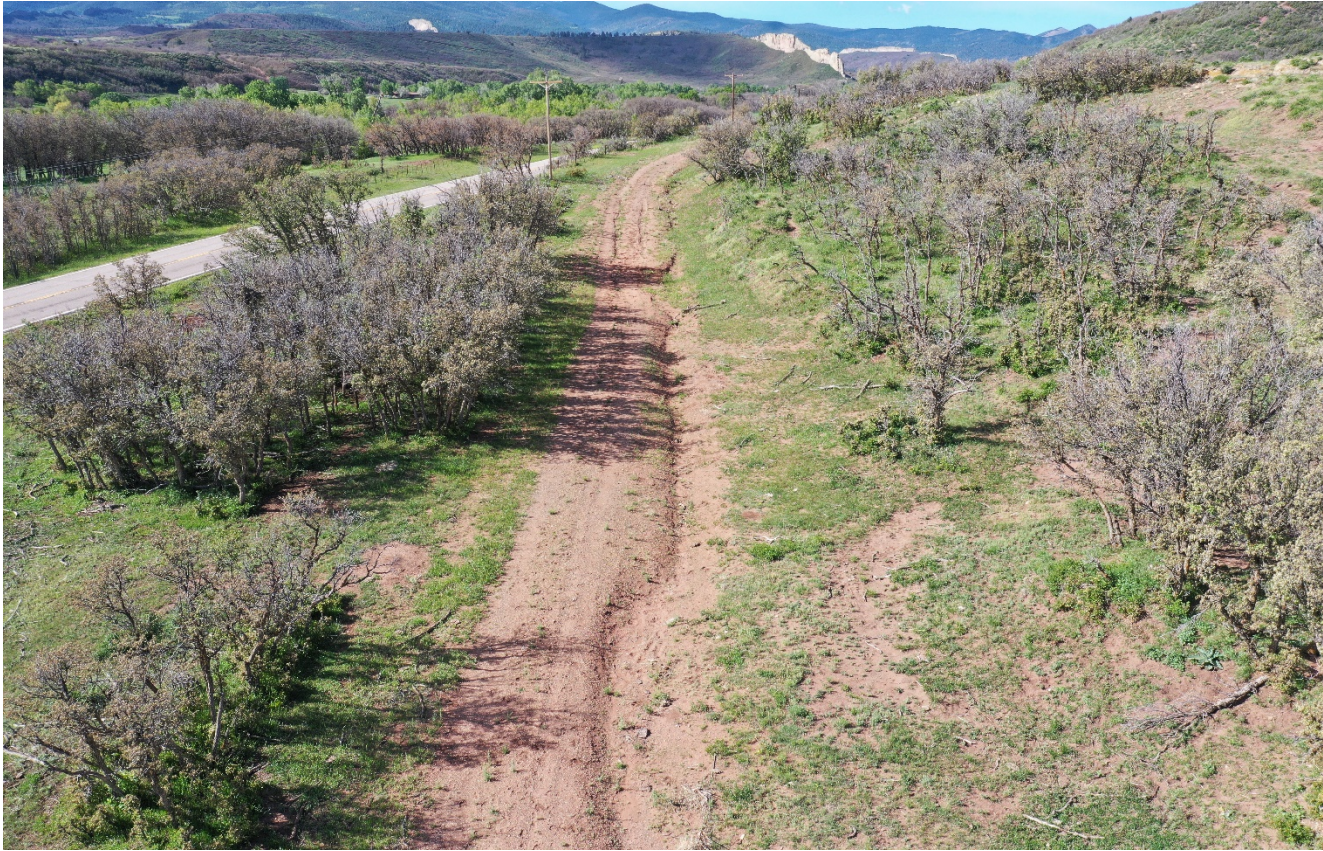
Photo 2. Drone aerial photo facing southwest along the access road. There is erosion occurring along the road which has not been repaired and stabilized.

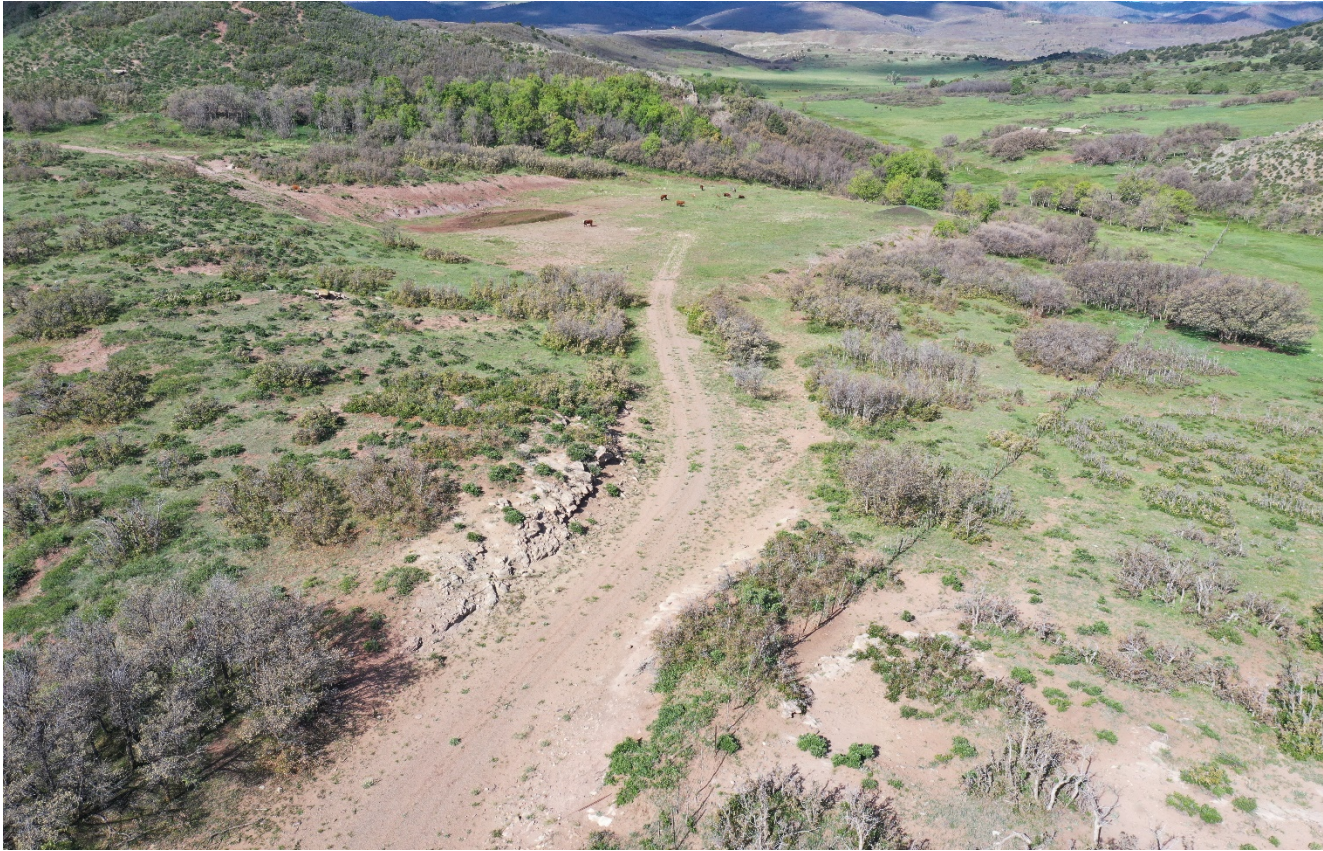
Photo 3. Drone aerial photo facing northwest along the access road. The access road has not been recontored and reclaimed.

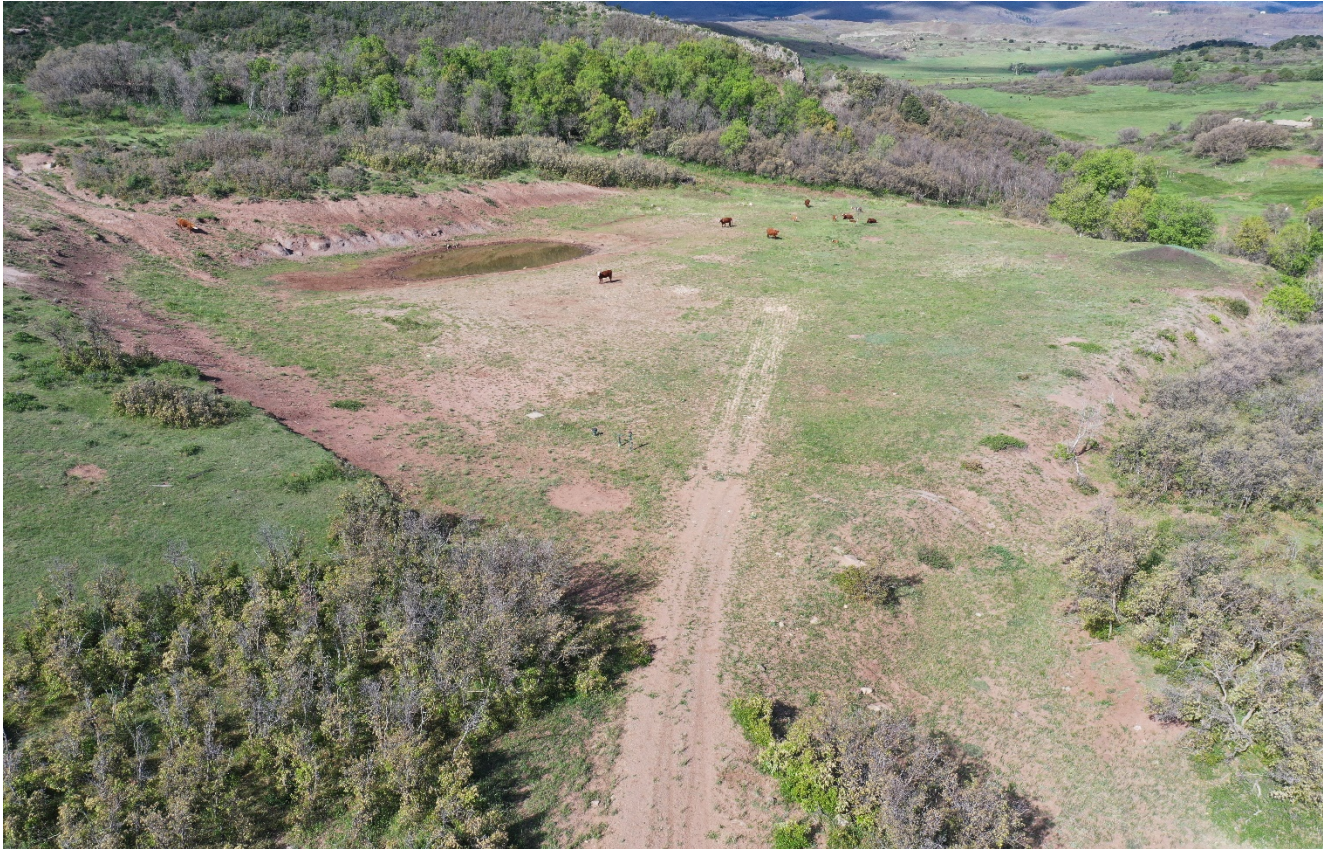
Photo 4. Drone aerial photo facing northwest shows the location has not been recontoured and reclaimed. The location disturbance is approximately 3.3 acres.

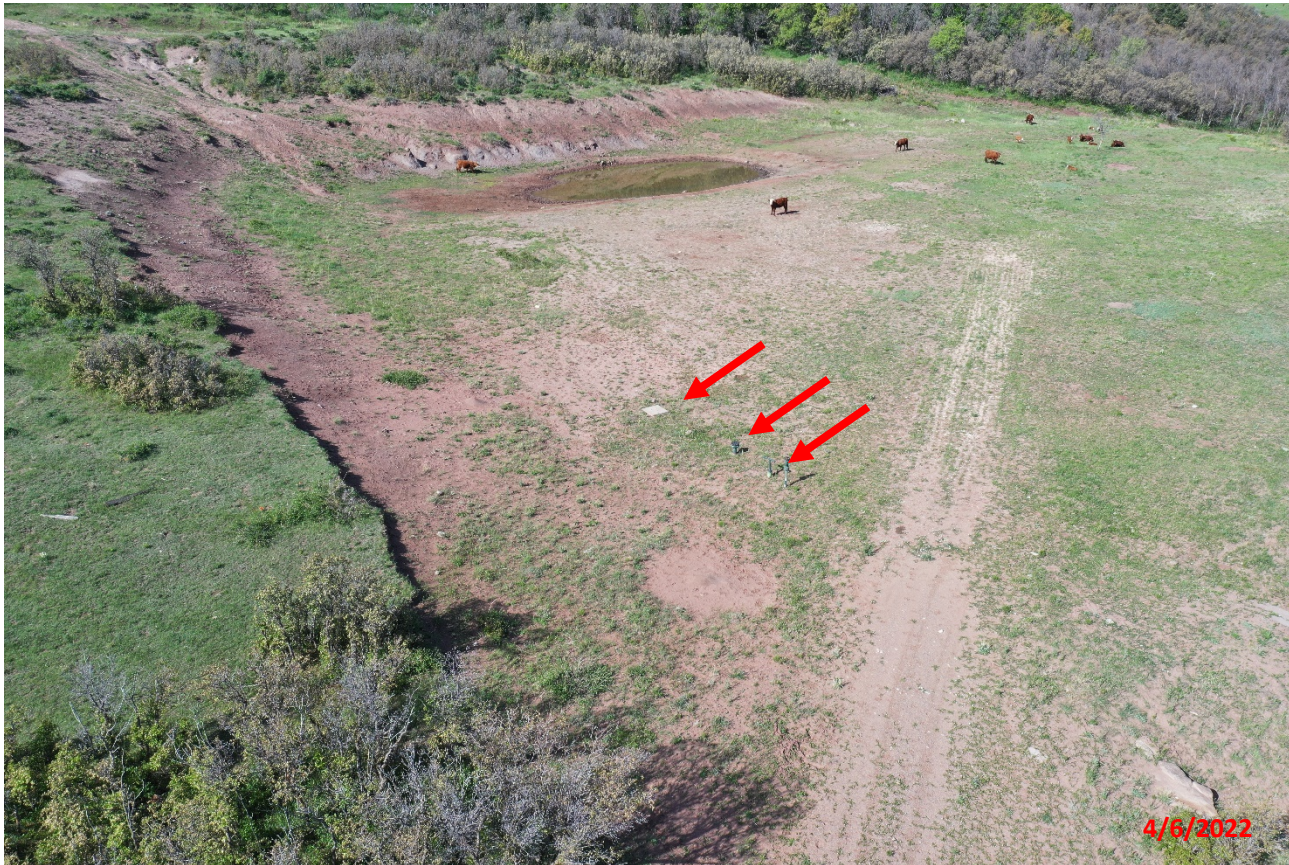
Photo 5. The pipeline risers still remain at the location shown at red arrows. Pipeline riser should have been abandoned per 1100 Rules.

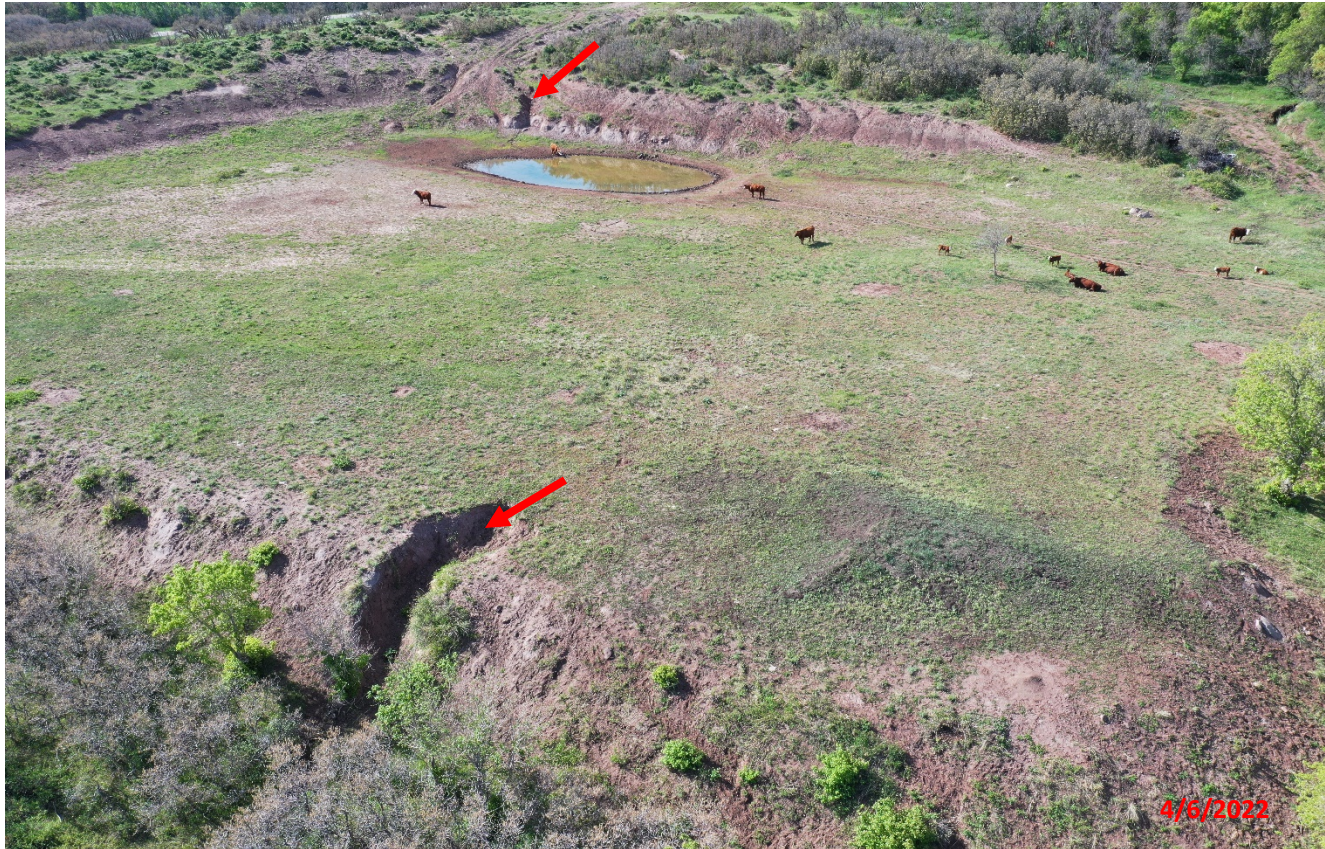
Photo 6. Facing southwest overlooking the location. There are multiple areas of significant gully erosion along the cut and fill slopes shown at red arrows.

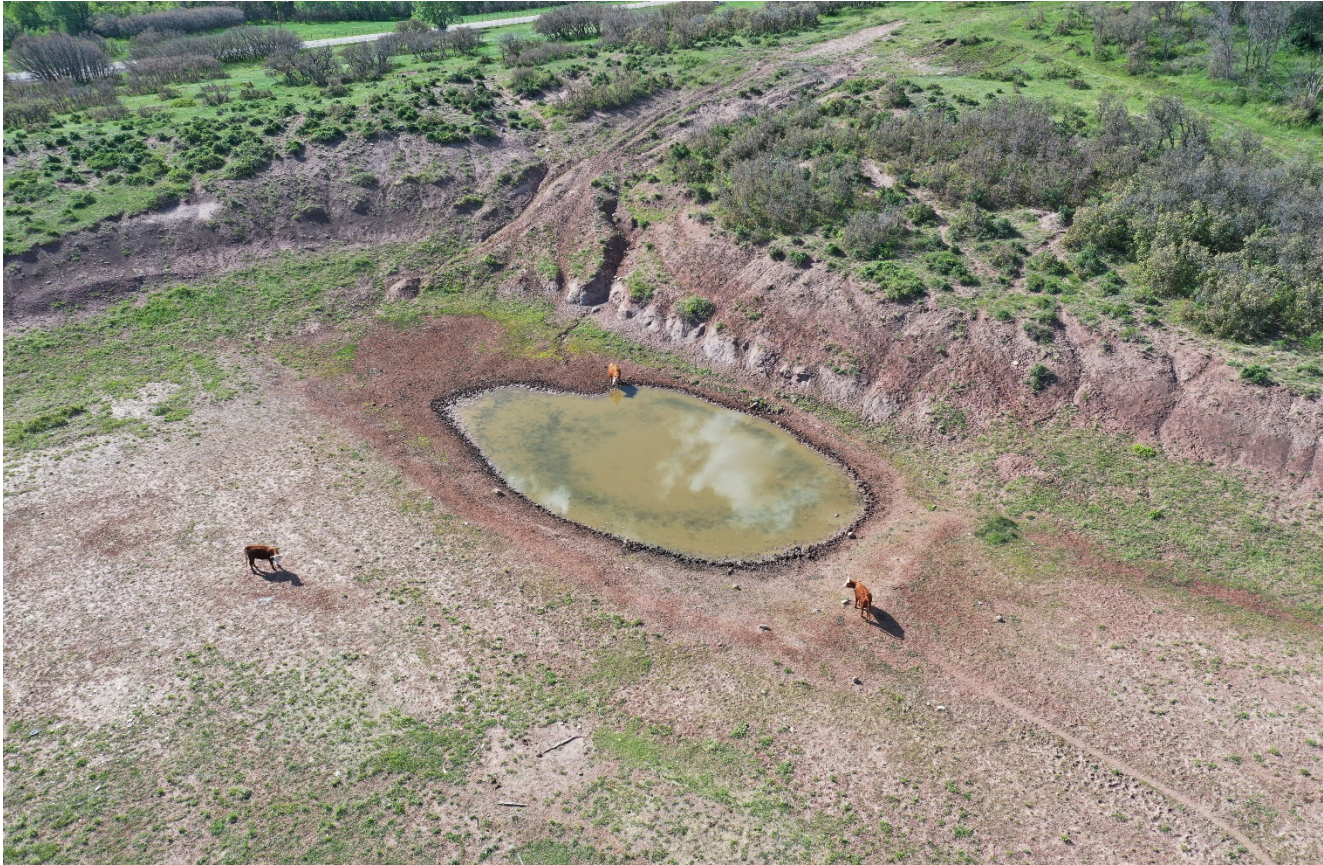
Photo 7. The pit was never backfilled and reclaimed. This photo shows the significant erosion along the cut slope.
