# Inspection Photos

Operator: SWN Production Company LLC - #10396

Location Name: Amelia-67N93W /1SESE

Inspection Document #: 702800320

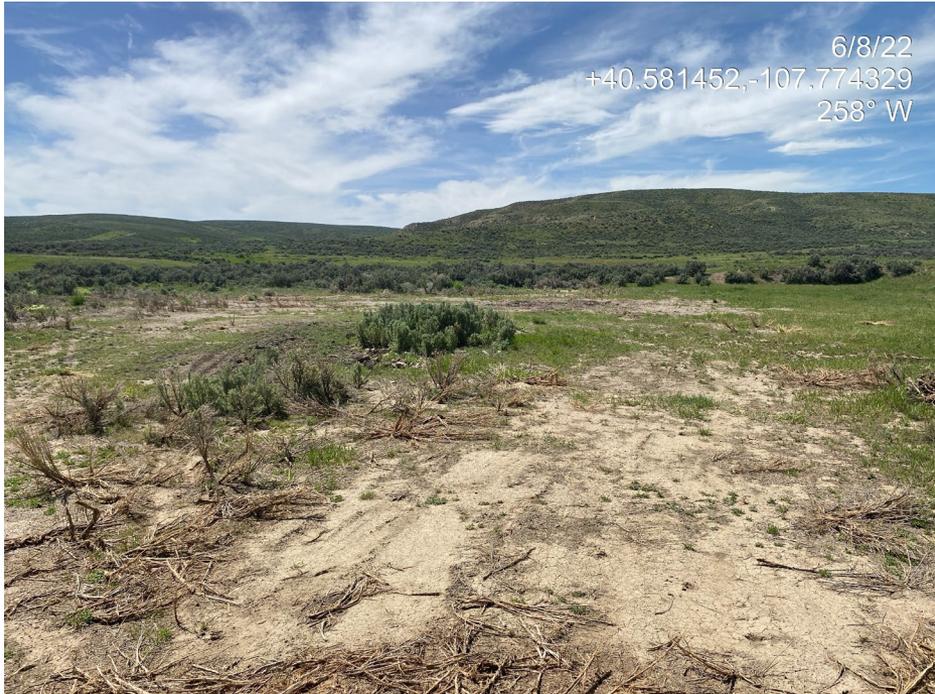
**Photo 1.** Photo taken from the south of the Location shows an overview of the Location.

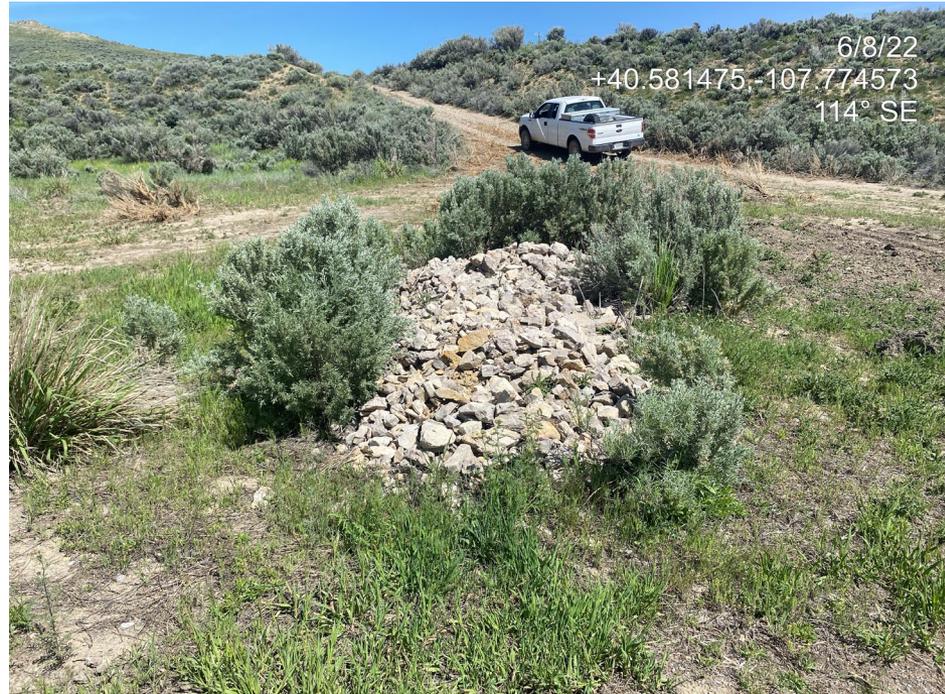
**Photo 2.** Photo taken from the south of the Location shows a pile of stone which must be removed for final reclamation.

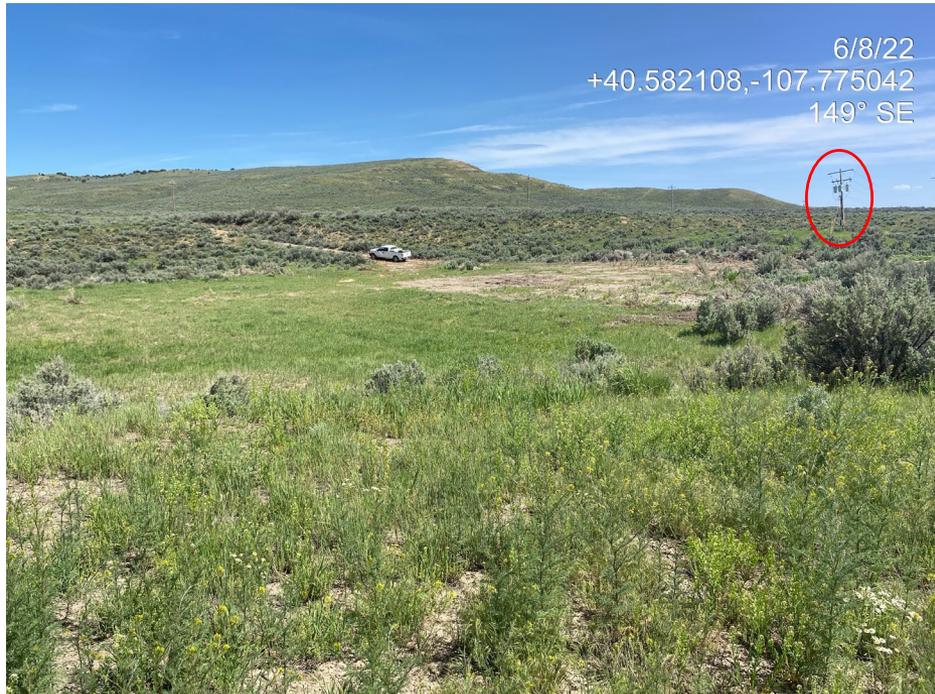
**Photo 3.** Photo taken from the northwest of the Location shows a power line to the south which must be removed for final reclamation. Photo also shows the contour of the pad does not match the surrounding landscape.

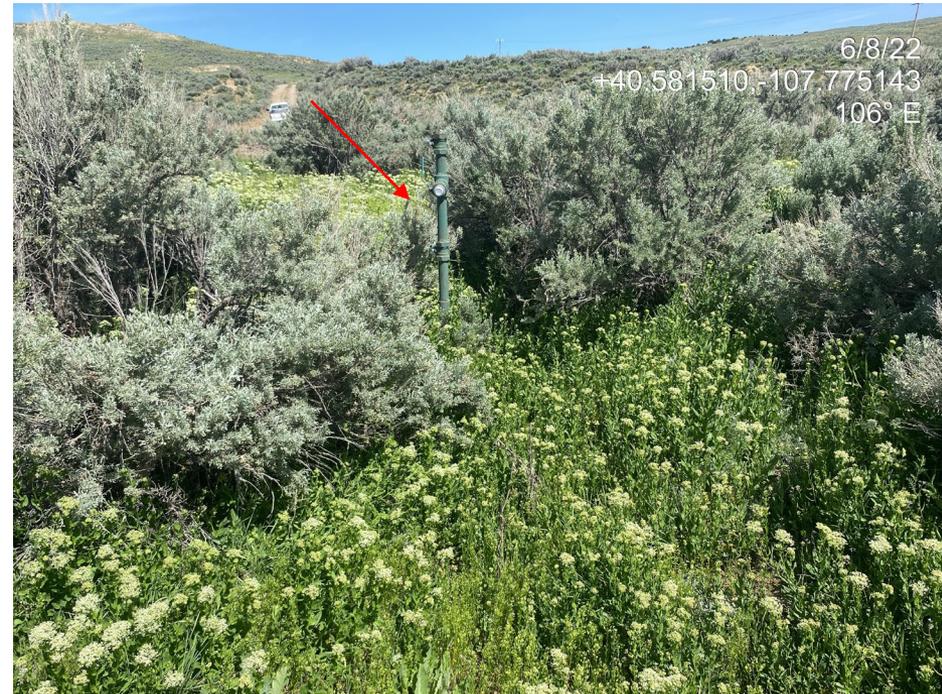
**Photo 4.** Photo taken from the south of the Location shows a riser which will need to be removed for final reclamation. Also note dense cover of whitetop, a noxious weed.

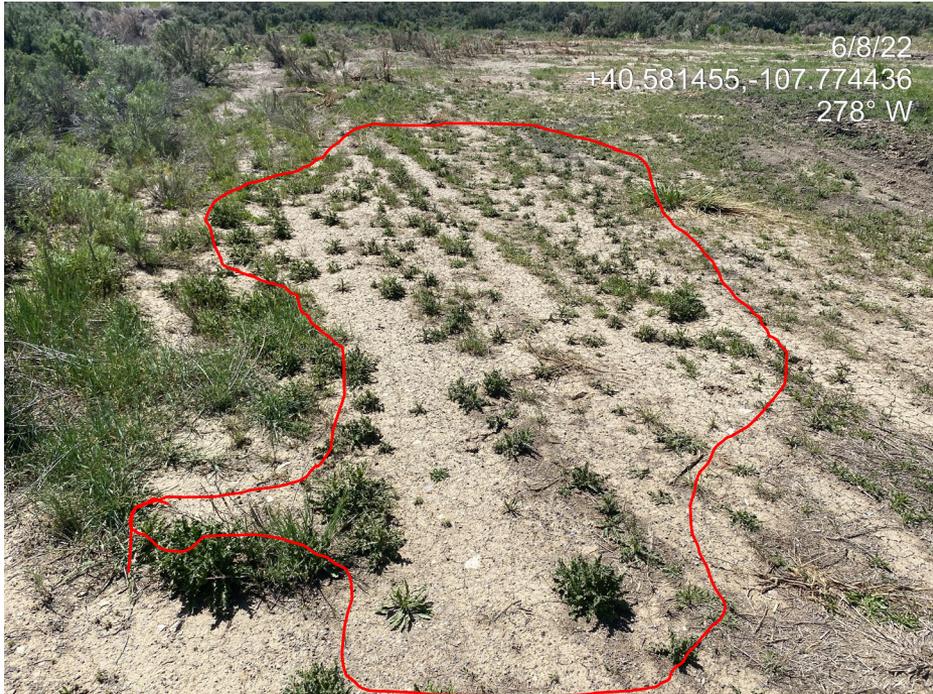
**Photo 5.** Photo taken from the south of the Location shows a patch of Canada thistle, a noxious weed.

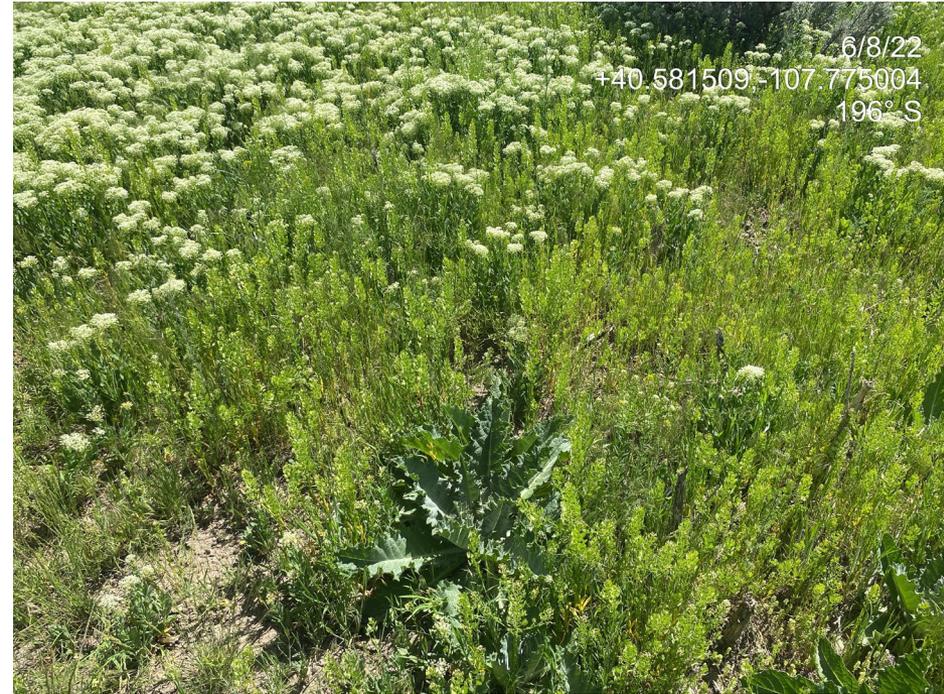
**Photo 6.** Photo taken from the south of the Location shows a patch of whitetop and a scotch thistle, both noxious weeds.

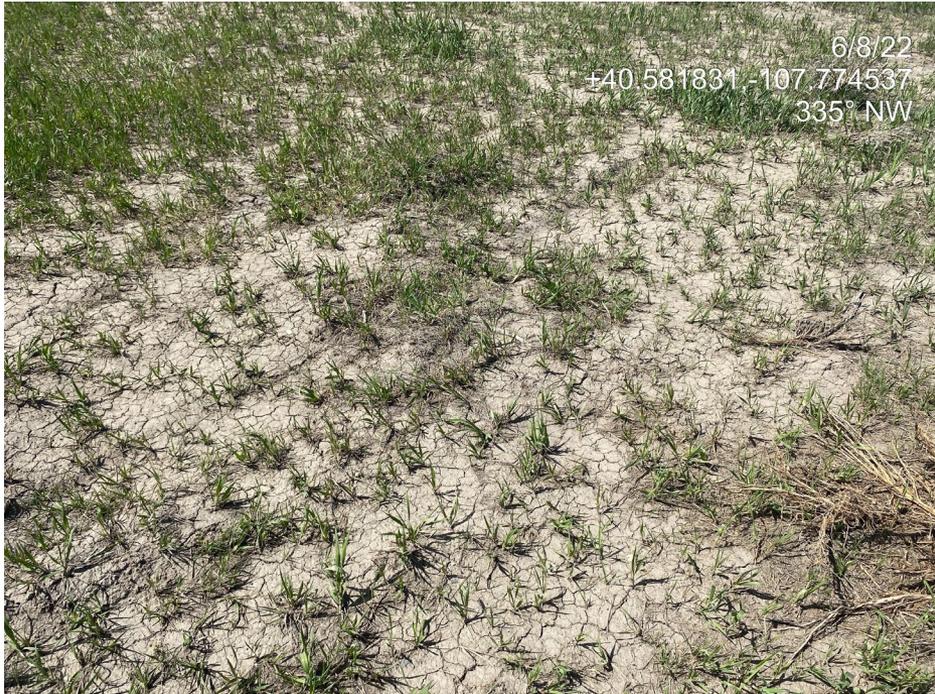
**Photo 7.** Photo taken from the north of the Location shows interim areas with poor vegetation cover due to highly compacted soils.

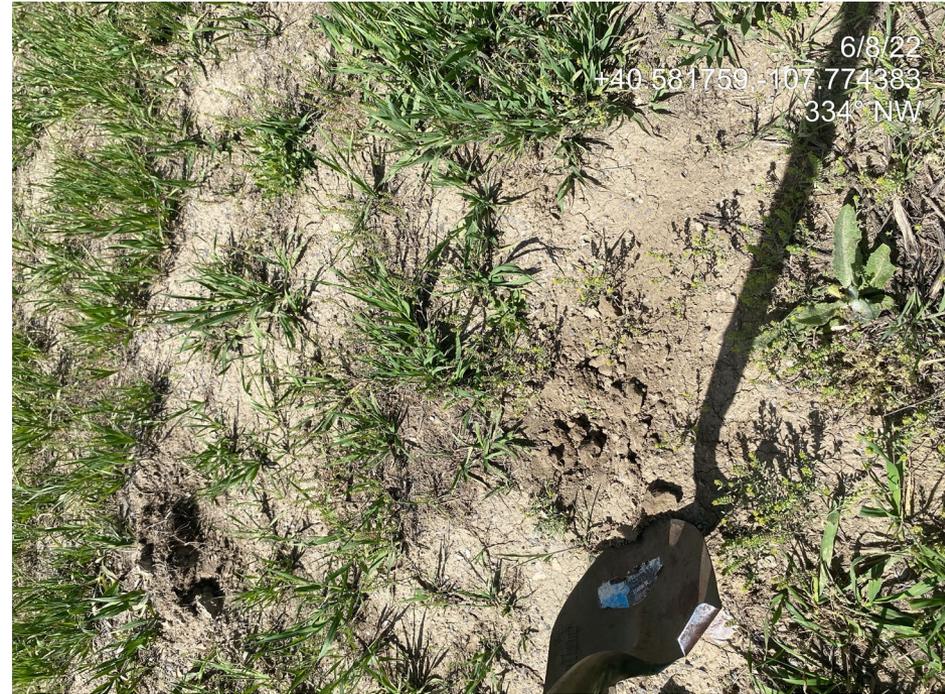
**Photo 8.** Photo taken from the north of the Location shows interim areas with highly compacted soils.

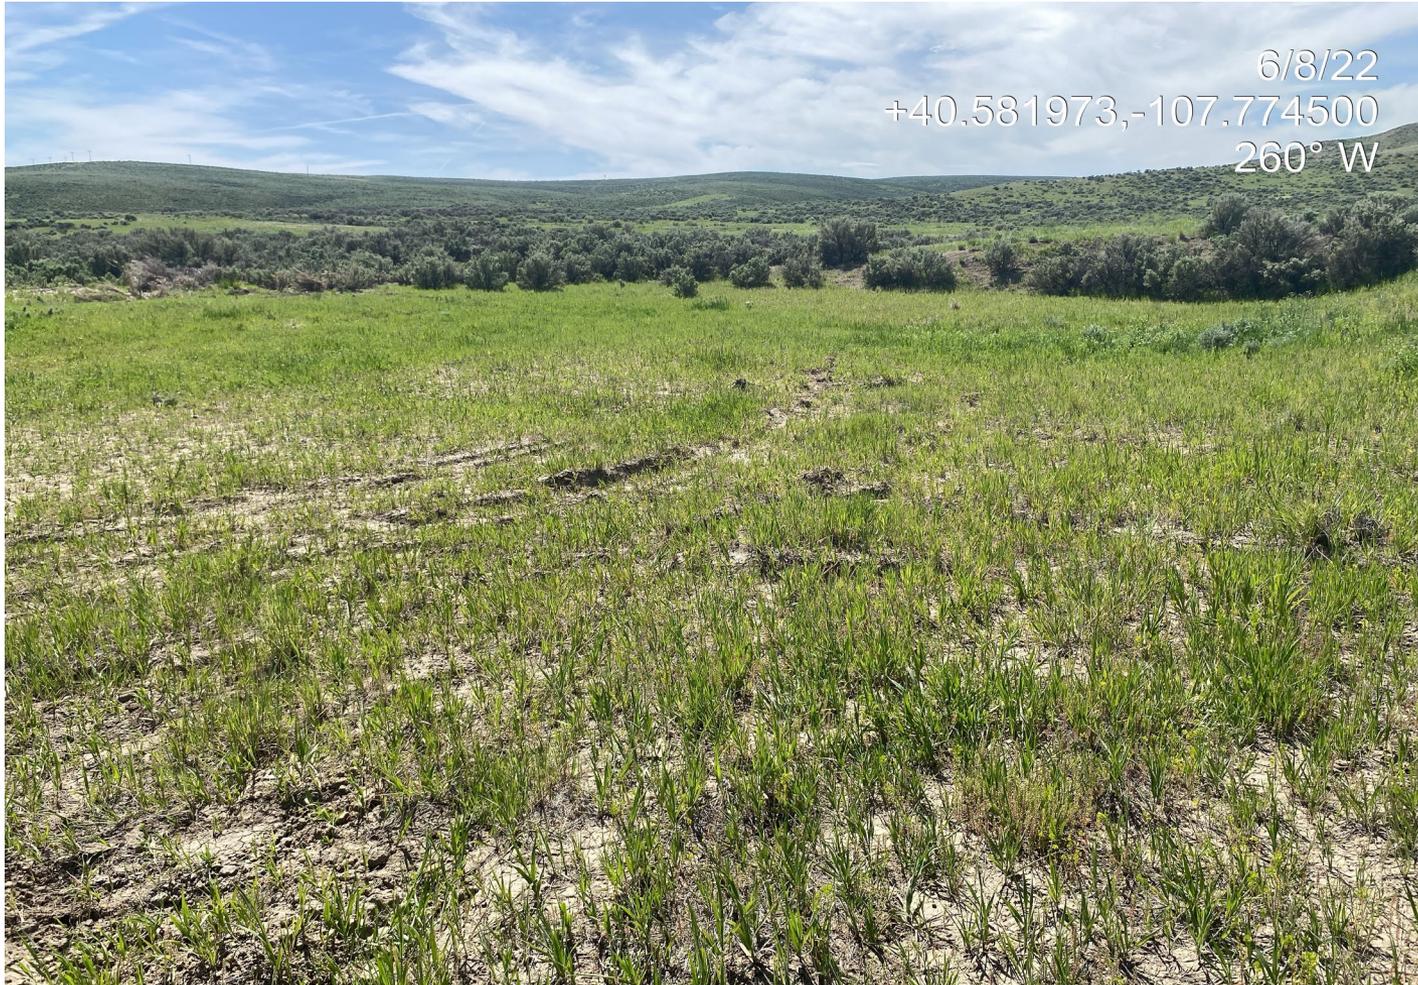
**Photo 9.** Photo taken from the north of the Location shows areas seeded with smooth brome, a nonnative species not found in the adjacent reference areas.

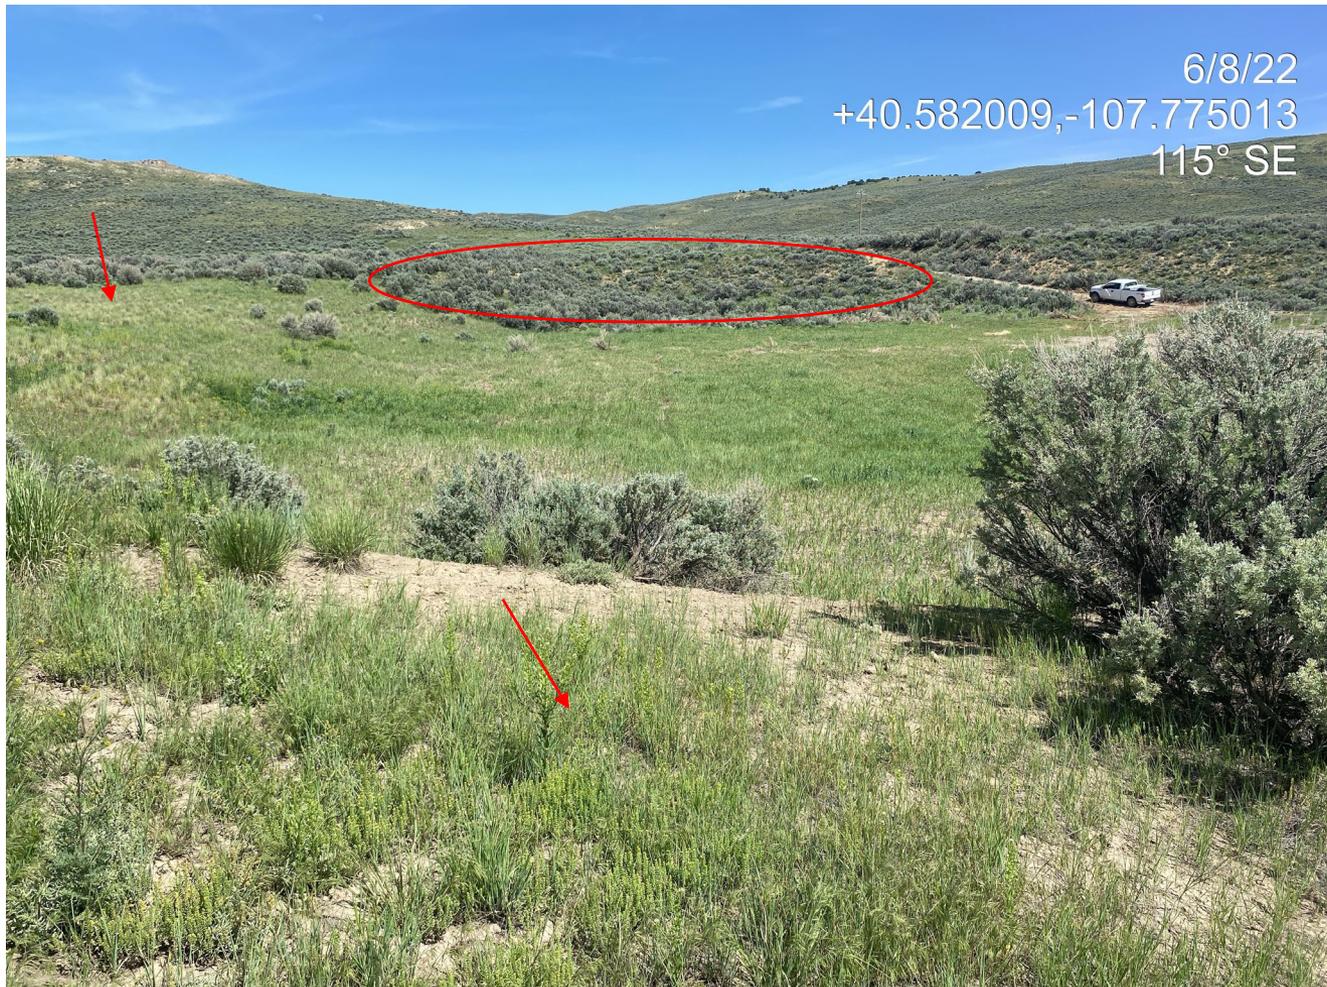
**Photo 10.** Photo taken from the northwest of the Location shows the contour of the Location does not match the adjacent areas. The cut slope (red circle) remains. There are also several berms and /or soil piles on Location (red arrows).

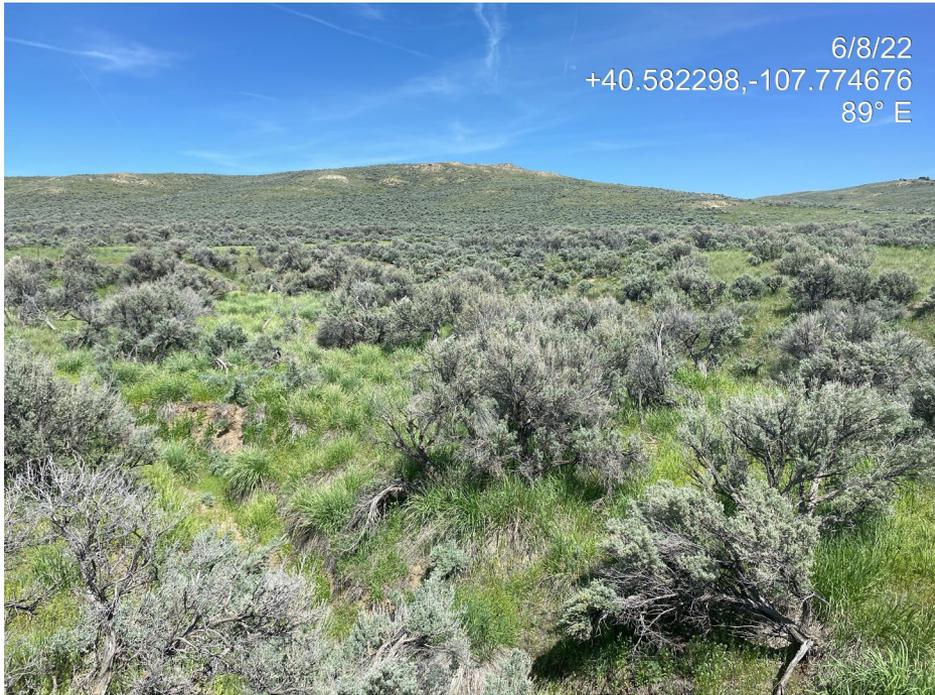
**Photo 11.** Photo taken from the north of the Location shows adjacent reference area vegetation.

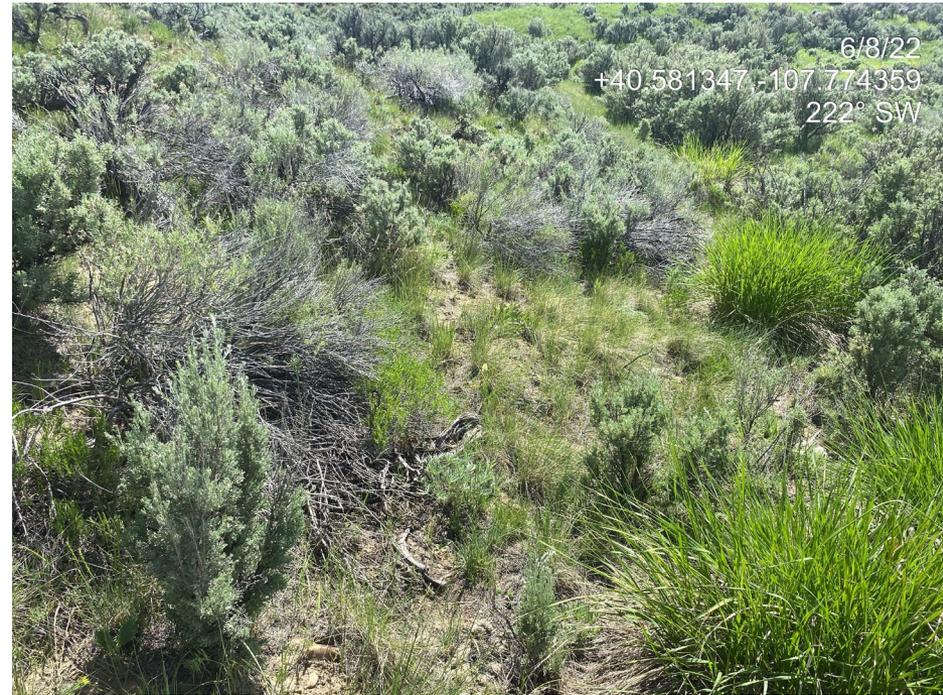
**Photo 12.** Photo taken from the south of the Location shows adjacent reference area vegetation.
