Inspection Photos

Operator: SWN Production Company LLC - #10396

Location Name: Antietam-67N93W /12NWNW

Inspection Document #: 702800325

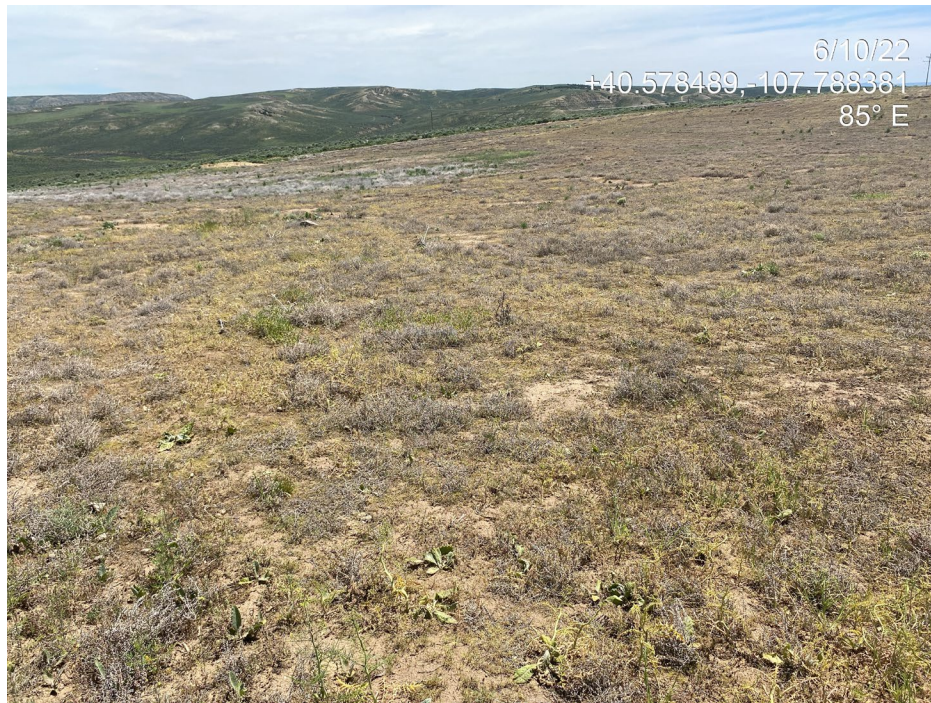
Photo 1. Photo taken from the northwest of the Location. Vegetation is dominated by noxious and undesirable species. Weeds were recently sprayed, although some were missed in treated areas and other areas were not treated at all. Seeded plant species are rare.

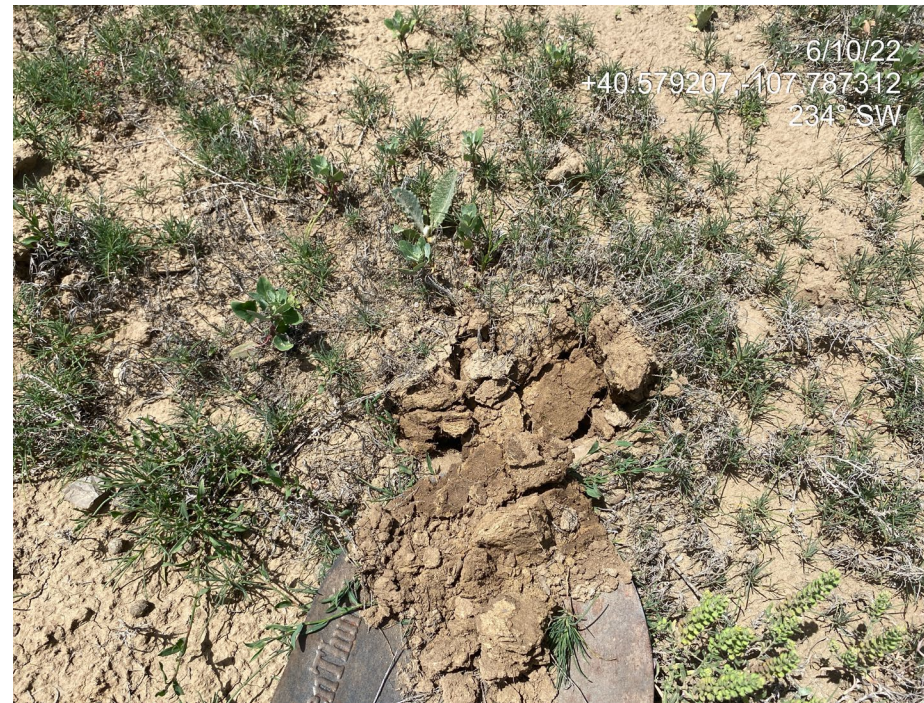
Photo 2. Photo taken from the northeast of the Location shows platy soil structure indicating compacted soils.

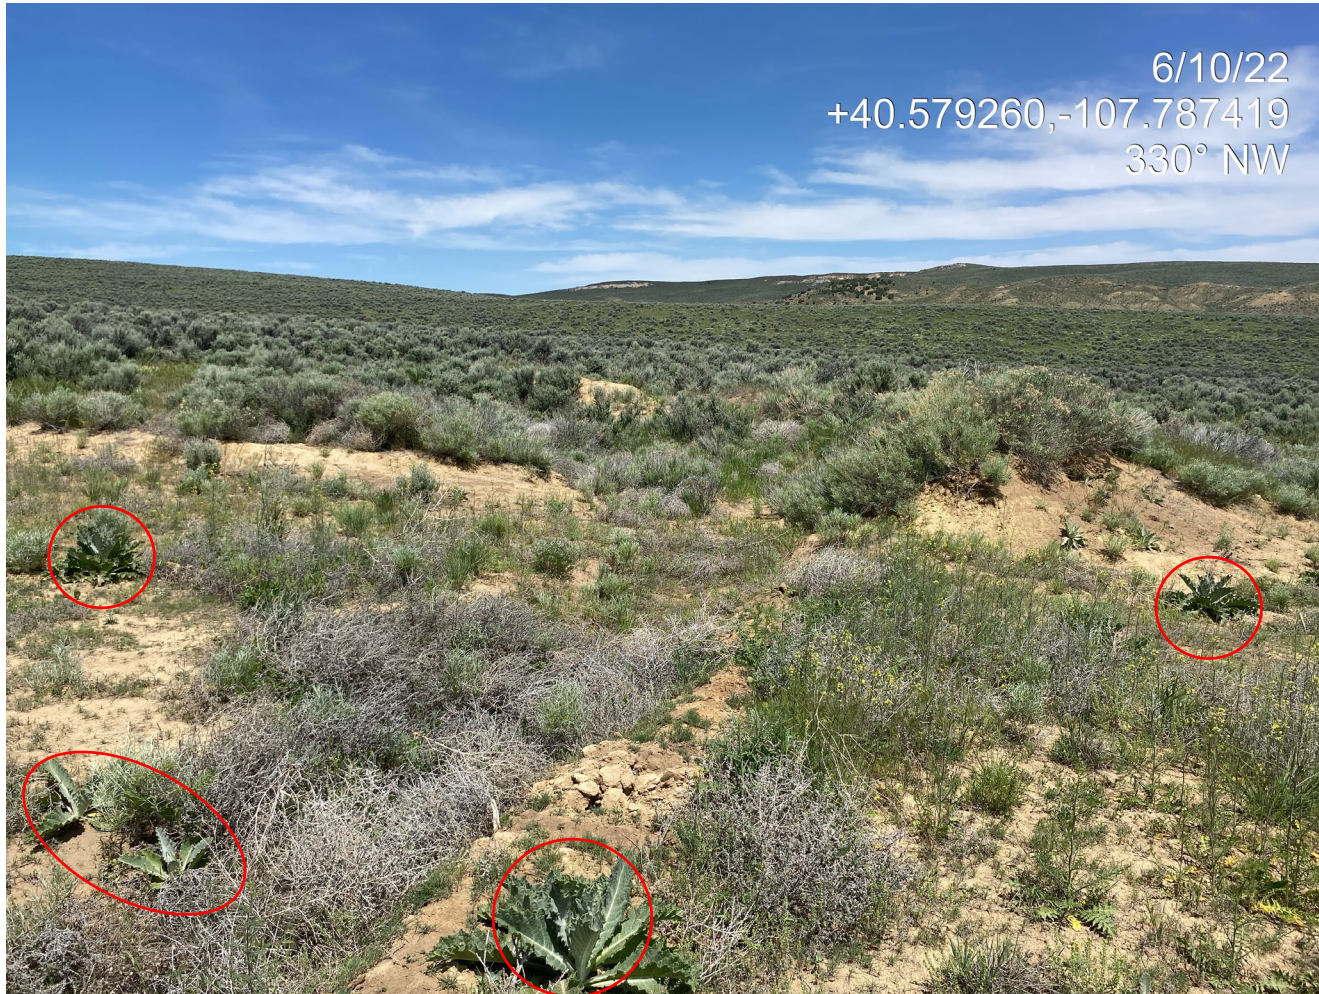
Photo 3. Photo taken from the northeast of the Location shows a stormwater BMP/berm which has not been removed and recountoured. Note untreated noxious weeds (red circles).

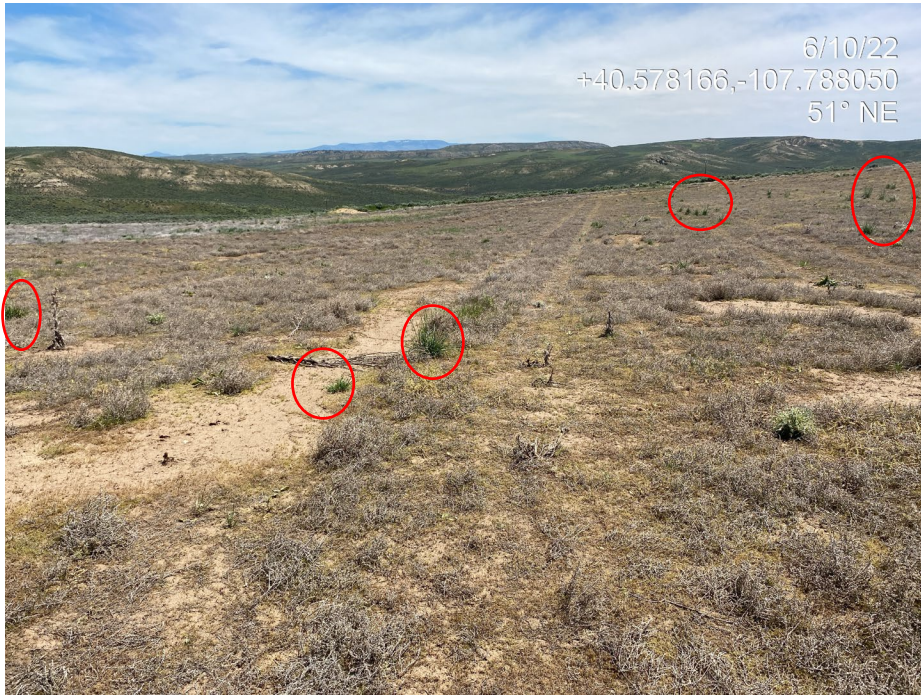
Photo 4. Photo taken from the west of the Location shows the vegetation community. Note the almost complete lack of seeded species (red circles). Seeded species are non-native, and do not match the adjacent native reference areas.

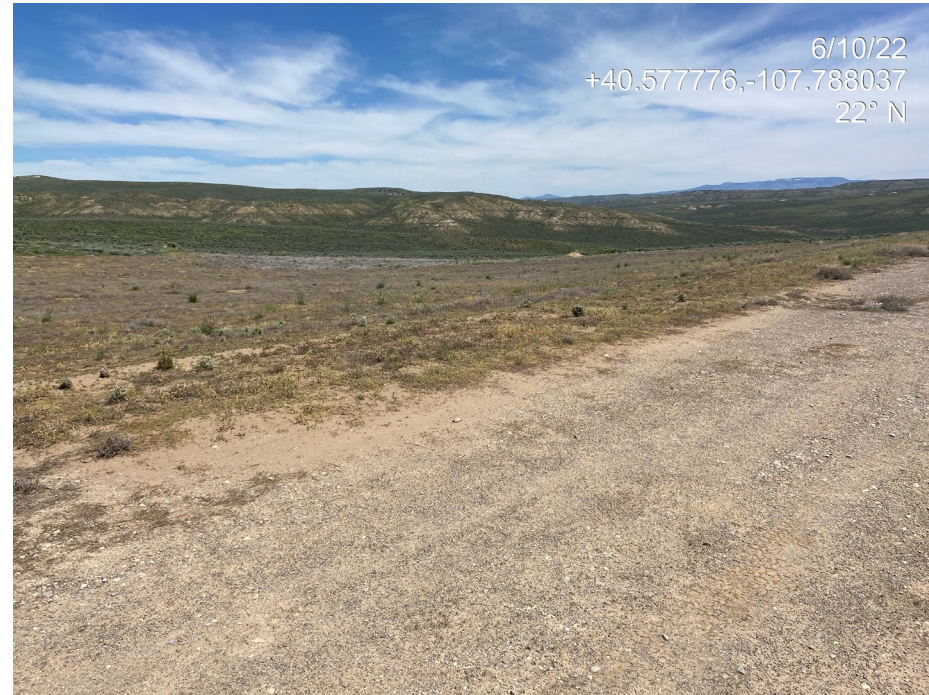
Photo 5. Photo taken from the south of the Location shows the access road, which needs to be reclaimed for final reclamation.

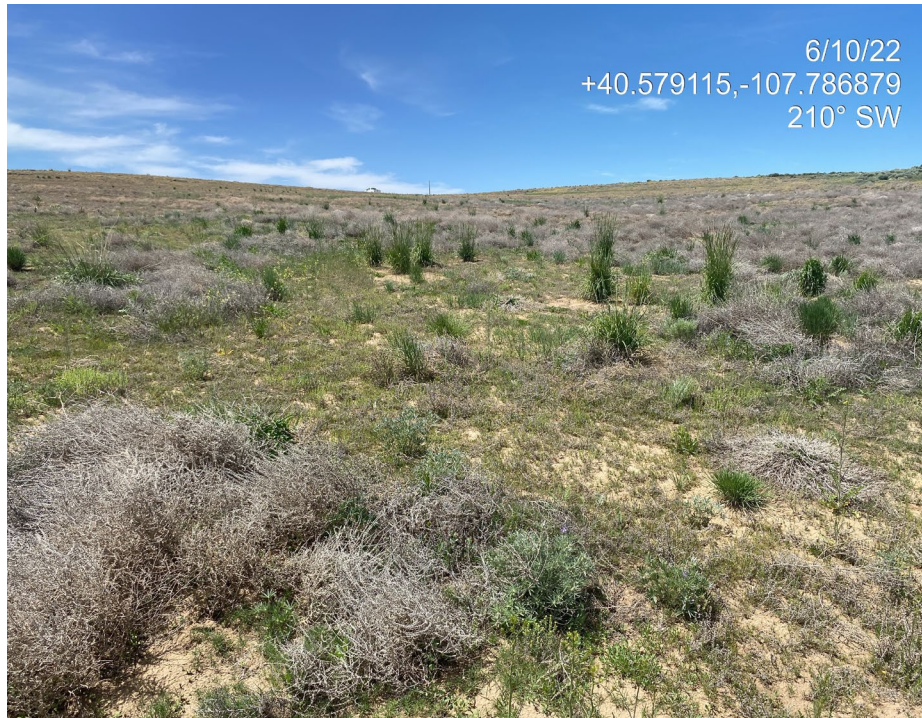
Photo 6. Photo taken from the previously reclaimed area at the north of the Location shows establishment of sparse seeded species and dominance of noxious and undesirable species. Weeds in this area have not been treated. Seeded species are non-native, and do not match the adjacent native reference areas.

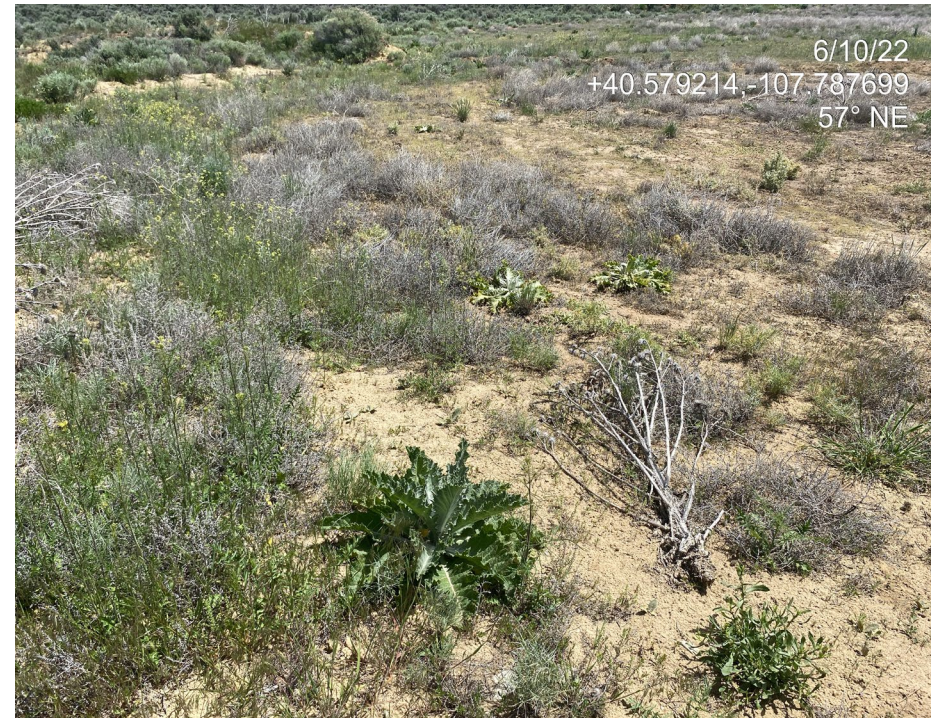
Photo 7. Photo taken from the previously reclaimed area at the north of the Location shows an area with no establishment of seeded species and dominance of noxious and undesirable species. Weeds in this area have not been treated.

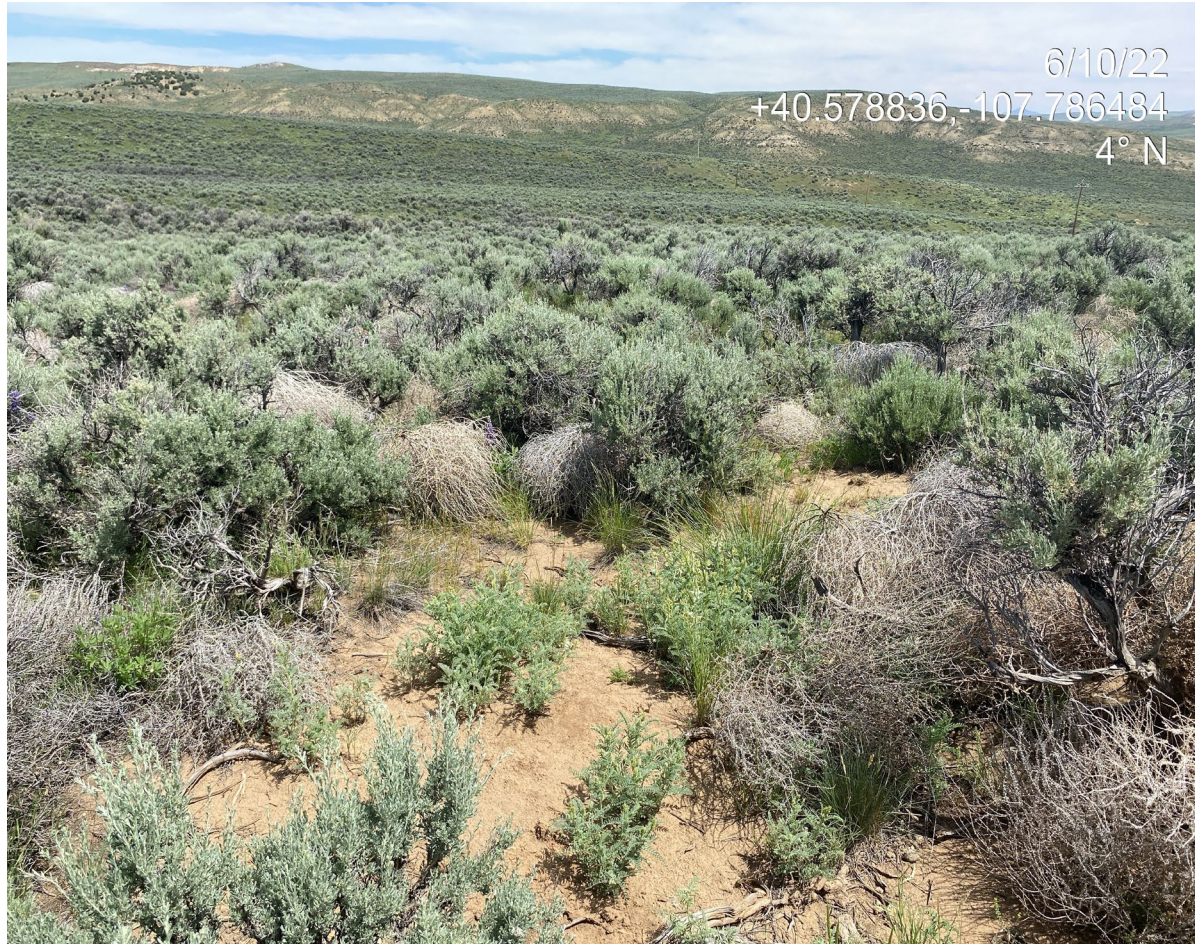
Photo 8. Photo taken from the east of the Location shows the reference area vegetation community is native rangeland. Note weed debris from the Location is impacting adjacent areas.

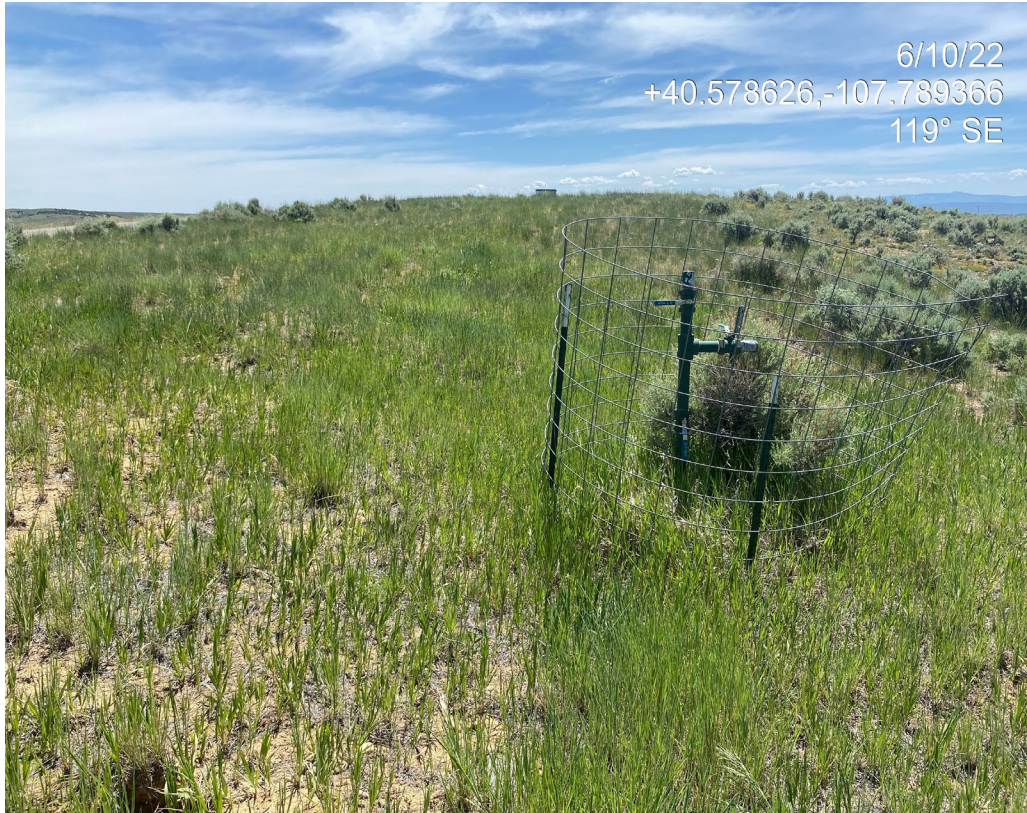
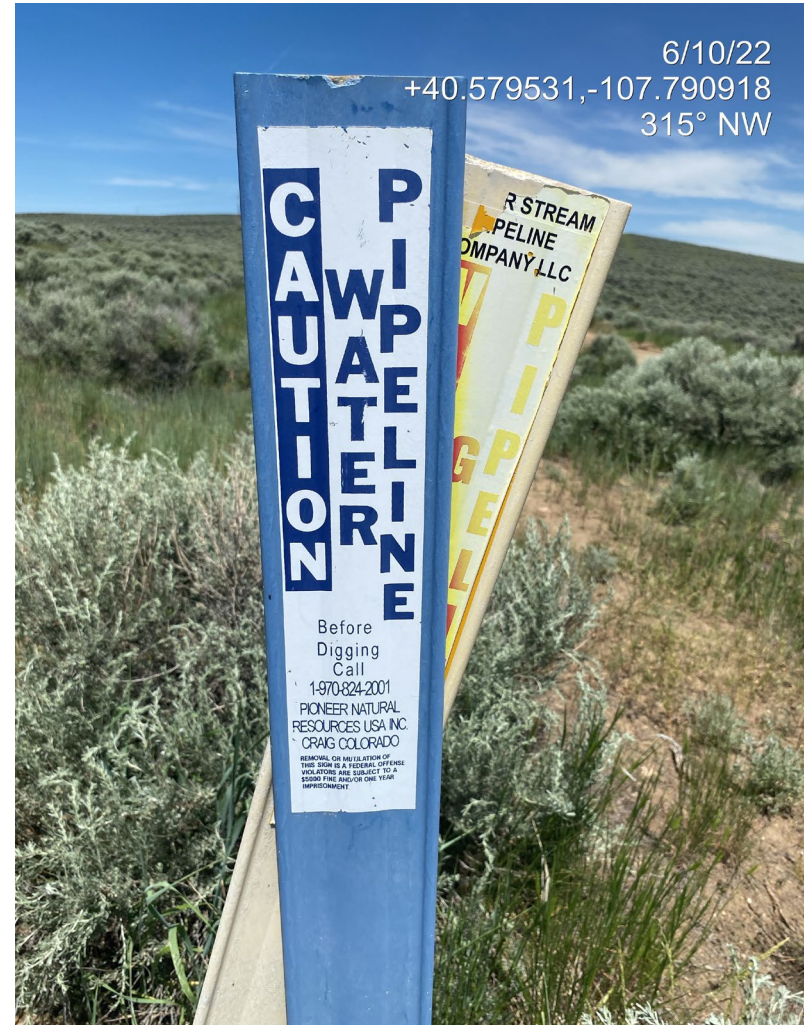
Photo 9. Photos taken from west of the Location across the road shows a pipeline riser which must be removed for final reclamation. Pipeline signage reads “Silver Stream Pipeline Company LLC” and “Pioneer Natural Resources USA Inc.”
