Inspection Photos

Operator: SWN Production Company LLC - #10396

Location Name: Trenton Federal-67N93W /2SESE

Inspection Document #: 702800327

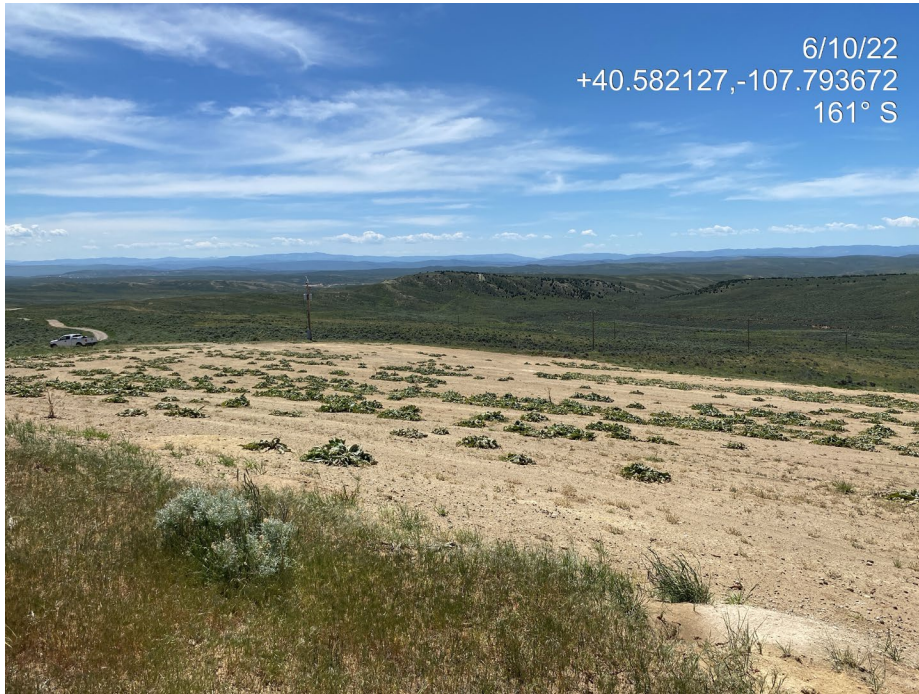
Photo 1. Photo taken from the north of the Location shows an overview of the Location which is almost completely bare ground and noxious weeds (Scotch thistle). Weeds were recently treated although some appear to remain untreated.

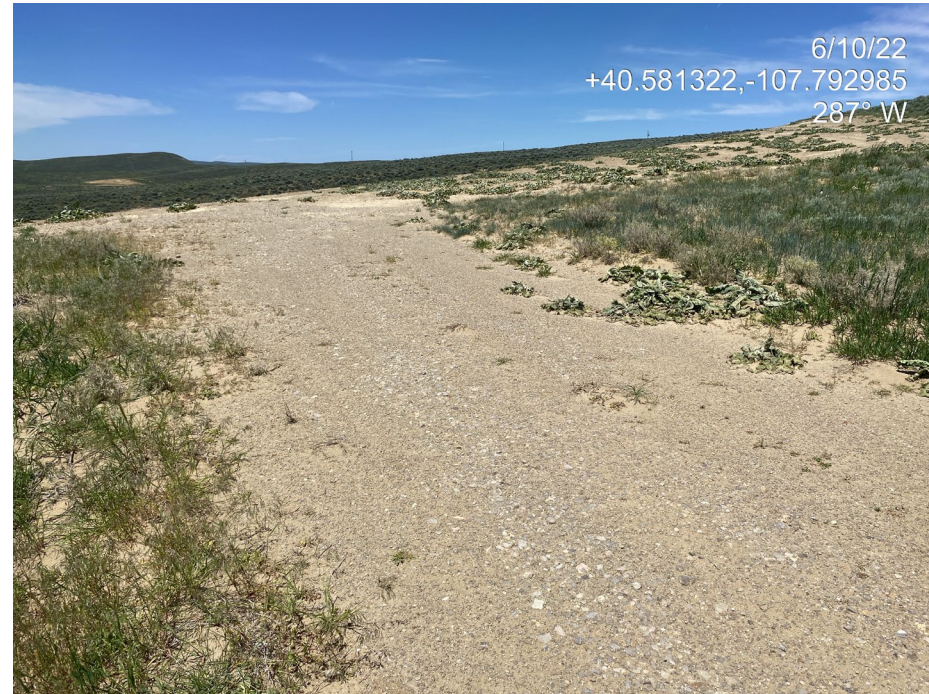
Photo 2. Photo taken from the east of the Location shows the access road, which must be reclaimed.

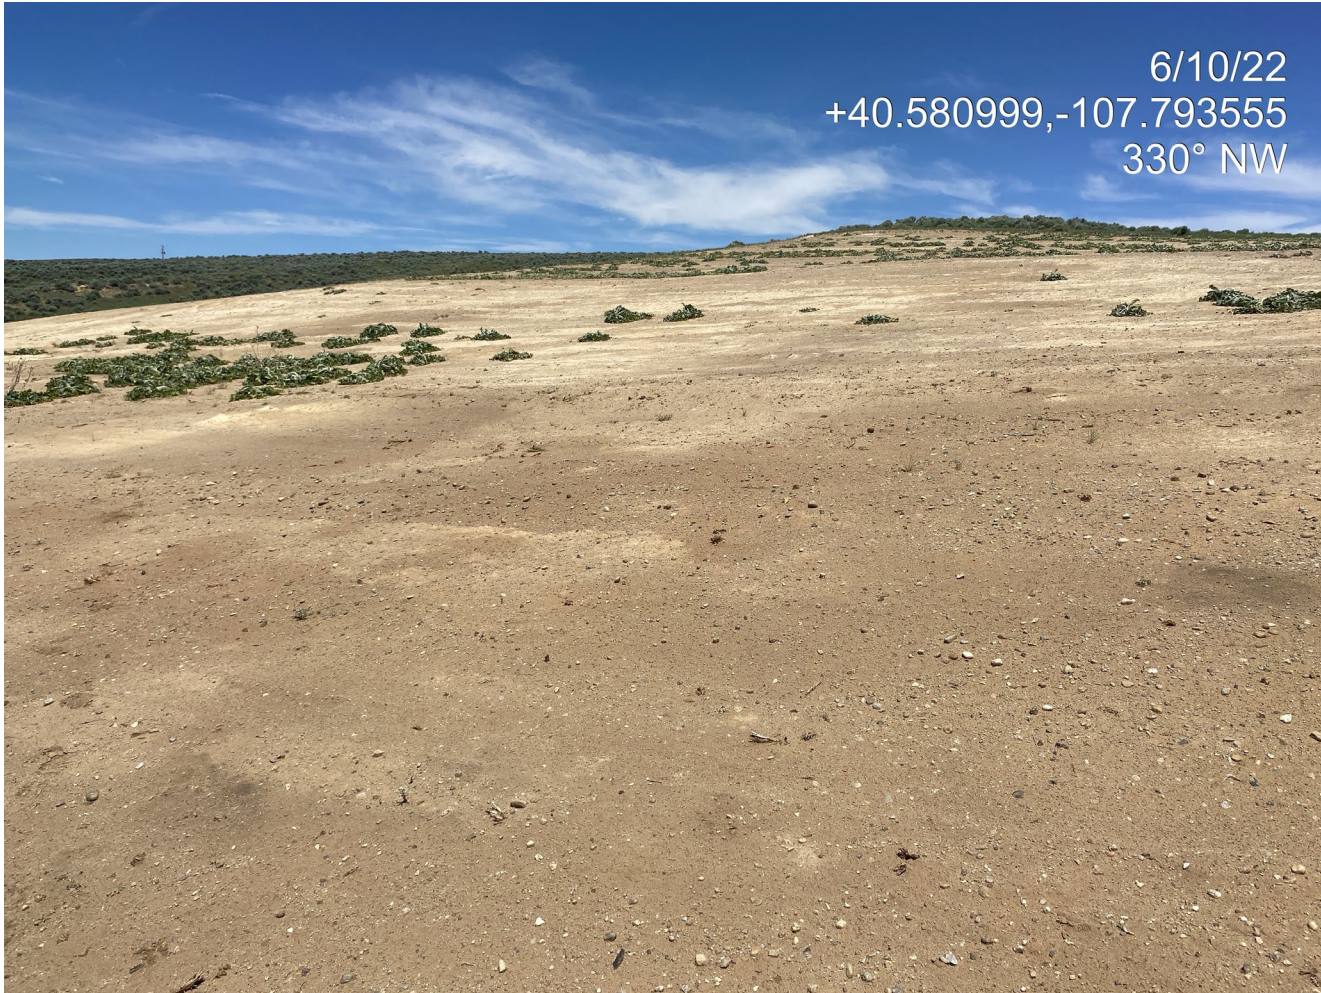
Photo 3. Photo taken from the south of the Location shows seeding has failed. Photo also shows the seedbed/soil surface appears to have been graded smooth.

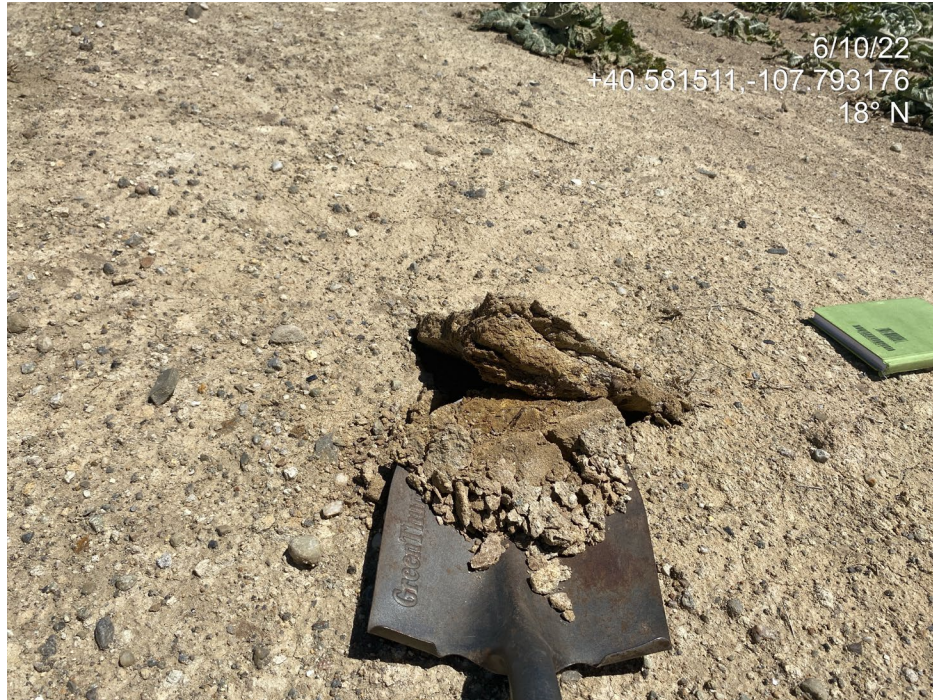
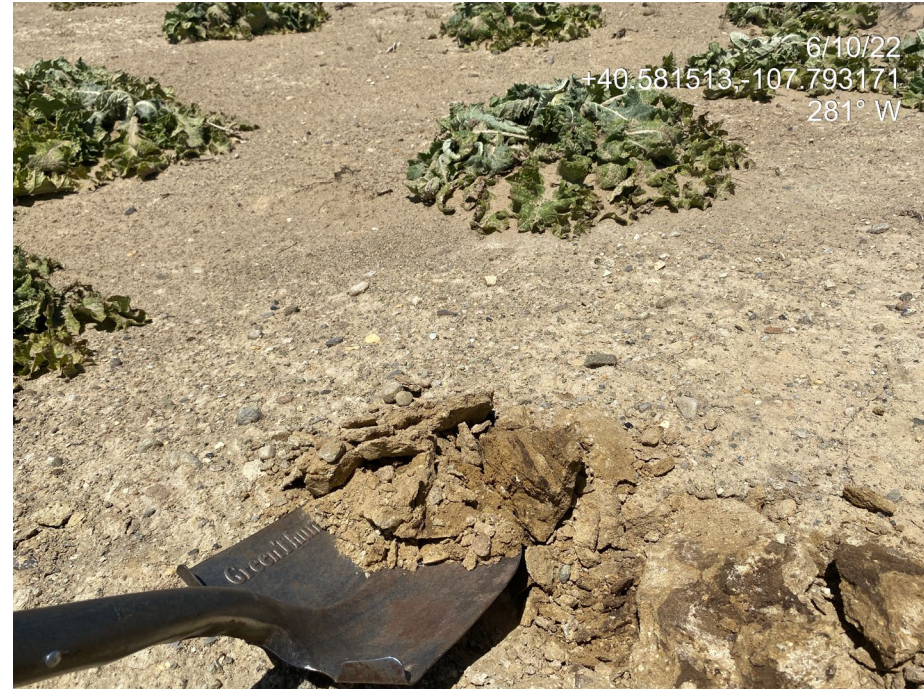
Photo 4. Photo taken from the east of the Location shows platy soil structure indicating compacted soils. Soils were very firm and penetration below approximately 2 inches was very difficult compared to adjacent undisturbed areas.

Photo 5. Refer to Photo 4 comments.

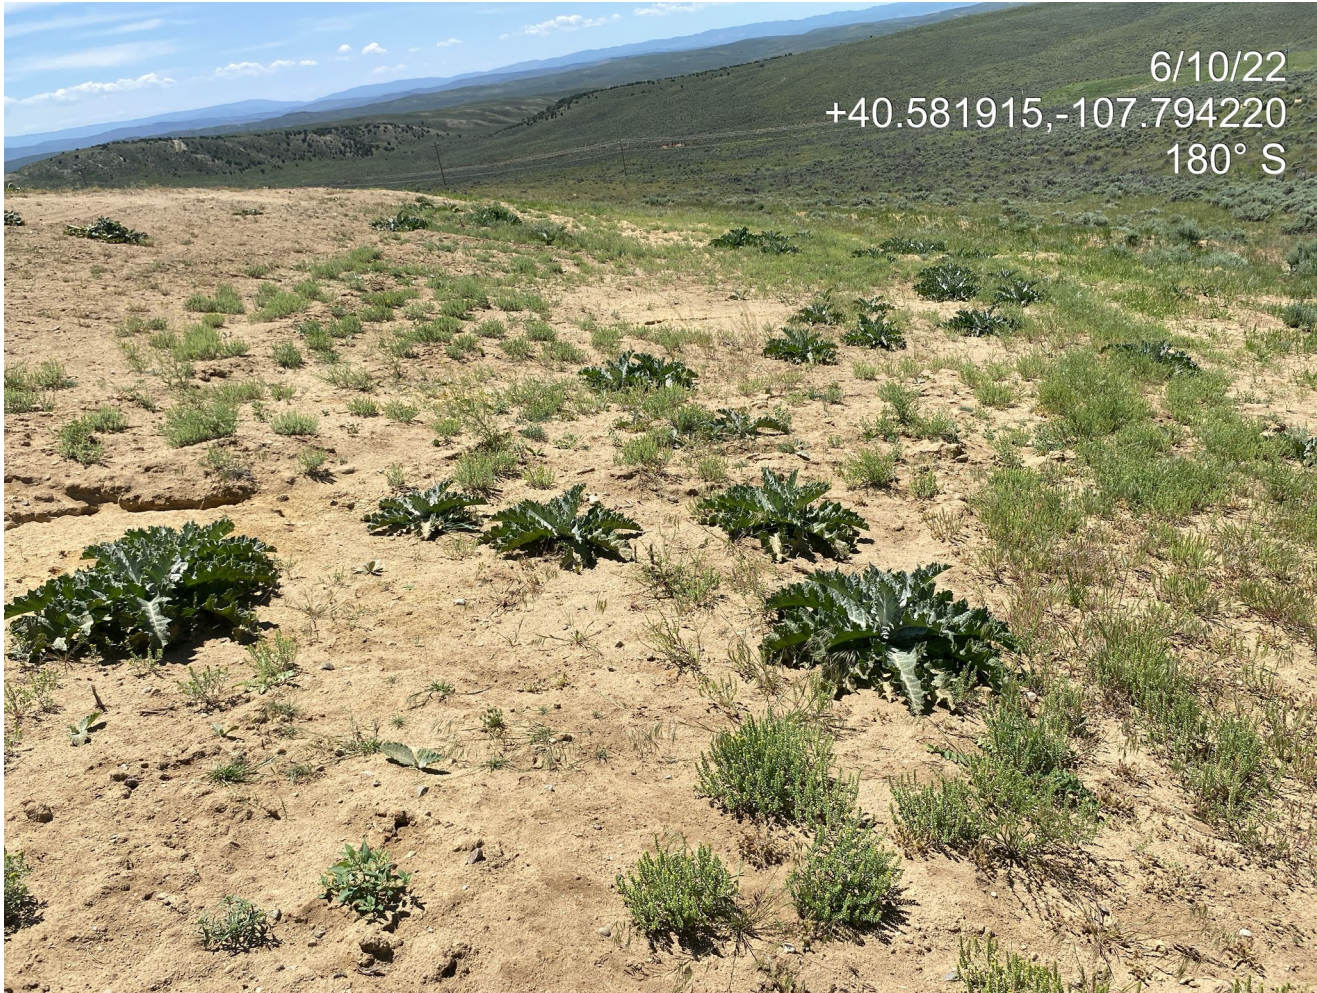
Photo 6. Photo taken from the west of the Location shows noxious weeds which appear to have been missed during the recent treatment.

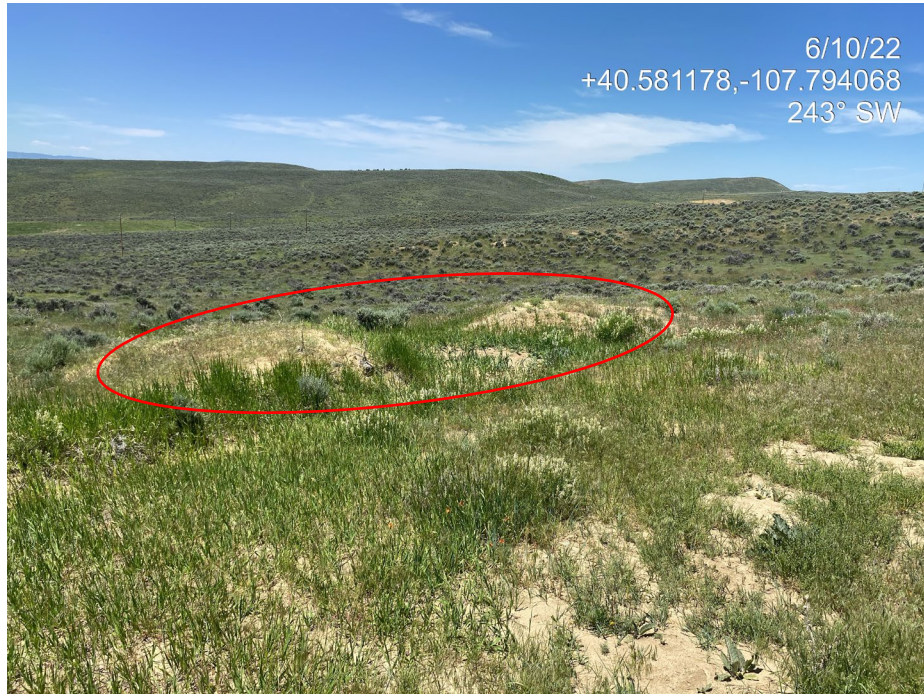
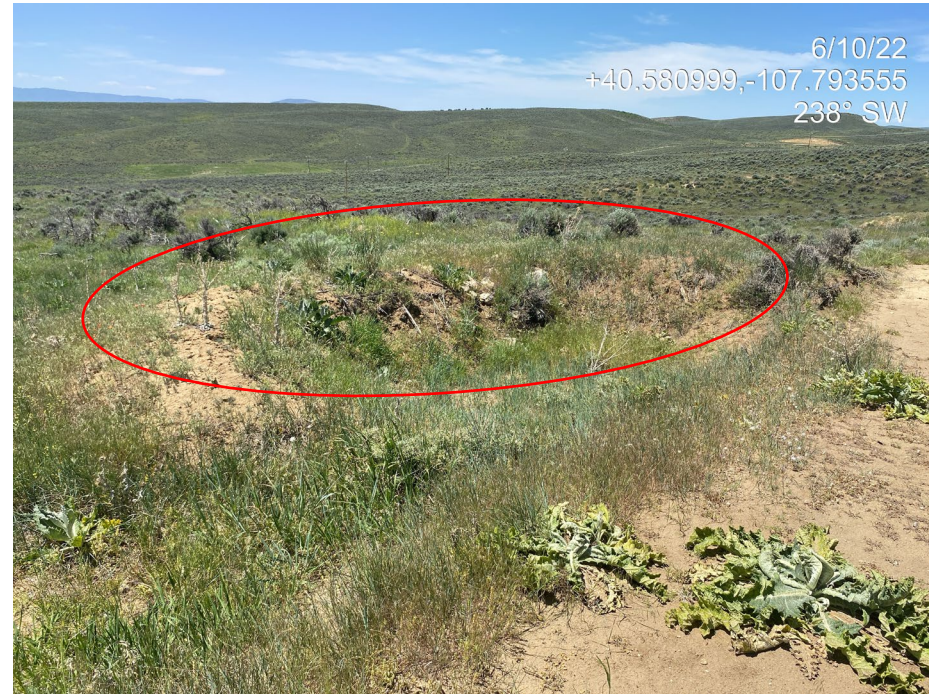
Photo 7. Photo taken from the south of the Location shows a stormwater BMP which has not been removed.

Photo 8. Refer to Photo 7 comment.

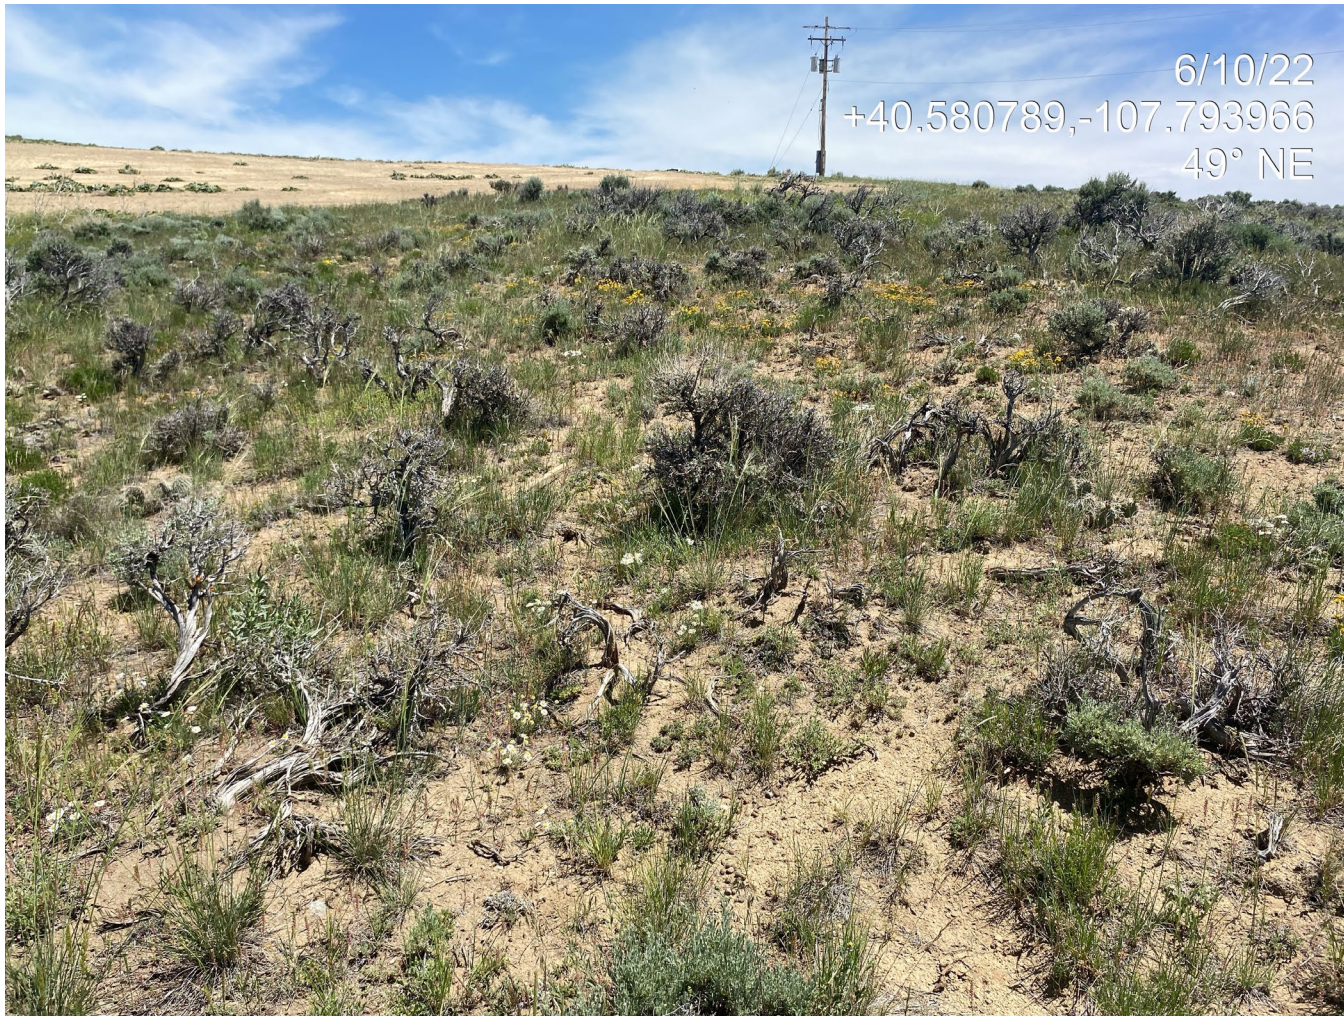
Photo 9. Photo taken from the south of the Location shows the reference area vegetation community is native rangeland. Note also the power line remaining just off Location.
