# Inspection Photos

Location Name: Boston Federal-67N93W /2NWSE

Inspection Document #: 702800330

Anna O'Malley  
Reclamation Specialist, COGCC

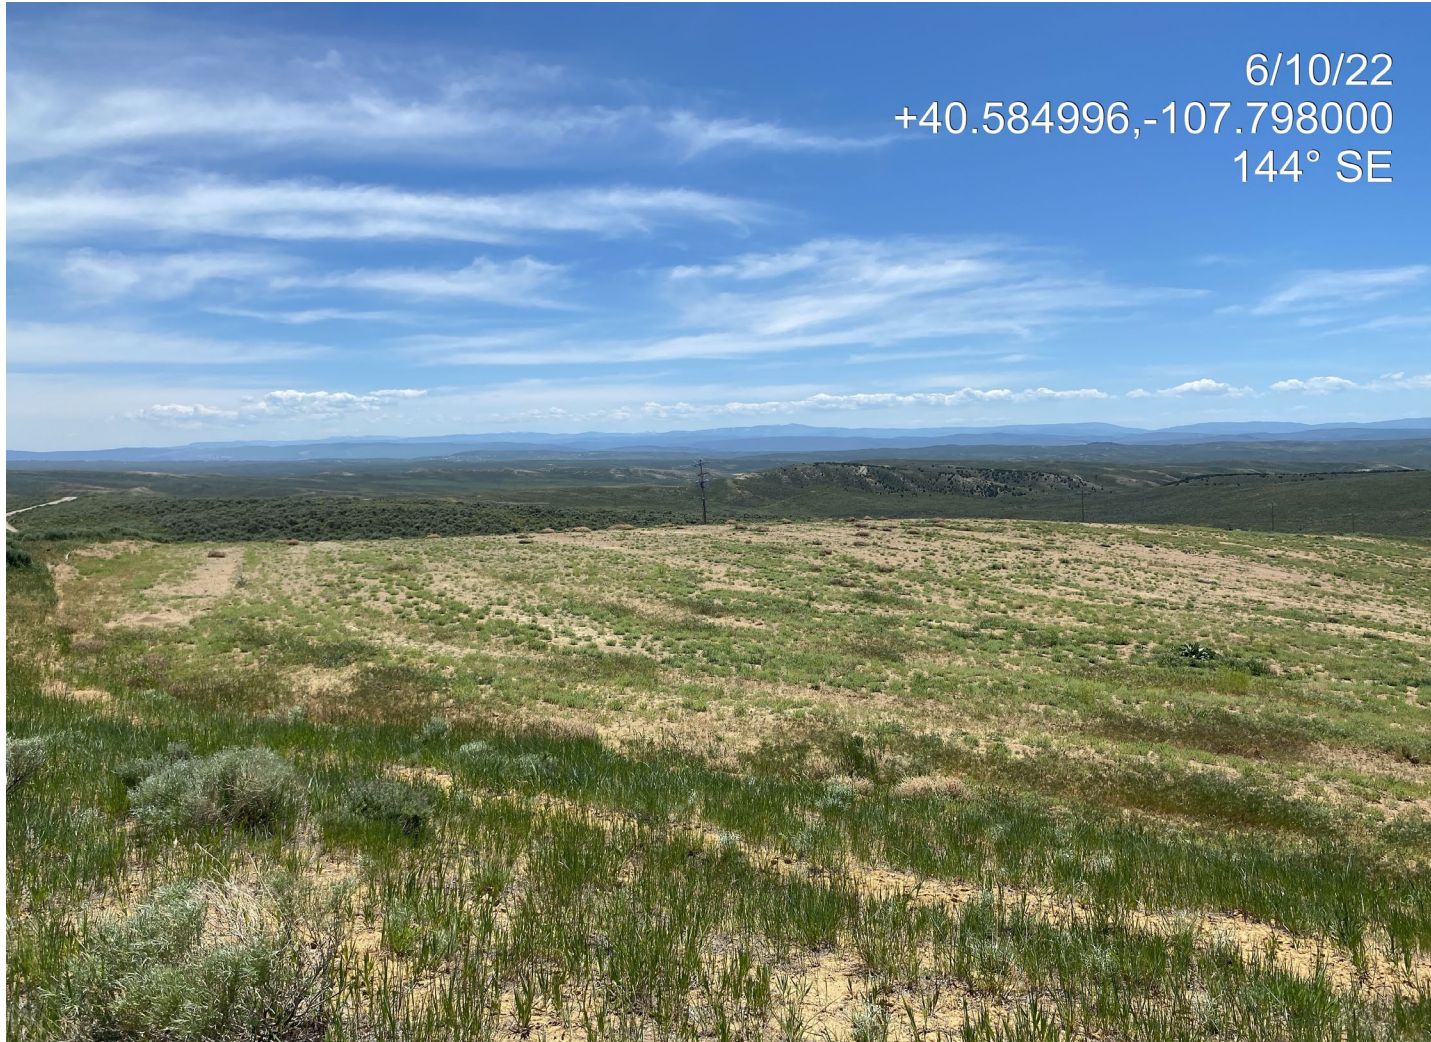
**Photo 1.** Photo taken from the north of the Location shows an overview of the Location.

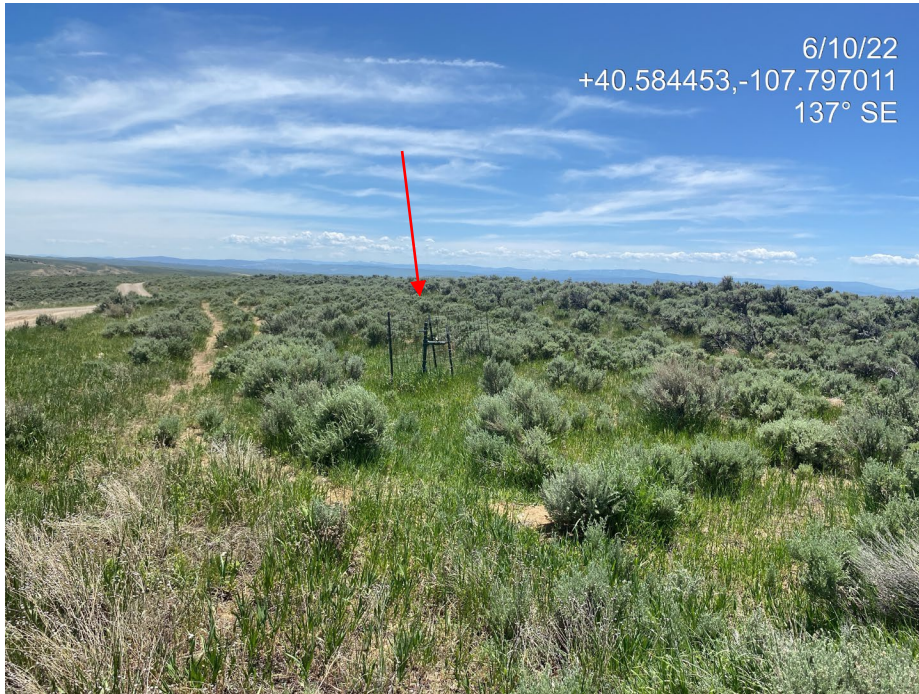
**Photo 2.** Photo taken from the northeast of the Location shows an off Location flowline riser which must be removed and reclaimed.

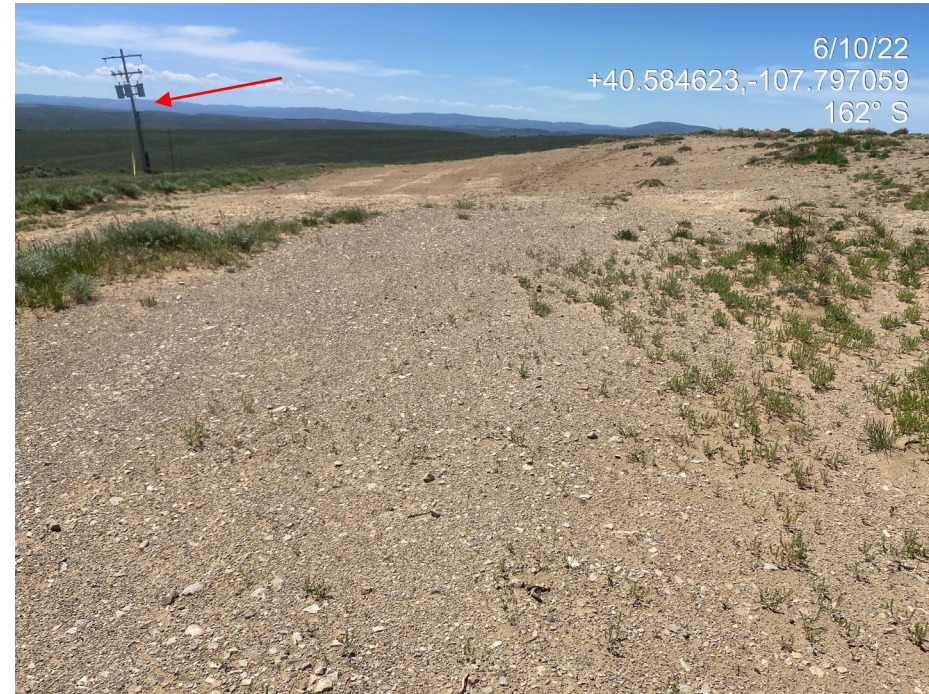
**Photo 3.** Photo taken from the northeast of the Location shows the access road, which must be reclaimed. Note also the power line remaining just off Location which must be removed and reclaimed.

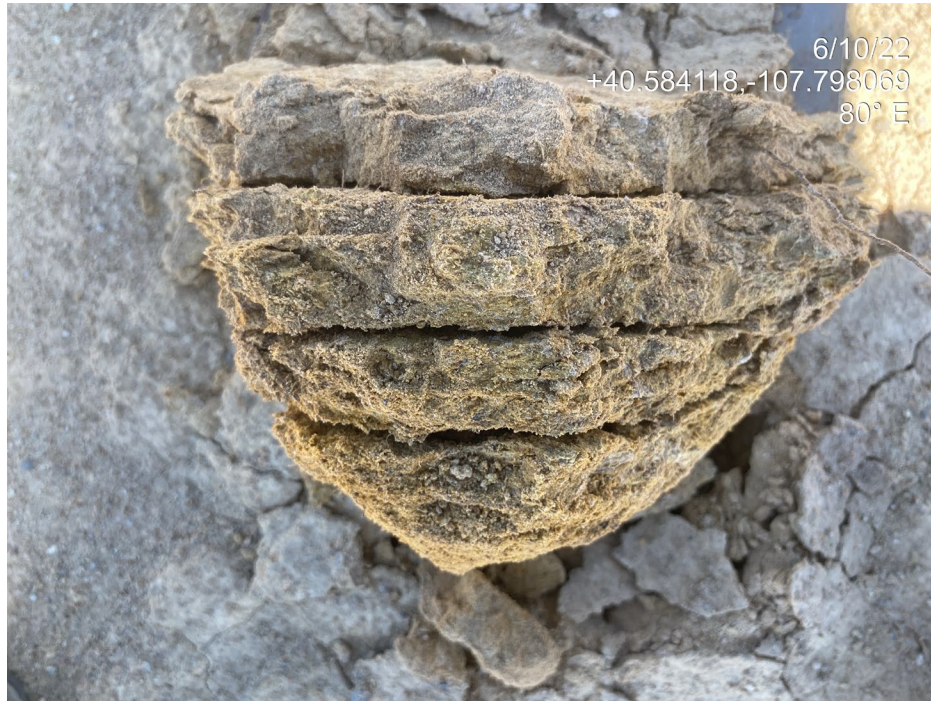
**Photo 4.** Photo taken at the south of the Location shows platy soil structure indicating compacted soils. Soils were firm compared to adjacent undisturbed areas.

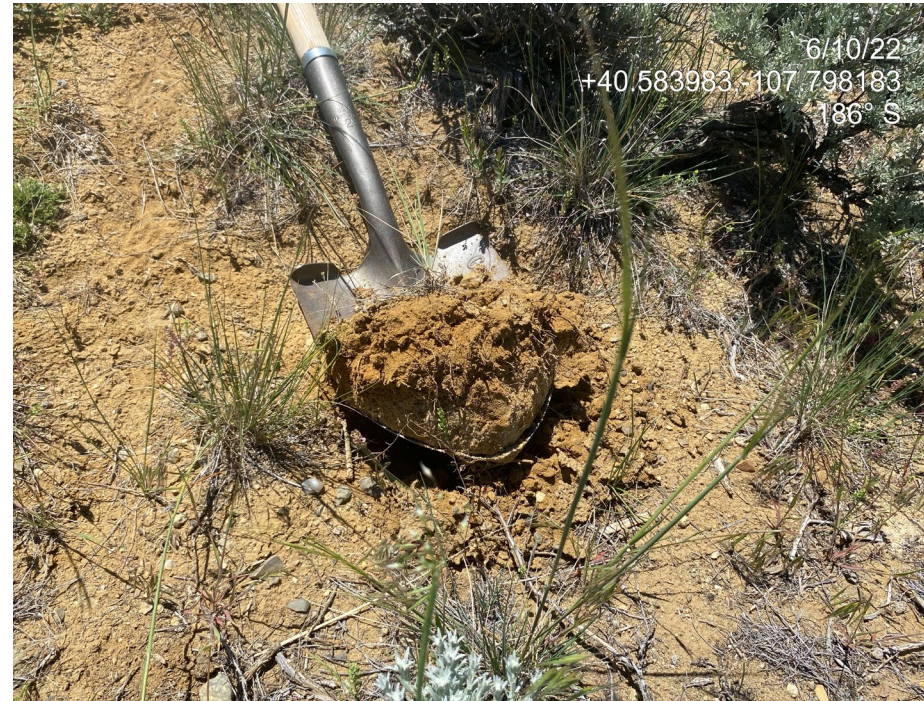
**Photo 5.** Photo taken to the south of the Location in adjacent undisturbed areas shows loose, granular and subangular blocky soil structures.

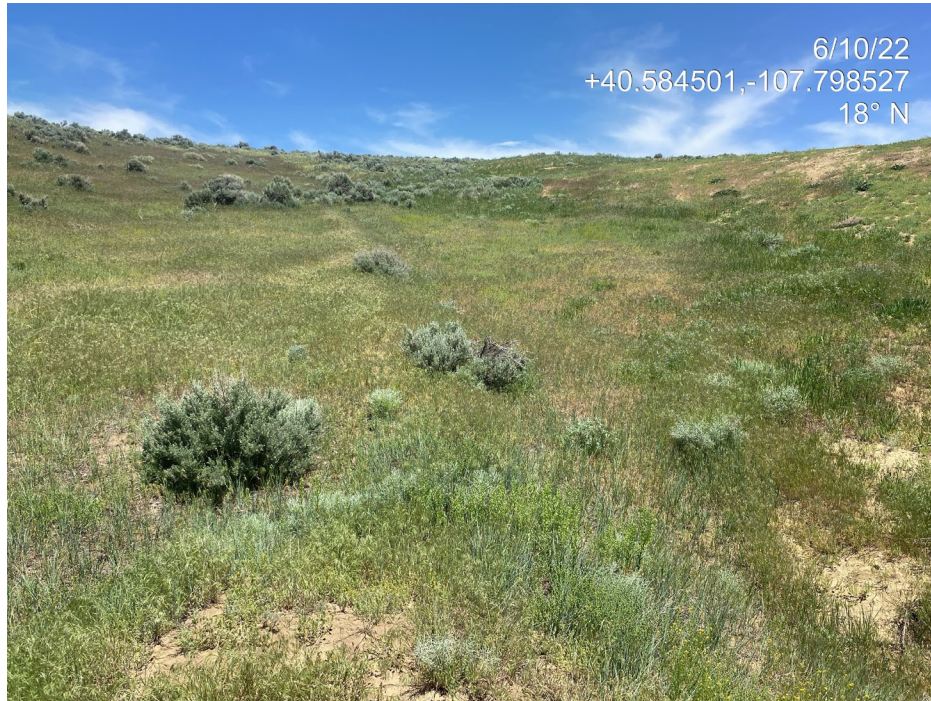
**Photo 6.** Photo taken from the west of the Location shows some establishment of perennial plants (western wheatgrass, sagebrush) and dense cover of the noxious weed, cheatgrass.

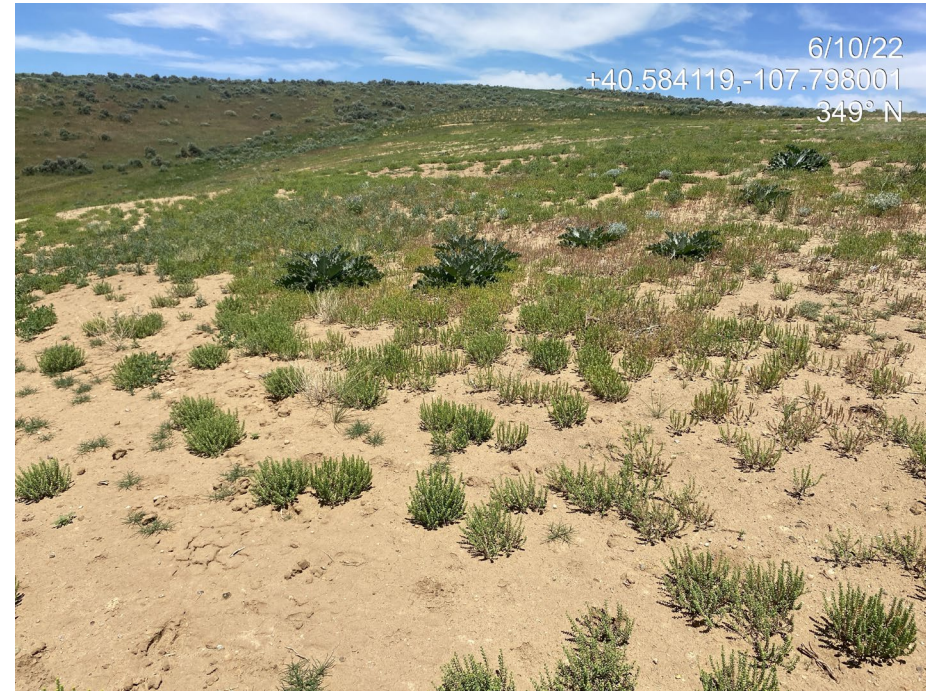
**Photo 7.** Photo taken from the south of the Location shows the majority of the Location without any perennial plants. Vegetation is dominated by desert madwort (annual undesirable species), cheatgrass and Scotch thistle (noxious weeds).

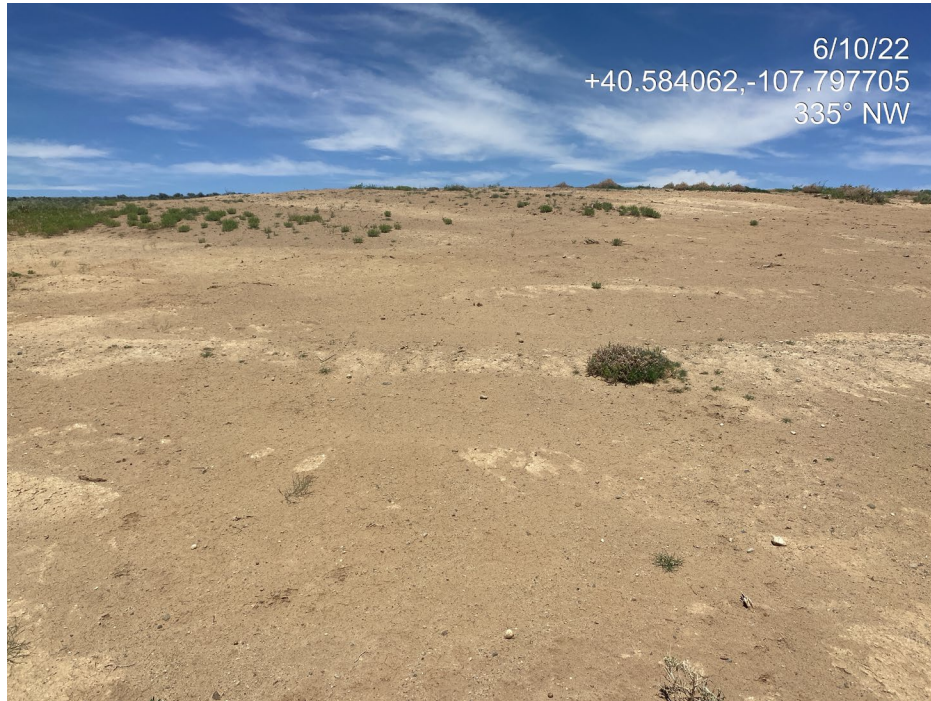
**Photo 8.** Photo taken from the south of the Location shows an area which is almost completely bare of vegetation.

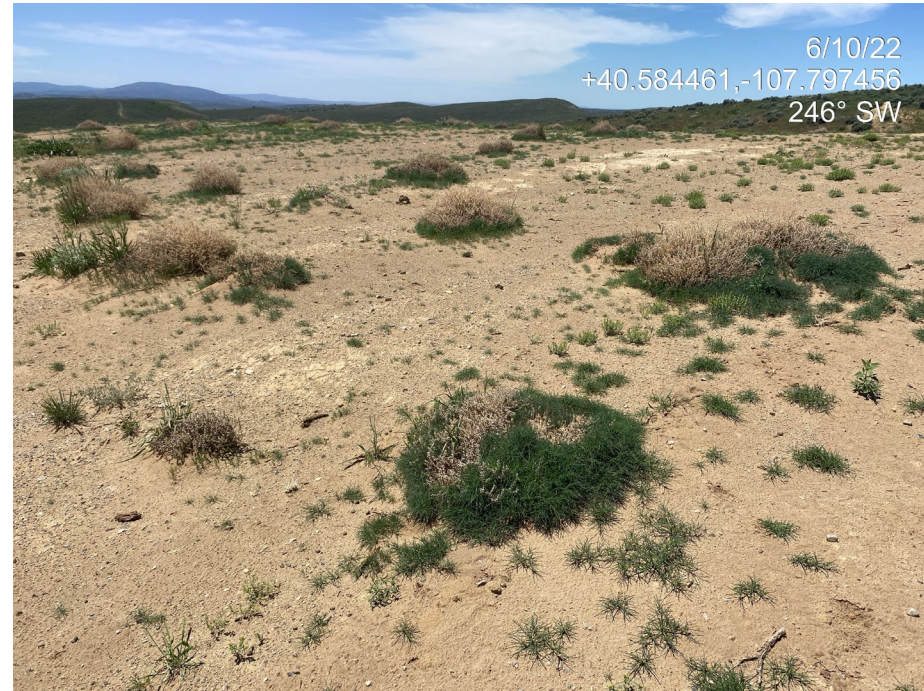
**Photo 9.** Photo taken from the east of the Location shows an area which is dominated by the undesirable plant species/weed Russian thistle and bare ground.

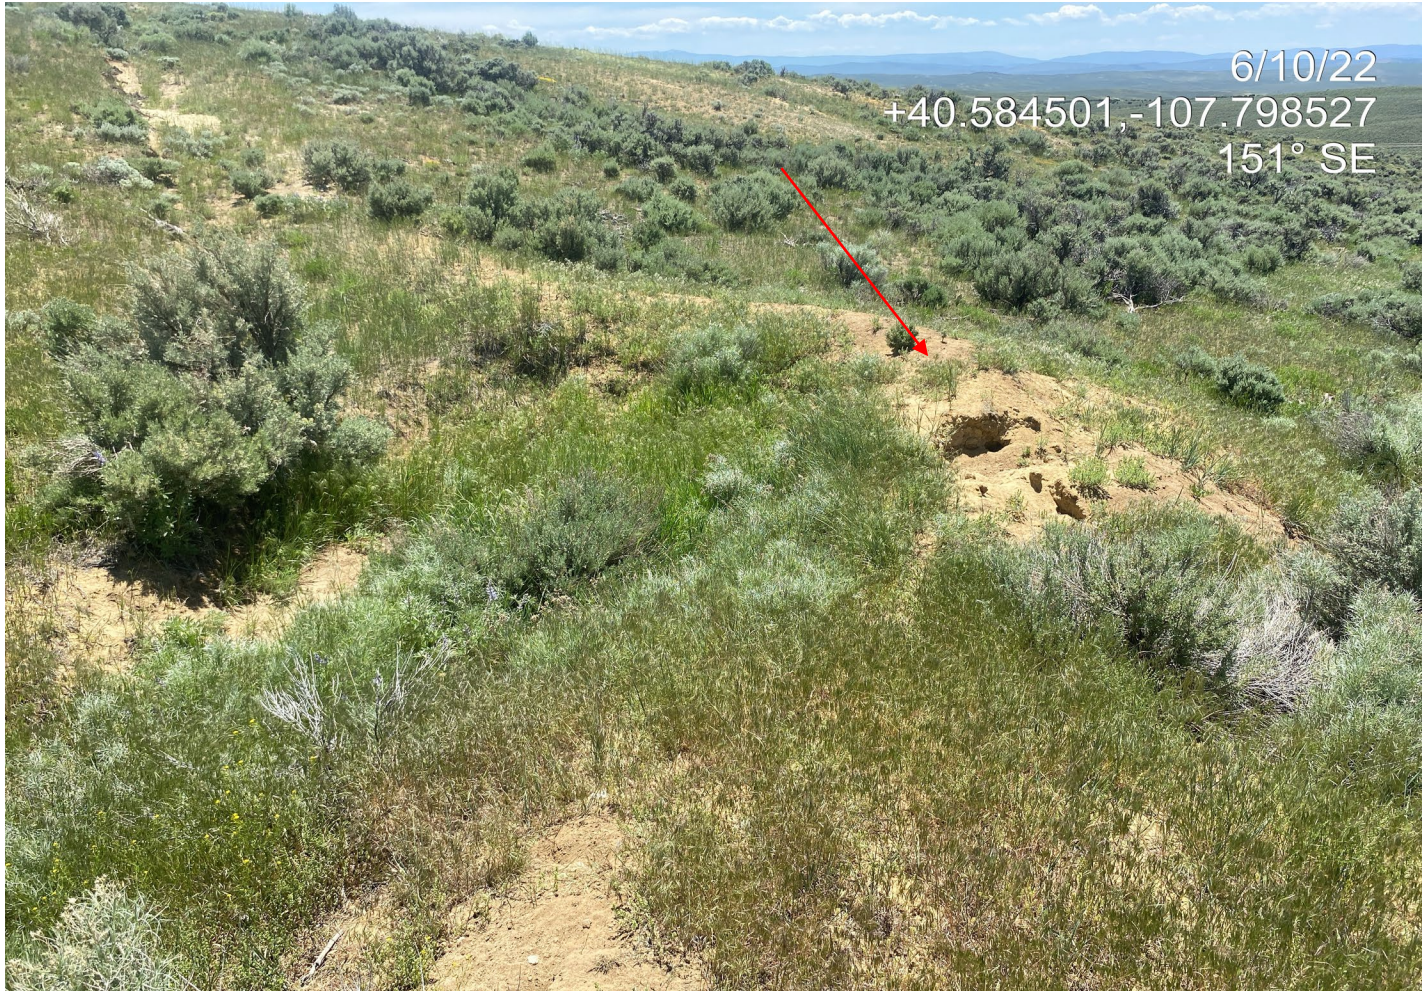
**Photo 10.** Photo taken from the south of the Location shows a stormwater BMP which has not been removed.

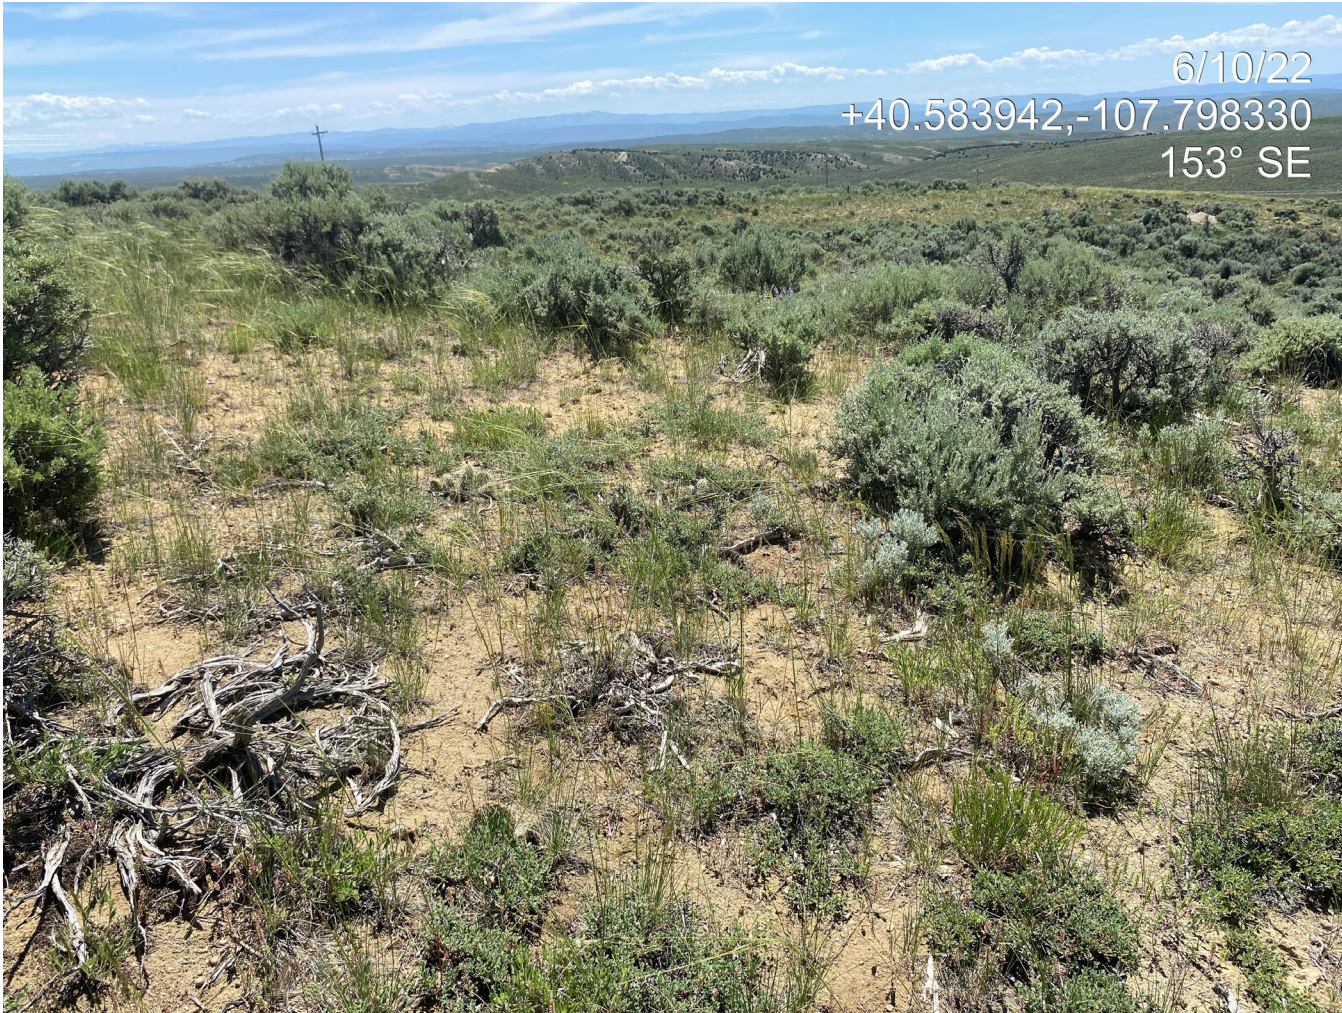
**Photo 11.** Photo taken from the south of the Location shows the reference area vegetation community is native rangeland.
