Inspection Photos

API: 071-07915

Operator: WAPITI OPERATING LLC

Inspection Date: 6/14/2022

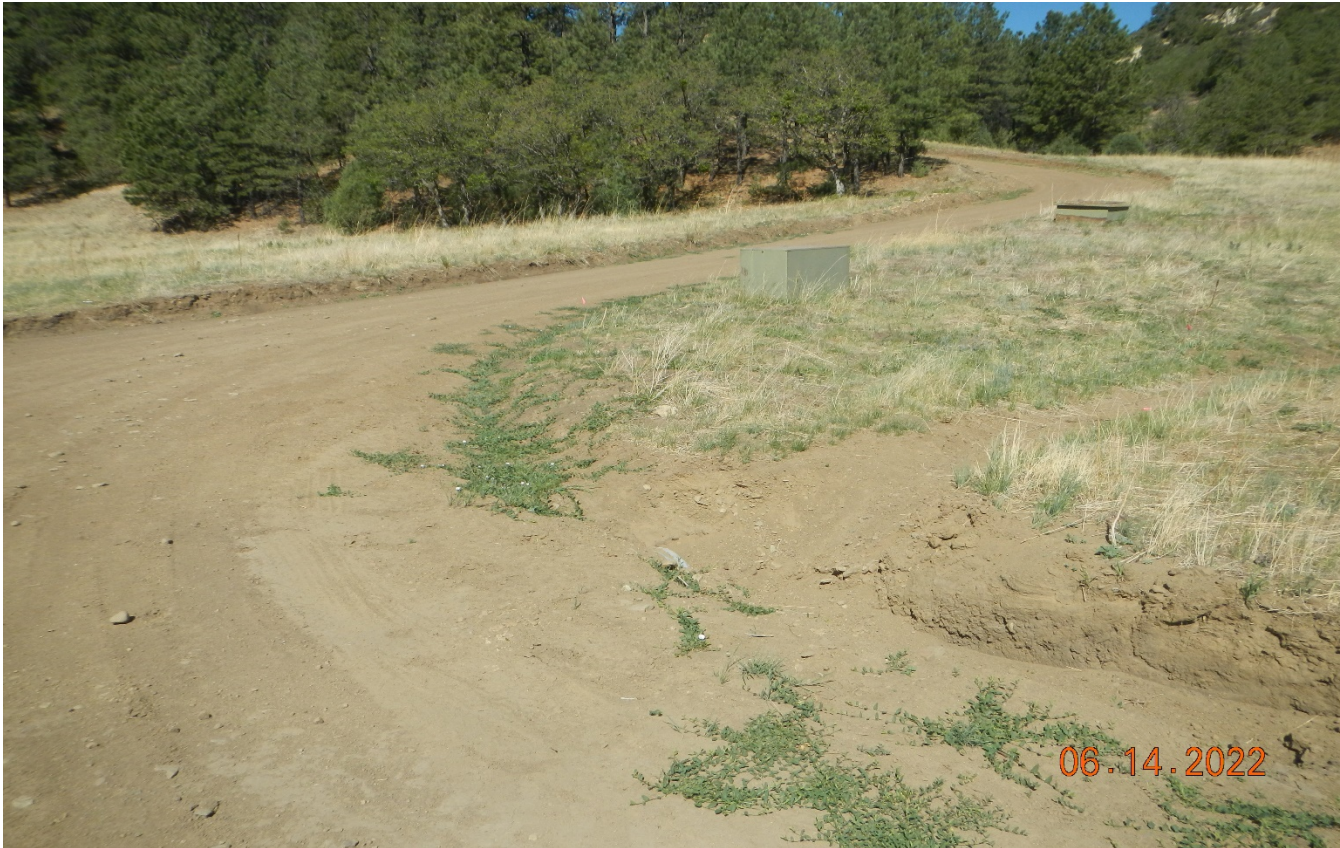
Photo 1. Facing west toward the access road ascending the hillside. The road has been graded. The culvert inlet cleaned out and repaired.

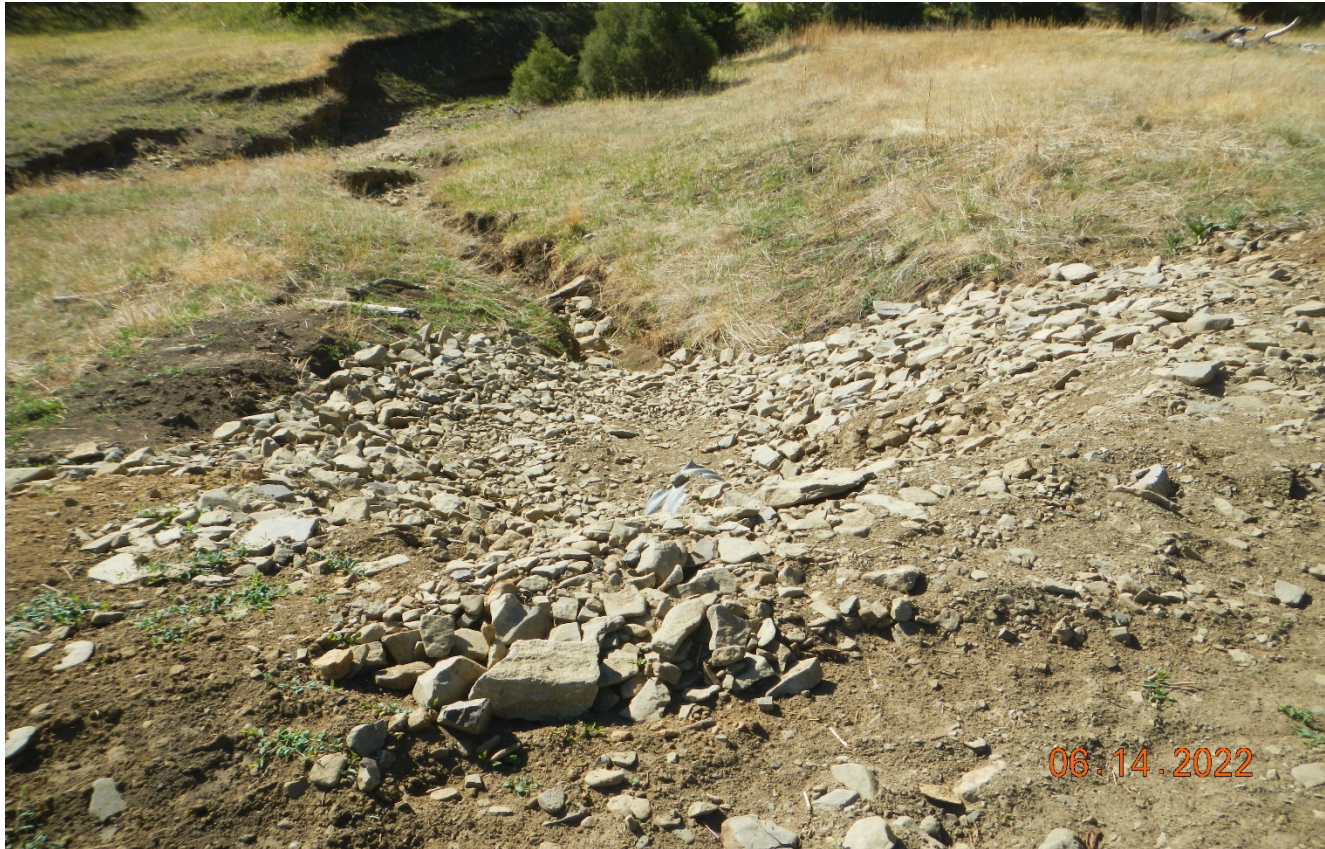
Photo 2. The culvert outlet has been repaired and rock rip/rap outlet protection has been installed.

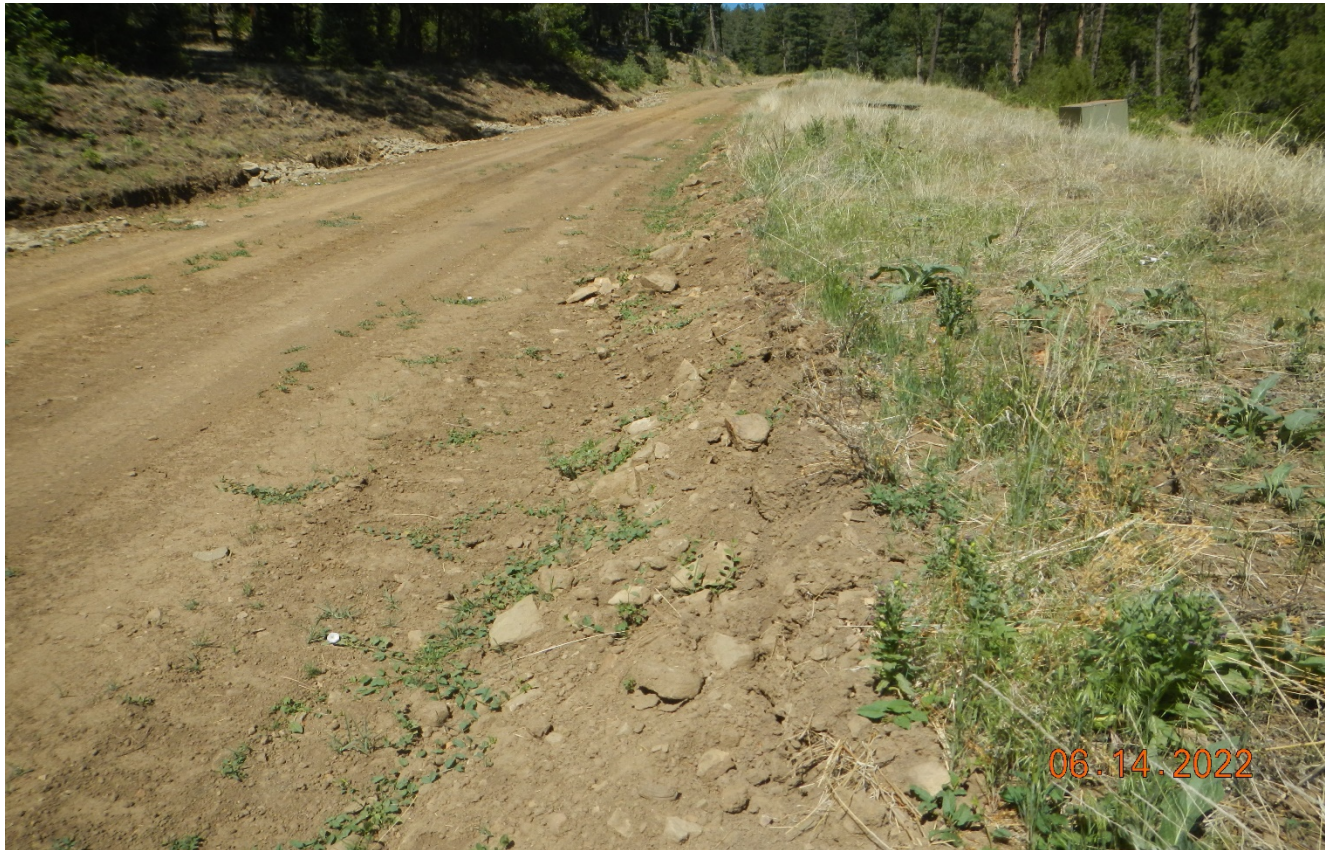
Photo 3. There are noxious weeds along the access road that need to be controlled.

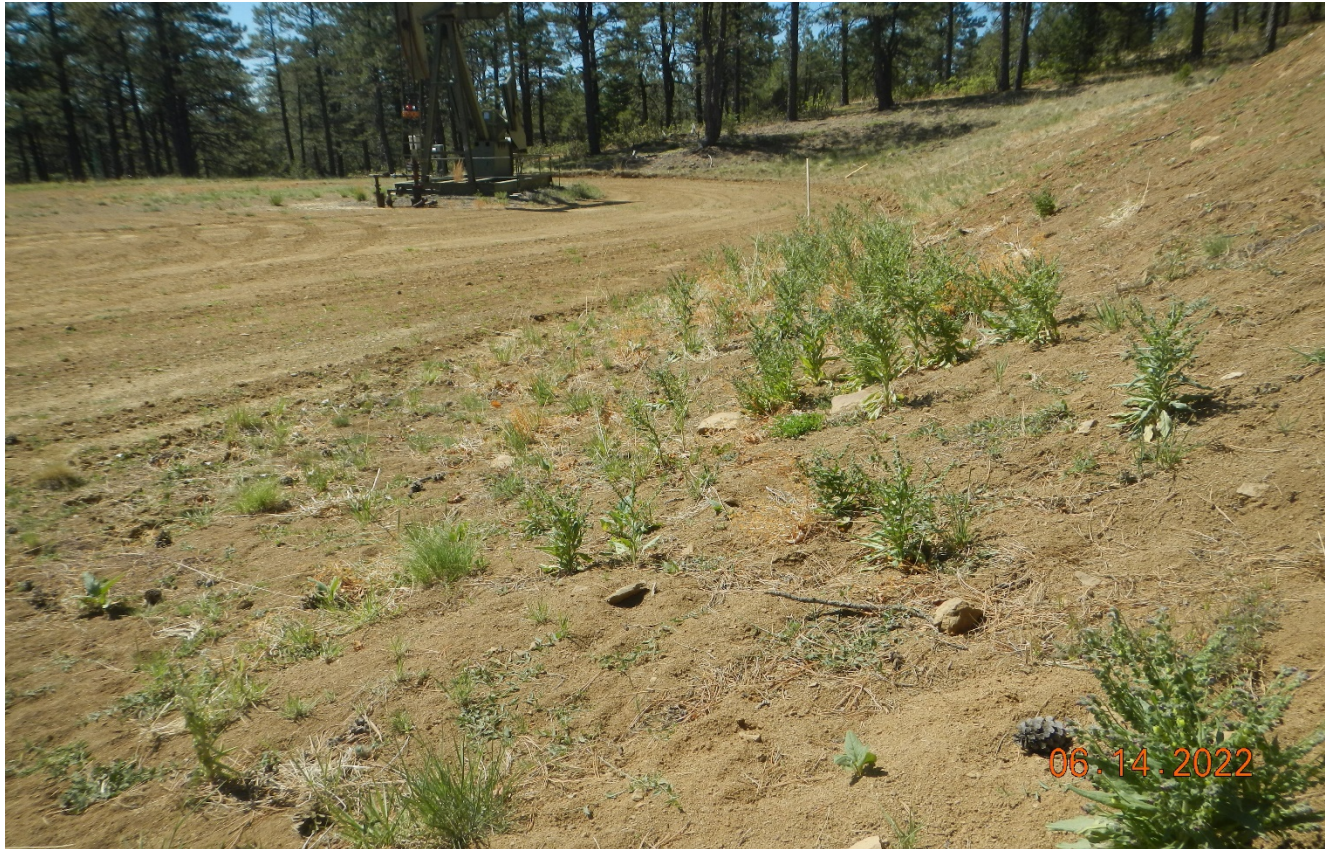
Photo 5. There are noxious weeds Hounds tongue which has not been controlled. The noxious weeds have already produced seed so the weeds will now need to be bagged and removed. Previous corrective action not completed.
