Inspection Photos and Issue Report

6/14/2022

Operator: UTAH GAS OP LTD DBA UTAH GAS
CORP - 10539

Location ID: 322513
Garfield County, CO

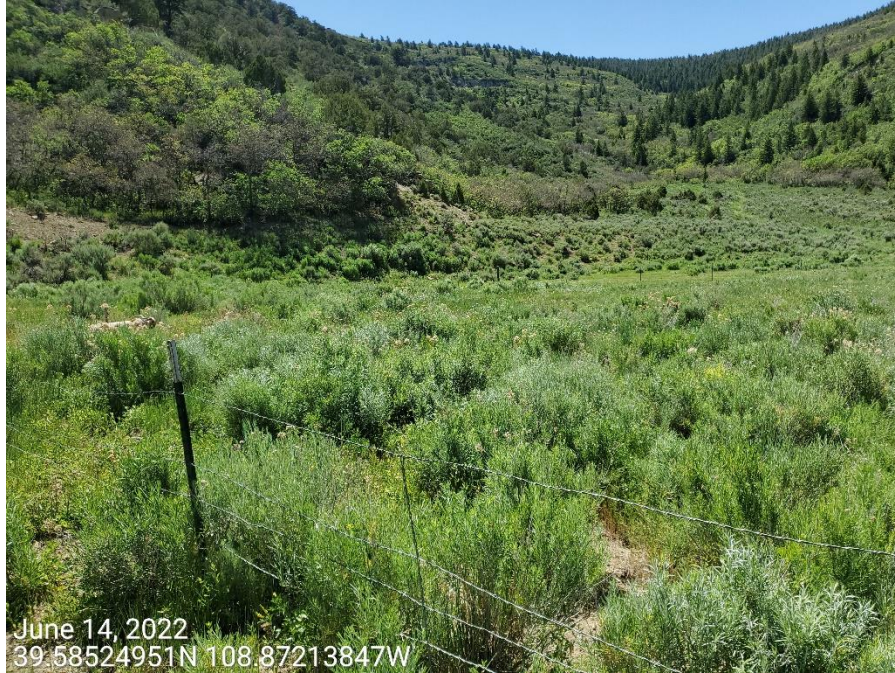
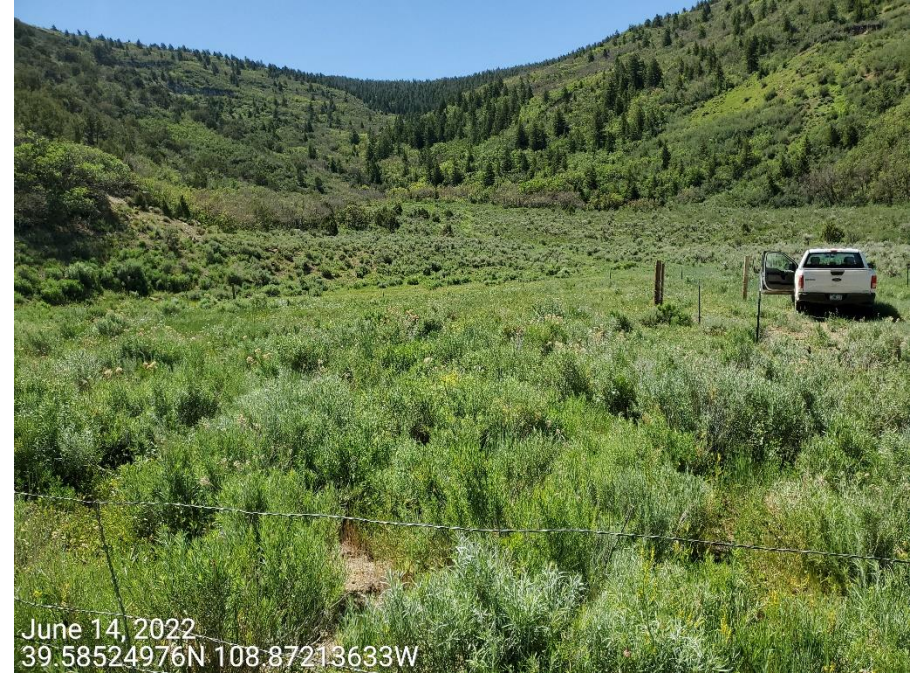
Photo 1: Photos taken from the north end of the Location, facing southeast / south. Photos show reclamation of the Location meets 1004 reclamation requirements,

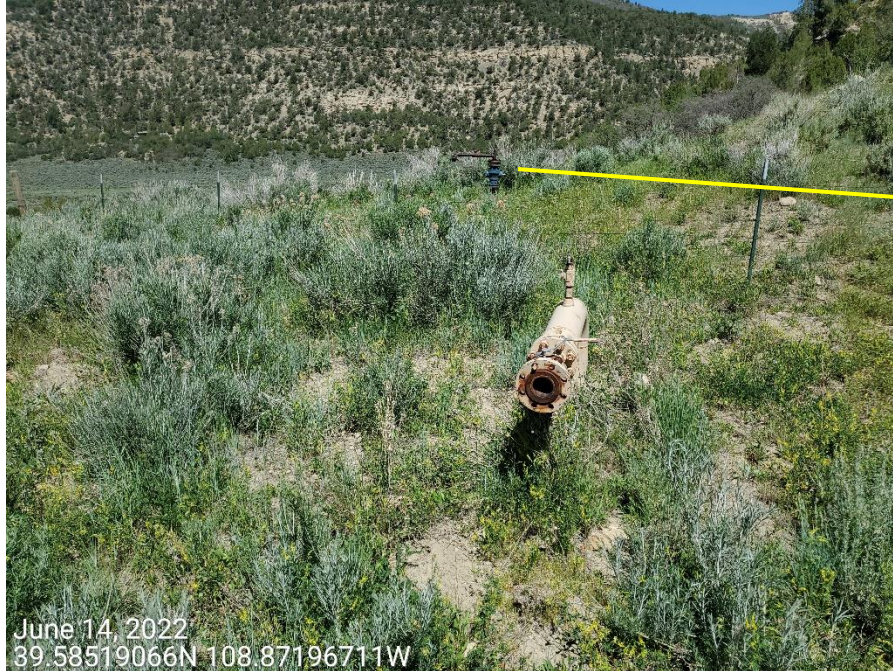
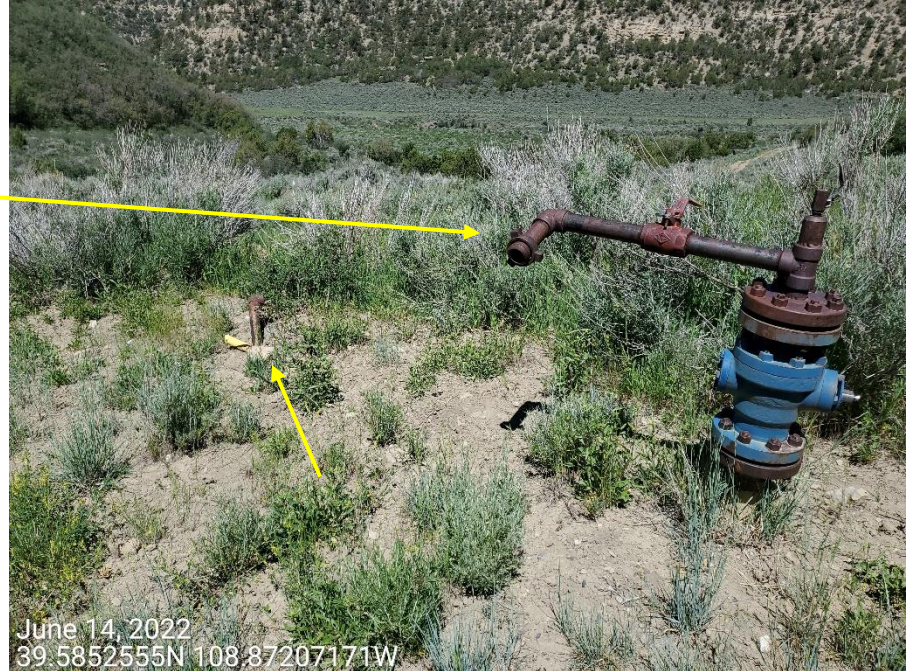
Photo 2: Photos taken from the North end of the Location. Photo shows piper risers / surface equipment remaining on the Locaiton. Equipment requires removal pursuant to Rule 1004.a

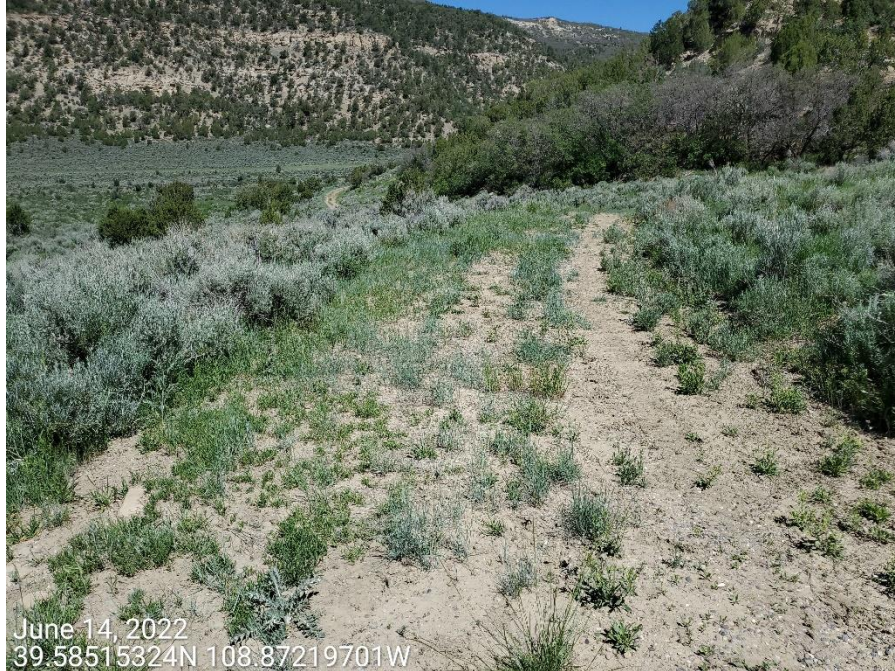
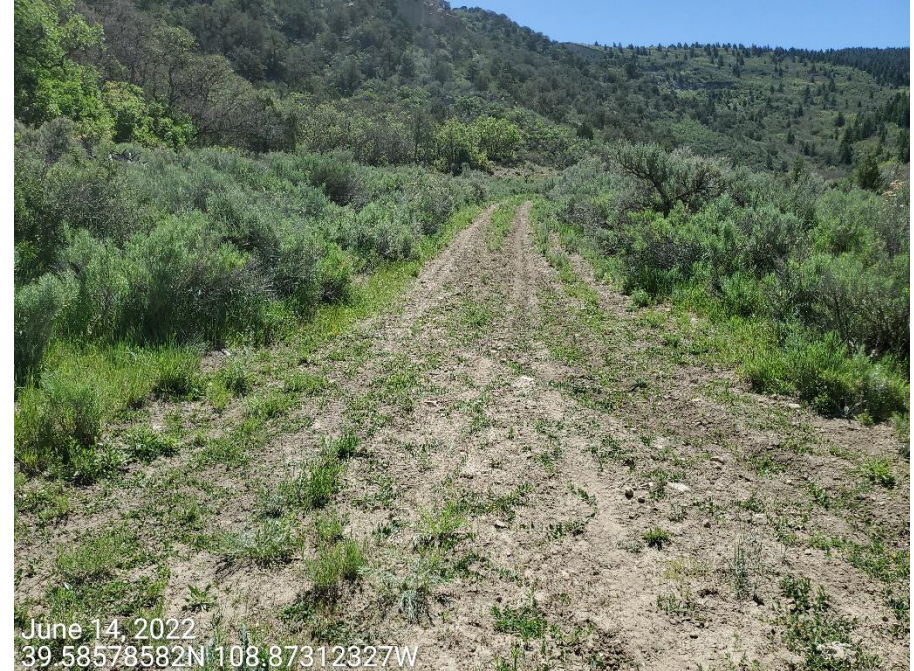
Photo 3: Photos show access road north of the Location. Historic aerial imagery shows access road pre-existed the O&G Location.

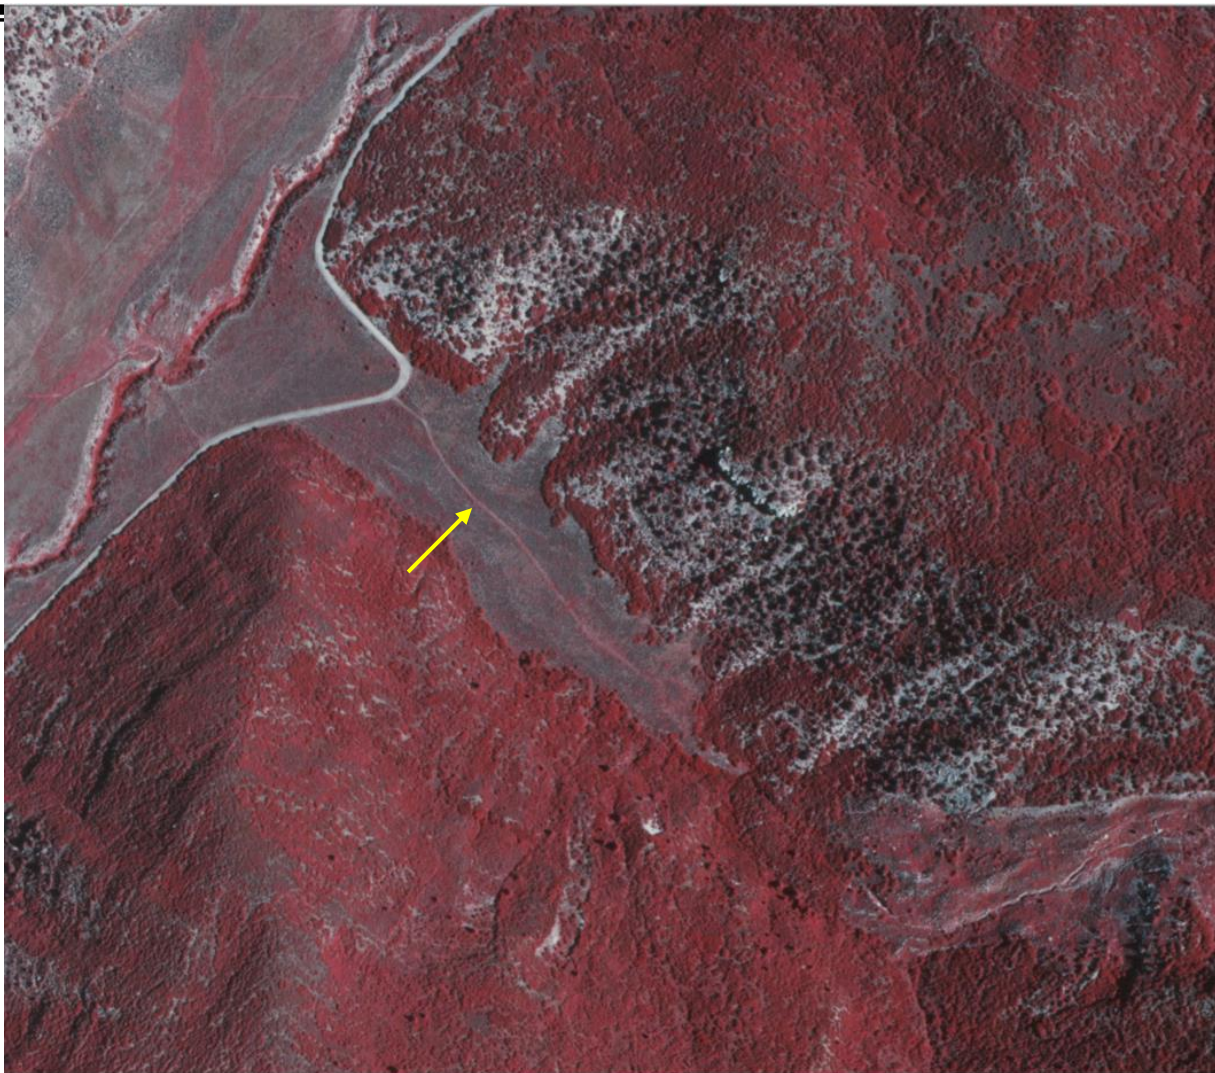
Photo 4: USGS Aerial Photo dated 7/21/1981 (Entity ID: AR4C81A02039027). Well was SPUD 7/22/1982- Photo shows access road pre-exists the O&G Location.
