# Inspection Photos

Operator: SWN Production Company LLC - #10396

Location Name: Saratoga-67N93W /3SESE

Inspection Document #: 702800334

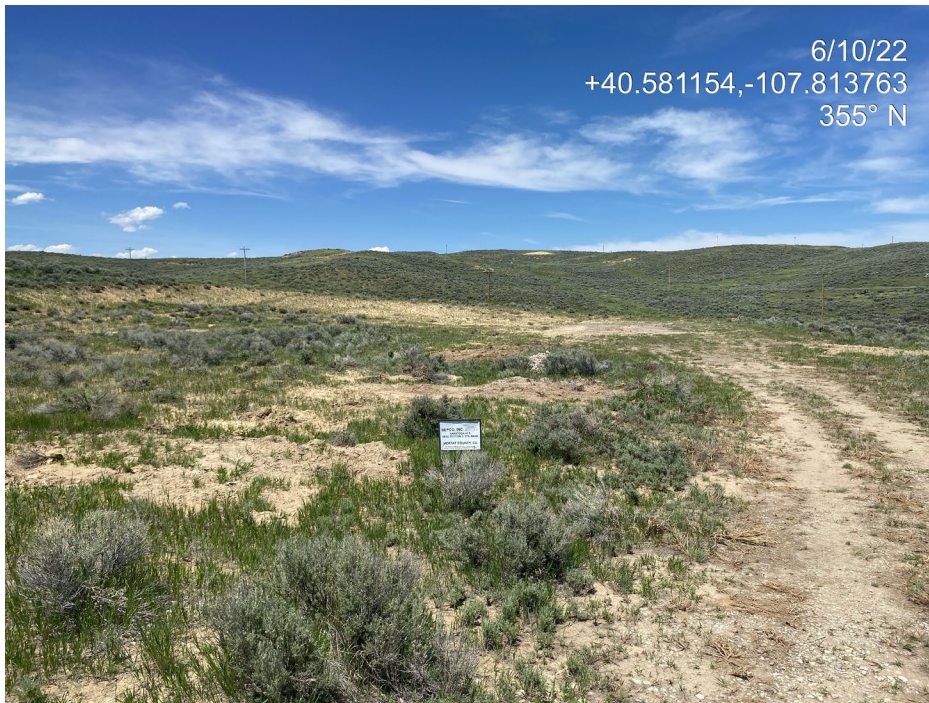
**Photo 1.** Photo taken from the south of the Location shows an overview of the Location.

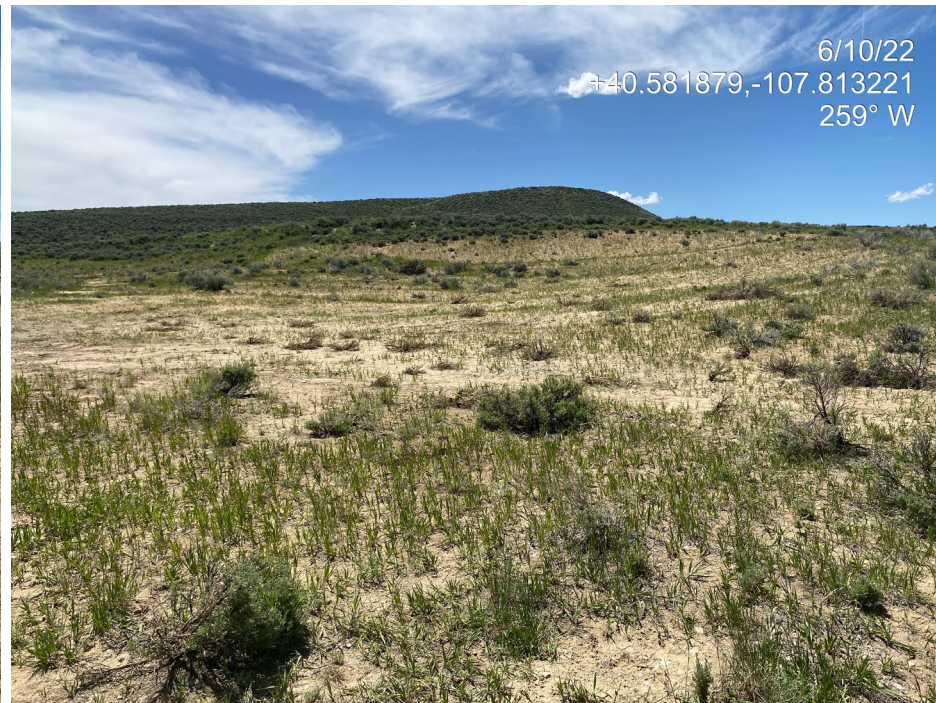
**Photo 2.** Photo taken from the northeast of the Location shows an overview of the Location.

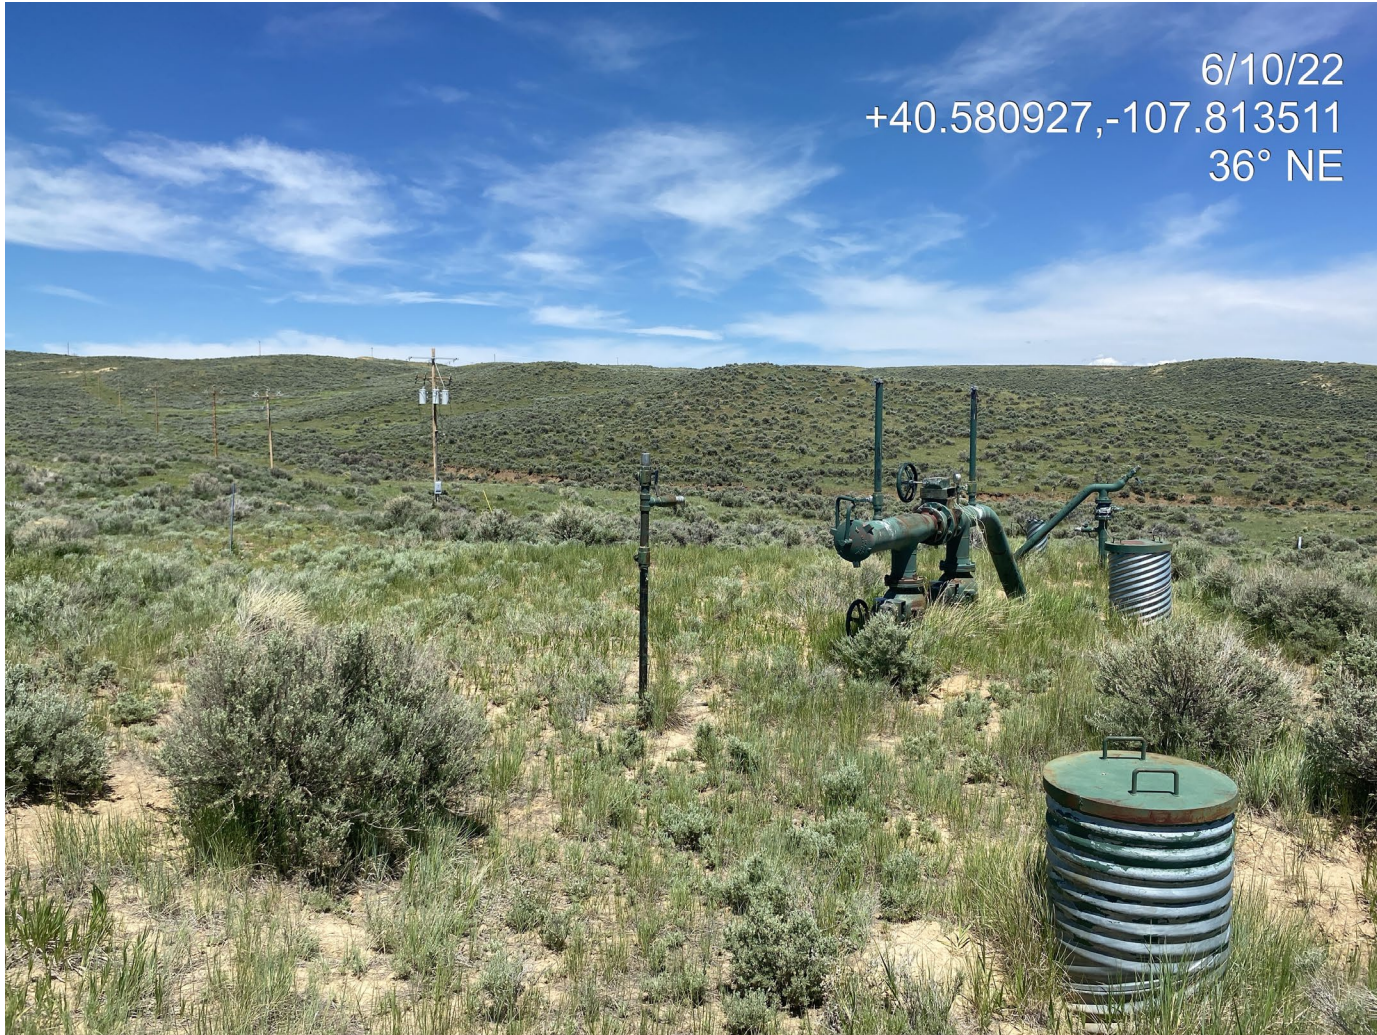
**Photo 3.** Photo taken from the south of the Location shows risers, pipes and power lines which must be removed for final reclamation per Rule 1004.a.

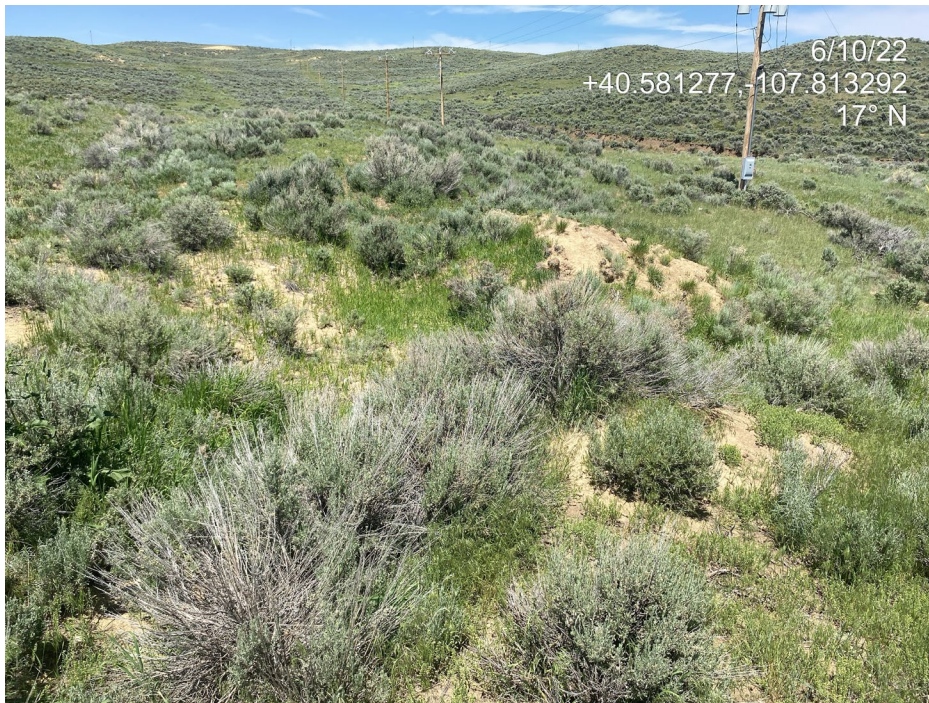
**Photo 4.** Photo taken from the southeast of the Location shows berms associated with stormwater BMPs which must be removed along with ditches to pass final reclamation.

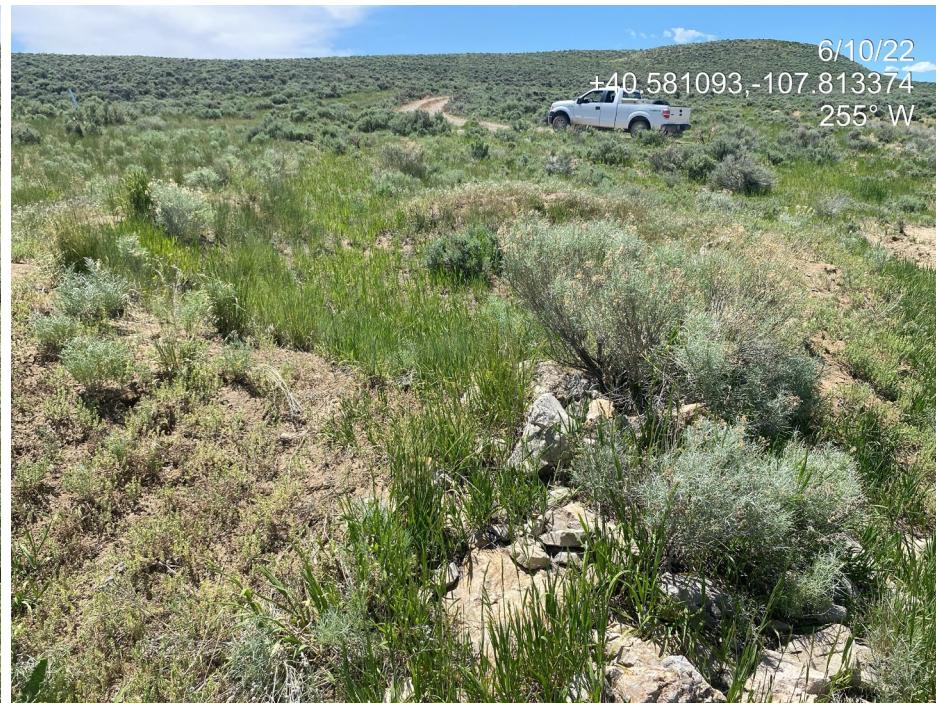
**Photo 5.** Photo taken from the southeast of the Location shows an impoundment which must be removed and contoured to match the surrounding landscape to pass final reclamation.

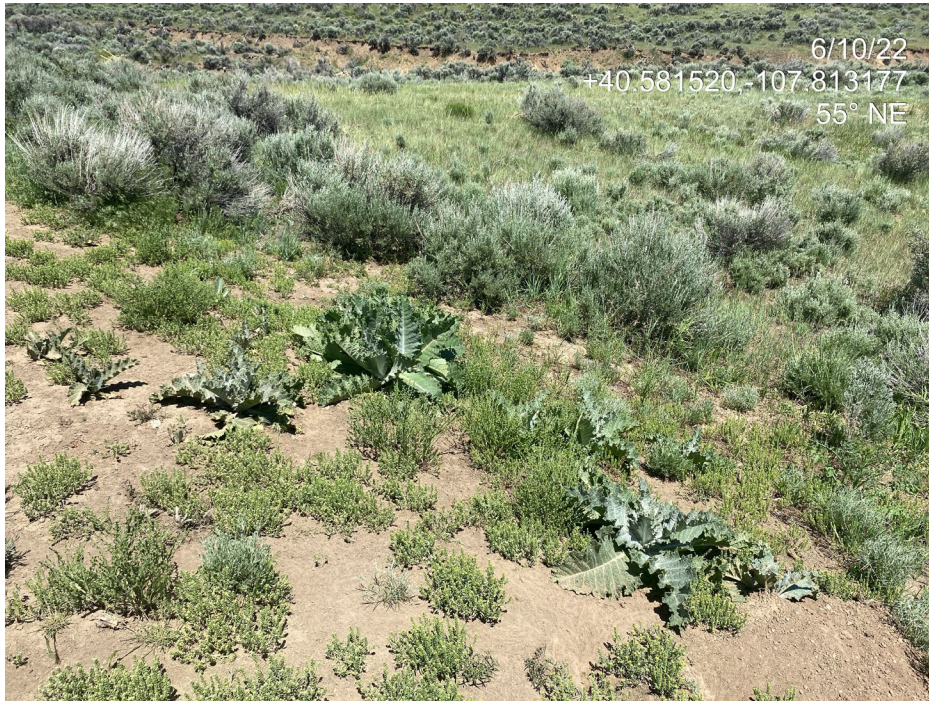
**Photo 6.** Photo taken from the east of the Location shows Scotch thistle, a noxious weed.

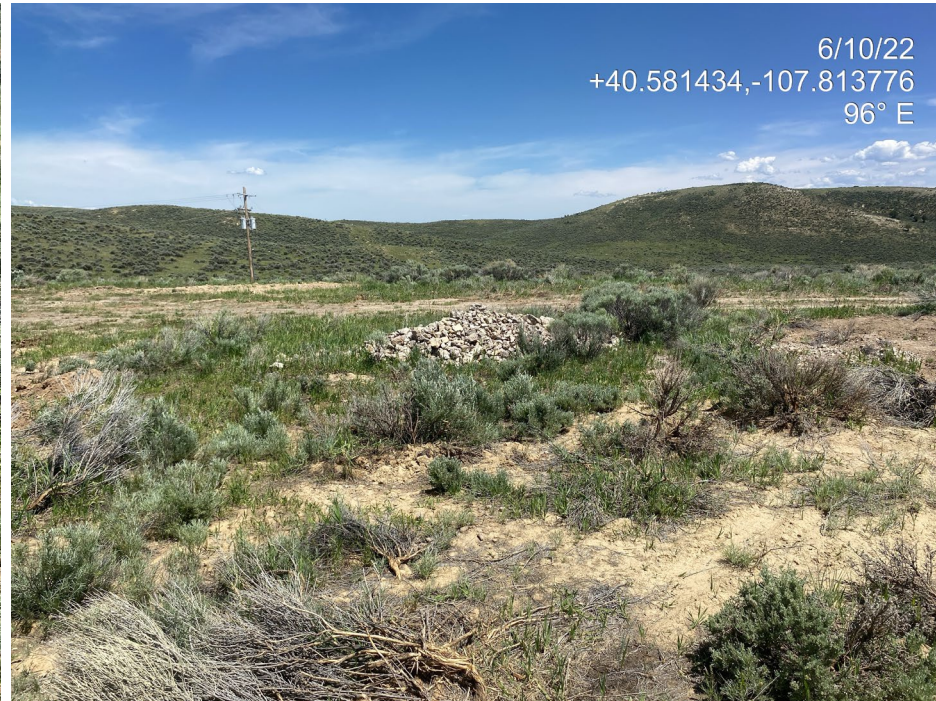
**Photo 7.** Photo taken from the center of the Location shows a pile of stone which must be removed for final reclamation.

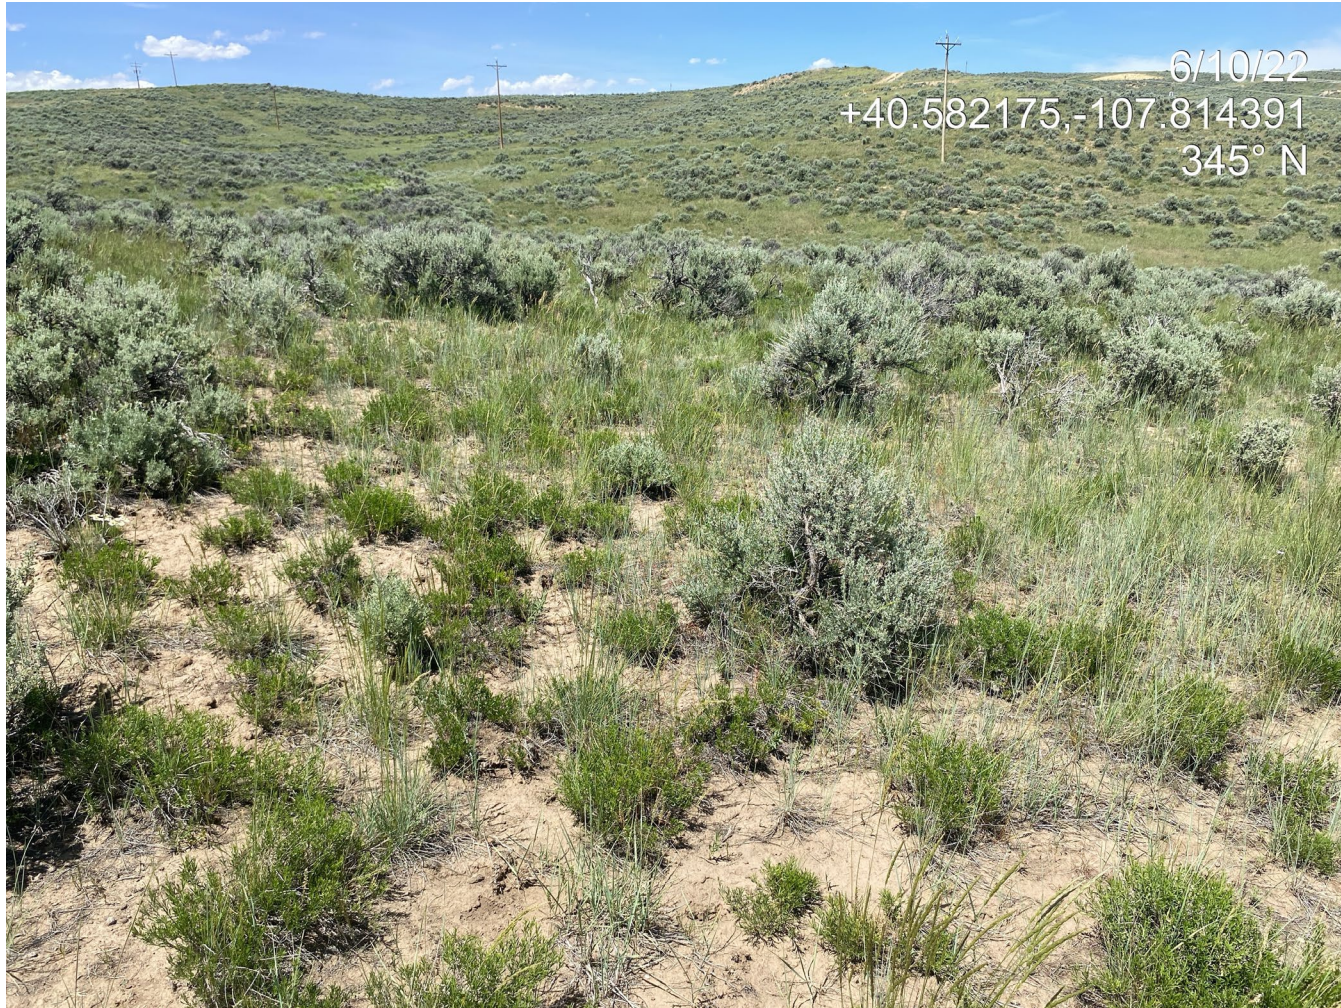
**Photo 8.** Photo taken from the north of the Location shows adjacent reference area vegetation.
