Inspection Photos and Issue Report

6/21/2022

Operator: CAERUS PICEANCE LLC #10456

Location ID: 458475

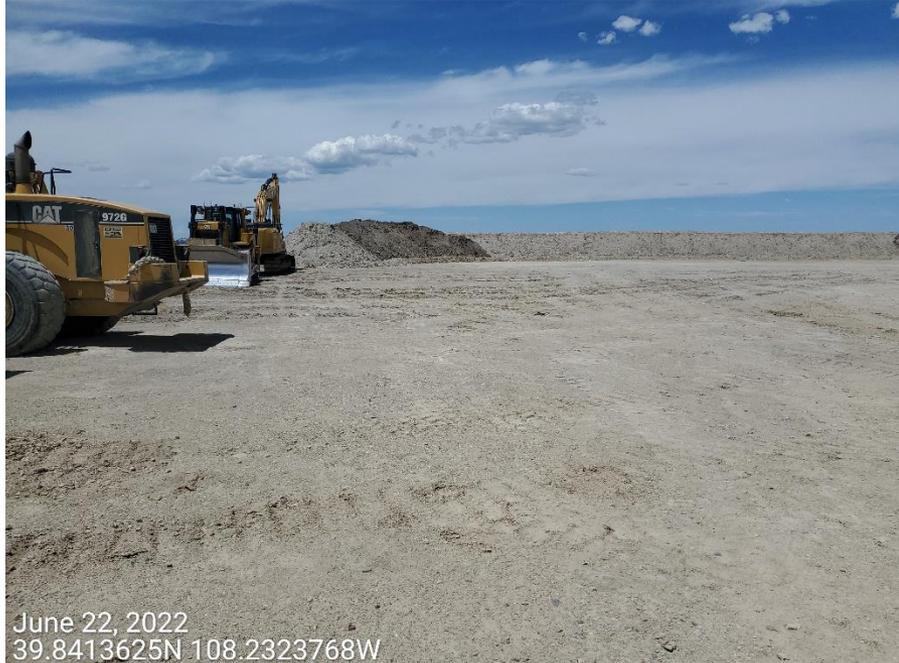
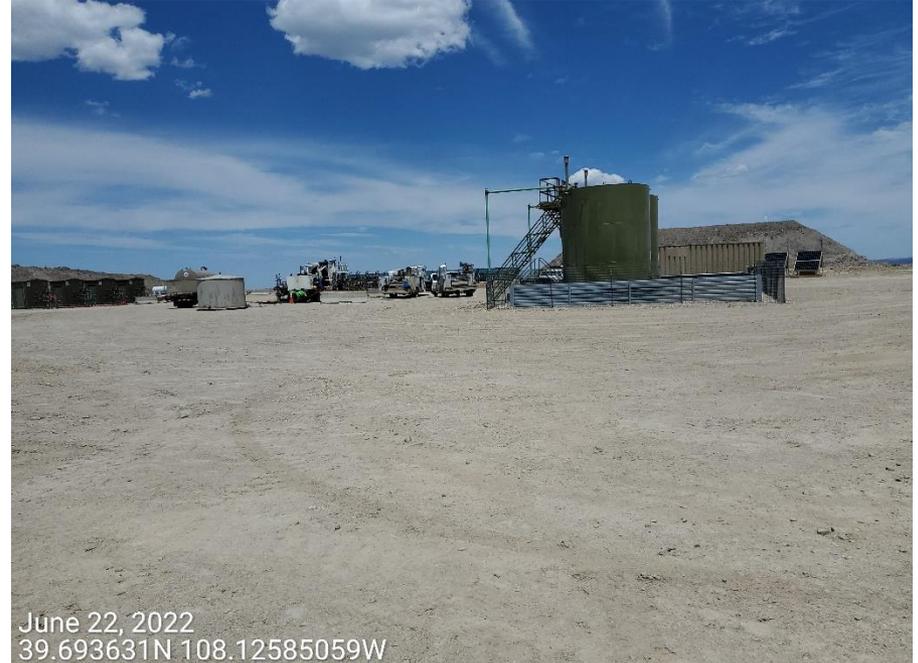
Photo 1: Photos taken from the southeast end of the Location, facing west and north. Photos provide overview of the Location. Interim reclamation of the Location has not been completed.

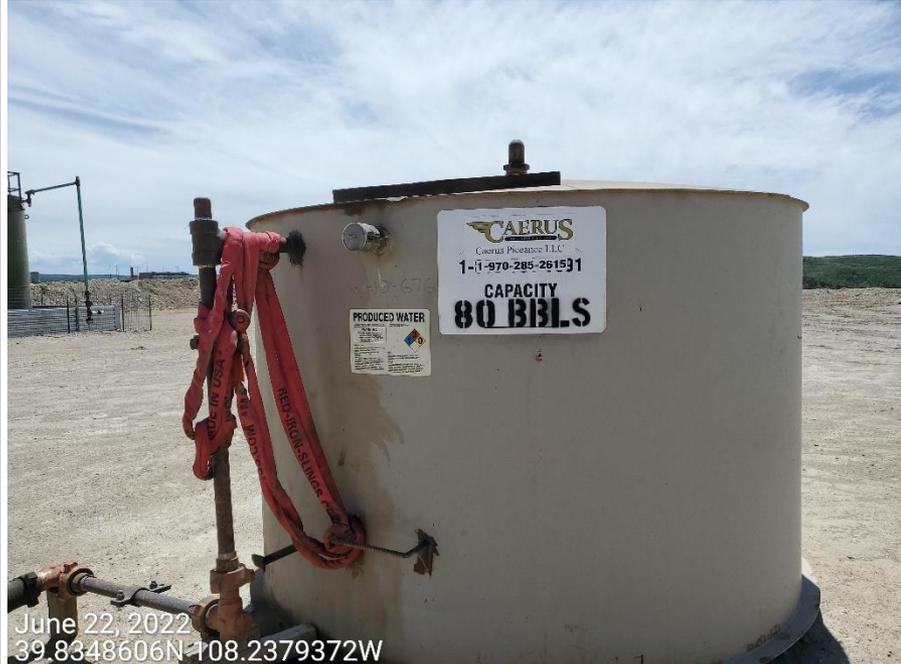
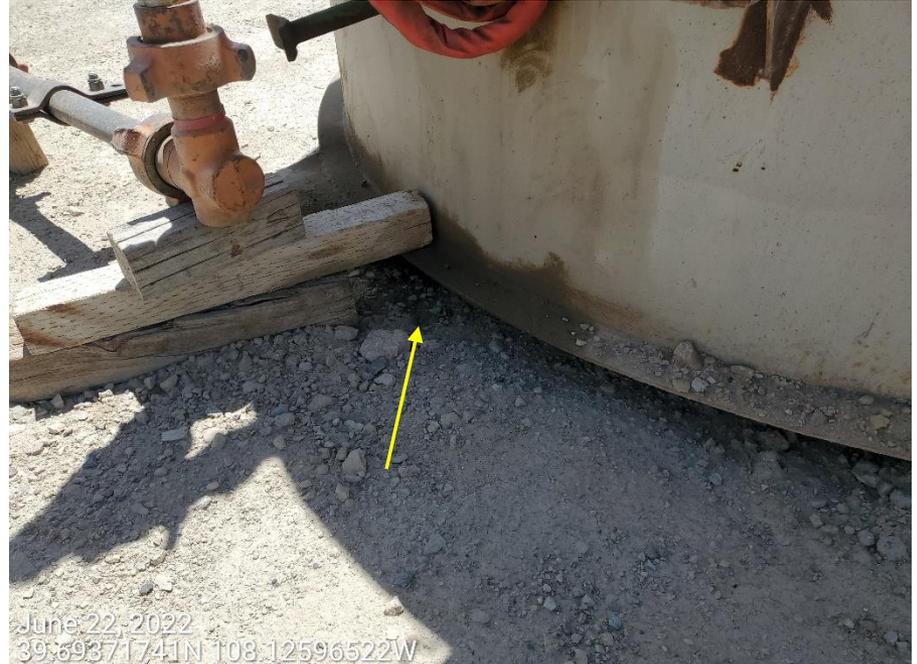
Photo 2: Photo left show labelling on tank has been installed. Previous inspection observed fluids actively discharging from tank. Photo right shows all impacted soils at the base AND beneath the tank do not appear to have been cleaned/remediated.

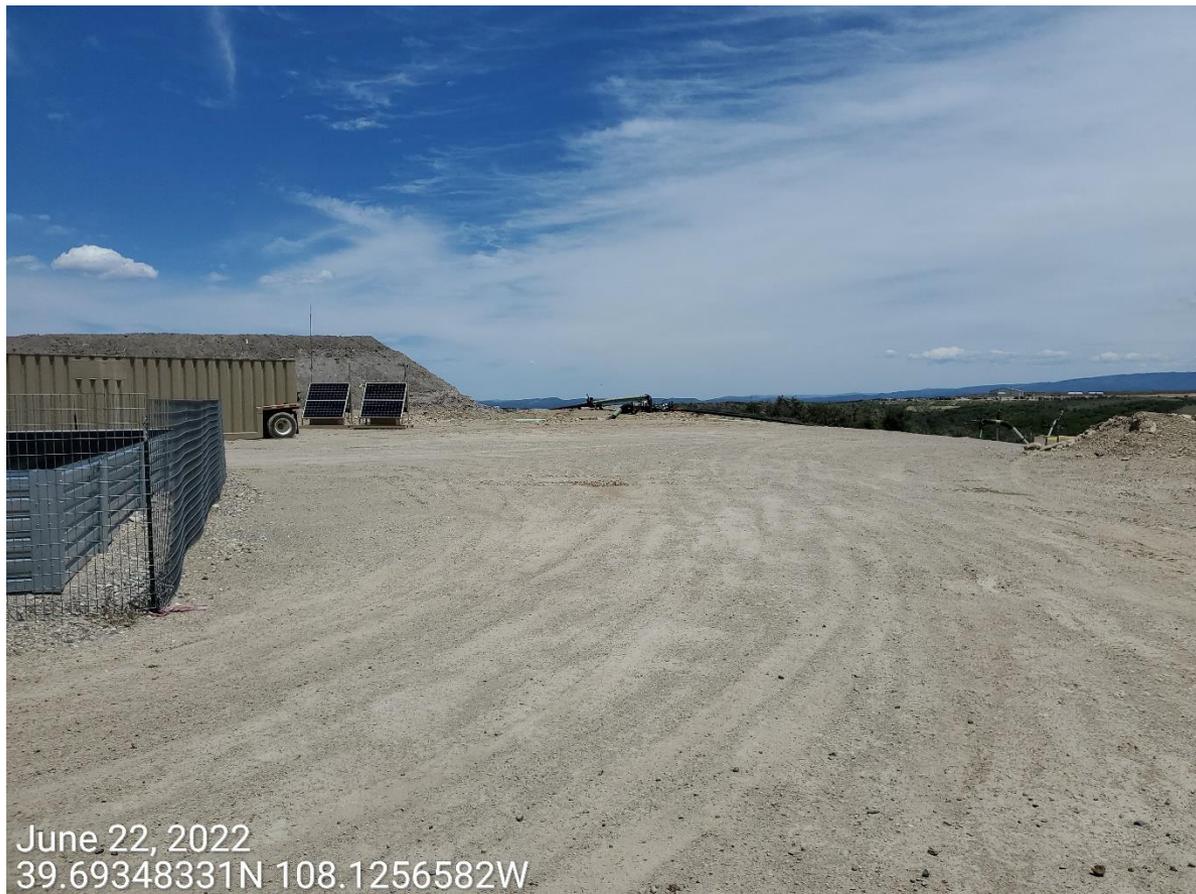
Photo 3: Photo shows tank with inadequate secondary containment has been removed.

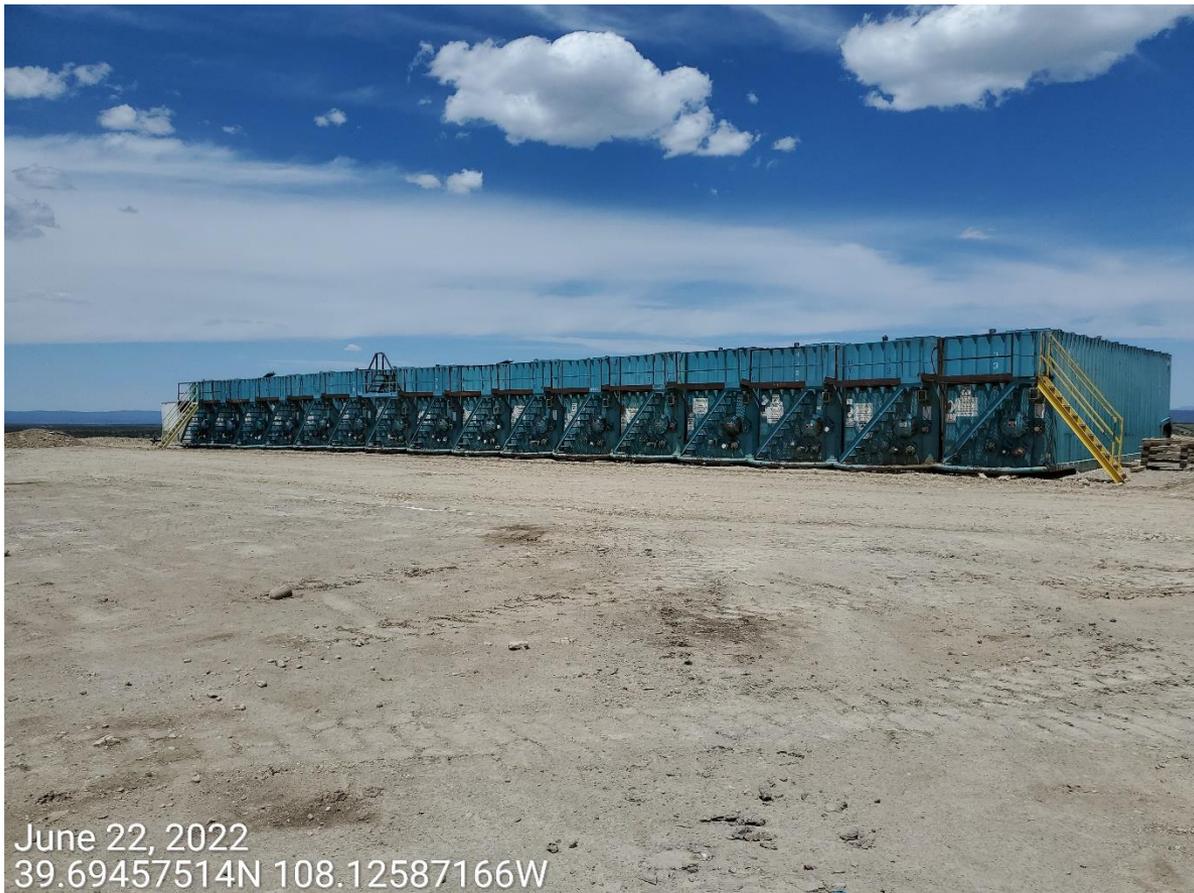
June 22, 2022
39.69457514N 108.12587166W

Photo 4: Photo shows tanks have not been removed from the Location.

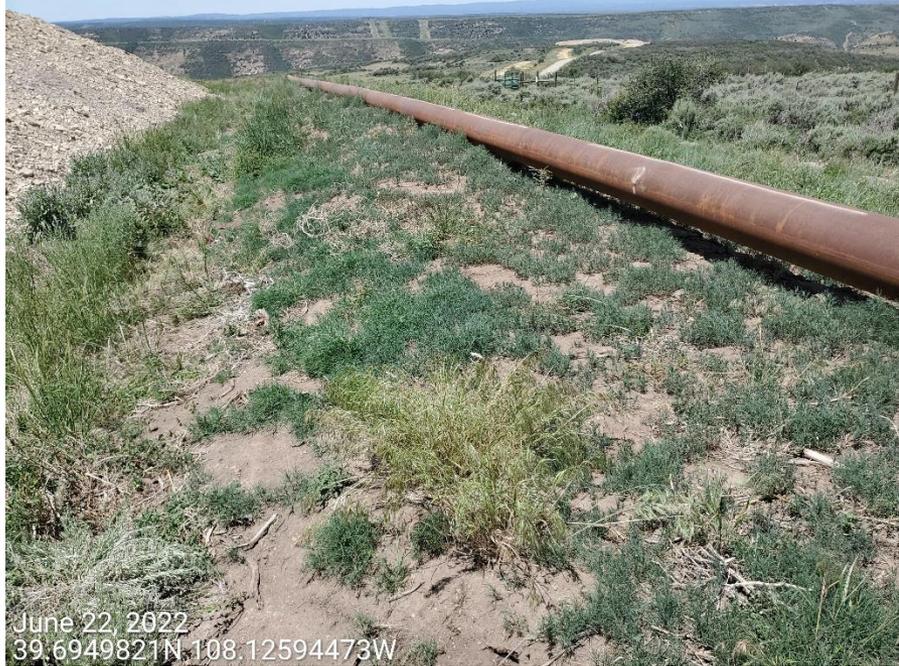
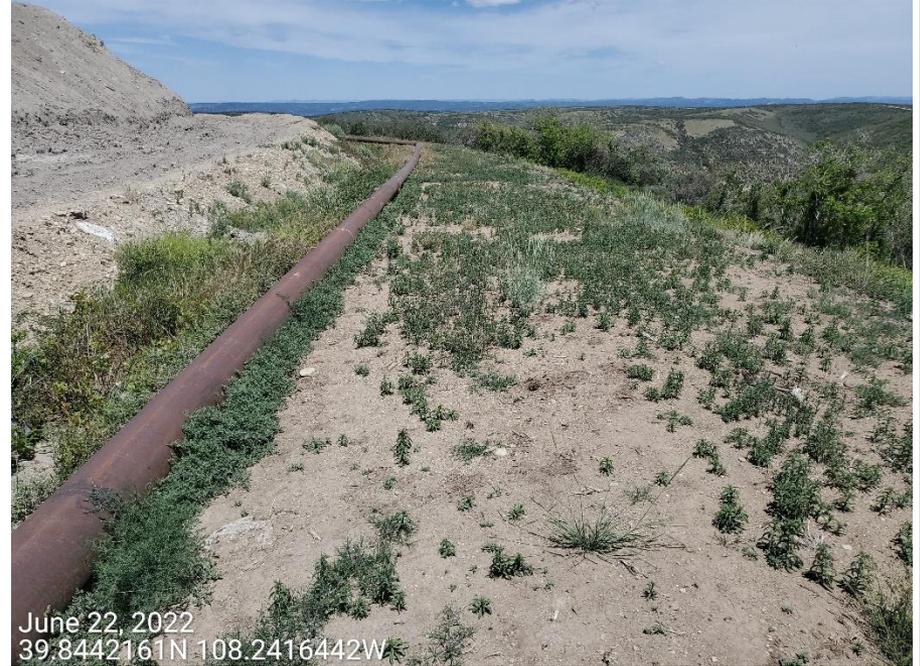
Photo 5: Photos taken from the topsoil stockpile on the north and east end of the Location. Photo shows vegetation on top of the stockpiles are predominantly Undesirable Plant Species. BMPs to protect topsoil stockpile is inadequate.

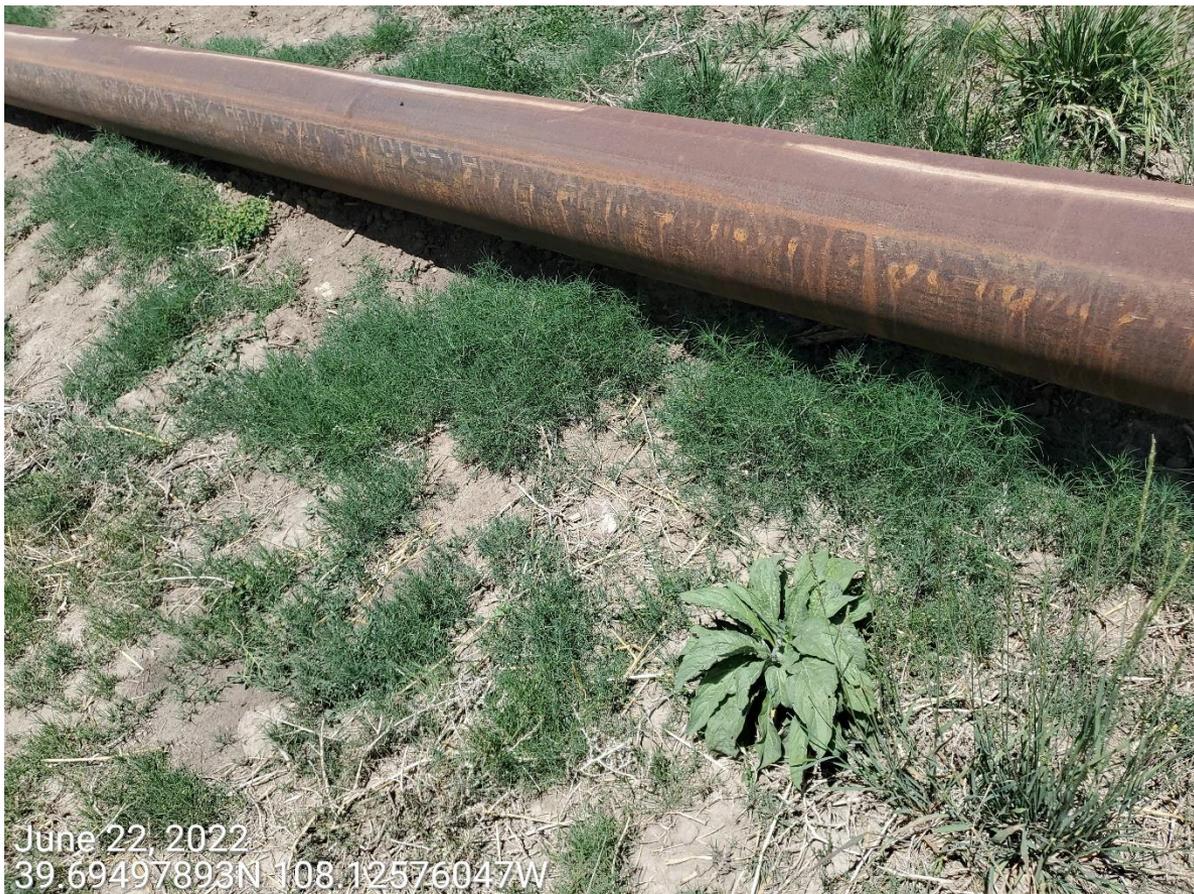
Photo 6: Continued from photo 5. Photo shows vegetation establishment on top of the Stockpiles are Undesirable Plant Species.
