Inspection Photos

Location Name: Burns-66S94W /35SWSE

Inspection Document #: 702800371

Anna O'Malley
Reclamation Specialist, COGCC

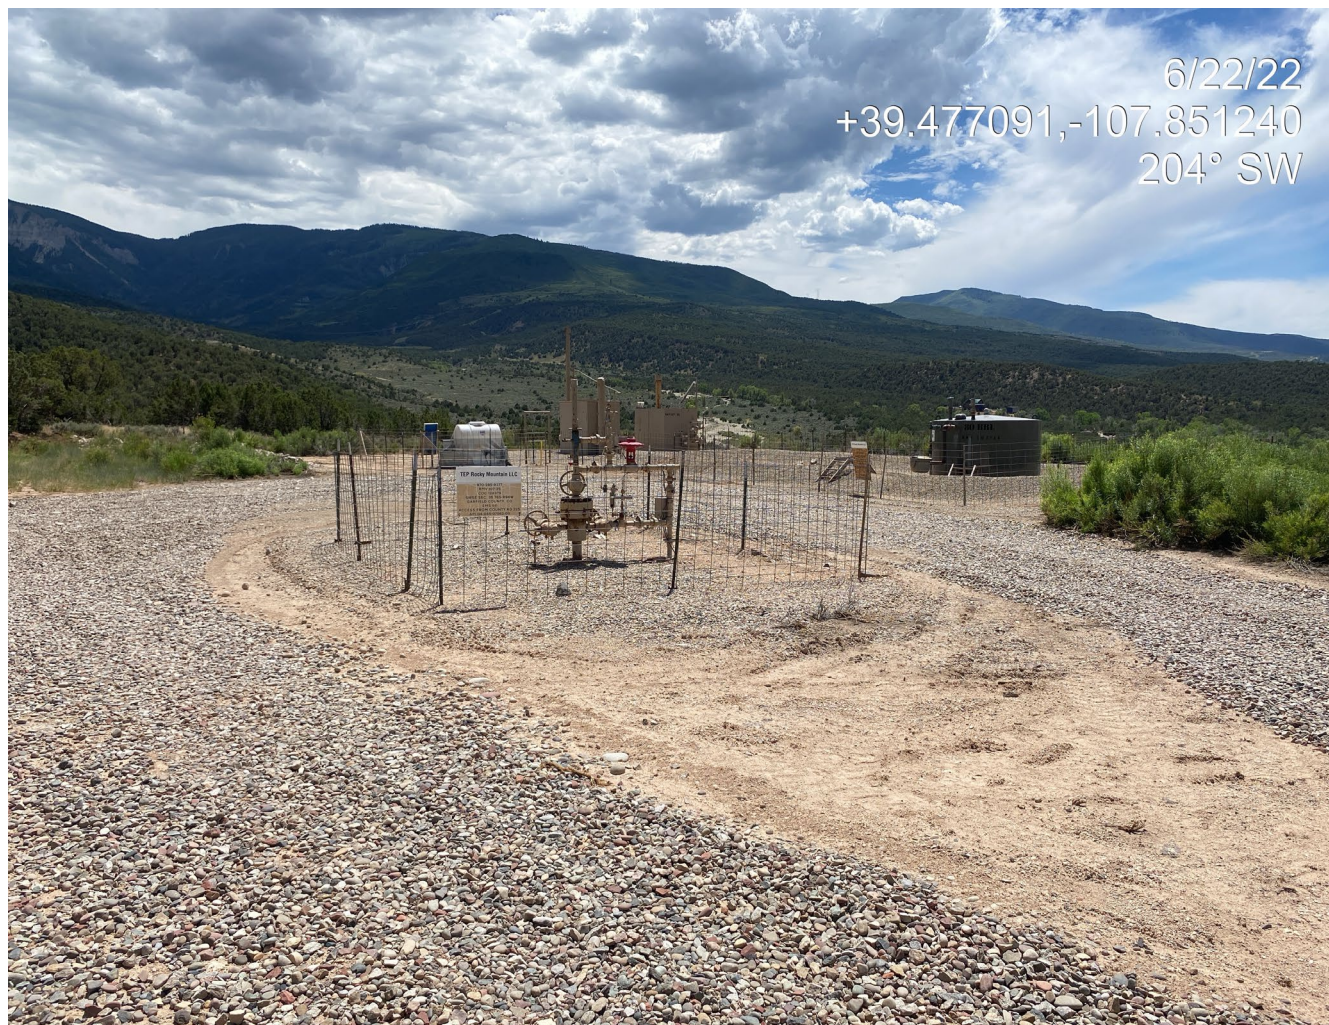
Photo 1. Photo taken from the north shows an overview of the Location.

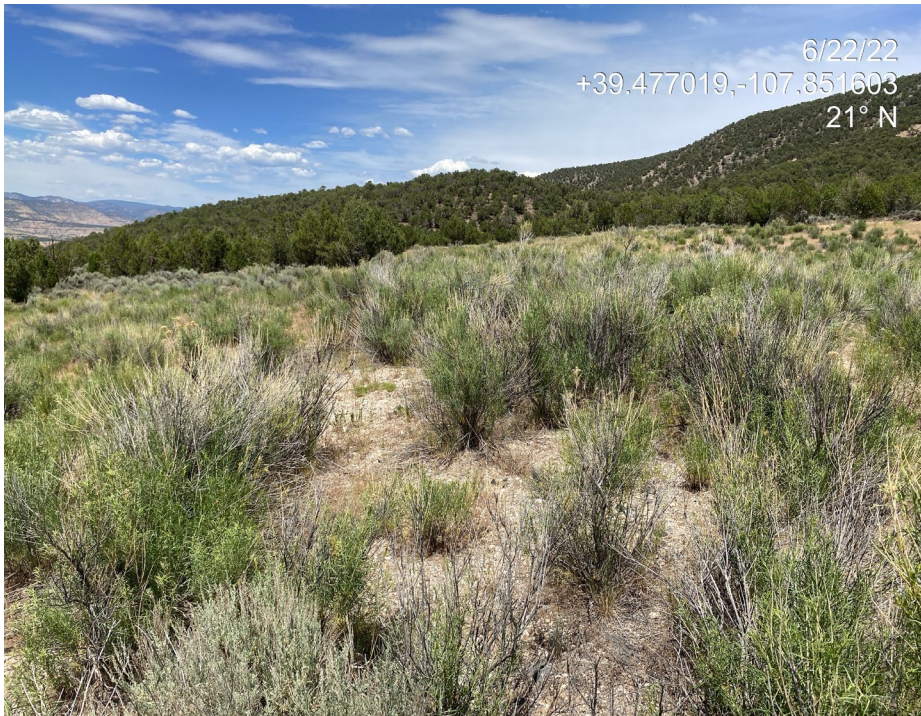
Photo 2. Photo taken from the east of the Location shows interim areas dominated by the weedy, native shrub, rubber rabbitbrush.

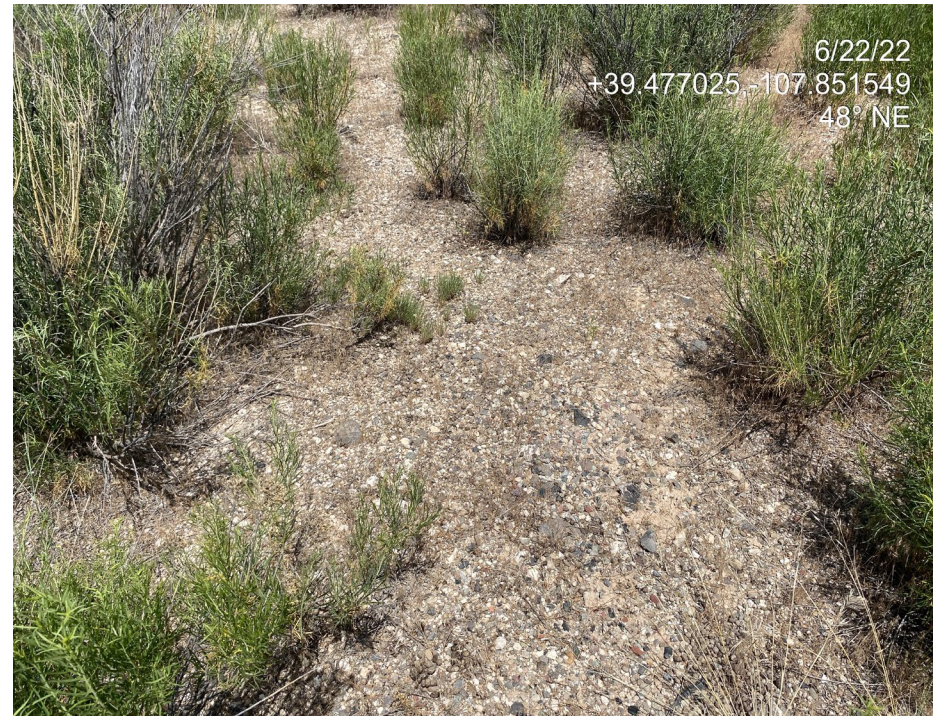
Photo 3. Photo taken from the east of the Location shows interim areas with a large amount of gravel covering the soil surface which is not found in reference areas.

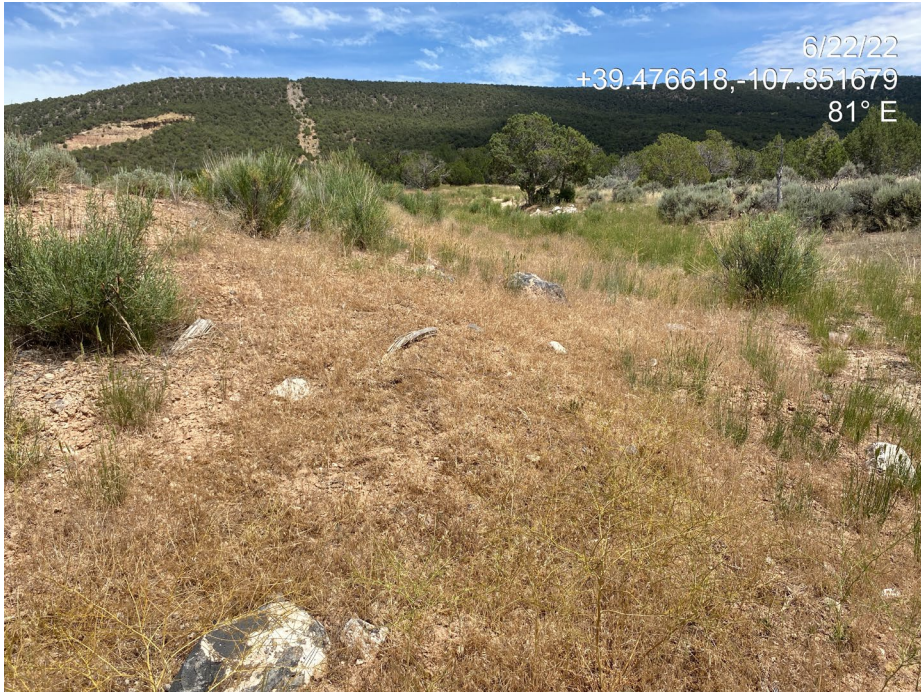
Photo 4. Photo taken from the fill slopes at the southwest of the Location shows an area where vegetation is dominated by noxious weeds (cheatgrass and field bindweed).

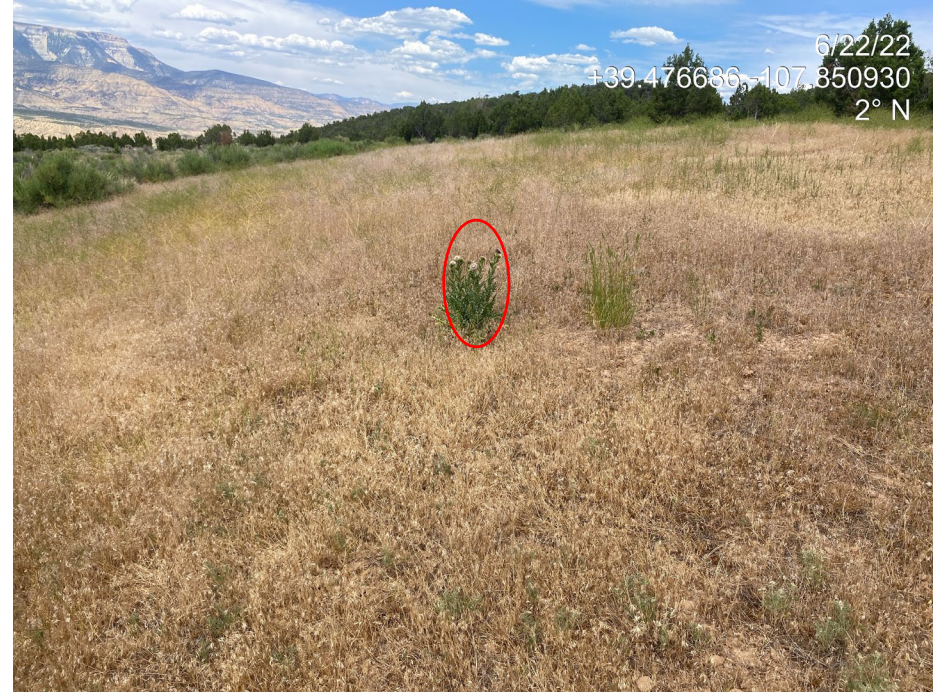
Photo 5. Photo taken from the east of the Location shows a portion of the interim area which is dominated by the noxious weed cheatgrass. One musk thistle was also present.

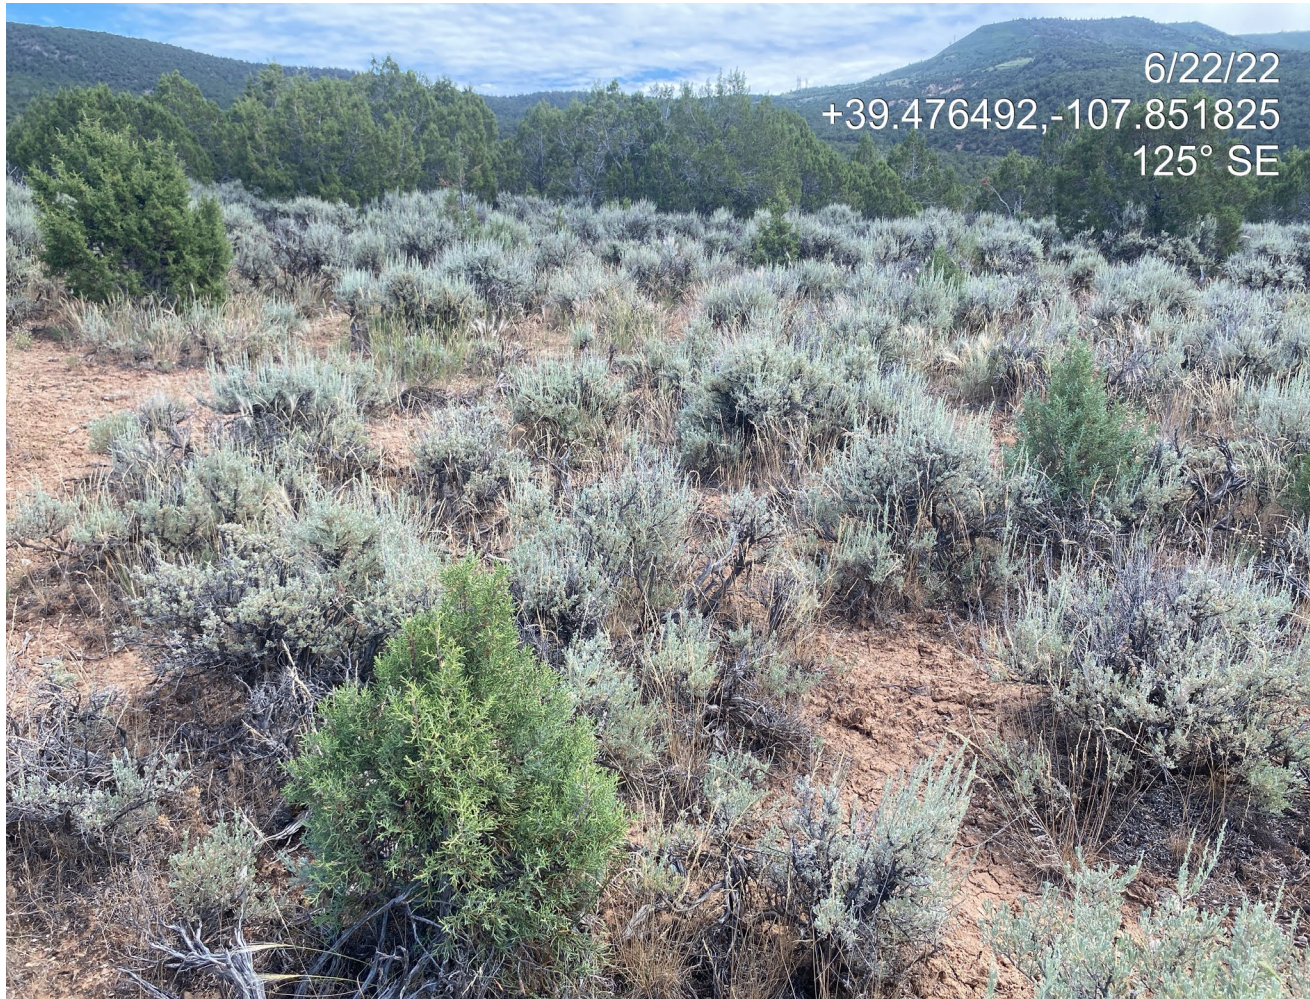
Photo 6. Photo taken to the southwest of the Location shows the reference area vegetation community is native rangeland. Cheatgrass is uncommon.
